*This document is an English translation of the Final Report on the accident involving the Boeing 737-8KN aircraft registered A6-FDN that occurred on March 19, 2016 (00:42 UTC) at Rostov-on-Don aerodrome, the Rostov Region, Russian Federation.*

**INTERSTATE AVIATION COMMITTEE  
AIR ACCIDENT INVESTIGATION COMMISSION  
FINAL REPORT**

Type of occurrence	Fatal accident
Type of aircraft	Boeing 737-8KN, airplane
Nationality and registration marks	A6-FDN
Owner	Celestial Aviation Trading 38 Limited, Shannon, County Clare, Ireland
Operator	Dubai Aviation Corporation, P.O. Box: 353, United Arab Emirates
Aviation authority of the place of occurrence	Southern FATA Interregional Territorial Department
Place of occurrence	Russian Federation, the Rostov region, the Rostov-on-Don aerodrome, reference position: 47°15'54.7" N, 039°49'43.8" E
Date and time	19.03.2016, 03:42 local time (00:42 UTC), nighttime

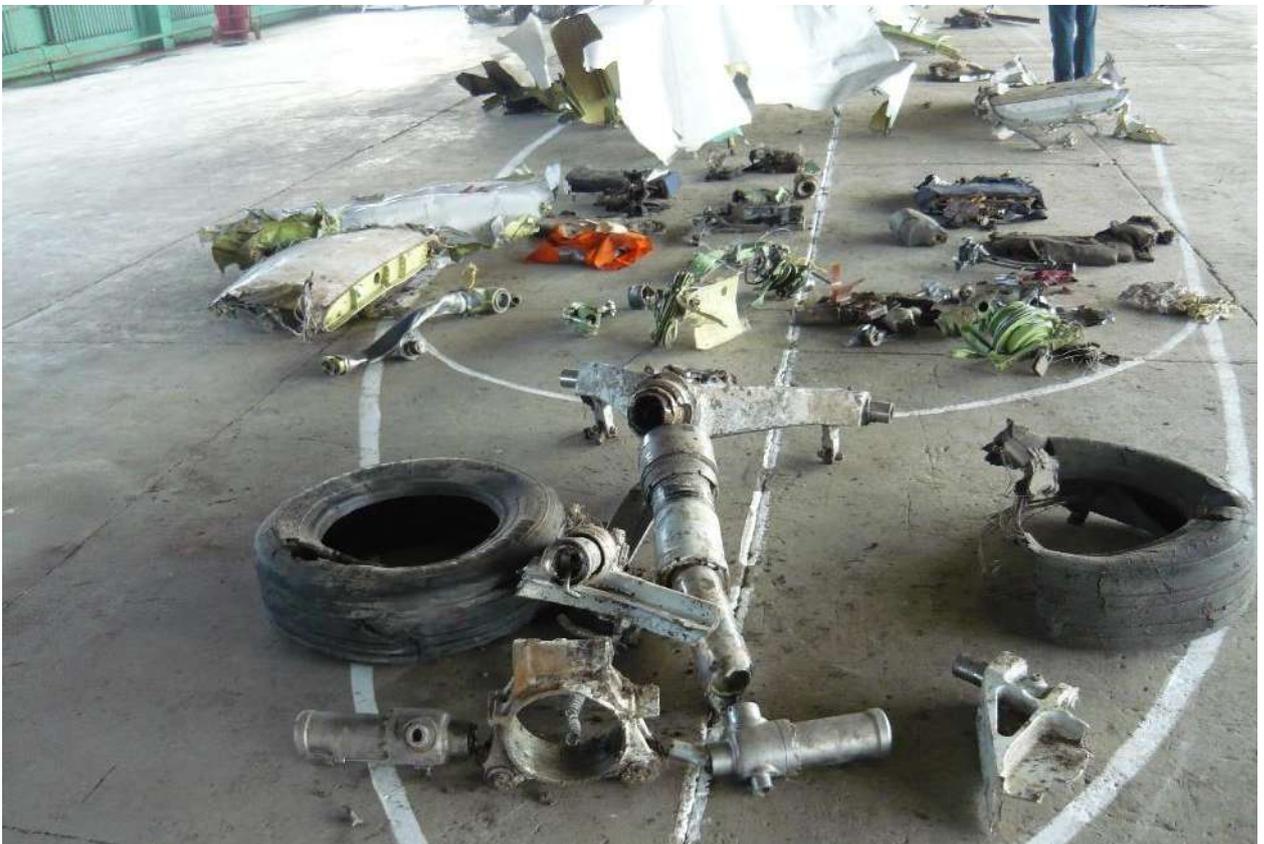
The aircraft flight controls and the equipment, located inside the cockpit are almost completely destroyed (Fig. 1).

**Fig. 1. The elements of the cockpit and the nose landing gear leg**

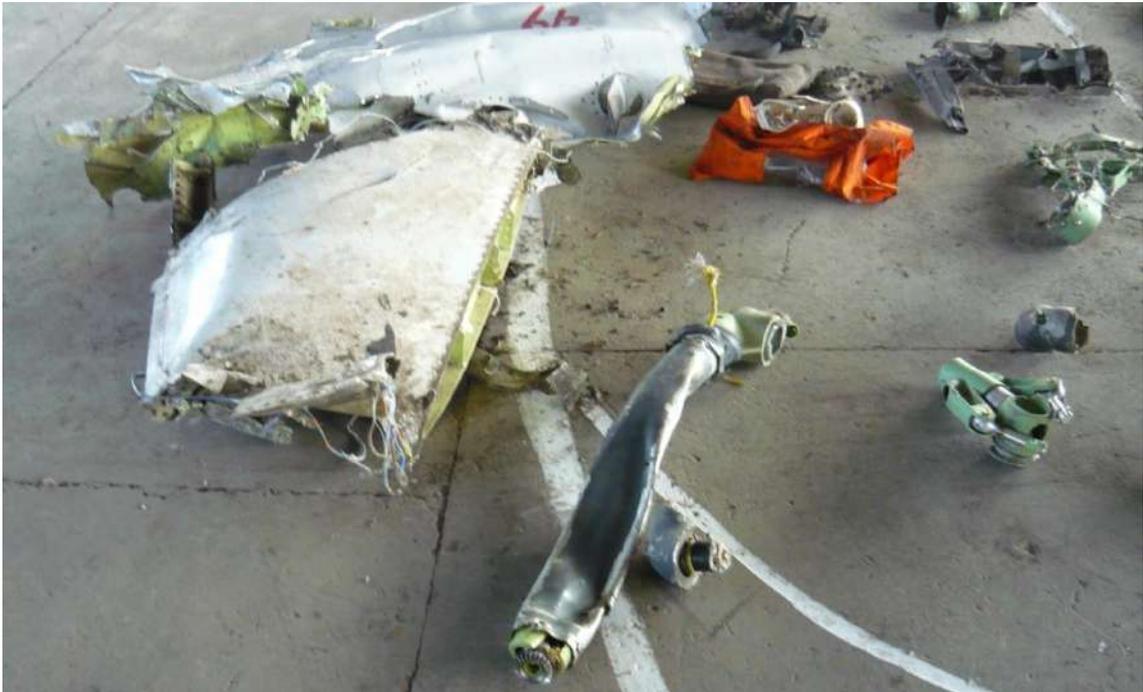
The partly survived F/O control column part with the elements of the control wheel was discovered having been considerably deformed (Fig. 2). The control wheel elements integrated the partly destroyed trim switch.

**Fig. 2. The element of the F/O control column**

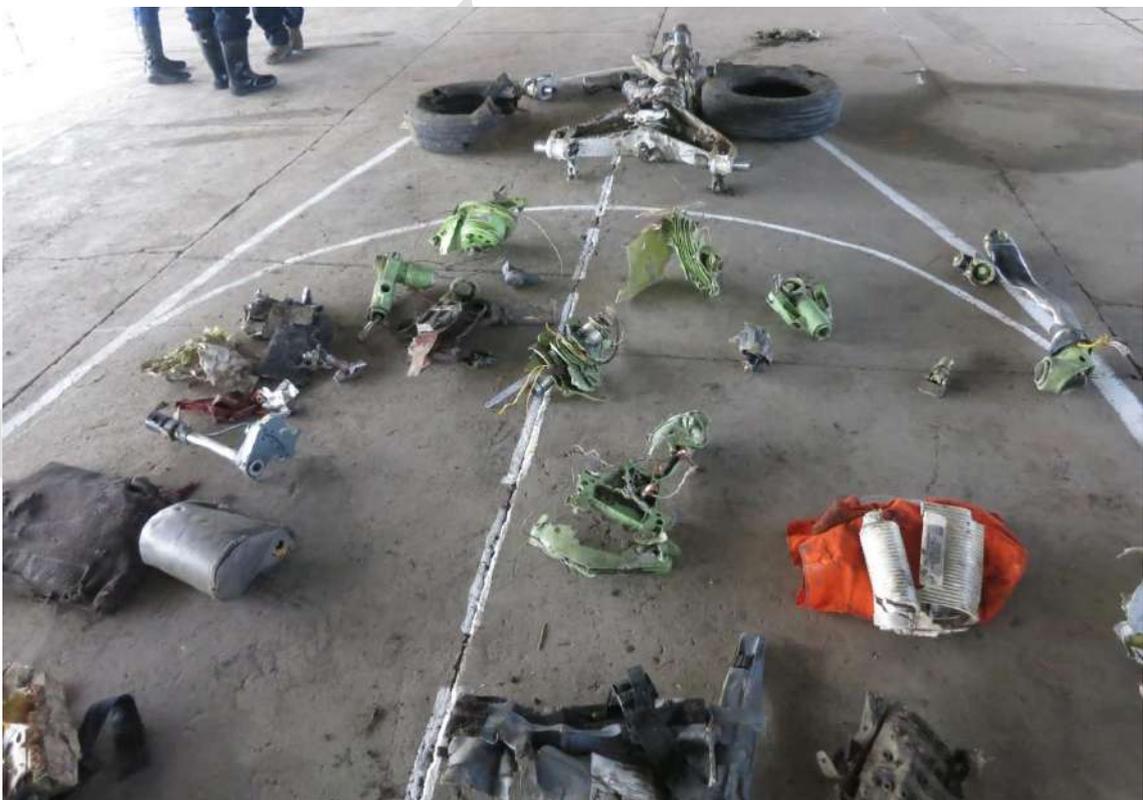
The elements of the elevator, ailerons and rudder control systems, mounted in the cockpit underfloor compartment, are presented on Fig. 3.

**Fig. 3. The elements of the elevator, ailerons and rudder control systems, mounted in the cockpit underfloor compartment**

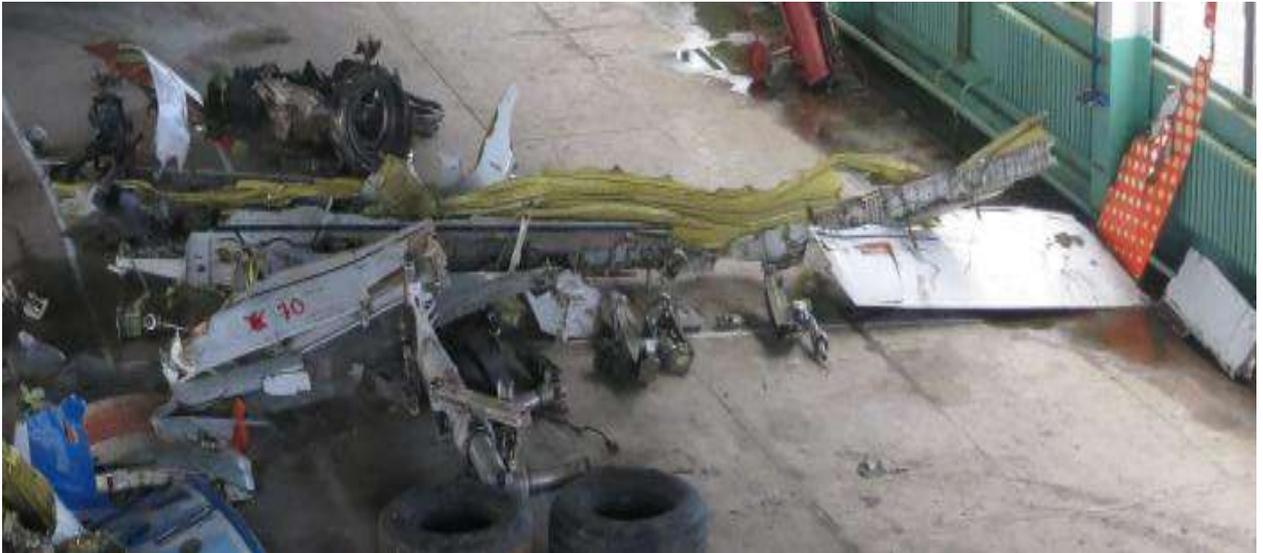
**Fig. 4. The fragments of the RH wing panel**

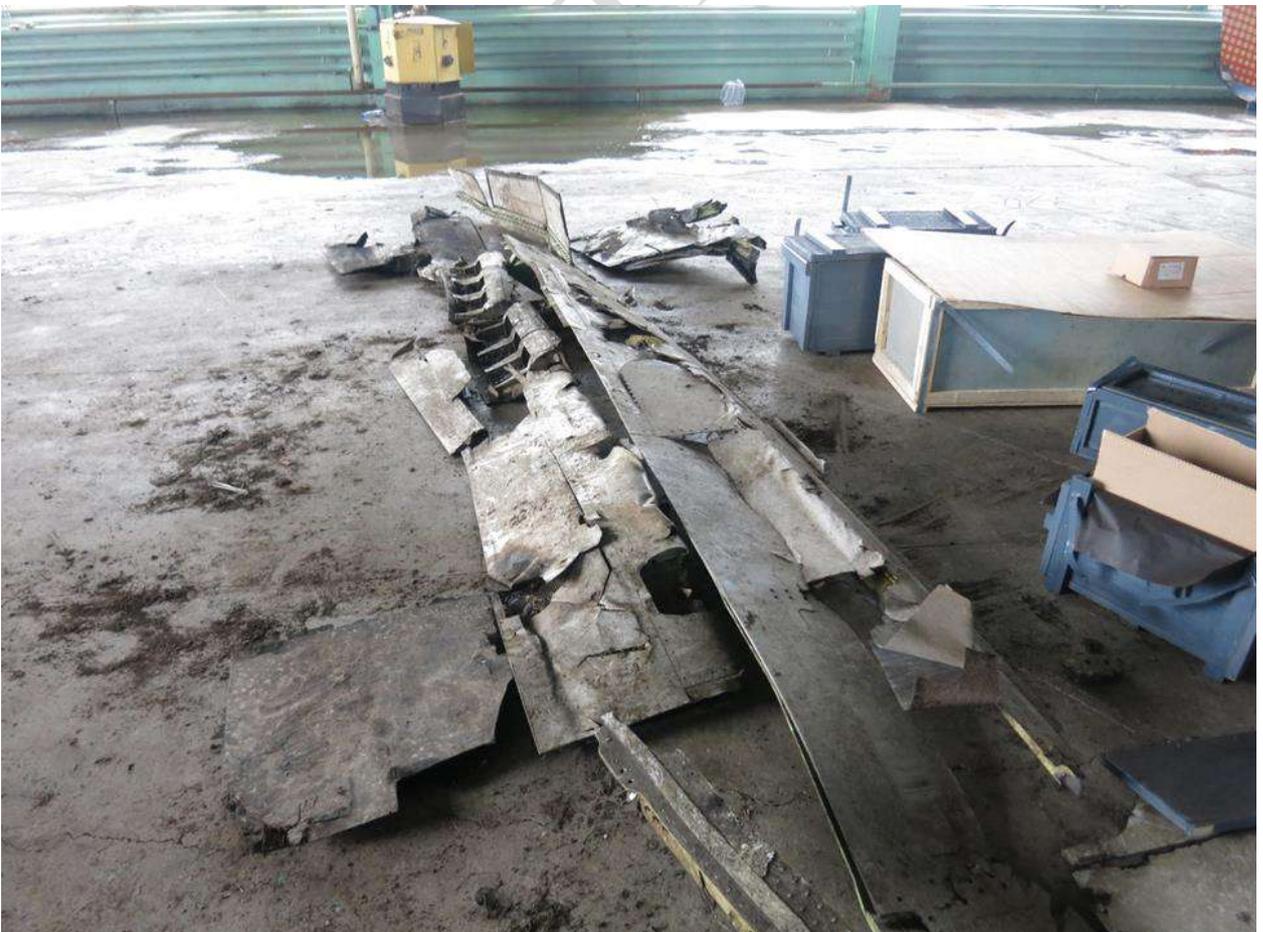
**Fig. 5. The fragments of the LH wing panel**

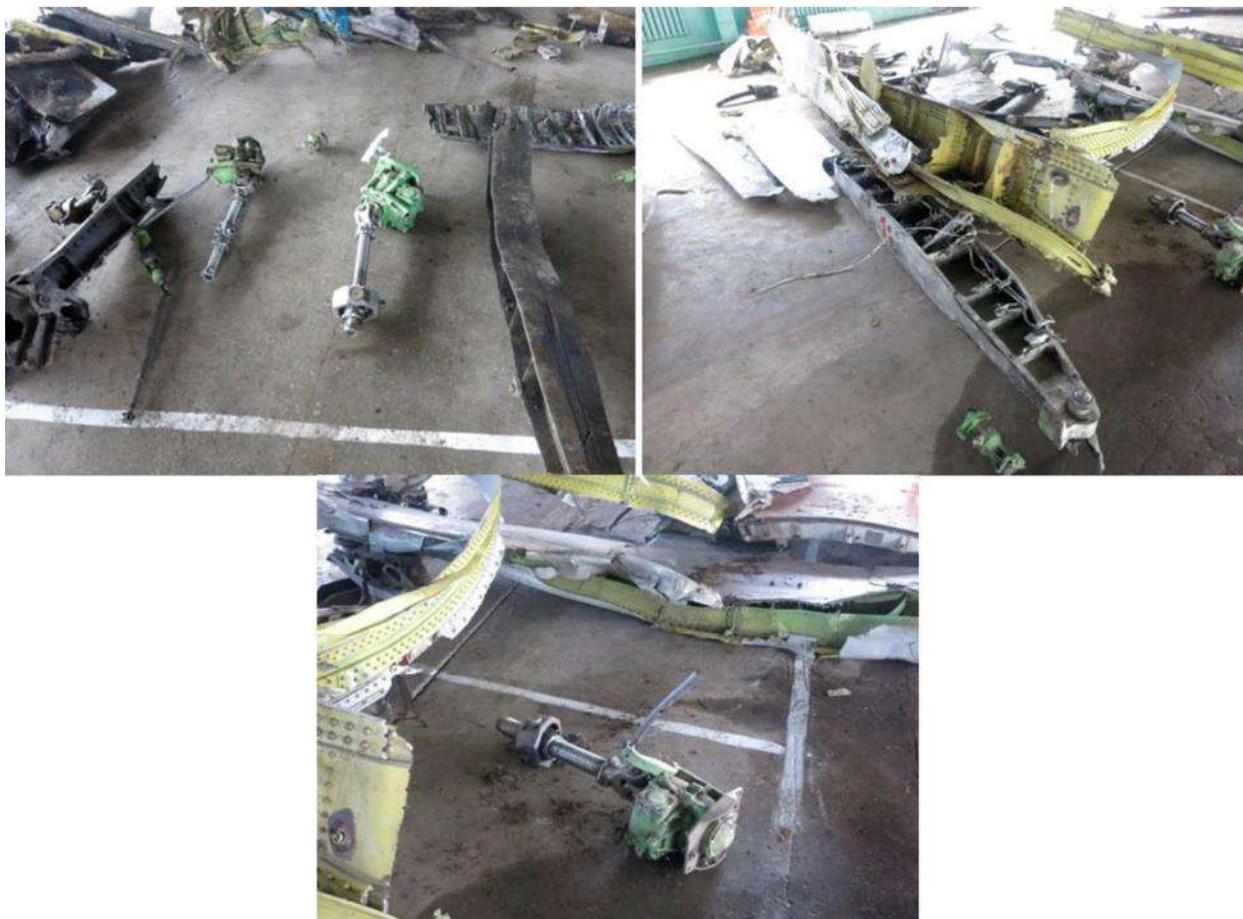
As the result of the aircraft impact with ground, the slats had been totally destroyed, in the progress of the layout only the smaller fragments of the flaps were retrieved. The transmission of the flaps, laid along the aft wing spar, is destroyed. All the eight jackscrews and eight single unit tracks of the flaps retraction/extension mechanism had been discovered (Fig. 6). The elements in question are mechanically damaged, the screw parts are destroyed and deformed.

**Fig. 6. Jackscrews and single unit tracks**

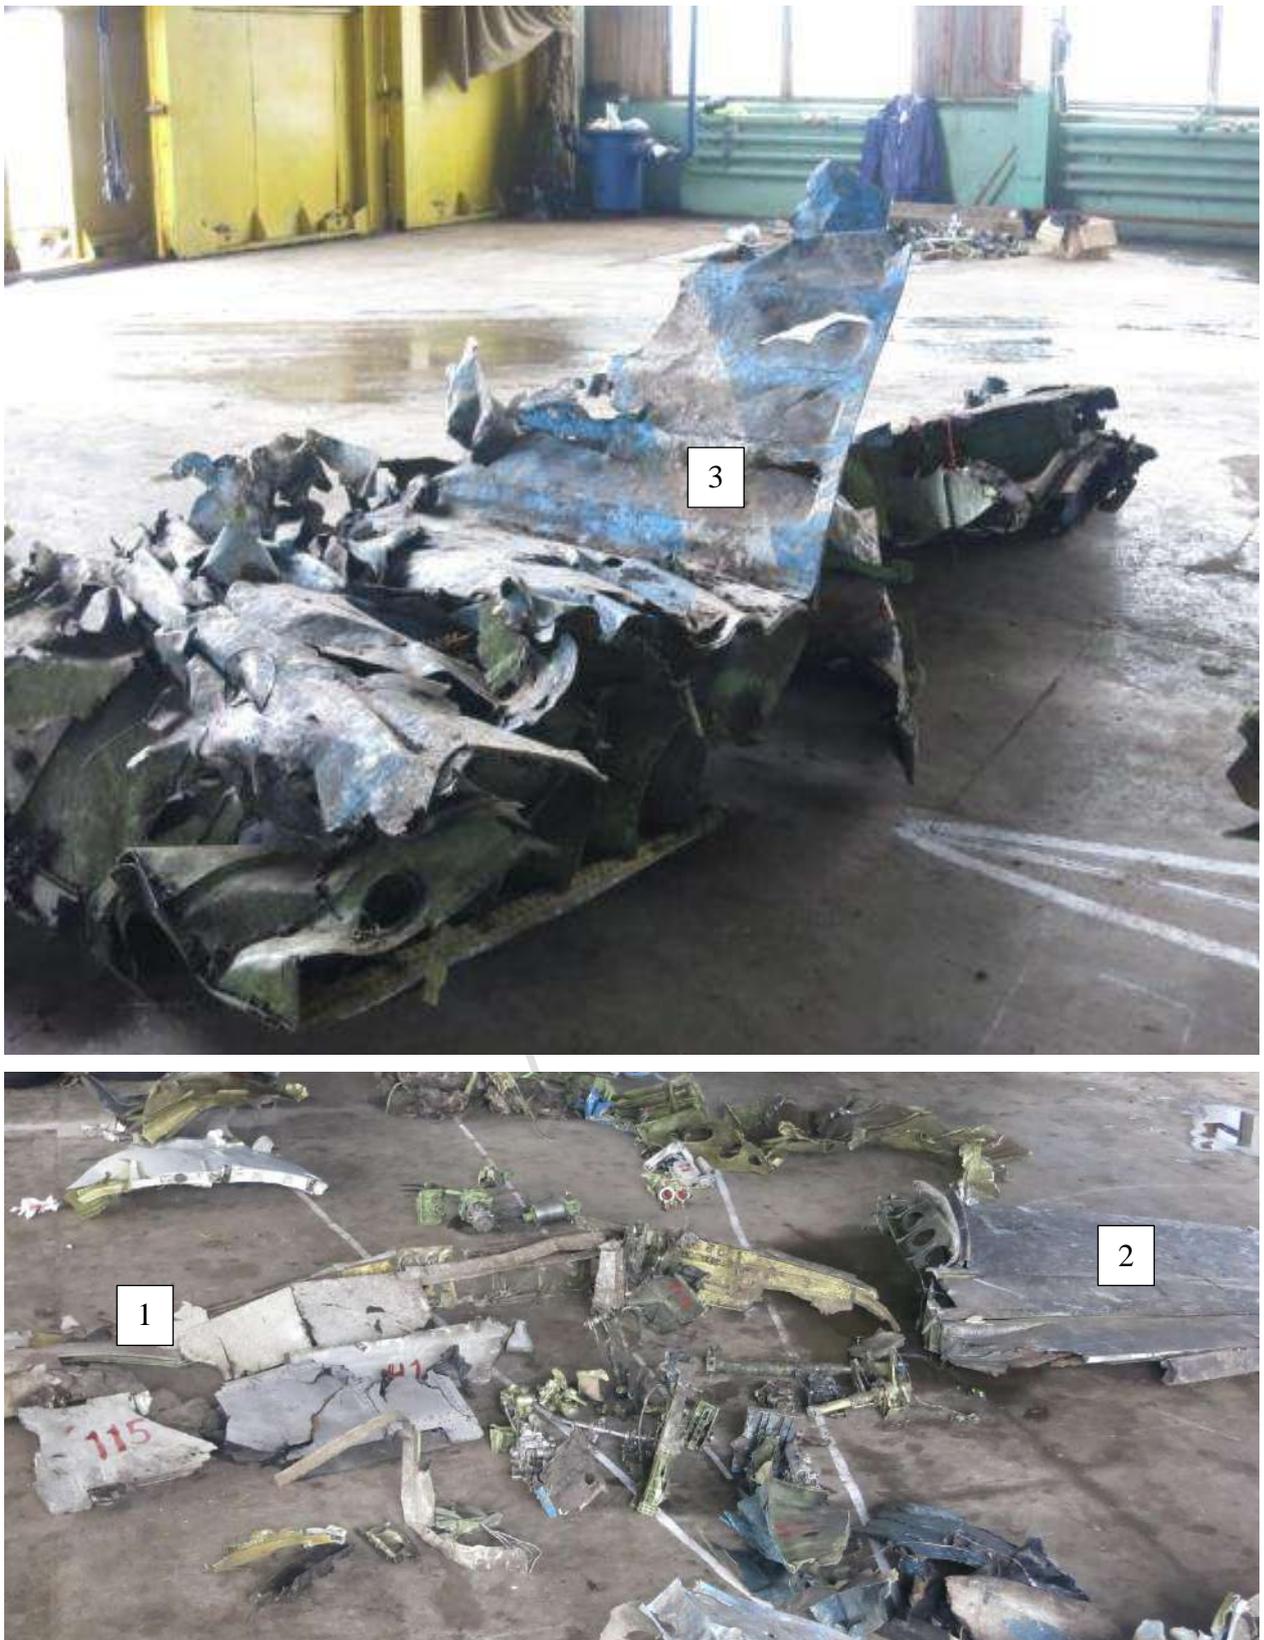
The vertical stabilizer, disintegrated in several parts, separated from the fuselage at the area of attachment. The composite rudder is completely destroyed as the result of the impact with ground. The skin and the frame of the vertical stabilizer are considerably damaged. There are no signs of fire and soot on the vertical stabilizer. The horizontal stabilizer had been destroyed and separated from the vertical stabilizer structure.

**Fig. 7. The vertical and horizontal stabilizer elements (1 – LH half of the stabilizer, 2 - RH half of the stabilizer, 3- the vertical stabilizer elements)**

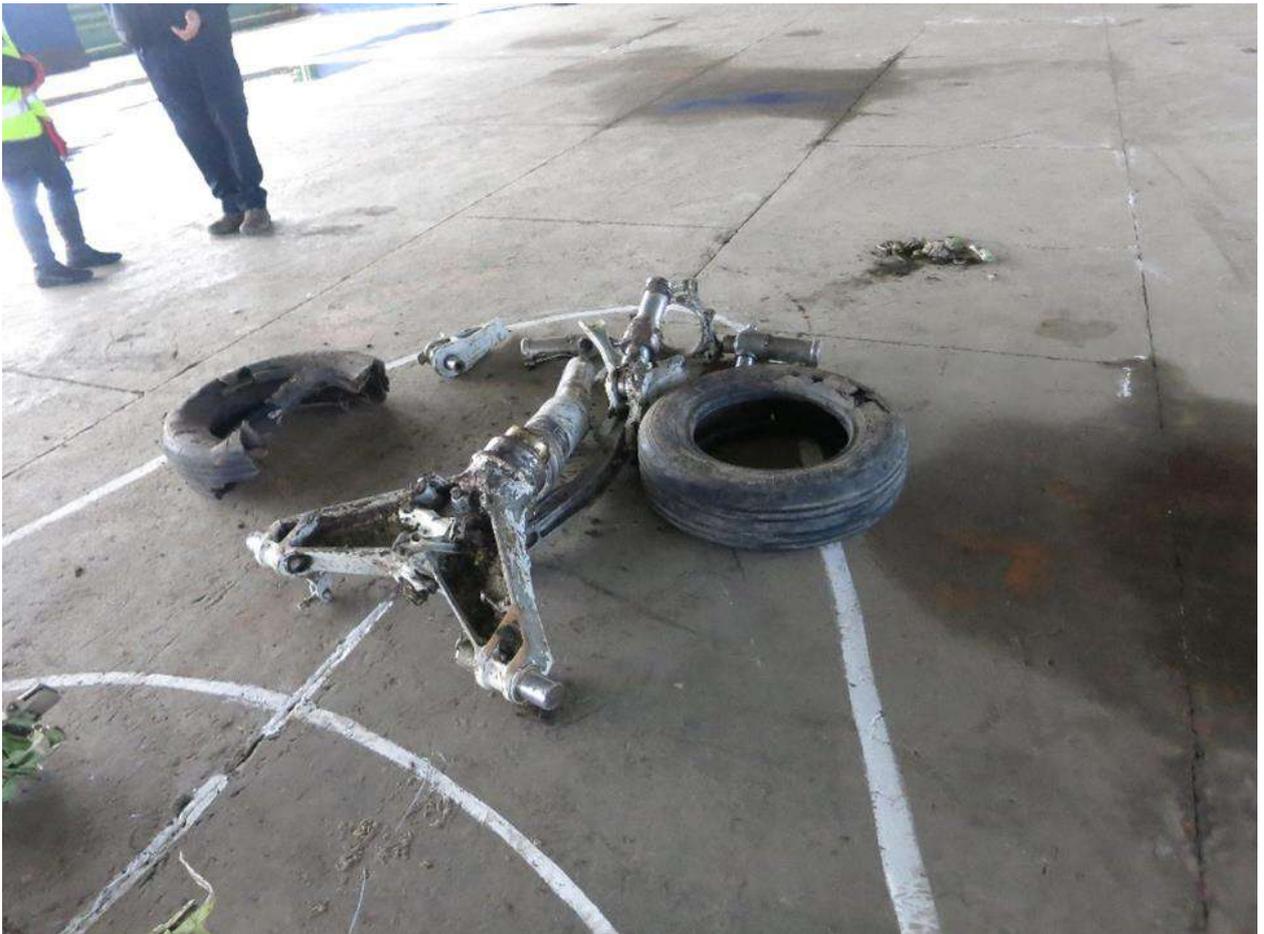
nose landing gear steering actuator cylinders are separated from the standard attachment points. The nose landing gear wheels attachment pivot and the wheels' disks are totally destroyed.

**Fig. 8. Nose landing gear**

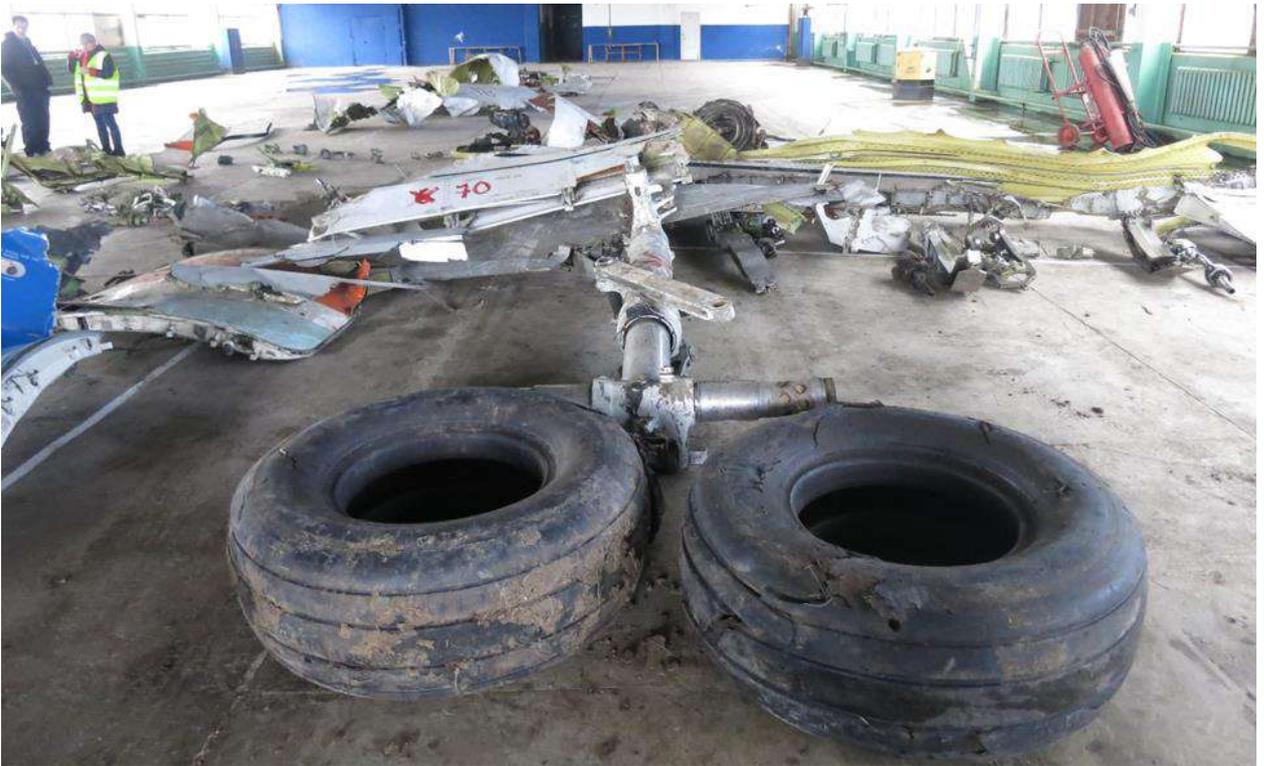
The right and left main landing gear legs (Fig. 9 and Fig. 10) are considerably damaged. The landing gear legs are separated from the fuselage attachment beams. The torsion links of the shock struts are destroyed. The retraction/extension actuators are separated off the legs main structure. The disks of the brakes are broken off. The brakes hubs are considerably damaged. The hubs of the wheels are separated off the tires.

**Fig. 9. The elements of the right main landing gear leg**

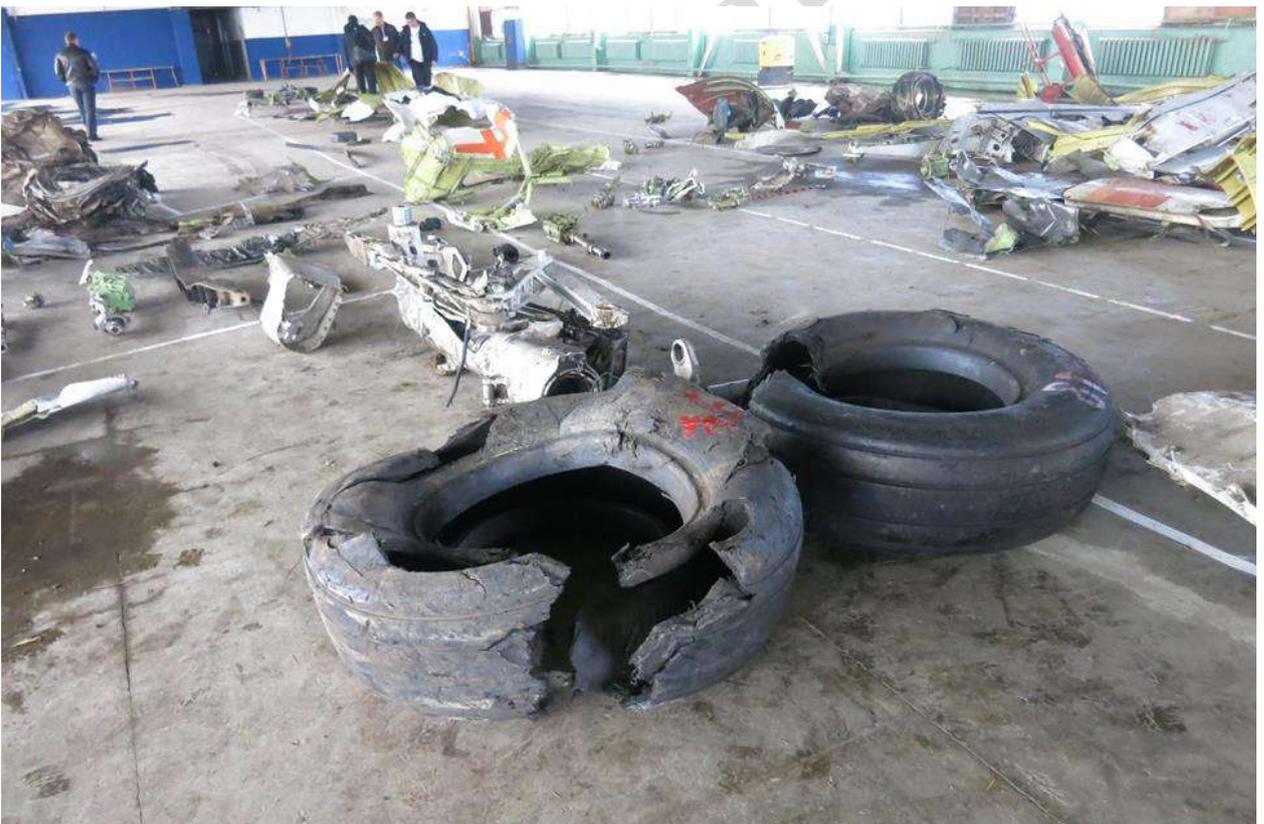
**Fig. 10. The elements of the left main landing gear leg**

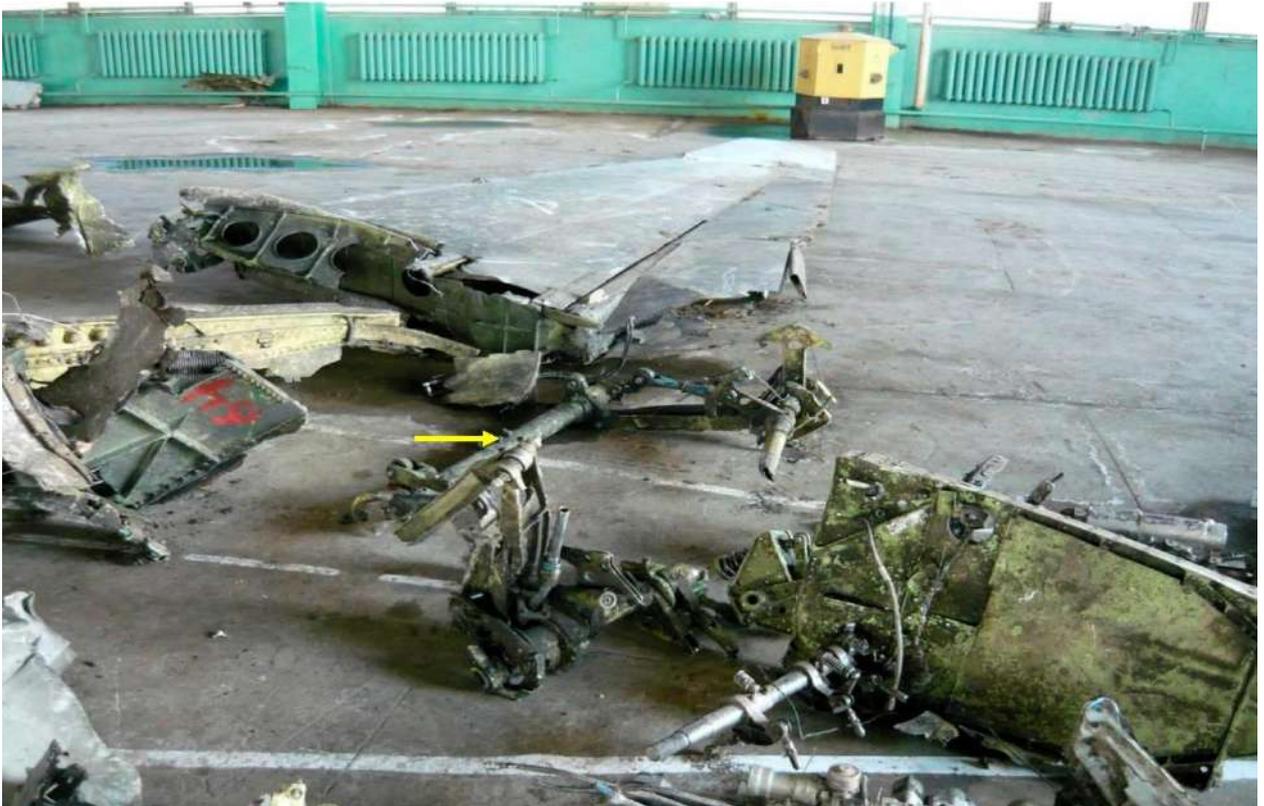
The fragments of the elevator control system (the input rods, the PCUs and the elevator autopilot electrohydraulic actuator) (Fig. 11) are significantly damaged as the structure had disintegrated at the aircraft impact with ground.

**Fig. 11. The elevator control system output shaft (pointed with arrow)**

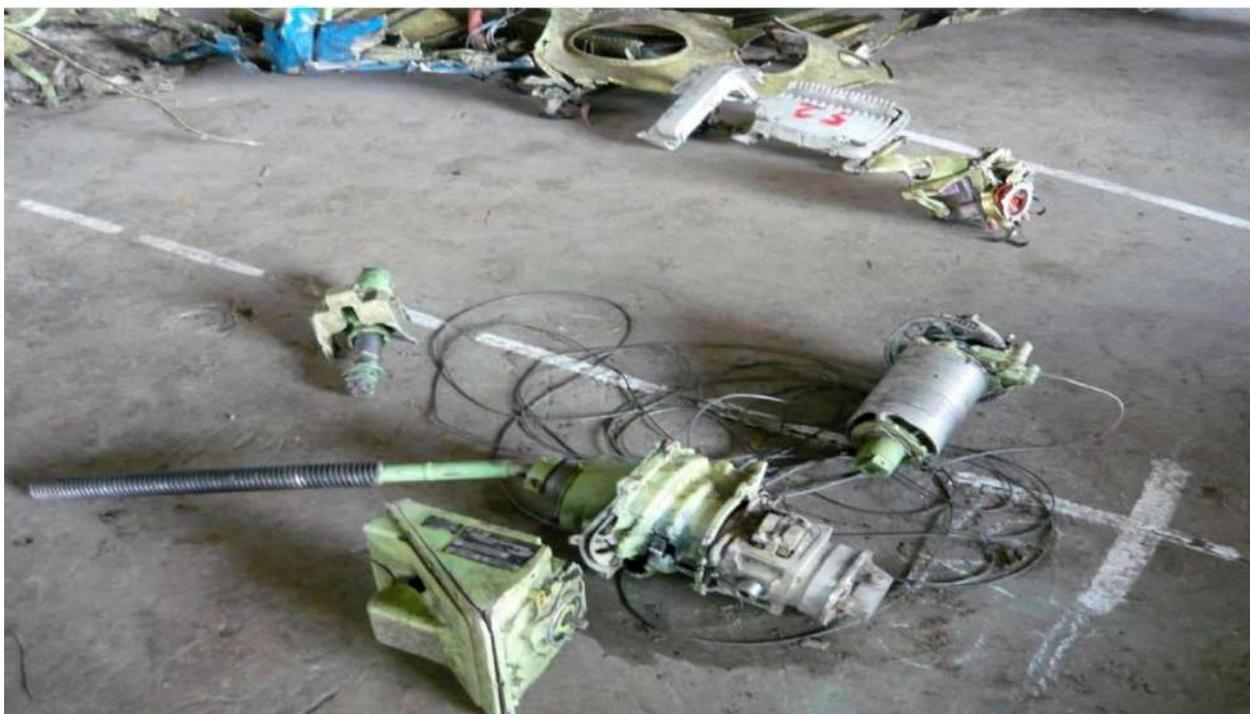
the off-design loads application. The jackscrew with the attachment fitting to stabilizer (Fig. 12) had been discovered apart of the stabilizer being disintegrated due to the off-design loads.

**Fig. 12. The recovered elements of the stab trim actuator**

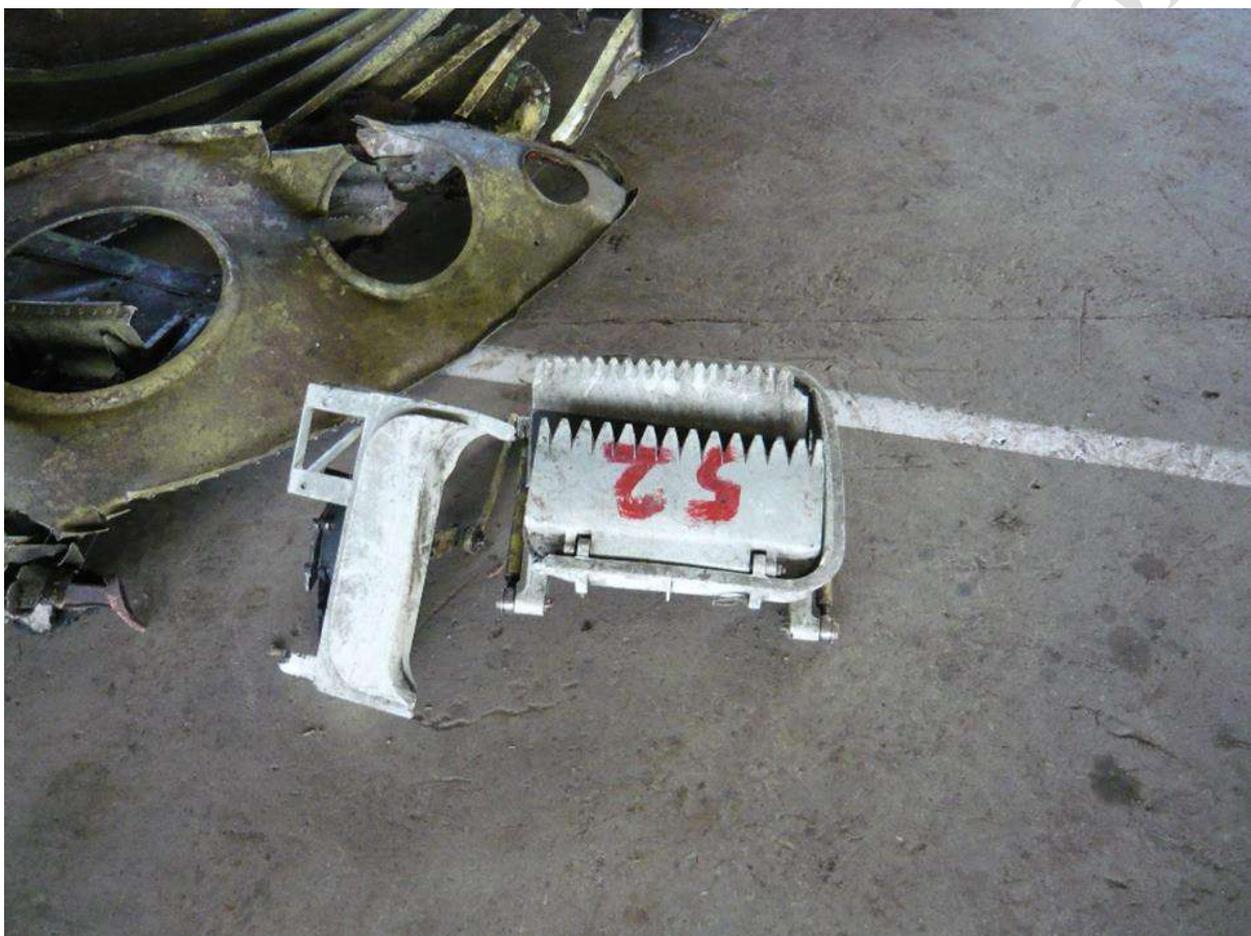
The pressurization control assemblies are totally disintegrated as well. In the progress of the accident site inspection only the outflow valve out of this system had been discovered (Fig. 13).

**Fig. 13. The air conditioning system outflow valve**

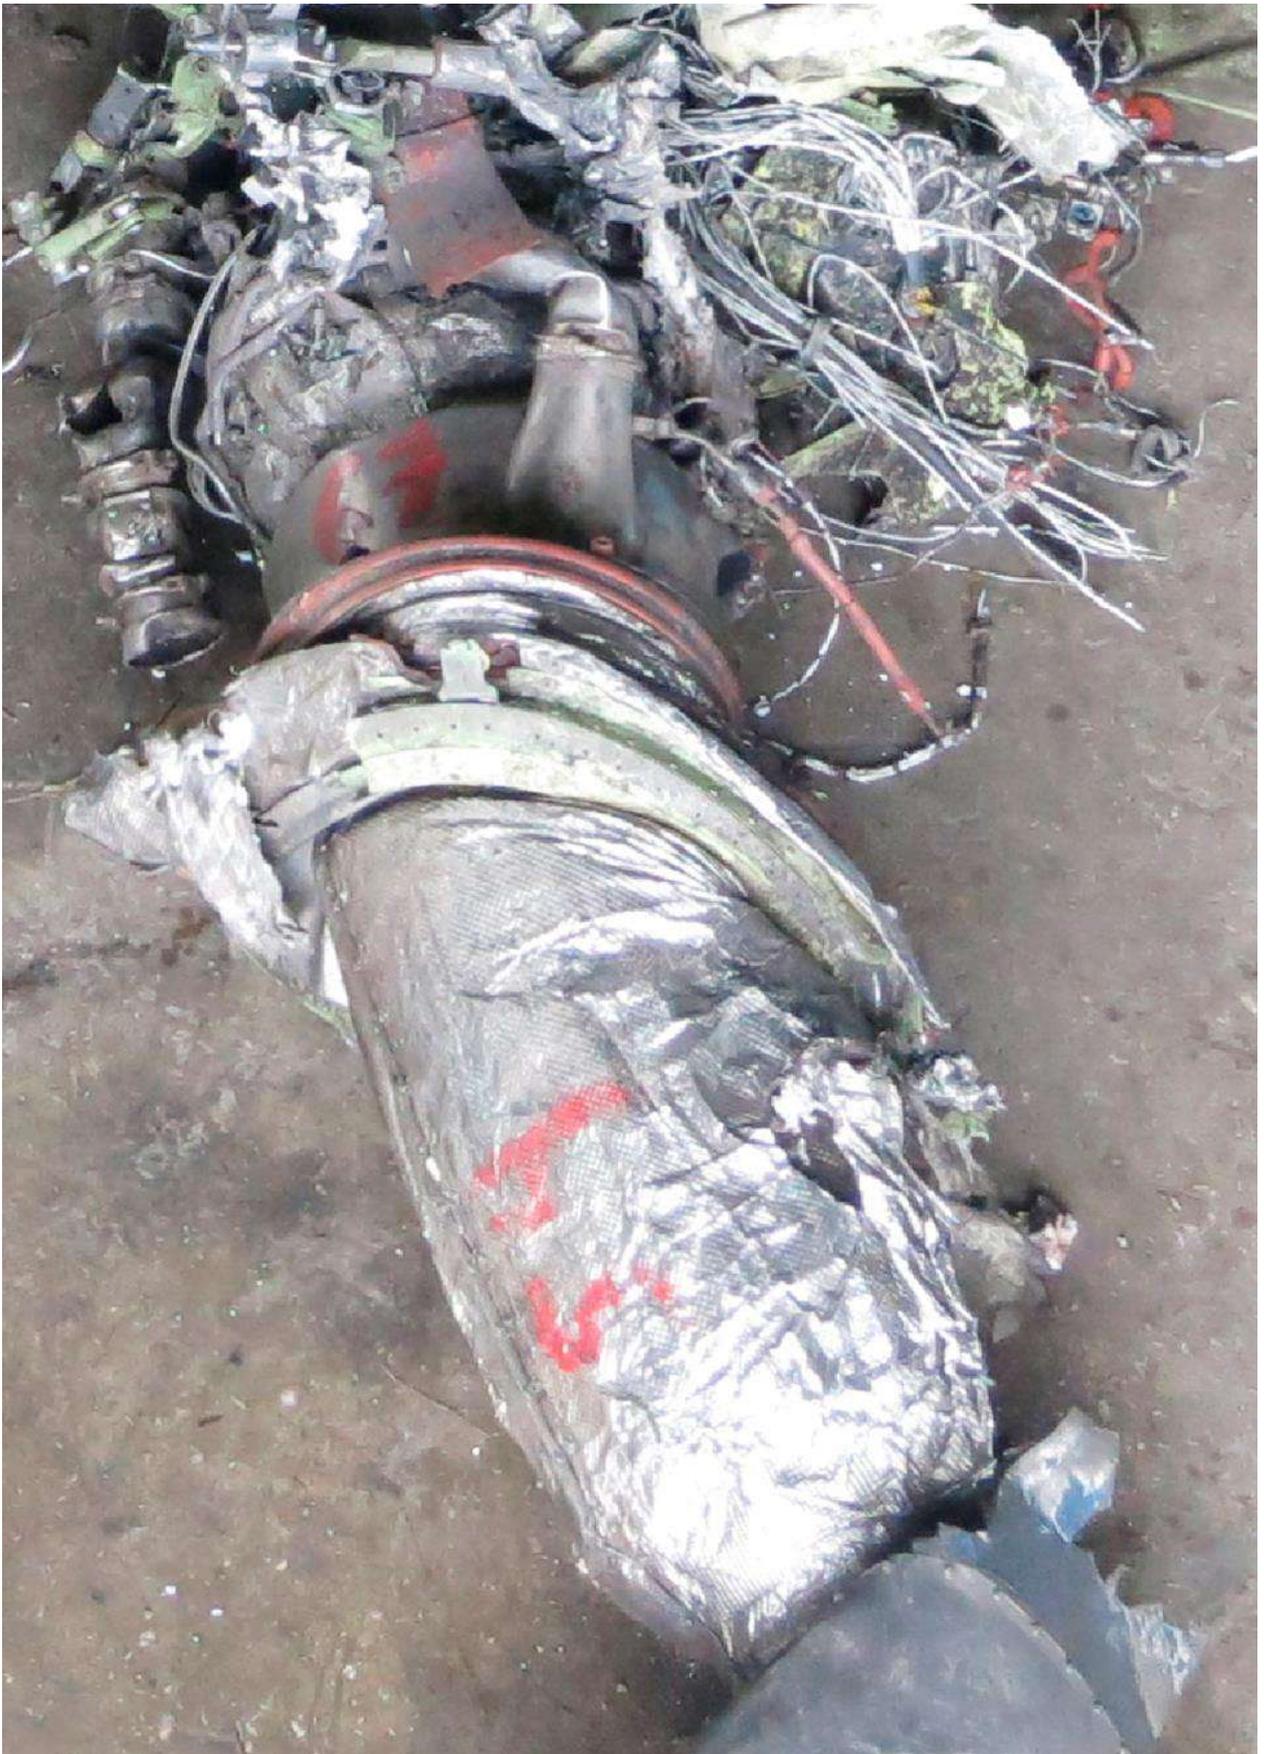
The APU is disintegrated (Fig. 14). The inspection of the APU gas generator plumbing and wiring assemblies did not reveal the ducting and control elements uncoupling.

**Fig. 14. The APU fragment with the exhaust duct and the fuselage tailcone**

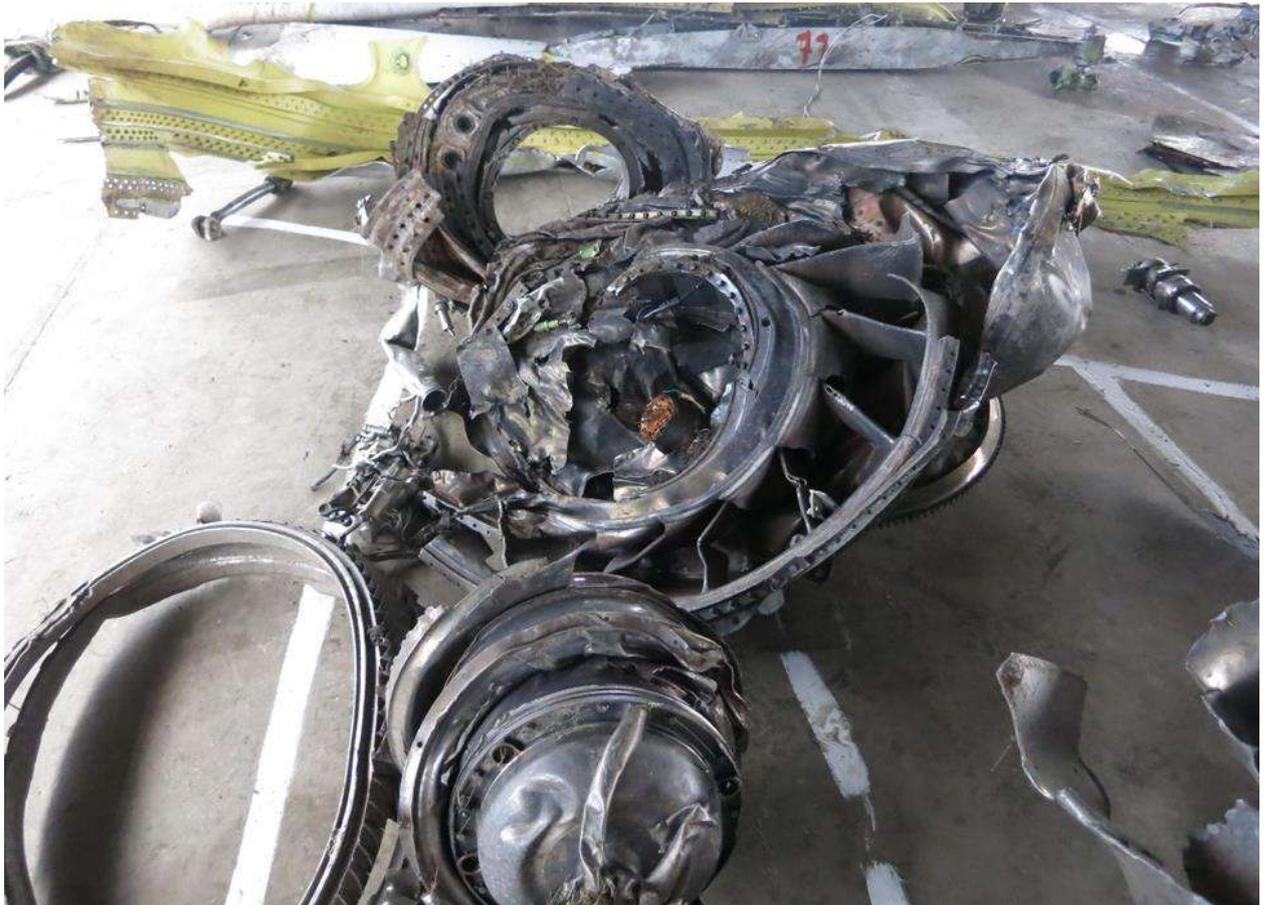
The left and the right engines are totally destroyed (Fig. 15, Fig. 16).

**Fig. 15. The left engine fragments**

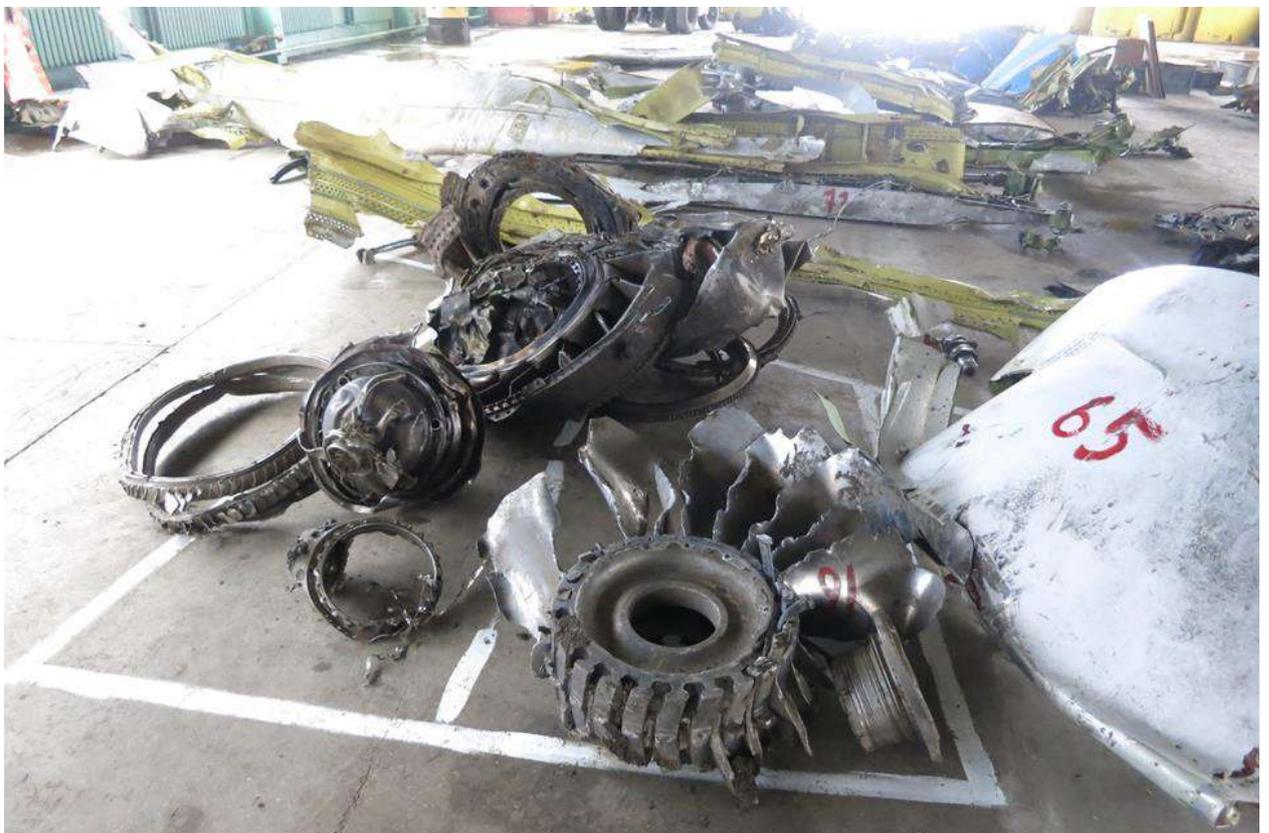
**Fig. 16. The right engine fragments**

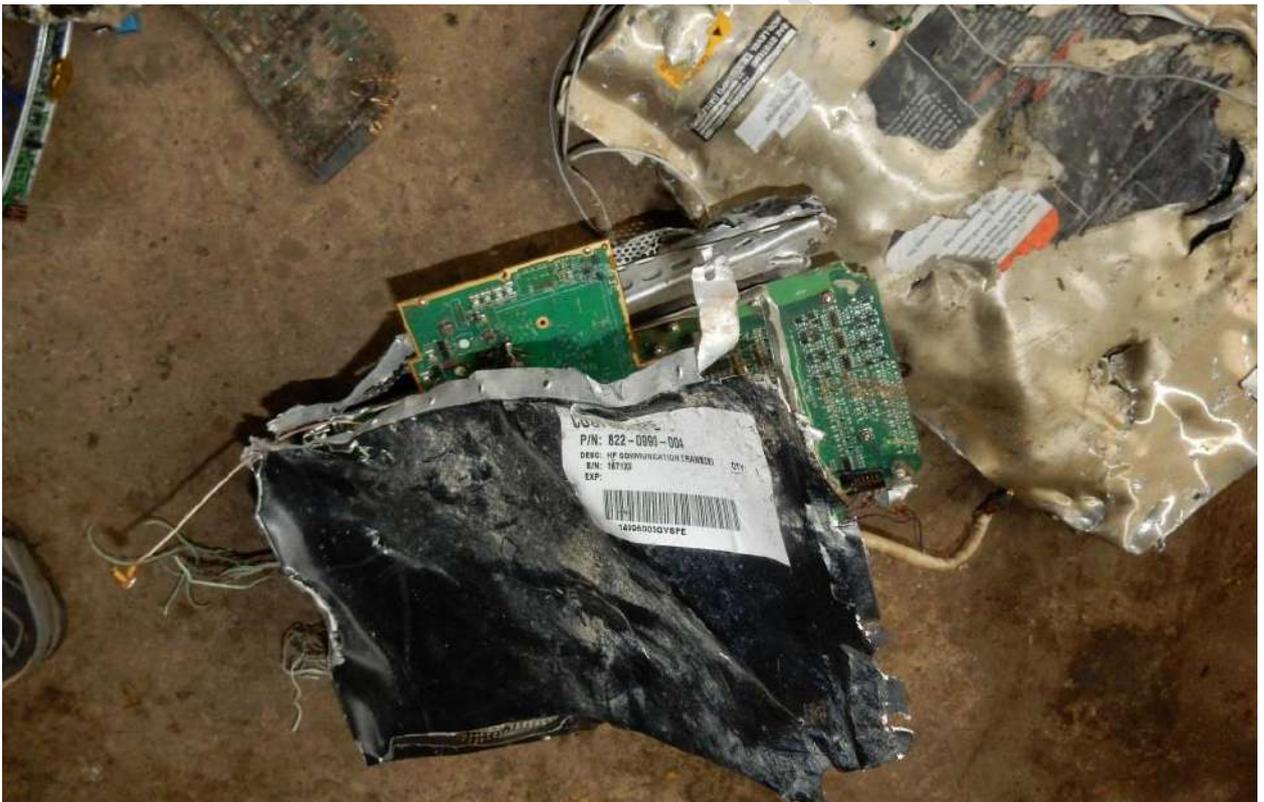
The radio communication units are completely destroyed and are impossible to identify. There were retrieved the fragments of the HF radio set switching unit (p/n 822 0990 004, s/n 1871X9) (Fig. 17).

**Fig. 17. The HF radio set switching unit fragments**

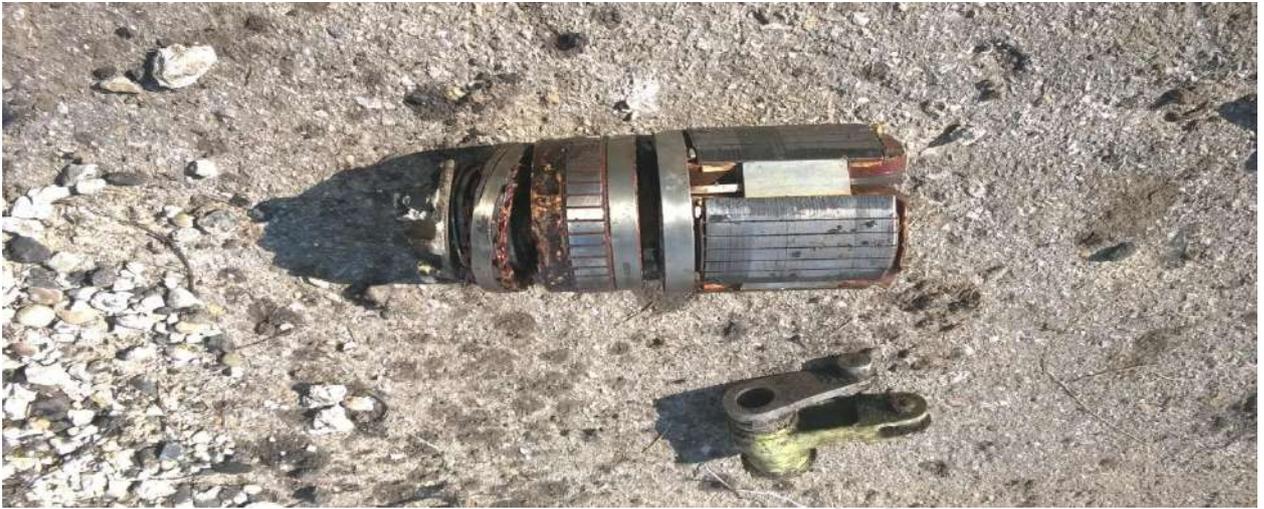
supply system consists of three transformer-rectifier units. The electrical battery is operated as the direct current emergency power supplies. The generators and electrical battery are completely destroyed subsequent to the impact. There was discovered the rotor of one of the generators (Fig. 18).

**Fig. 18. The generator rotor**

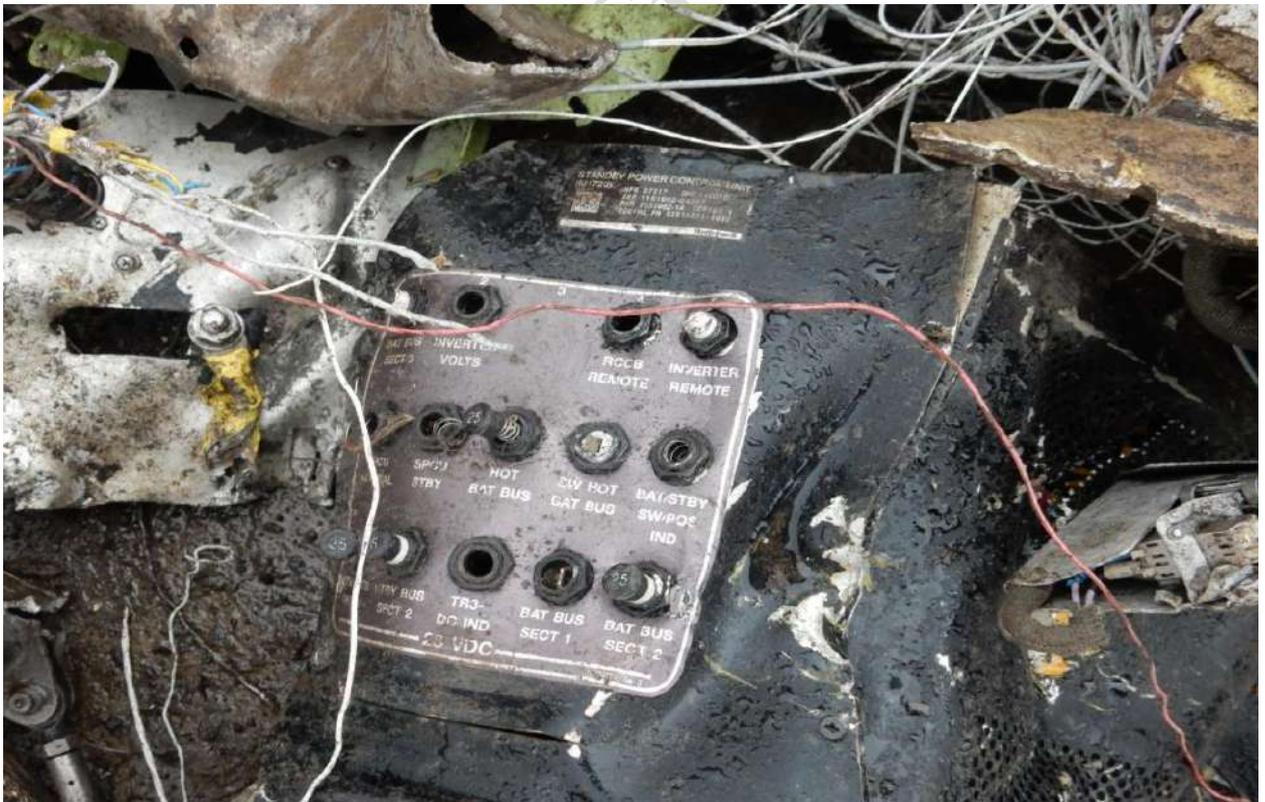
**Fig. 19. The standby power control unit**

All the units sustained considerable damage.
