*This document is an English translation of the Final Report on the accident involving the Boeing 737-8KN aircraft registered A6-FDN that occurred on March 19, 2016 (00:42 UTC) at Rostov-on-Don aerodrome, the Rostov Region, Russian Federation.*

**INTERSTATE AVIATION COMMITTEE  
AIR ACCIDENT INVESTIGATION COMMISSION  
FINAL REPORT**

Type of occurrence	Fatal accident
Type of aircraft	Boeing 737-8KN, airplane
Nationality and registration marks	A6-FDN
Owner	Celestial Aviation Trading 38 Limited, Shannon, County Clare, Ireland
Operator	Dubai Aviation Corporation, P.O. Box: 353, United Arab Emirates
Aviation authority of the place of occurrence	Southern FATA Interregional Territorial Department
Place of occurrence	Russian Federation, the Rostov region, the Rostov-on-Don aerodrome, reference position: 47°15'54.7" N, 039°49'43.8" E
Date and time	19.03.2016, 03:42 local time (00:42 UTC), nighttime

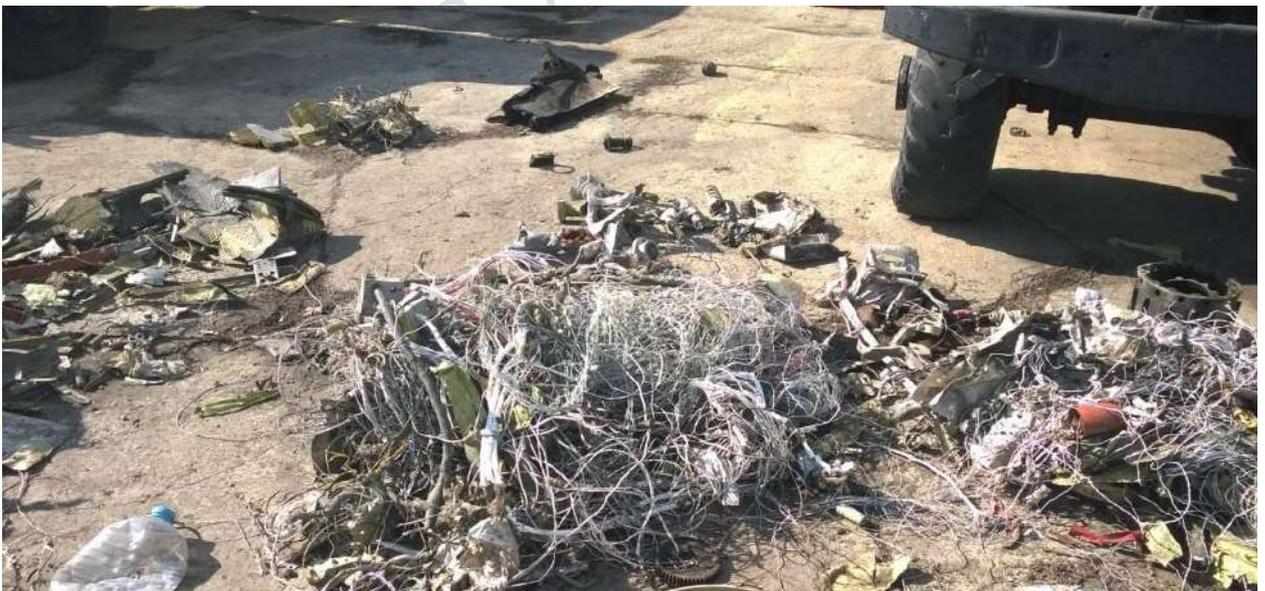
At the site of the aircraft impact with ground the debris of the aircraft electrical supply were retrieved along the impact heading (Fig. 23). The aircraft electrical supply is totally destroyed, there were no signs revealed of the short circuit, might have been evident in the electrical wiring insulation melt.

**Fig. 23. The debris of the aircraft electrical supply**

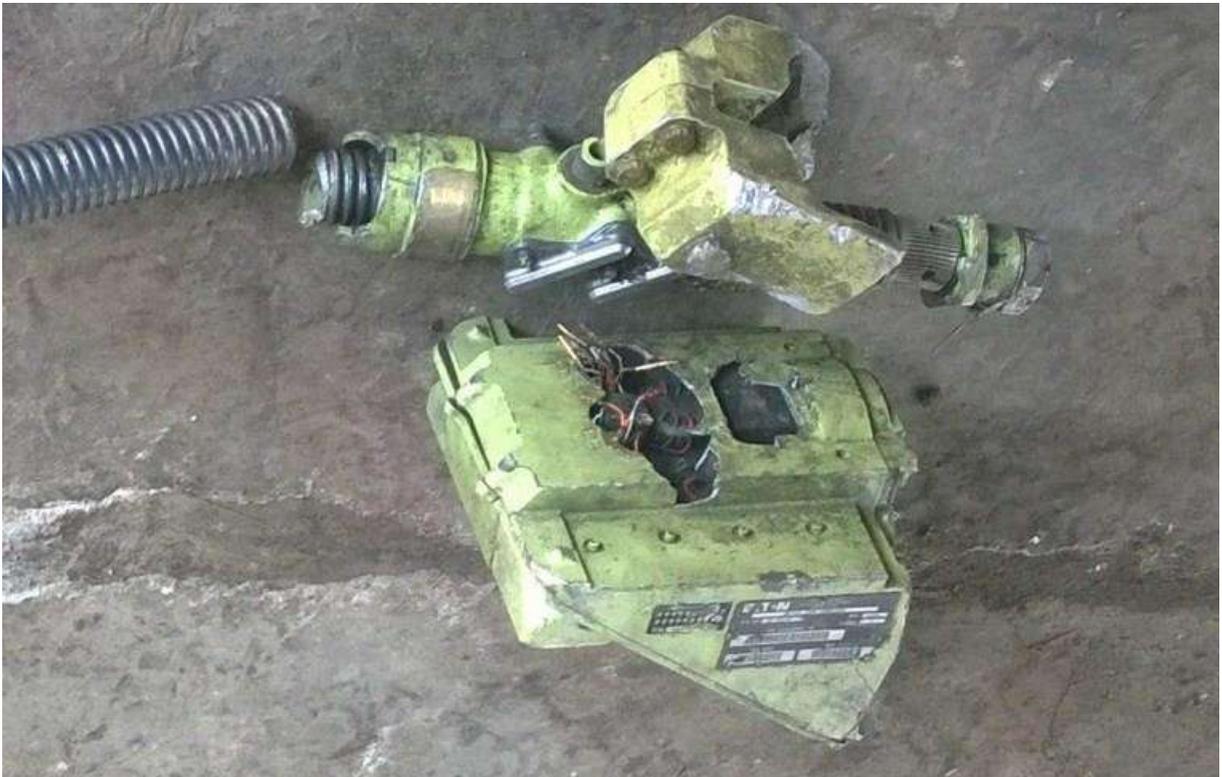
The stab trim motor, p/n 6355C0001-01, s/n 2062 had been retrieved (Fig. 24).

**Fig. 24. The stab trim motor elements**

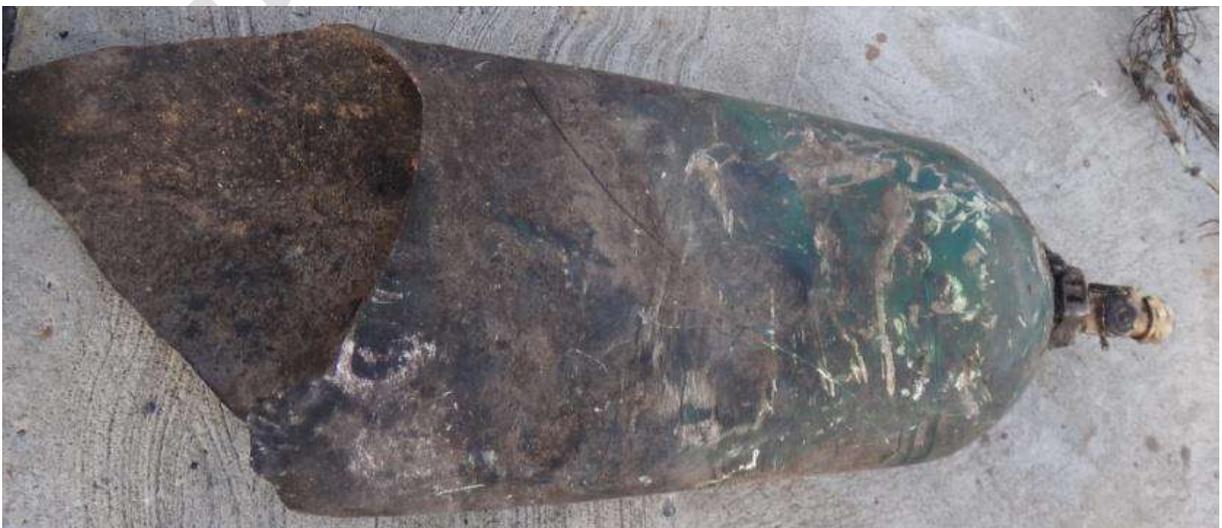
The flight crew main stationary oxygen cylinder had been retrieved (its mounting location is in the electronics and avionics bay). Based on the nature of its destruction it can be concluded that the cylinder had been destroyed in the impact sequence (Fig. 25).

**Fig. 25. Main stationary oxygen cylinder**

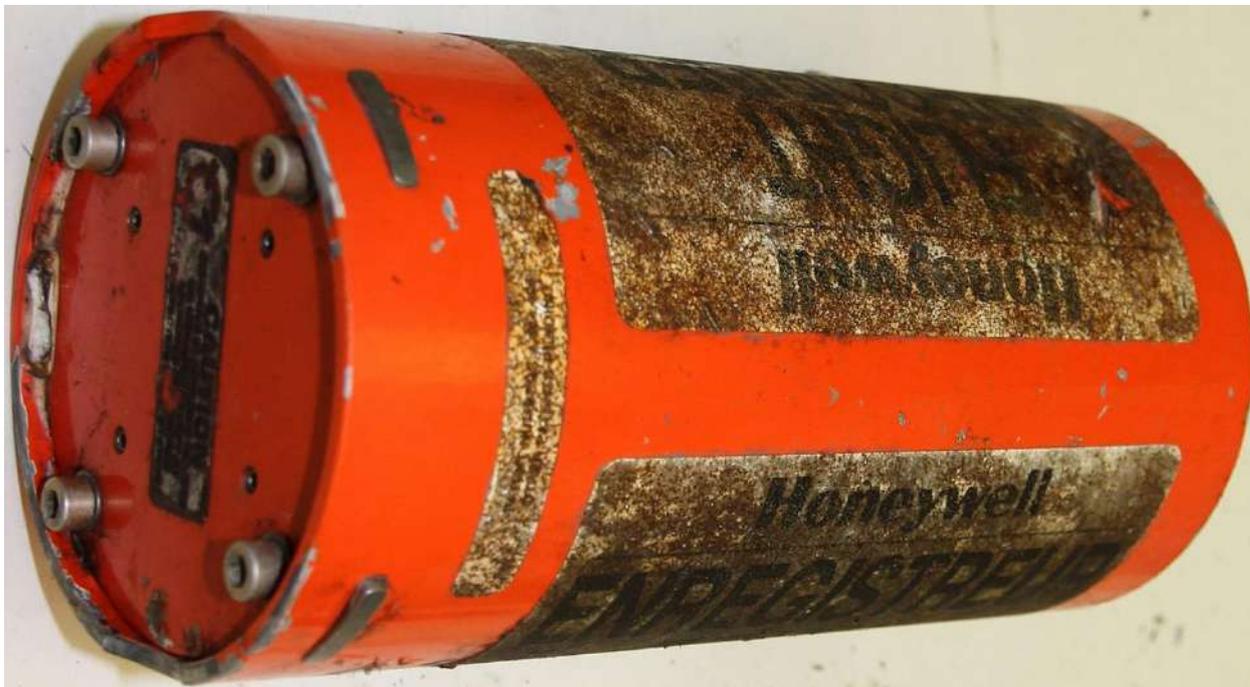
The Honeywell SSFDR p/n 980-4700-042 with the secure memory unit s/n 35907 had been installed on the accident aircraft. On the accident scene, the secure memory unit was retrieved being out of the recorder case (Fig. 35).

Fig. 35. The FDR secure memory unit

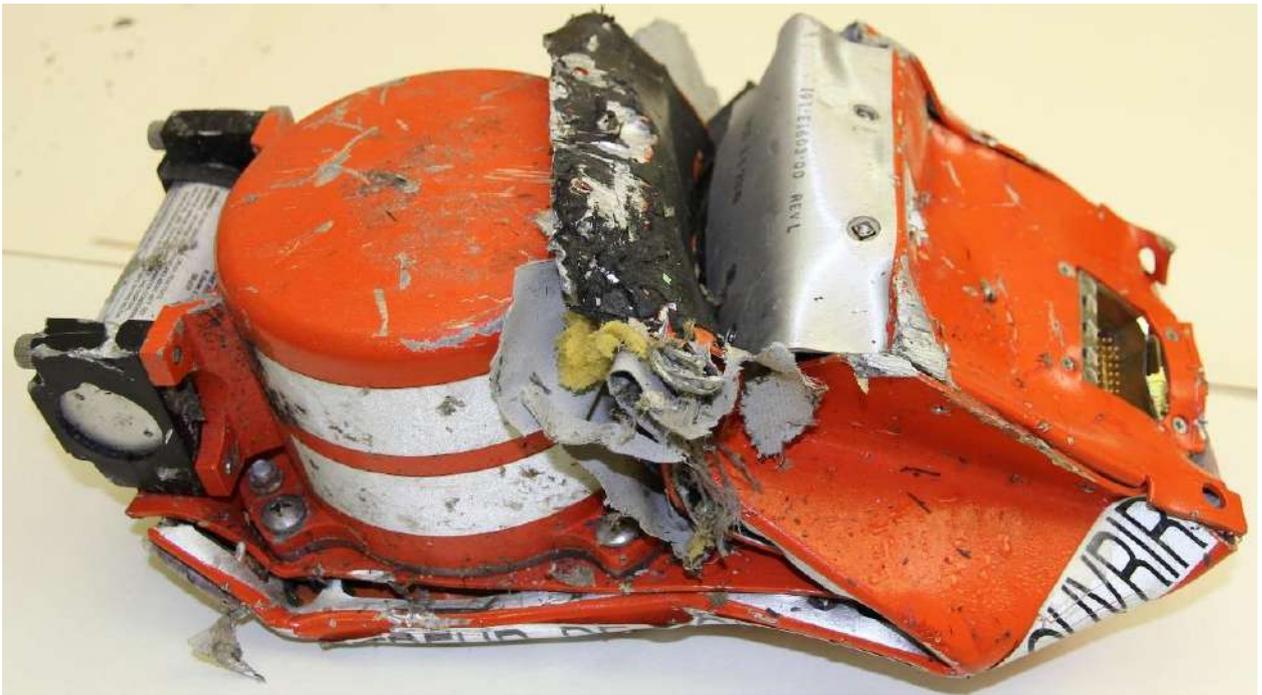
The L3 FA2100 2100-1020-00 cockpit voice recorder (CVR) had been installed on the accident aircraft. The recorder case had been removed from the accident site. At the inspection, it was noted that the case sustained considerable mechanical damage (Fig. 36).

**Fig. 36. The external view of the CVR**

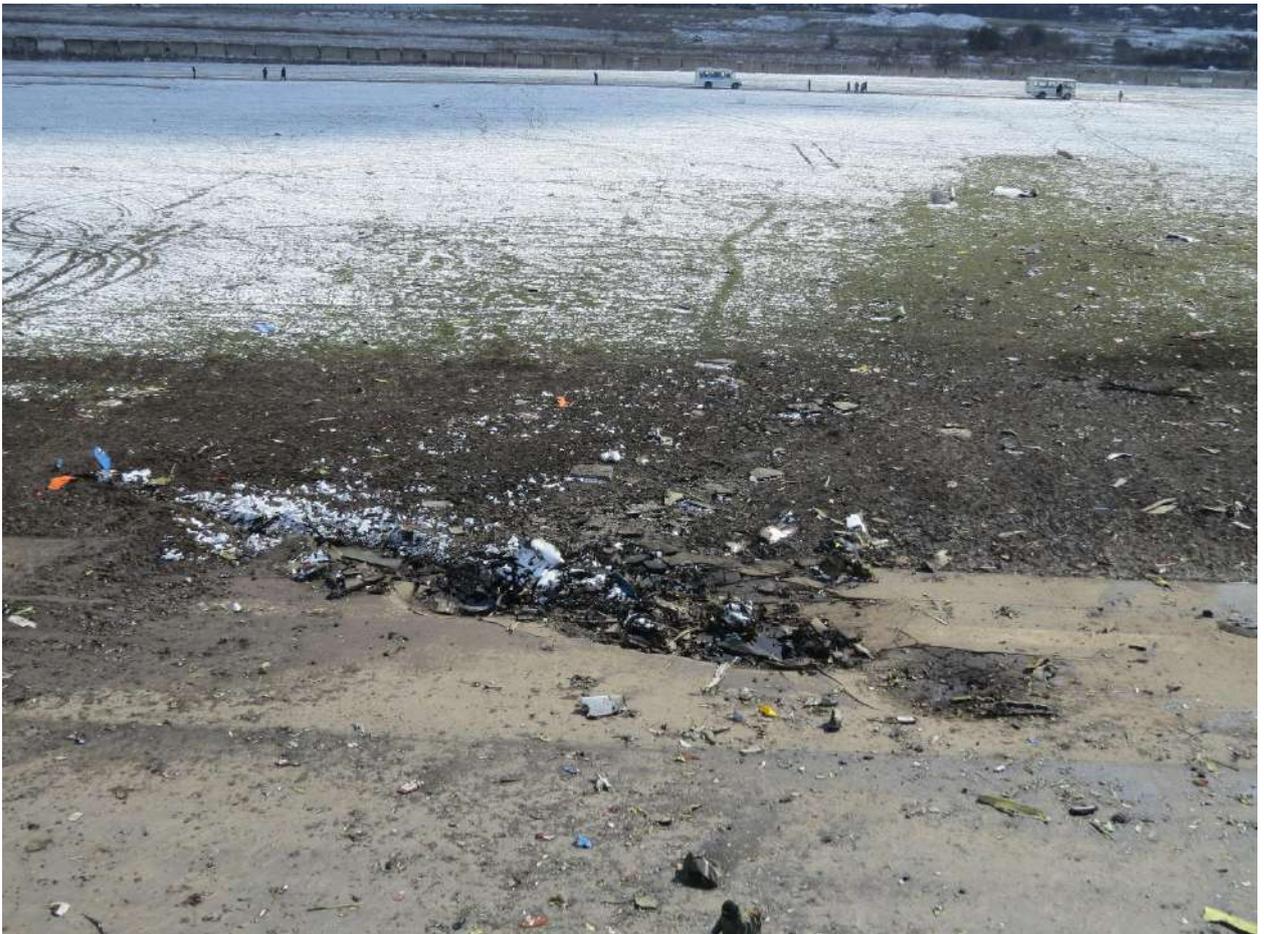
The accident scene is located at the Rostov-on-Don airport airfield. The first point of impact with ground (the RWY concrete surface) occurred at the  $\approx 120$  m off the RWY22 threshold along the RWY left edge looking forward, reference position: 47°15'54.7" N, 039°49'43.8" E. The main wreckage scatter area is located at the distance of 150-400 m off the RWY22 threshold to the left (the major portion of the wreckage) and to the right of the RWY centerline (Fig. 37).

**Fig. 37. First point of impact with ground (the left-to-right direction of flight)**

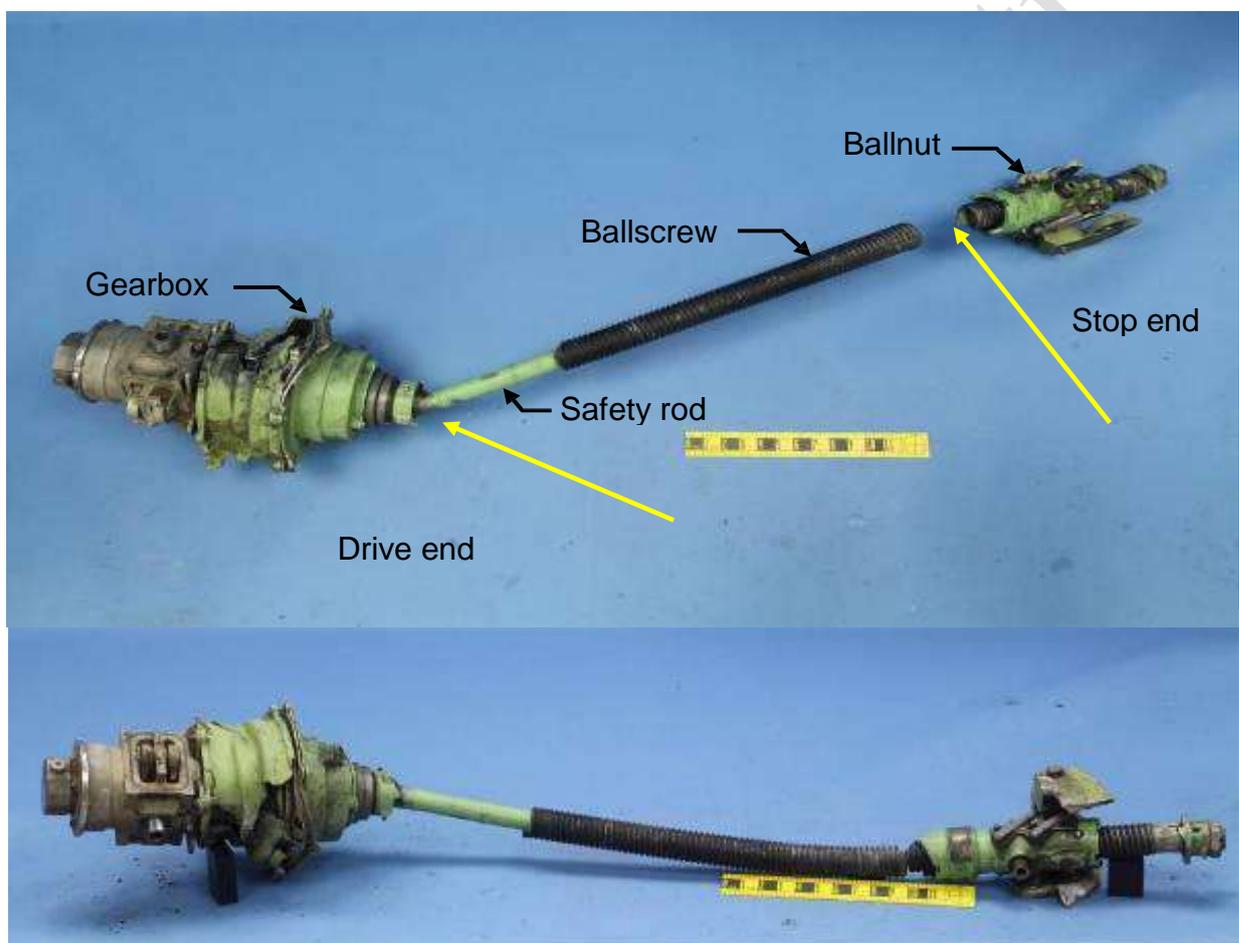
The jackscrew elements (Fig. 42) in an assembly were retrieved from the aircraft wreckage and transferred to the NTSB Material lab, where on 20.10.2016 they had been examined to perform the physical and chemical analysis of the fractured areas and the developed bend with the measurement of the inner diameter and the safety rod wall thickness. In addition, the works were carried out on the identification of the metal samples of the jackscrew and safety rod with the aim to determine whether they met the material specification requirements (AMS 6265 and AMS 6411/6427). The examination of the jackscrew of the stabilizer trim mechanism (p/n 07322P000-05, s/n 1847) was performed at the participation and under the guidance of the air accident investigation team representatives, as well as with the participation of the AAIS experts.

**Fig. 42. The jackscrew assembly with the fractures (the fractures are pointed with arrows)**

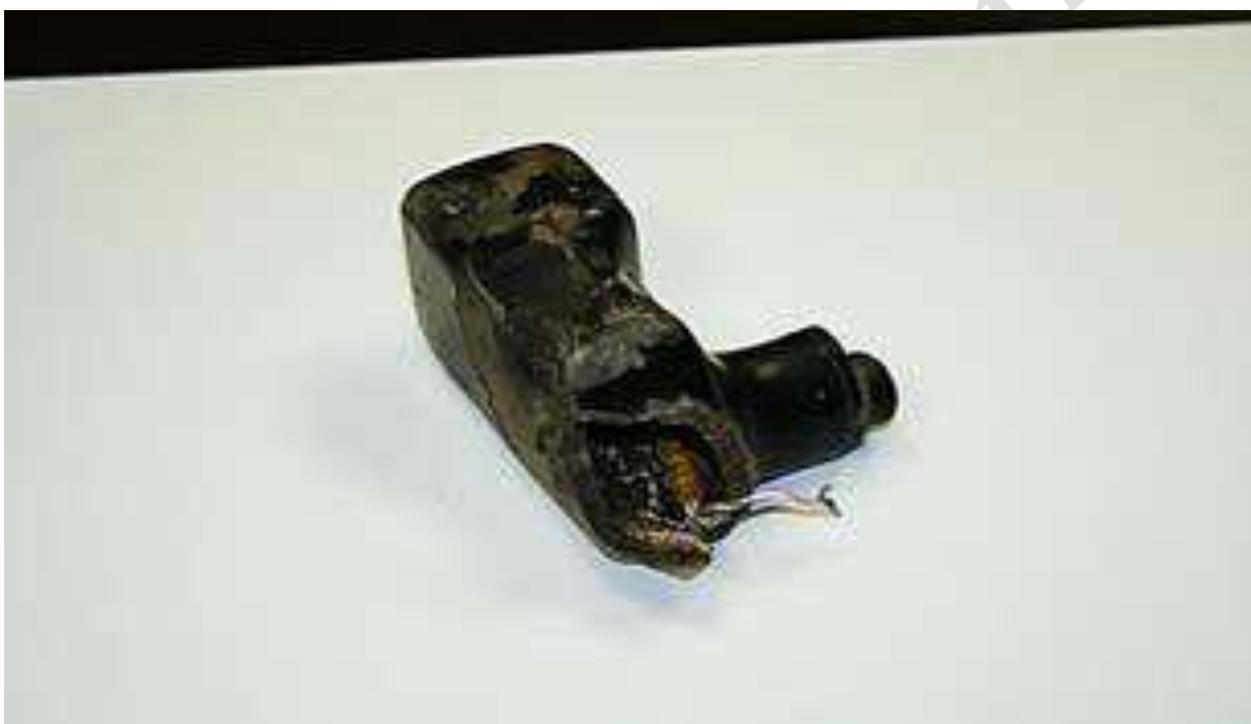
On the accident scene the stabilizer trim control switch (ensuring the “power supply”)<sup>10</sup>, integrated to the F/O control wheel, had been discovered (Fig. 43).

**Fig. 43. Stabilizer trim control switch of the F/O control wheel**

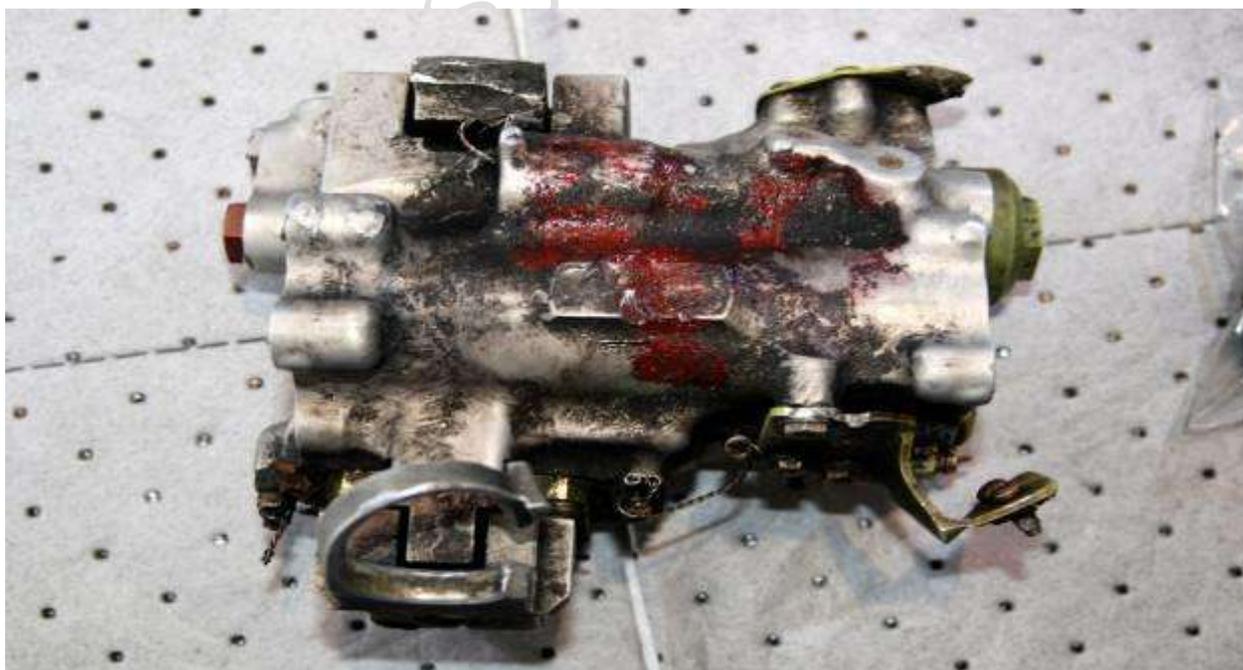
Left PCU (Fig. 44) sustained considerable damage in the accident sequence as follows:

Fig. 44. The left PCU external view

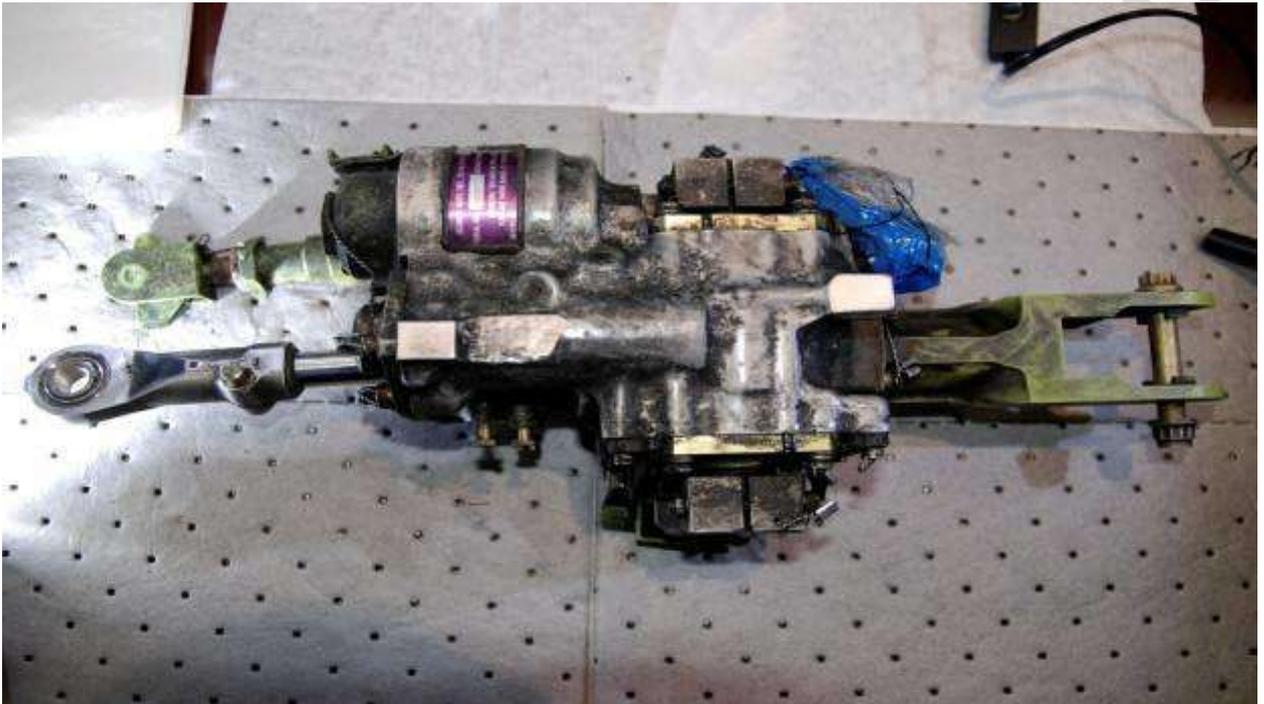
The right PCU (Fig. 45) had been submitted for the examination with the elements of the input pogos. The external surfaces of the PCU are significantly dirtied.

**Fig. 45. The external view of the right PCU**
