## **FINAL ACCIDENT REPORT**

**Airbus A320**  
**SATA INTERNACIONAL**

**CS-TKO**

**REPORT Nr 33/ACCID/2009**

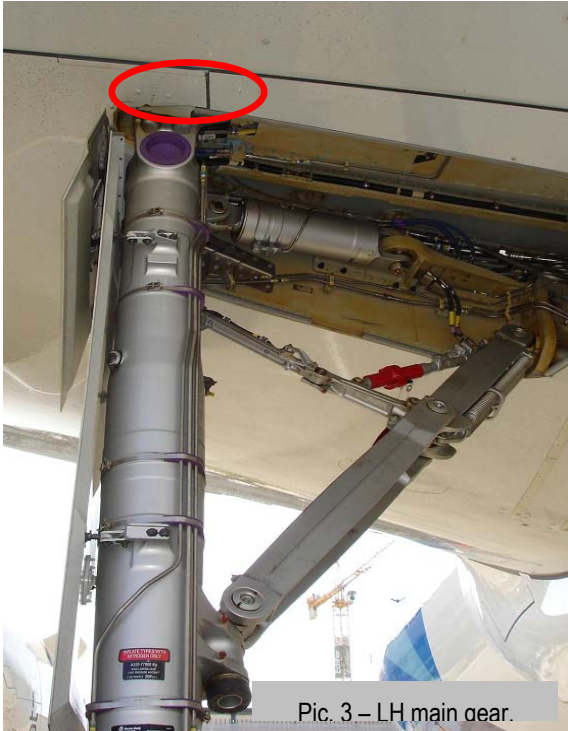
*Wing Shroud Box Lower Panels*, on both sides, showed some damage (pic. 3, 4, 5 and 6). Some rivets on these panels popped out.

Pic. 3 – LH main gear.

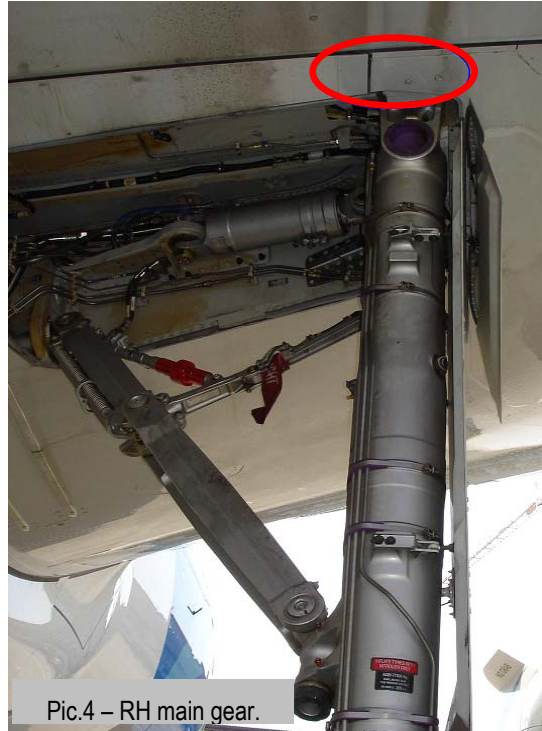
Pic. 4 – RH main gear.

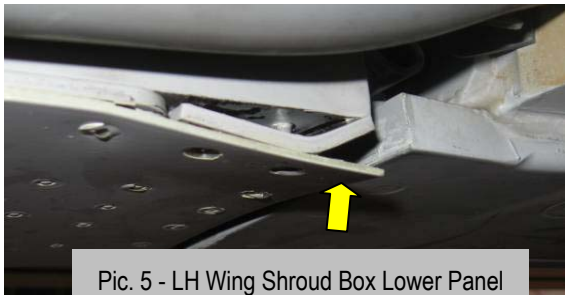
Pic. 5 - LH Wing Shroud Box Lower Panel

CS-TKO Inspection Status	
<p><b>1. General Inspections (AMM 05-51-11 Inspection for Severe Hard Landing)</b></p> <ul style="list-style-type: none"> <li>Small damage in LH &amp; RH Wing Shroud Boxes Lower Panel - damage repaired.</li> <li>No further damage found.</li> </ul> <p><b>2. Fuselage - Sections 18 and 19.1</b></p> <ul style="list-style-type: none"> <li>NIL Findings.</li> </ul> <p><b>3. Fuselage - Sections 15, 16/17, 19, Keel Beam and rudder</b></p> <ul style="list-style-type: none"> <li>Small mark found on AFT cargo door lock fitting/fitting blended-out.</li> <li>Small gap found in a fitting in the aft cargo compartment/applied sealant to fill the gap.</li> <li>Some cracked sealant found in the aft cargo compartment/restored sealant.</li> <li>No further damage found.</li> </ul> <p><b>4. Fuselage - Section 21</b></p> <ul style="list-style-type: none"> <li>Found just one hi-lock broken - hi-lock replaced.</li> <li>No further damage found.</li> </ul> <p><b>5. Belly Fairings</b></p> <ul style="list-style-type: none"> <li>NIL Findings.</li> </ul> <p><b>6. Fuselage - Sections 11/12 and 13/14</b></p> <ul style="list-style-type: none"> <li>NIL Findings.</li> </ul> <p><b>7. Cockpit</b></p> <ul style="list-style-type: none"> <li>NIL Findings.</li> </ul> <p><b>8. Pylons and engine mounts</b></p> <ul style="list-style-type: none"> <li>Sealant in pylon-to-wing #1 aft attachment fitting found damaged - sealant to be restored.</li> </ul>	<ul style="list-style-type: none"> <li>Small crack found in a pylon #1 inboard panel - panel will be replaced.</li> <li>No further damage found.</li> </ul> <p><b>9. Thrust reversers and Nacelles</b></p> <ul style="list-style-type: none"> <li>NIL Findings.</li> </ul> <p><b>10. Wing structure</b></p> <ul style="list-style-type: none"> <li>Lack of sealant at aft edge of reinforcing plate - RH wing bottom skin - seal repaired.</li> <li>Some fasteners found with head dishing - fasteners to be replaced.</li> <li>Some fasteners found with cracked paint around head - paint to be restored.</li> <li>Slight ovality in MLG rib lugs with no further findings - lugs reworked.</li> <li>Small damage in LH &amp; RH Wing Shroud Boxes Lower Panel - damage repaired.</li> <li>No further damage found.</li> </ul> <p><b>11. Trimmable Horizontal Stabiliser (THS)</b></p> <ul style="list-style-type: none"> <li>Paint peeled off over a rivet head and over a sealant area in THS - will be repainted.</li> <li>Slight waviness in panel 4 of the upper skin THS - waviness Ok according with Airbus.</li> <li>Hinge arm #6 with small lack of material - hinge smoothly blended-out and reprotected.</li> <li>No further damage found.</li> </ul> <p><b>12. Engines</b></p> <ul style="list-style-type: none"> <li>NIL Findings.</li> </ul> <p><b>13. APU</b></p> <ul style="list-style-type: none"> <li>NIL Findings.</li> </ul>

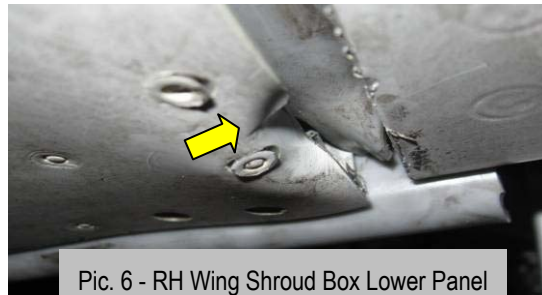
Pic. 6 - RH Wing Shroud Box Lower Panel

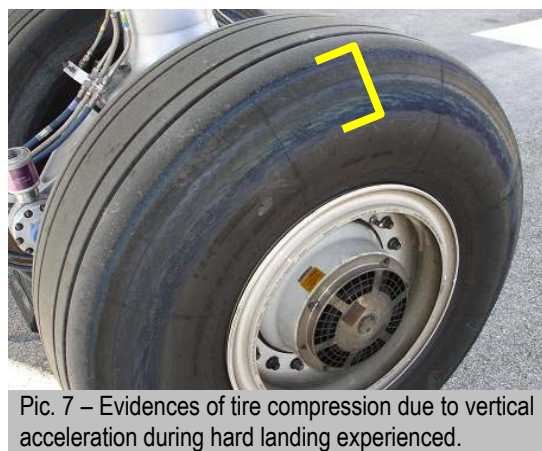
It was found compression marks on the main gear tires (pic. 7) due to the impact on the RWY.

Pic. 7 – Evidences of tire compression due to vertical acceleration during hard landing experienced.

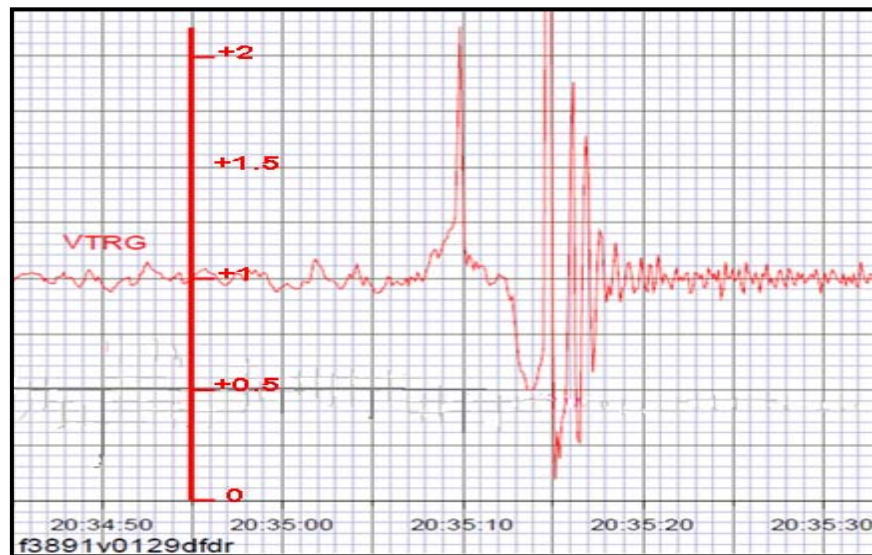
- At 20:35:09 hours:
  - Aircraft touches down on both MLG simultaneously with a Ground Speed of 141kt, a vertical speed of 12.5 ft/sec. (752ft/min), with an attitude of 7.03 degrees nose up;
  - Vertical acceleration was +2.13g;

Pic 15 – Gráfico da aceleração vertical do CS-TKO

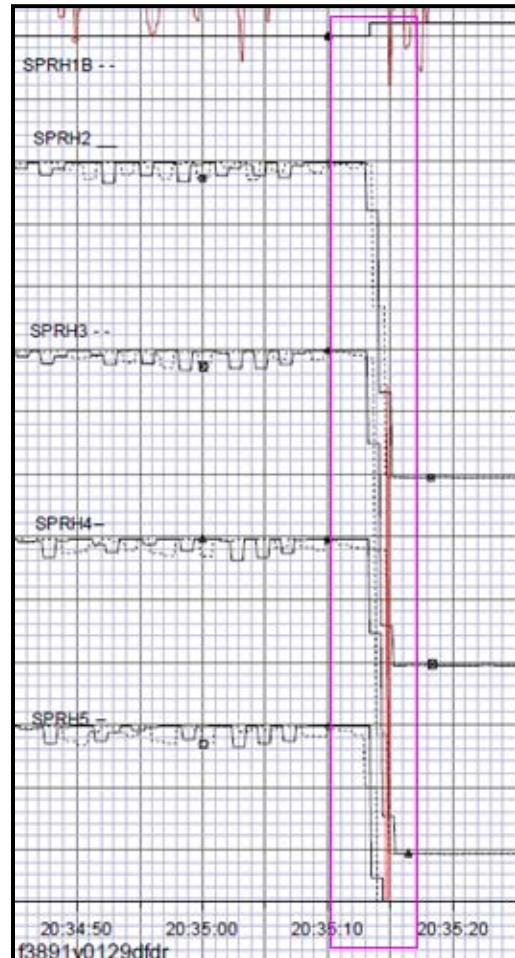
- At 20:35:12 hours:
  - During the bounce, PF ordered some alternate pitch up/pitch down inputs that changed the attitude to 3.7 degrees up;
  - Being A/THR active and speed decreasing, automatism reacted suitably and power was increased on both engines;
- At 20:35:13 hours:
  - Aircraft bounced up to 12ft RA;
  - PF ordered full nose-up input and pitch started to increase again.
- At 20:35:13,5 hours:
  - THR levers were set to *IDLE* notch and this action led to the A/THR disconnection (pic. 13) and a power decreasing;
  - Simultaneously, Ground Spoilers were extended, causing drag leading to a vertical speed acceleration increment of the aircraft towards the ground (pic16).
- At 20:35:14 hours:
  - Action applied on the rudder pedal was maintained during the whole bounce which lasted for about 5 seconds.

Pic. 16 – Spoilers extension graphic

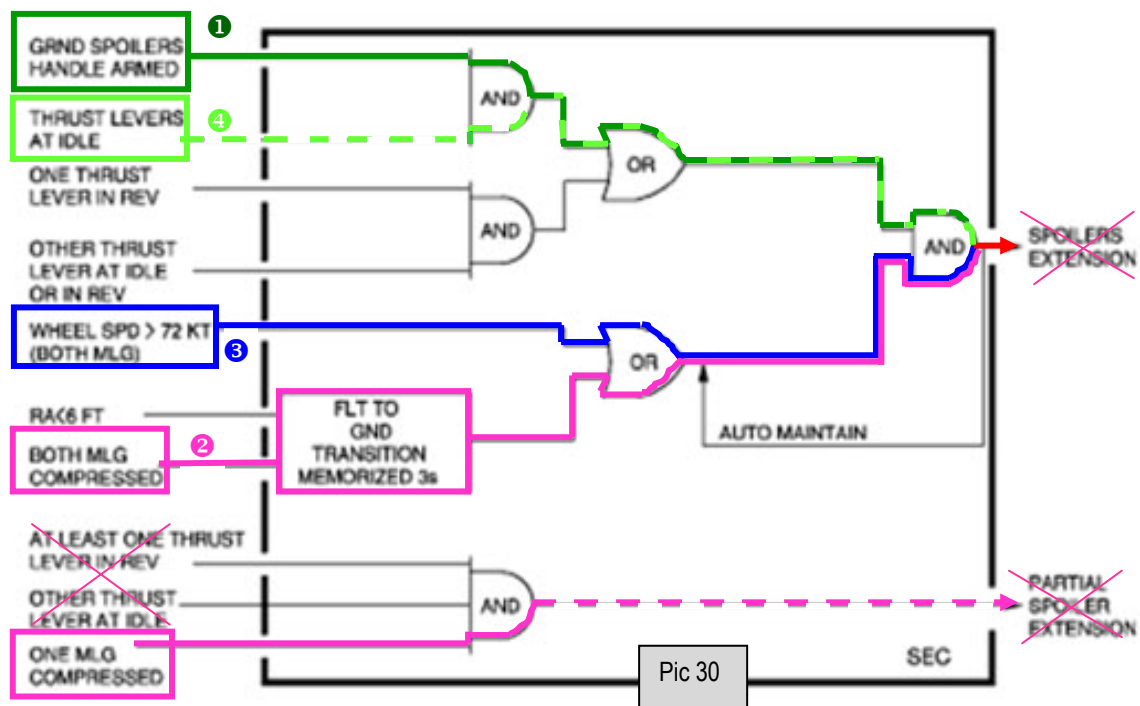
Ground spoilers were not deployed because thrust levers were set at “CLB” and condition ❹ was not fulfilled, thus condition ❶ was not enough to close the circuit and spoilers’ extension was disabled (pic. 30).

There was no partial deployment, even with main landing gear compressed, because thrust levers were not in required position.

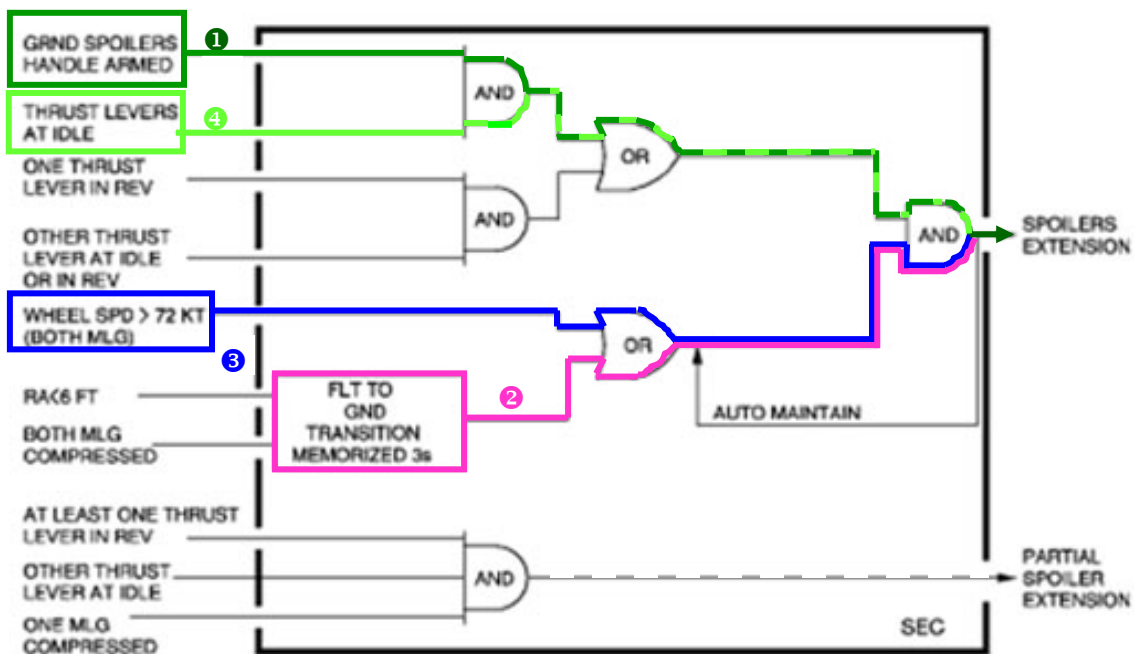
Pic. 31

In fact, consulting FCOM 1.27.10 (pic. 31), necessary conditions for ground spoilers' deployment are possible not only on the ground but in the air during a bounce, if the crew has not retarded the thrust levers for touchdown and retards the thrust levers during the bounce.

- The aircraft came for landing with spoilers “ARMED”, fulfilling condition ①;
- When it touched down both main landing gear struts were compressed and condition ② remained active for 3s; Both main wheels started rotating and its speed attained >72kt, giving condition ③ as a backup for condition ②;
- When the pilot reduced thrust levers to “IDLE”, condition ④, associated with condition ①, provided the necessary signal for the system to command ground spoilers' extension in the air.

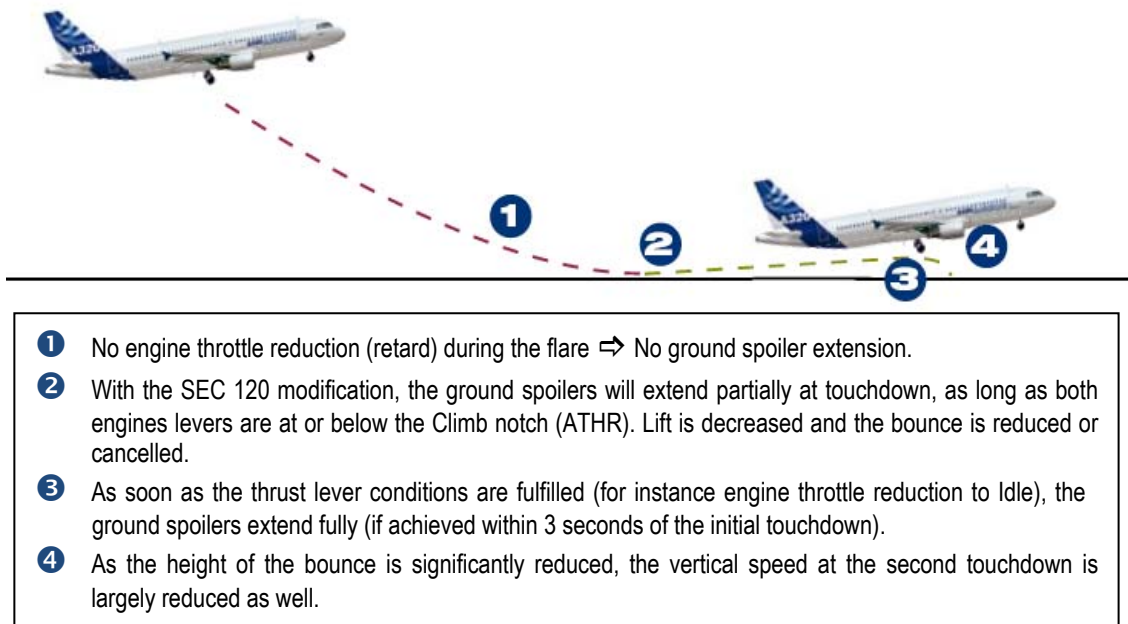
Pic. 34

If new PLD logic was already implemented on CS-TKO, the bounce height on this event would have been significantly reduced and the impact at the second touchdown would have been considerably lighter (about +1,7g instead of the experienced +4.86g, as stated by Airbus).

So, Airbus expects to overcome eventual runway overrun events – with the Ground Spoilers automatic deployment even if speed brake lever is not retracted and thrust levers are above *IDLE* position – and to reduce the bounces' frequency and amplitude in hard landings situations – with the Ground Spoilers Partial Lift Dumping (PLD) at the
