Runway overrun Onur Air

Runway overrun after rejected take-off of
the Onur Air MD-88, registration TC-ONP, at
Groningen Airport Eelde on 17 June 2003

The Hague, 6 April 2006 (investigation number 2003071)

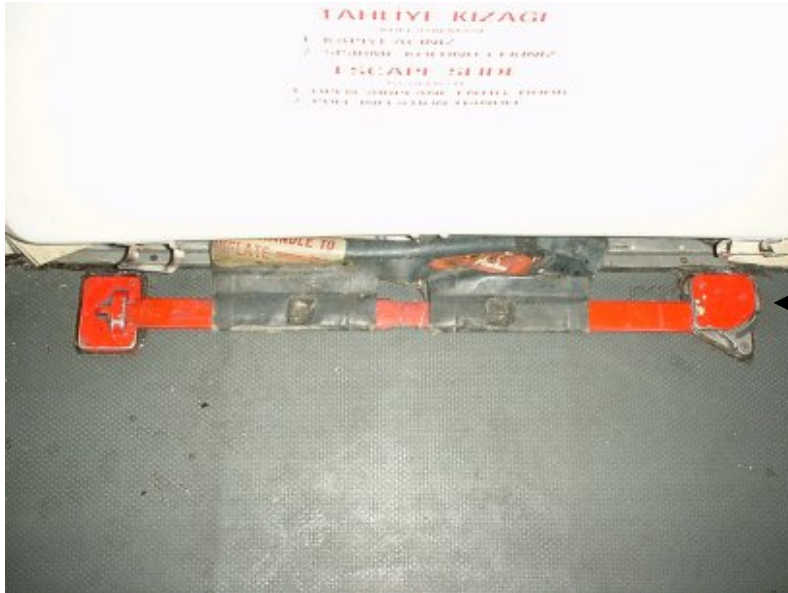
Slide bar right forward door

During the investigation it was noted that two different systems that hold the slide bar were used for the left and right forward aircraft doors. (See pictures below)

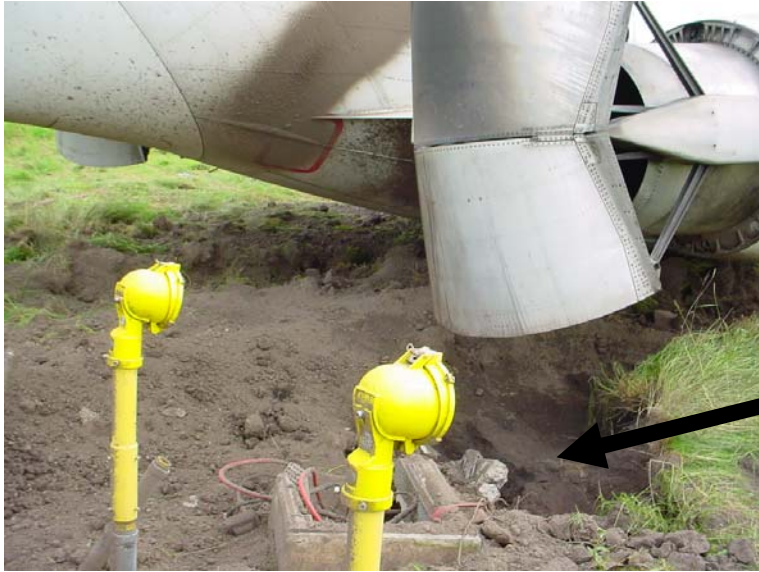
Investigation revealed that at the Groningen airport, in the area after the end of the runway, the so-called 'overrun area', there are underground concrete structures (transformation wells) in soft soil. The Dutch Safety Board holds the view that such a combination (underground structures and soft soil) entails a great fire hazard for the occupants in the event of a collision (the aircraft fuel, the risk of ignition of sparks and the engines which are hot). As Onur Air's MD-88 is a type of aircraft of which the engines are not located under the wing, but are mounted on the rear side of the fuselage, reducing the risk of contact with the ground.

At the day of the accident the soil in the overrun area was not strong enough to support the aircraft. During the overrun the main landing gear sank in the soft soil and damaged several of the approach light system embedded concrete structures and their contents. The centre and wing fuel tanks and engines did not encounter the concrete construction.

- It is recommended to the Minister of Transport, Public Works and Water Management to investigate to which extent the requirements concerning the underground infrastructure in the direct vicinity of start and landing runways has to be stepped up to prevent serious damage to aircraft that overrun the runway.
