Investigation report

L2012-08

Airliner Veering Off the Runway during the Landing Roll at Helsinki-Vantaa Airport on 19 August 2012

OH-ATH

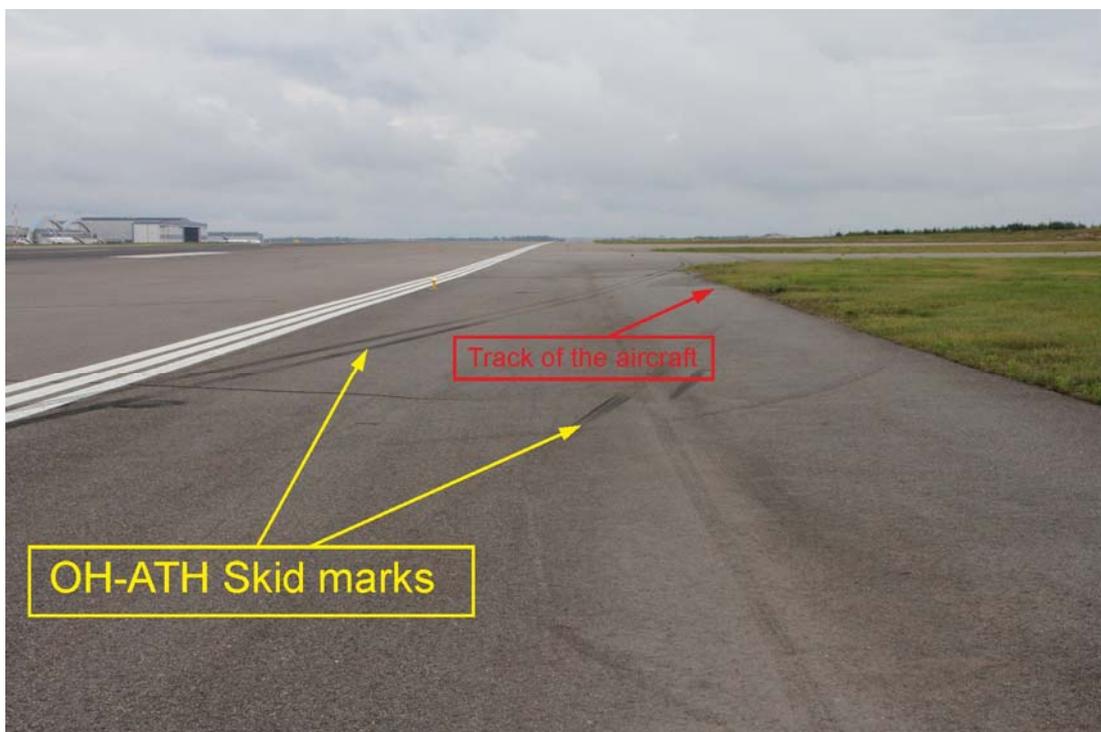
Figure 1. Skid marks and track of the aircraft.

Despite the fact that Helsinki-Vantaa RWY 22L is 60 m wide, the aircraft veered off the runway at approximately 550 m from the point where the tyres made first contact with the runway. The aircraft veered off the runway to the extent that both of its main landing gears ended up on the grassy runway shoulder strip. The width of the runway and the fact that the aircraft veered off in an intersecting area of the runway and taxiway mitigated the damage to the aircraft. The runway edge lights and other runway fixtures were positioned in such places that the aircraft did not hit them at any stage of veering off the runway or returning to it.

As the aircraft was, for all practical purposes, still in the air the operation, or non-operation, of the brake system has no bearing on the changes in the aircraft's heading. Moreover, skid marks left by the LH and RH landing gear were found on the runway, which testify to the fact that the fault discovered after the occurrence did not affect the course of events, at least by increasing the swing to the right [figures 1 and 2].

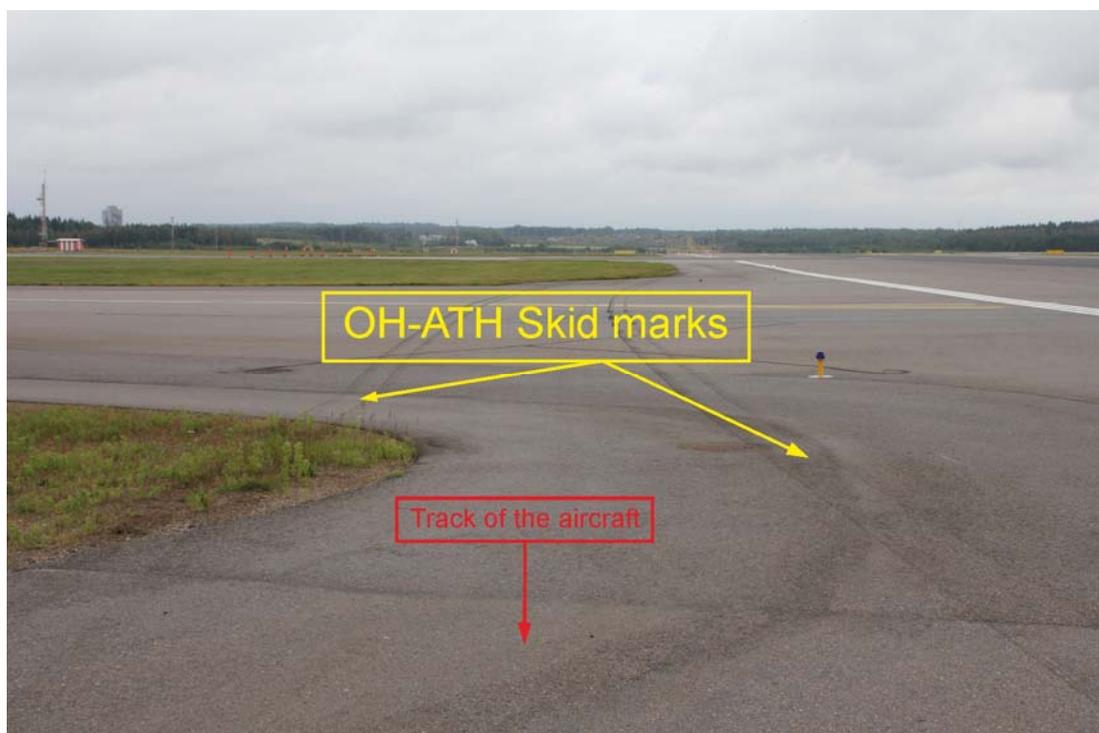
Figure 2. Skid marks and track of the aircraft.

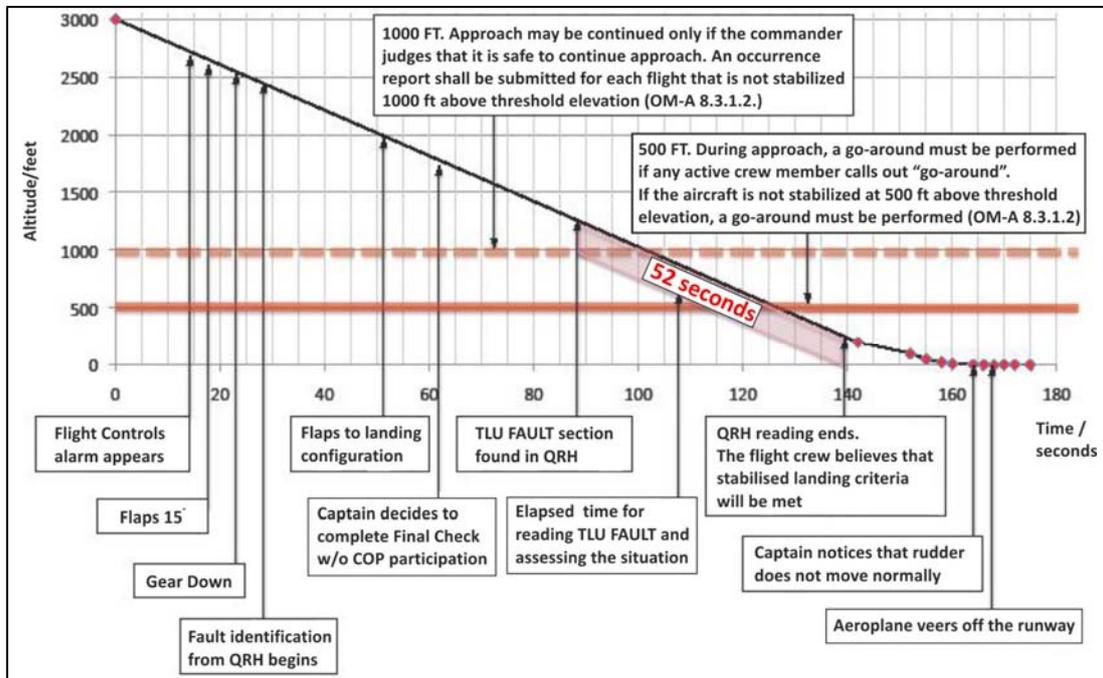
Figure 3. A recordings-based presentation of the course of events that resulted in the serious incident. Altitude information in the graph is approximate. Touchdown point elevation being used as zero altitude.

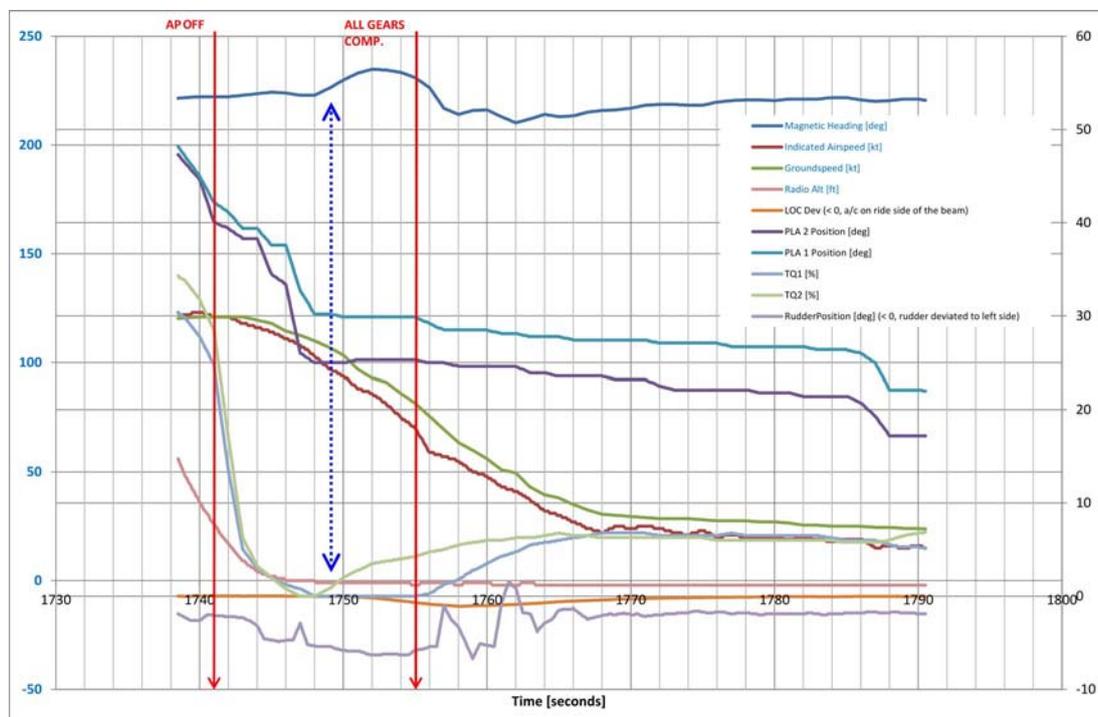
Figure 5 also shows that during the landing the Rudder Position was at the position of its maximum TLU-limited travel, 4° to the left, before the asymmetrical response of the engines to the use of power levers caused the aircraft to suddenly swing to the right. The recording shows figures exceeding the nominal 4° limit. Nevertheless, they are possibly caused by inaccuracies in the measuring system, mechanical wear or rudder flutter caused by aerodynamic forces.

Figure 5. FDR- graphs.

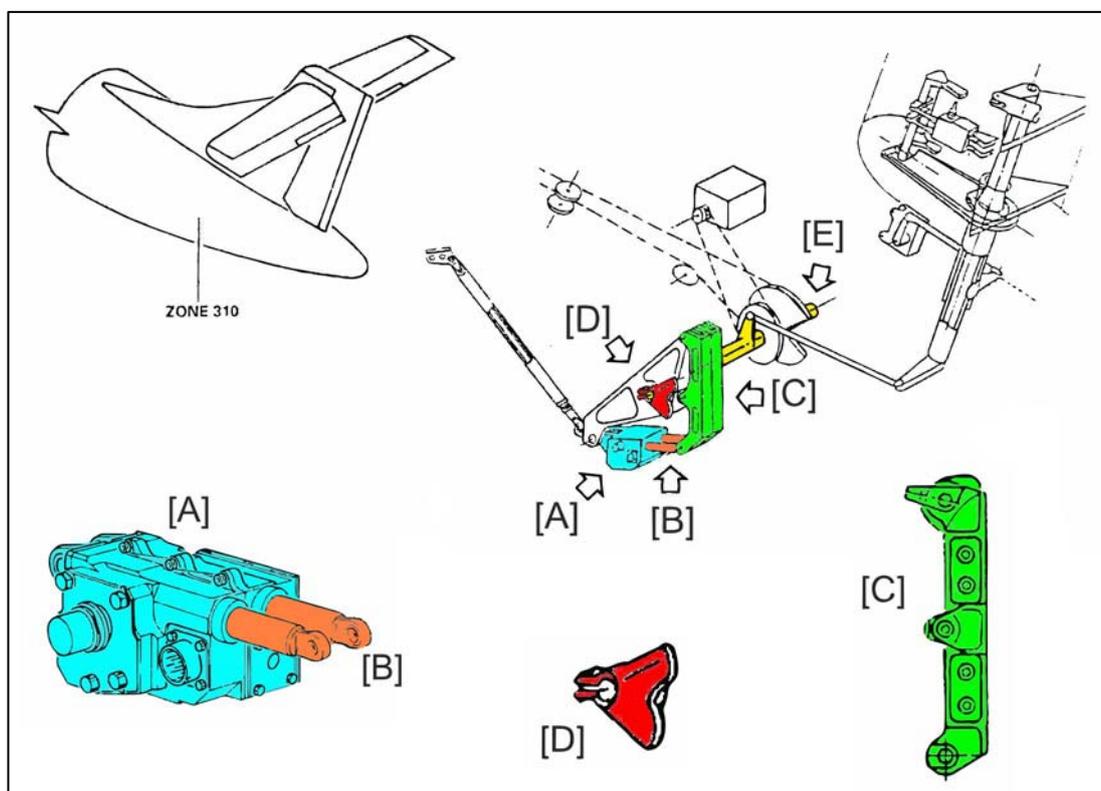
The Travel Limitation Unit’s automatic functioning failed because its electric motor (actuator) was broken. As a result of veering off the runway the cockpit avionics equipment cooling fan on the belly of the aircraft, the right hand (RH) main landing gear’s fairing and the nose landing gear’s RH tyre were damaged. In addition, the dome and the lamp of the red rotating beacon on the bottom of the fuselage were broken. The damage was not extensive because the aircraft veered off in an area where the runway and taxiway intersect and the ground was sufficiently hard and level to support an aircraft of this weight class.

Figure 7. The TLU's main components. (Source: ATR)

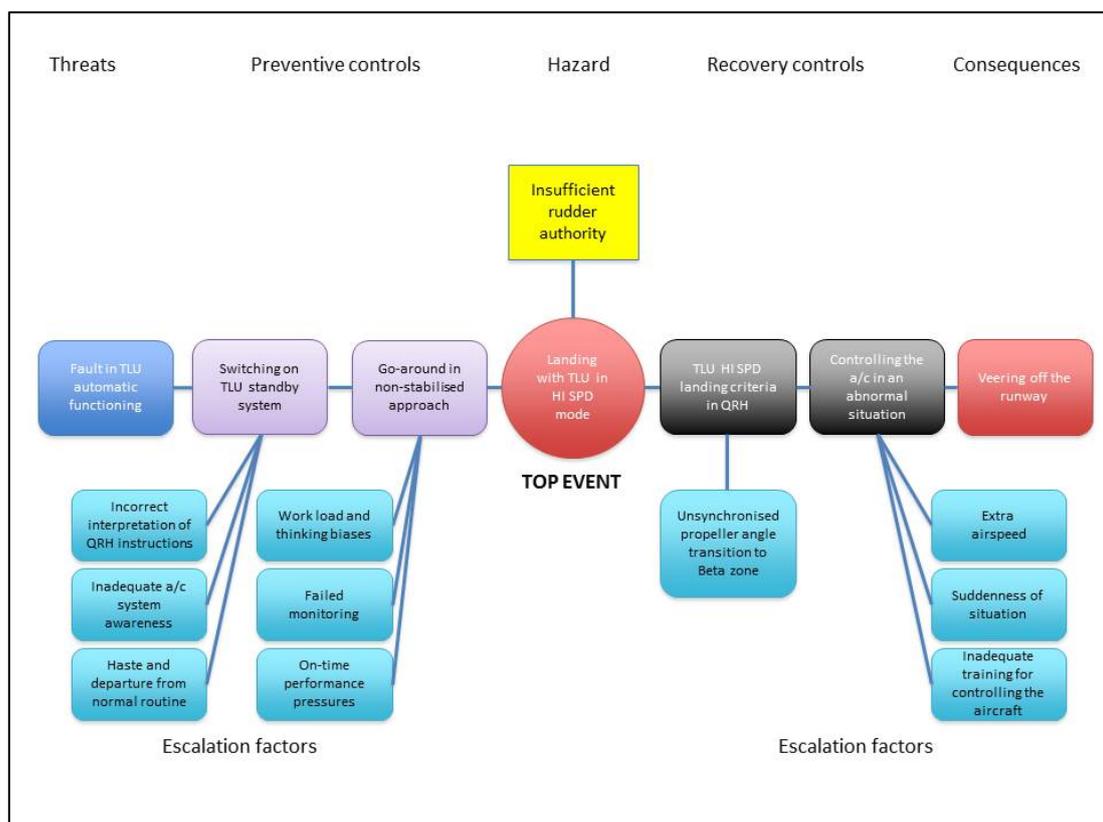
Figure 8. A Bow Tie analysis-based model of this occurrence.

A hazard is a contributing factor which, uncontrolled, will cause harm. A hazard can be, for example, a material or source of energy, a condition or an object. The missing rudder authority is the hazard in this particular diagram, which at worst can result in the loss of control of the aircraft. It is customary to try to mitigate this hazard by appropriately operating and maintaining the aeroplane.

The threats inherent in the system facilitate the realisation of the hazard. In this diagram the fault in the TLU's automatic functioning was the threat, through which the hazard was able to influence the top event. A top event is a seminal moment which turns the course of events, resulting in an unavoidable incident or accident. A top event unleashes the hitherto-contained hazard. The top event in this diagram is the landing with the TLU in the HI SPD mode.
