NATIONAL COMMISSION OF INQUIRY

REPORT

on the accident
on 6 March 2003
at Tamanrasset
to the Boeing 737-200
registered 7T-VEZ
operated by Air Algérie

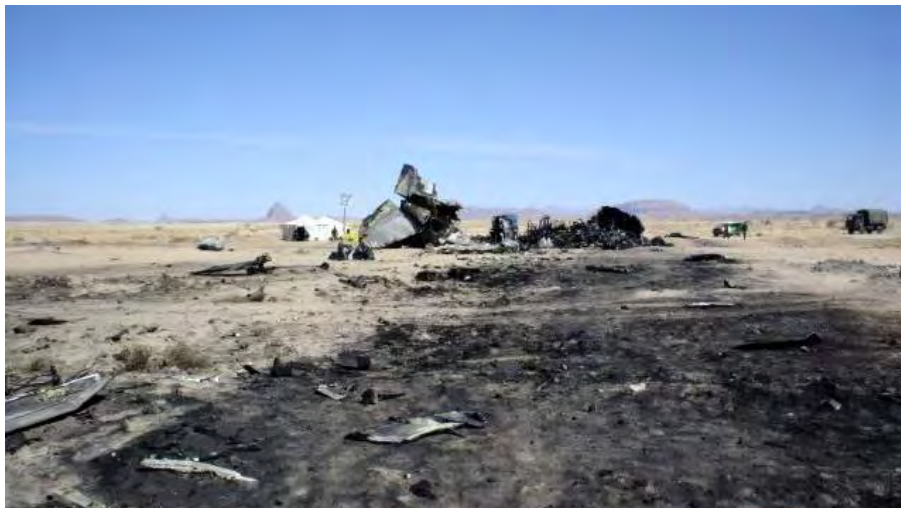
The take-off area is estimated to be abeam the Tower, just after the taxiway. Practically from this point onwards, engine debris was found. Around six hundred meters before the end of the runway, the debris was scattered to the left of the centerline, showing a track roughly fifteen degrees from the centerline. The first point of impact is at 1,645 m from the takeoff area. From this point on, a strip of land showing the marks of an intense fire shows the right of the track (see photo), roughly in line with the right wing. A lot of debris was found, including the engines. The airplane then crashed into the aerodrome perimeter fence and crossed the road. Beyond the road, the right main landing gear was found (without the wheels) then the main wreckage, which had pivoted towards the right.

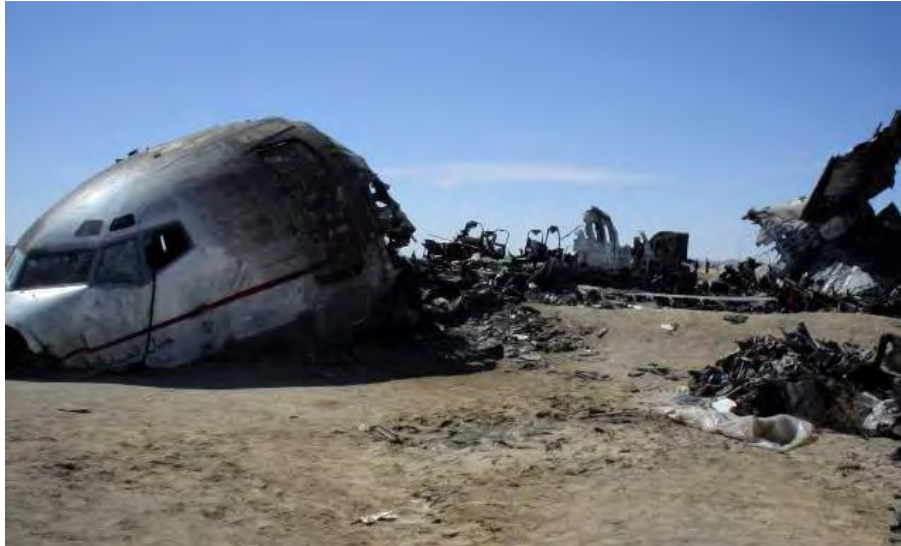
The main wreckage was practically in one single piece, had been destroyed by fire, the right wing was folded back along the fuselage and the rear section was detached and tipped over. The wheels of the two main landing gears were found there.

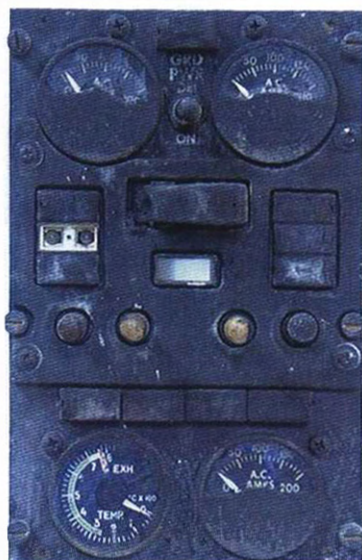
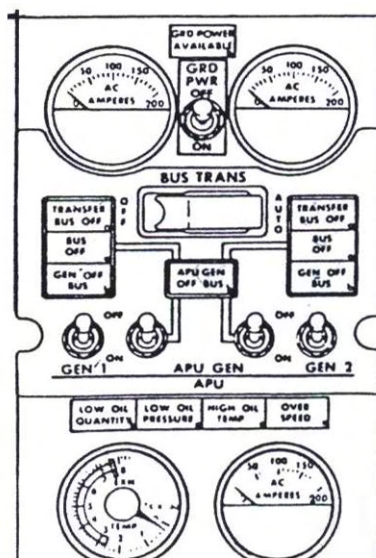
Examination of the electrical power system did not bring to light any malfunction. The photo below, accompanied by the graphic from the airplane manual, shows the module related to electrical power generating systems linked to the two generators and to the APU.

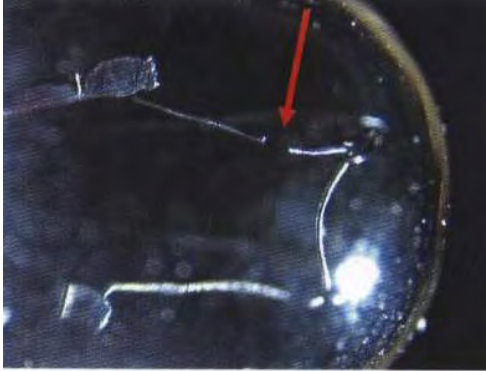
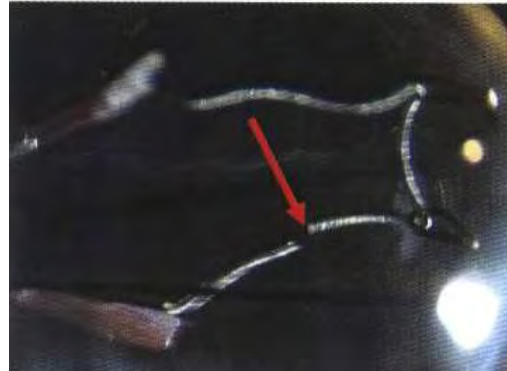
Warning lights GEN #1 TRANSFER BUS OFF and GEN #2 TRANSFER BUS OFF

The bulbs of several warning lights, including the TRANSFER BUS OFF, BUS OFF, GEN OFF BUS and APU GEN OFF BUS, were examined as the following photos illustrate. Their examination showed that most of the filaments were broken on impact.

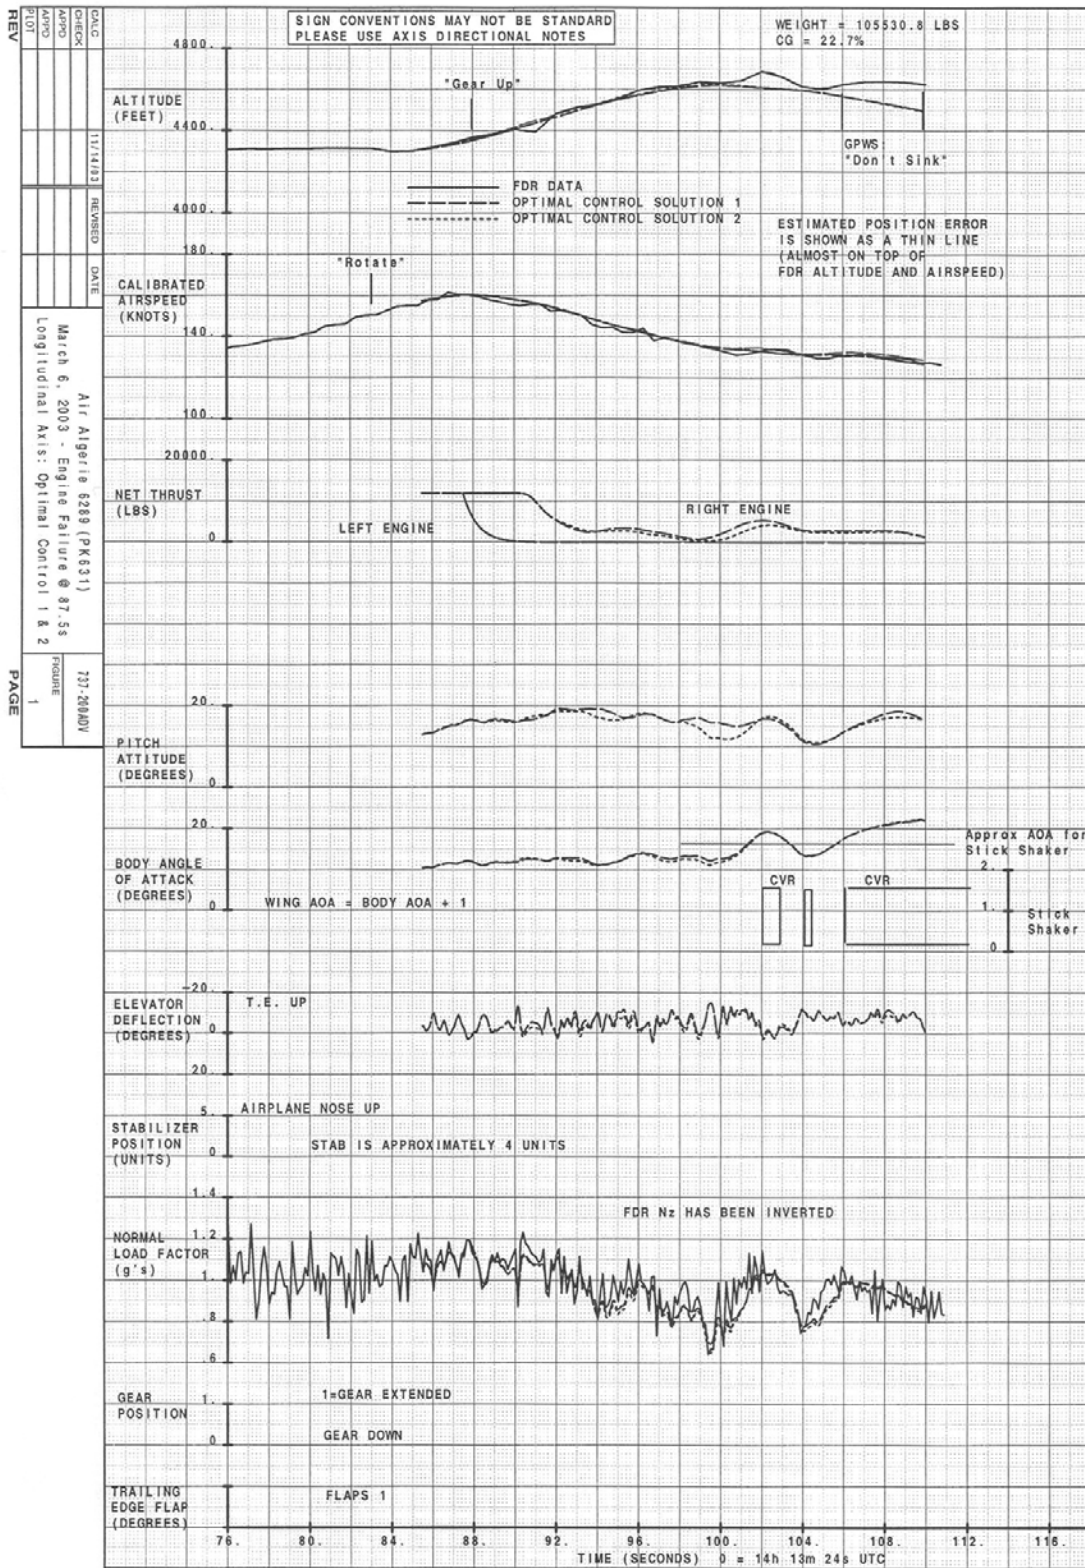
On Figure 1, the longitudinal parameters are plotted. The re-creation of the indicated (recorded) altitude provides an excellent match of the FDR trace. The re-creation's calculation of actual altitude is shown as well and it indicates a decreasing altitude after ~100 seconds. The deviation between the indicated altitude and the actual altitude is due to errors in pressure measurements (known as "position error") that can become quite large when the airplane enters a stall. The re-creation also provides a good match of the FDR airspeed. The airspeed decreases after the left engine failure, to the point that a stall condition is reached. Given that the airspeed and altitude are decreasing simultaneously, the airplane had severely degraded performance relative to a "normal" engine-out condition.

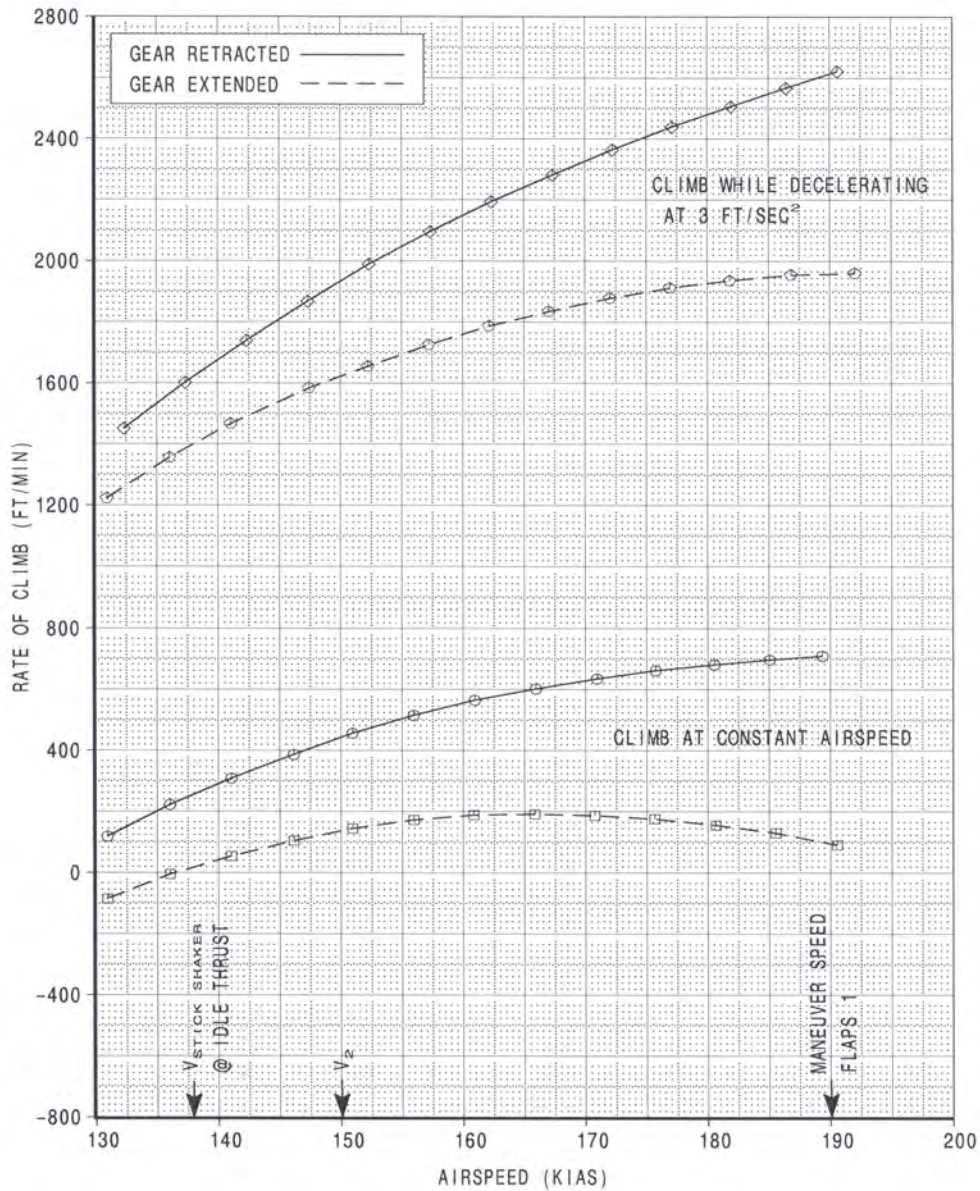
CLIMB CAPABILITY

- FLAPS 1
- ONE ENGINE INOPERATIVE
- GW = 107381 LB
- TEMP = ISA+16.5 DEG C (23 C)
- 150 FT ABOVE AIRPORT (4454 FT)
