# Report

Accident on **9 August 2007**  
off **the coast of Moorea (French Polynesia)**  
to the **DHC6-300**  
registered **F-OIQI**  
operated by **Air Moorea**

Bureau d'Enquêtes et d'Analyses  
pour la sécurité de l'aviation civile

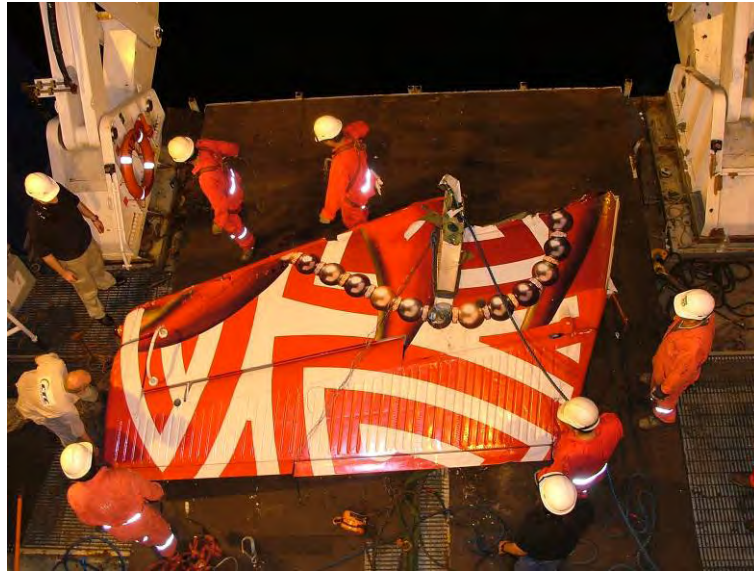
Fin after raising

The two rudder cables and the two elevator control cables were broken: three were about the same length but the fourth, the pitch-up cable, was about 2.5 metres long. On visual examination, one of the failures of this last cable had a different appearance from the others. It was thus decided to examine these parts as a priority.

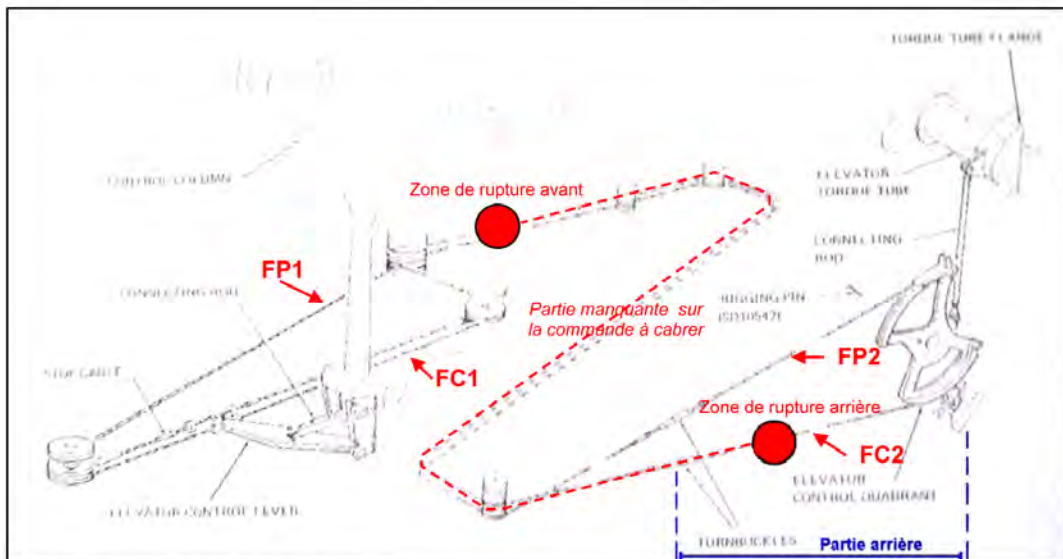
The two elevator control cables and the two rudder control cables broke off in a zone situated in the forward part of the aeroplane. The pitch-up control cable showed a second failure in the aft part of the aeroplane, with a different appearance to the other failures, and an 8.8-metre long piece of this cable was missing. All of the pitch-down elevator cable was recovered.

FP1 : Fragment of pitch-up cable attached to control column, length 1.55 metres  
 FP2 : Fragment of pitch-up cable attached to elevator, length 11.25 metres  
 FC1 : Fragment of pitch-down cable attached to control column, length 0.75 metres  
 FC2 : Fragment of pitch-down cable attached to elevator, length 2.60 metres  
 Total length of pitch-up cable = 12.80 metres  
 Total length of pitch-down cable = 12.15 metres

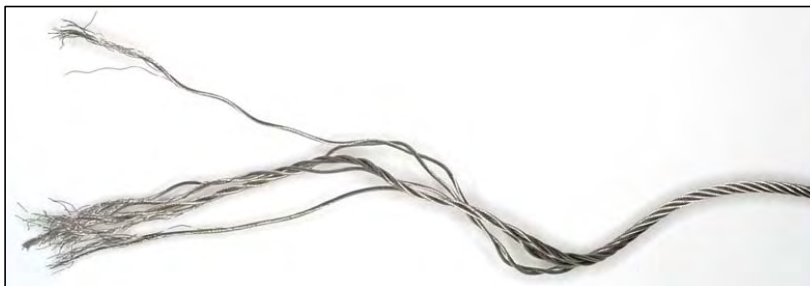
Typical failure of a cable broken off in the forward zone (scale 1:2)

All the failures that occurred in the forward zone were identical, the strands had separated (untwisting) over several centimetres. They were typical of overload failures. No deposit, traces of corrosion or signs of wear were observed in line with the failed areas.

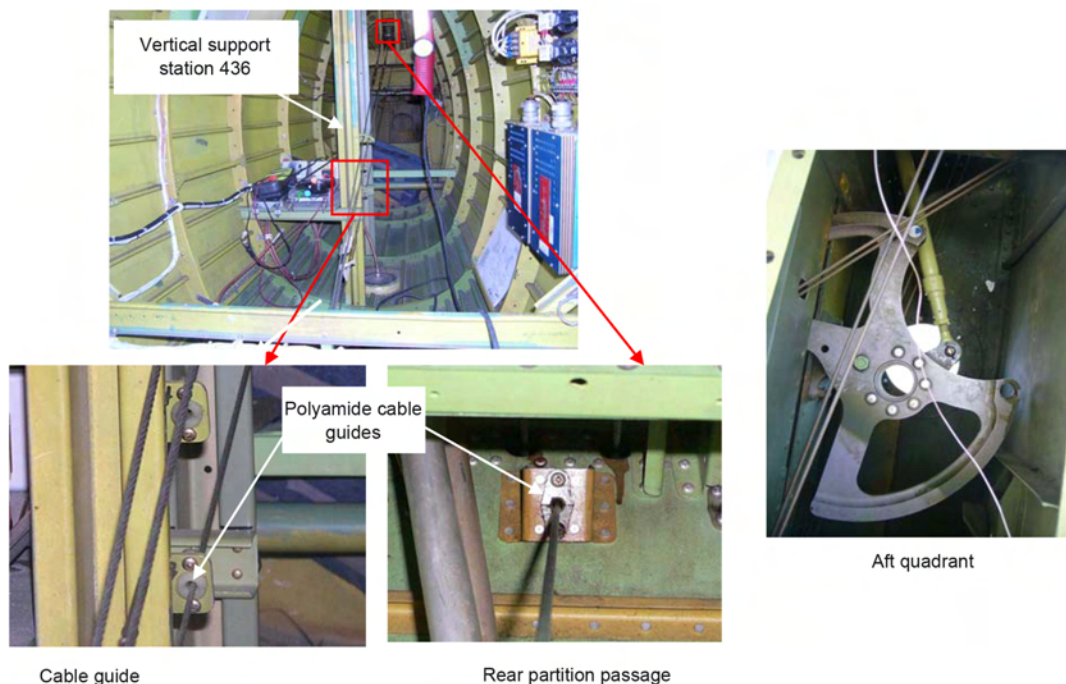
The two cables showed several signs of wear in the zones of contact with elements of the aeroplane: the rear quadrant, the rear partition passage and the cable guides attached to a vertical strut at the level of station 436. The formation of flat spots was observed on the section of the cables in contact with these elements and the presence of failed wires.

Wear at the metallic quadrant level presented a mat rough aspect relative to the metal on metal chafing. It was characterised by signs of chafing perpendicular to the cables' axis.

The areas of wear at the partition passage level and the cable guides had a shiny "polished" aspect. Their surface showed thin signs of chafing parallel to the cable axis. This wear was representative of chafing with the polyamide bushes located in the ferrules.

The rear failure of the pitch-up control cable was in line with the cable guide.

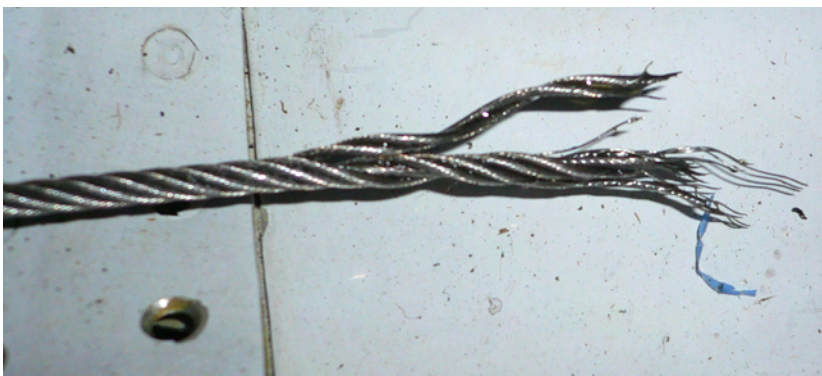
Aft failure of the pitch-up control cable (scale 1:1)

The strands stayed grouped on the whole in the aft failure area.

The specialists who conducted the examinations concluded that this cable had likely failed before hitting the water.

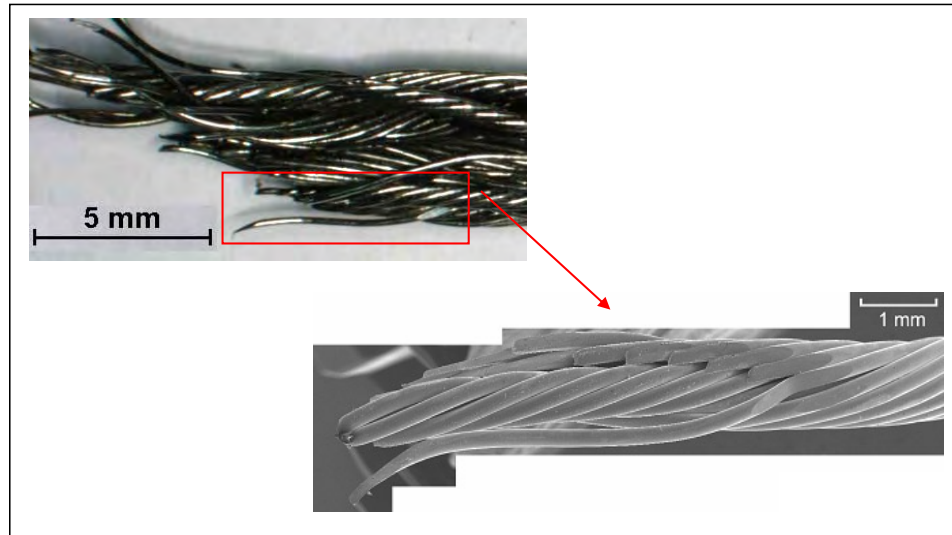
Profile of wear on the outer wires in the failure area

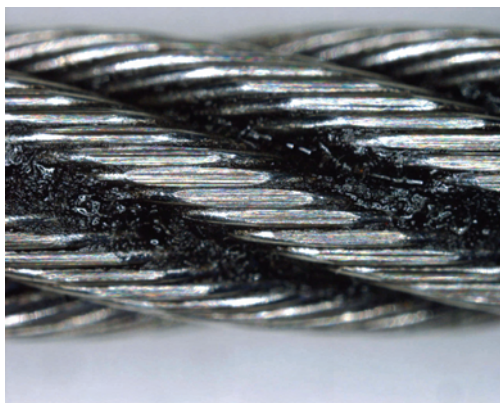
A range of wear appeared on the stainless steel cable whereas no wear was detectable on the carbon steel cable. These tests confirmed what had been noticed in operation (see 1.18.1). They did not, however, allow a possible cable wear law to be established, if only because calculating the rate of wear by counting wires implied cutting the cable. Because of this, and even if it seemed likely, it was not possible to say if the rhythm of wear accelerated at the same time.

Binocular view of the wear area  
on a stainless steel cable  
after 150,000 cycles

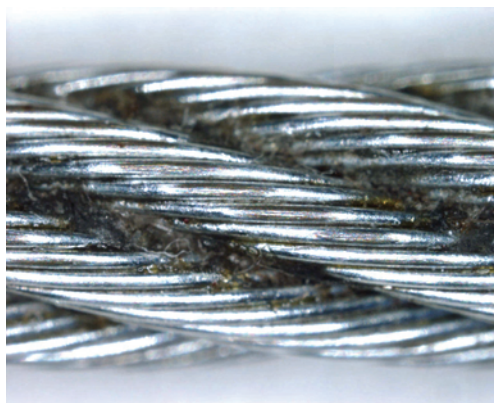
Binocular view of the wear area  
on a carbon steel cable  
after 150,000 cycles

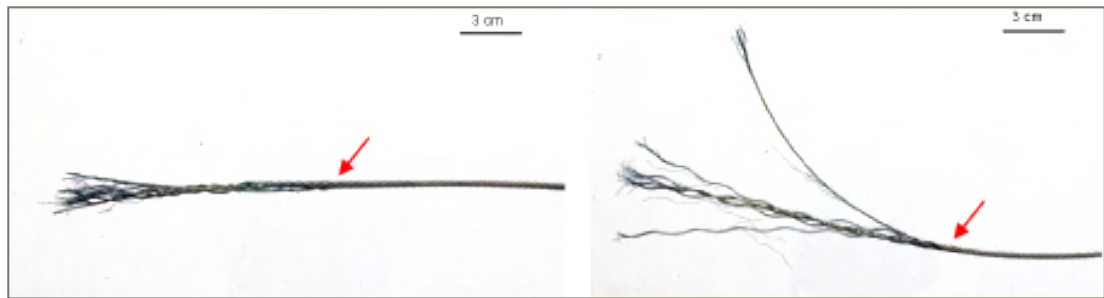
Failure occurred after 58,000 cycles, on the worn spot, with a strong untwisting as far as the fixation zone marked below by red arrows.

Appearance of the failed cable ends after fatigue test

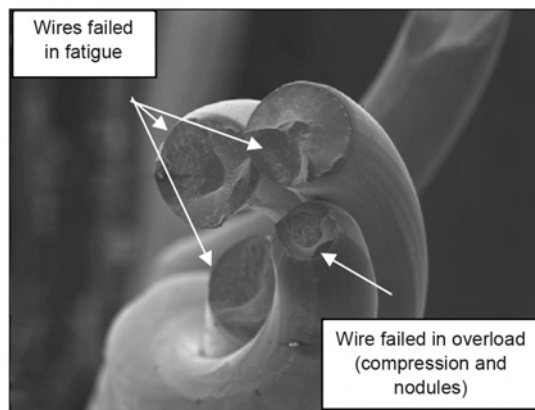
Several of the outer and central strand wires showed signs of fatigue (see photo below), unlike the F-OIQI's pitch-up cable wires.

Fatigue failures of wires

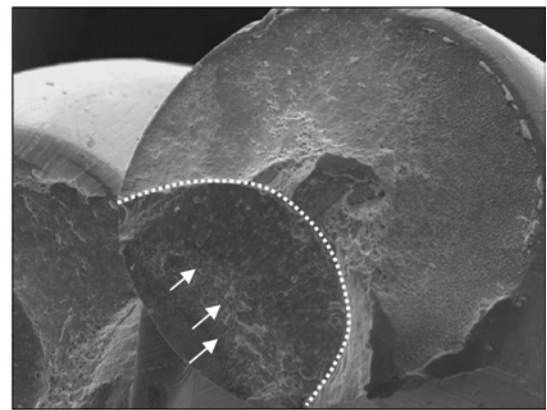
Overload failure of wire (stress and cups)

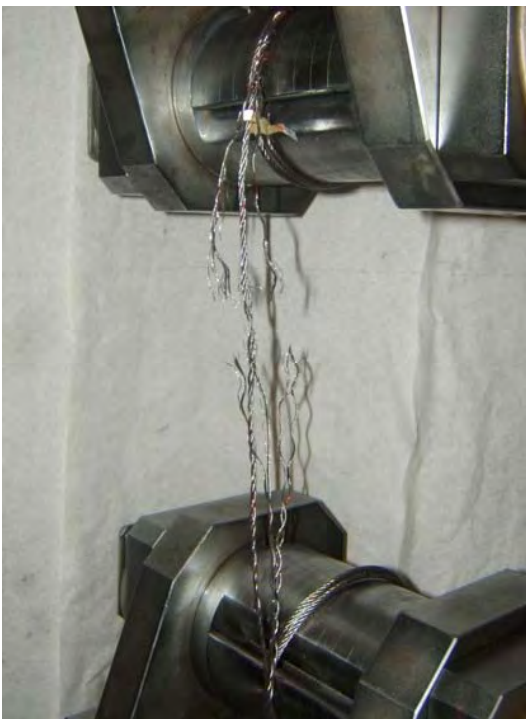
View of pitch-down cable  
on traction machine :  
high degree of untwisting

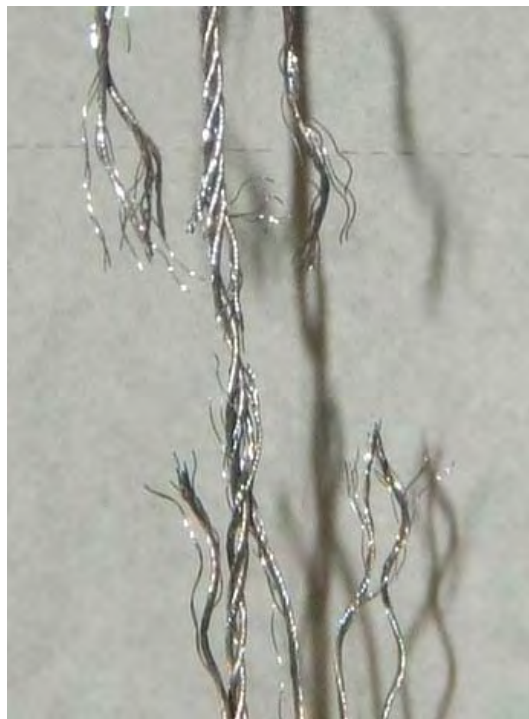
Note: For safety reasons, the test stopped when the drop in the load detected by the machine was above 80%. In both cases, two outer strands remained unbroken after the test.

Detail of pitch-down-cable  
after test : two outer strands  
not broken

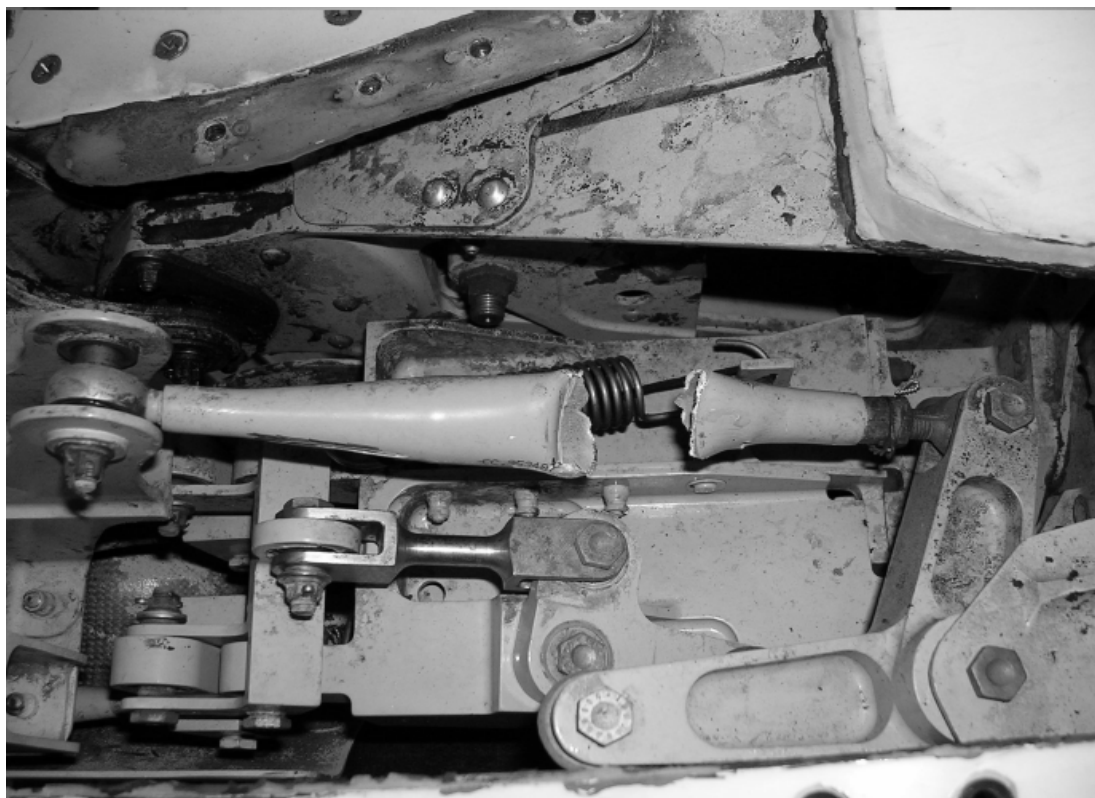
The right wing aileron pushrod was found broken as a result of bending.

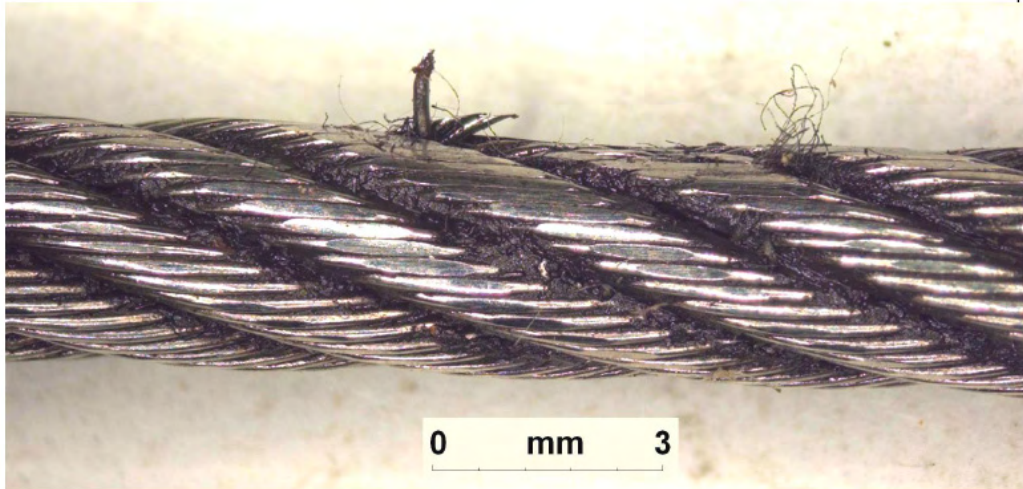
The wear noted on the lower and upper cables was located exactly the same distance from the stops and had the same appearance.

Cliché 5 : Zone d'usure E' sur le câble supérieur

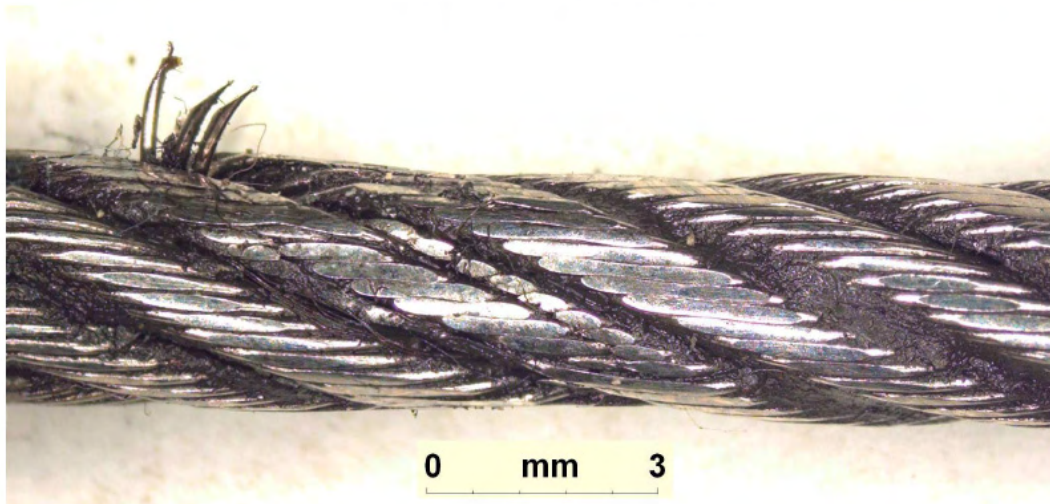
Cliché 6 : Zone d'usure E sur le câble inférieur

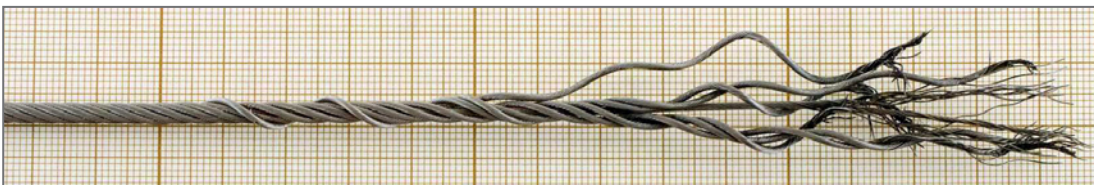
On the cross-section below (strands identified arbitrarily from A to F), the broken wires in line with wear are identified in red, that is to say 113 wires from a total of 133. This wear was characterised by the formation of flat spots, with traces of chafing parallel to the cable axis.
