Report

Incident on **2 May 2009**
on approach to Antalya (Turkey)
to the **Boeing 737-300**
registered **F-GFUF**
operated by **Europe Airpost**

Bureau d'Enquêtes et d'Analyses
pour la sécurité de l'aviation civile

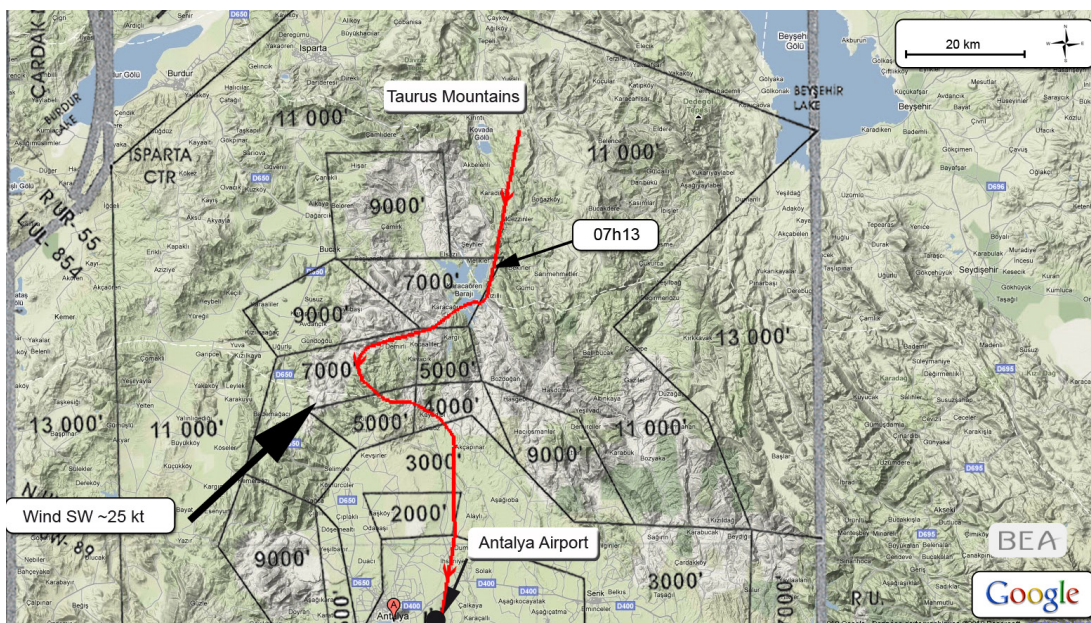
The south-west part of the Taurus Mountains is located north of Antalya aerodrome.

No documentation, official or from the operator, contained any specific instructions relating to the aerodrome, in particular relating to meteorological phenomena concerning the aerodrome environment.

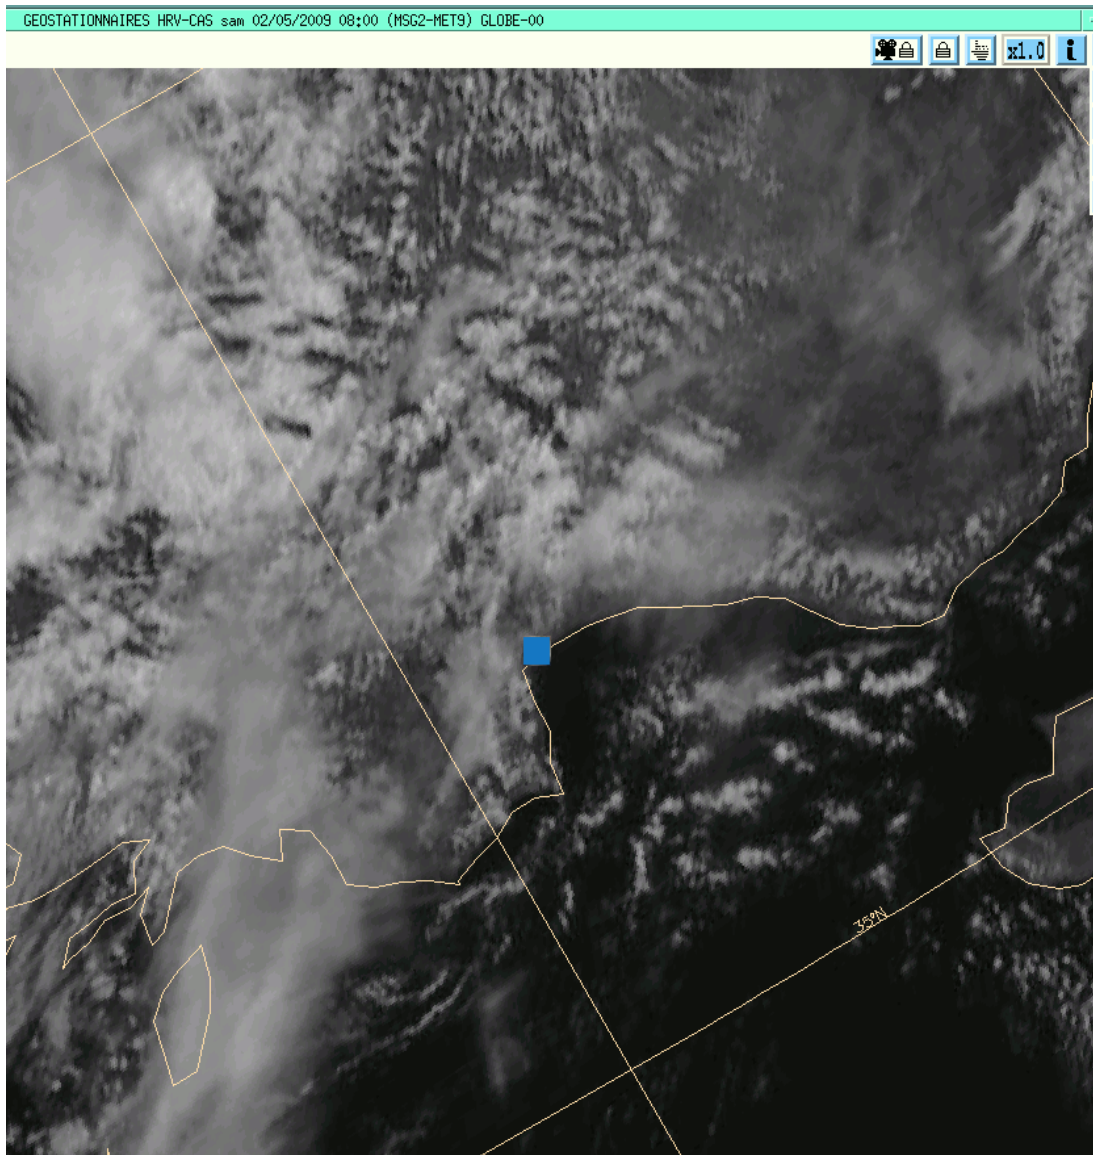
Satellite image at 7 h 00 UTC

Events:	Temporary loss of control, stall with AP and A/T
Consequences and damage:	No damage
Aircraft:	Boeing 737- 300
Date and time:	2 May 2009 at 7 h 13 UTC ⁽¹⁾
Operator:	Europe Airpost
Place:	On approach at about 30 NM north of Antalya (Turkey)
Type of flight:	Public transport of passengers (charter flight)
Persons on board:	2 flight crew - 3 cabin crew - 110 passengers
Meteorological conditions in the event area:	The satellite ⁽²⁾ image shows a steady south-westerly flow as well as the presence of mountain waves

⁽²⁾The crew did not possess this image. The meteorological file at its disposal did not make it possible to identify a mountain wave phenomenon. The satellite image is shown in Appendix.
