# **NATIONAL TRANSPORTATION SAFETY BOARD**

## **AIRCRAFT ACCIDENT REPORT**

**WHEELS-UP LANDING  
CONTINENTAL AIRLINES FLIGHT 1943  
DOUGLAS DC-9 N10556  
HOUSTON, TEXAS  
FEBRUARY 19, 1996**

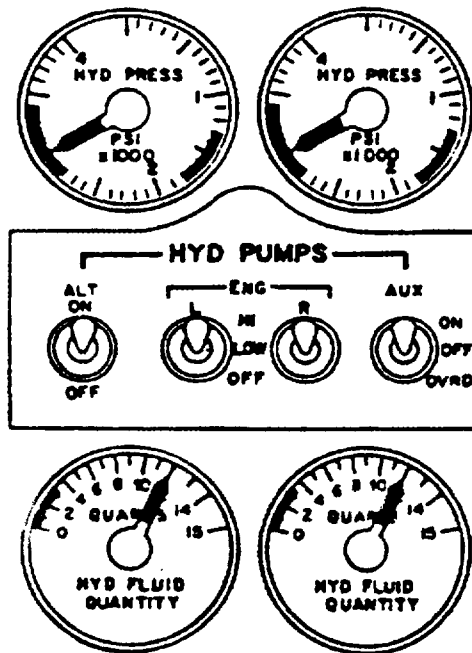
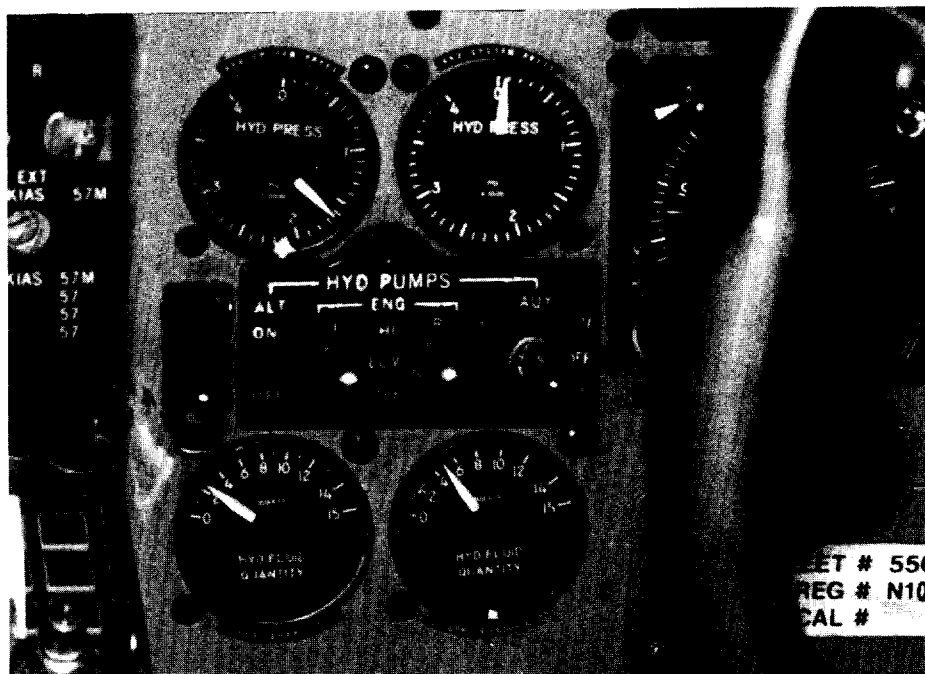
Figure 1 – Hydraulic switch panel.

Bottom Photo - Photo of accident airplane's hydraulic switch panel in low pressure configuration (see section 1.12).

Examination of the cockpit revealed that the landing gear handle was in the down position and the flap handle was set to 50°. The left and right engine-driven hydraulic pump switches were in the “LOW” position, and the ALT and AUX hydraulic pump switches were in the “OFF” position. The left hydraulic system gauge indicated 1,600 psi, and the right gauge indicated 0 psi (refer to figure 1). The safety wire on the GPWS flap override switch was found broken; however, the switch was not in the “OVRD” position.

The evidence indicates that the airplane's hydraulic system was not configured for landing. Because the hydraulic system remained in the low pressure mode, hydraulic pressure was not available to lower the landing gear and deploy the flaps. The flightcrew failed to detect this configuration error and continued its approach into Houston. Comments on the CVR and postaccident statements by the flightcrew indicate that both pilots recognized that the flaps did not deploy after the flaps were selected to 15°, but the flightcrew did not determine the cause of this problem or execute a go-around.
