FINAL
KNKT.13.04.09.04

Aircraft Accident Investigation Report

PT. Lion Mentari Airlines (Lion Air)
Boeing 737 - 800; PK-LKS
Ngurah Rai International Airport, Bali
Republic of Indonesia
13 April 2013

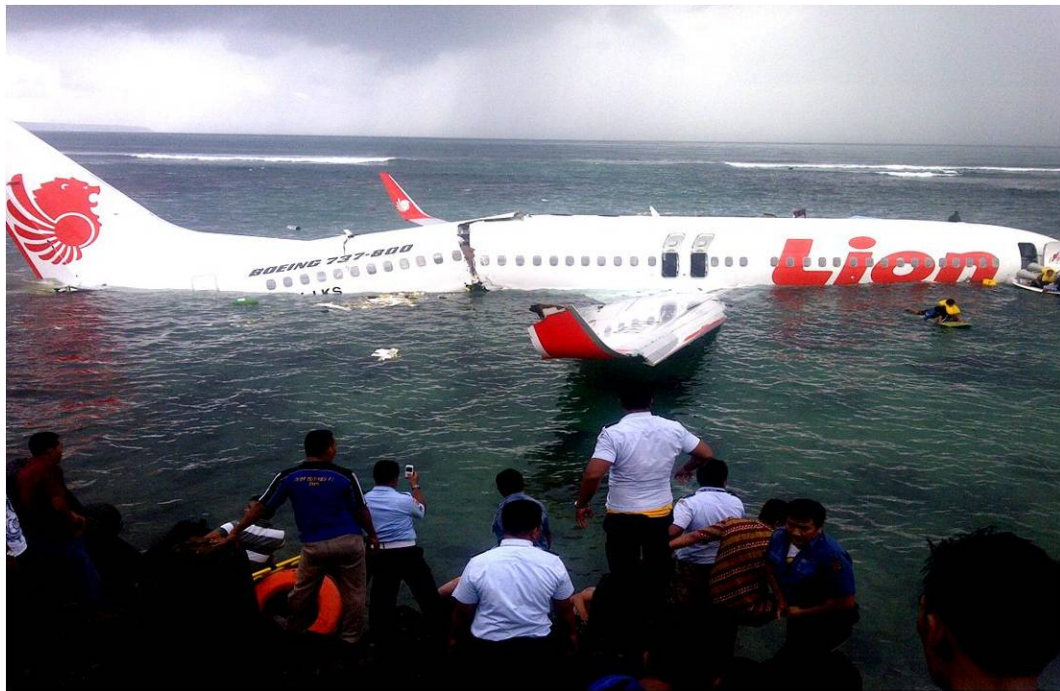
Figure 2: The aircraft after the accident

The aircraft was substantially damaged and submerged in shallow water.

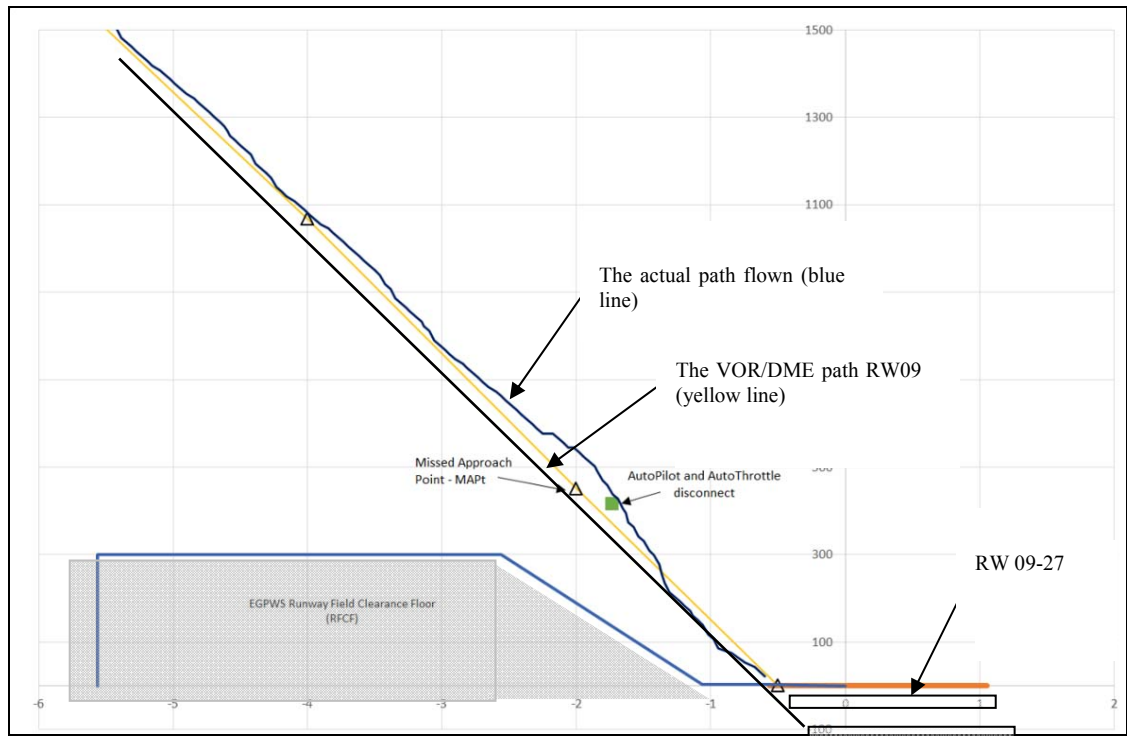
Figure 3: Aircraft flight path with respect to EGPWS envelope

Examination of the FDR and CVR information indicated that no EGPWS warnings occurred during the accident sequence. Further examination of FDR data indicated that the aircraft did not enter the EGPWS alert/ warning envelope during the approach (Figure 3).

The final approach phase of the flight profile was outside the envelope. Therefore there was no EGPWS terrain warning.

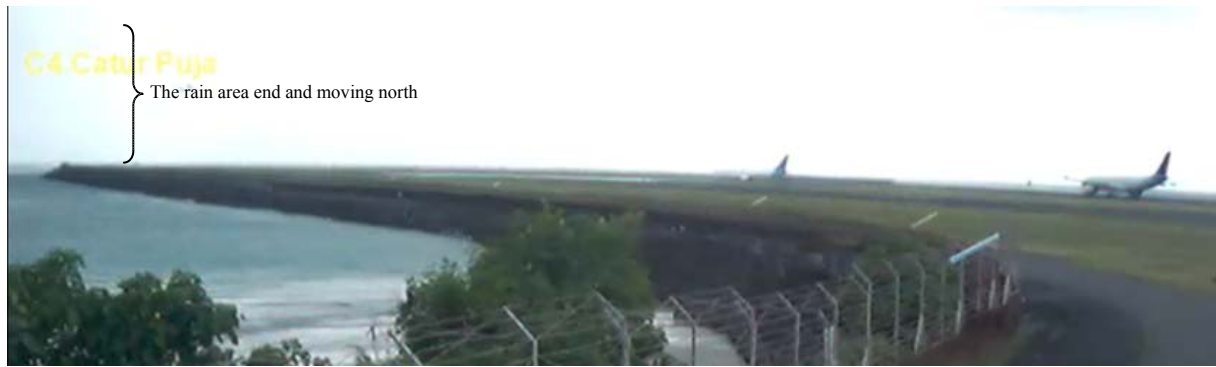
Figure 6: The weather 4 minutes prior to the accident

The airport Closed Circuit Television (CCTV) camera located on the south side of the runway recorded the changing weather. The rain showed as a grey area on the left corner, and moving across the short-final area. The weather 4 minutes before the accident (Figure 5) showed the final area was clear.

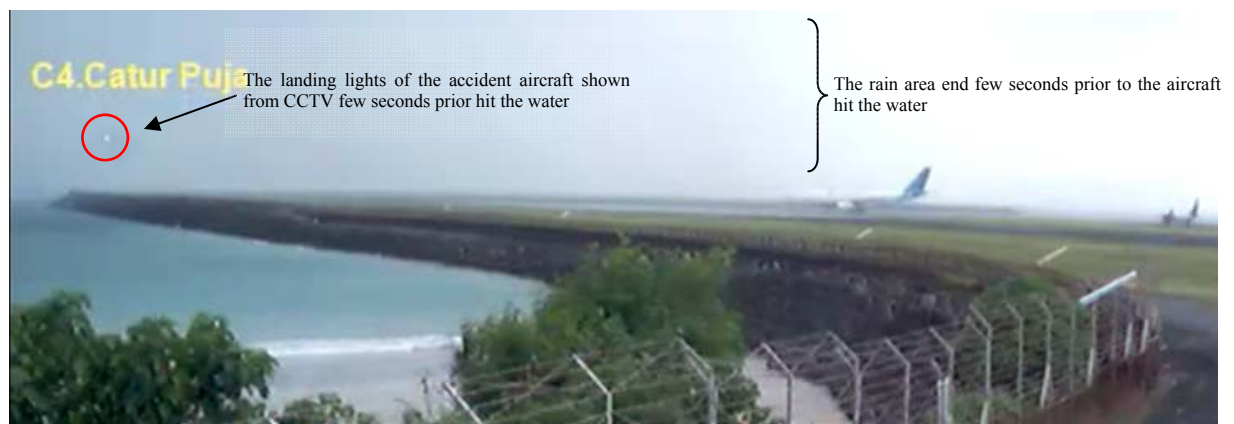
Figure 7: The weather few seconds prior to the accident

The weather a few seconds prior to the accident on figure 6 shows that the final area was raining as seen from the CCTV camera.

Four minutes prior to the accident, the airport CCTV recorded that the final approach area was clear. During the final approach of the aircraft, the CCTV recorded that the final approach area was raining. This indicated that the dark side that was initially observed by the PIC to the right of the aircraft had moved across the final approach path.

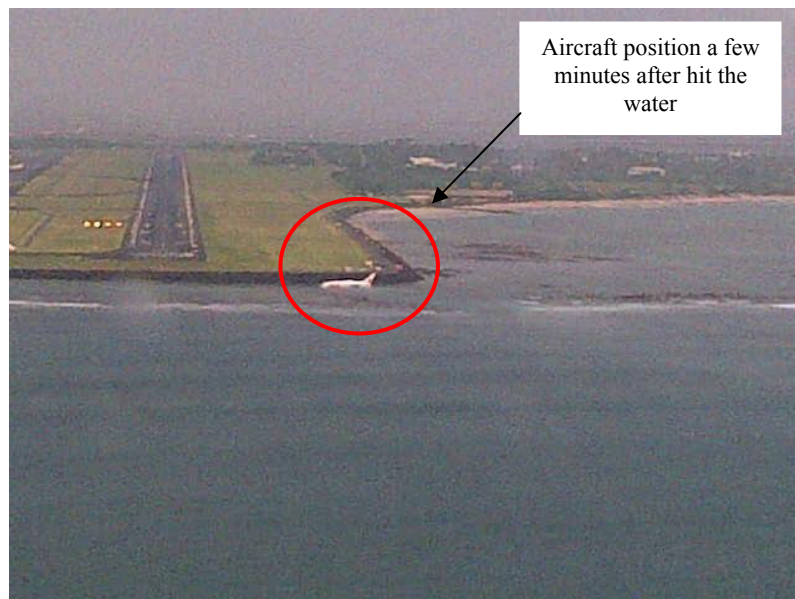
Figure 16: Final aircraft resting position

The main landing gears broke and detached. It was found about 300 meters from the last position of the main wreckage. The engines detached from the wing pylon. Those components detached most likely due to impact with rock of the shallow sea bed. After they detached, the aircraft swung to the left at its final position.

The aircraft came to a stop facing north about 20 meters from the shore and approximately 300 meters west of the runway 09 threshold.

The wreckage was submerged in shallow water between 2 to 5 meters in depth.
