Investigation Report

Type of Occurrence:	Accident
Date:	19 March 2008
Location:	Mannheim
Aircraft:	Airplane
Manufacturer / Model:	Dornier Luftfahrt GmbH / Do 328-100
Injuries to Persons:	5 minor injuries
Damage:	Aircraft severely damaged
Other Damage:	Minor field damage
Information Source:	Investigation by BFU
State File Number:	BFU 1X001-08

German Federal Bureau of
Aircraft Accident Investigation

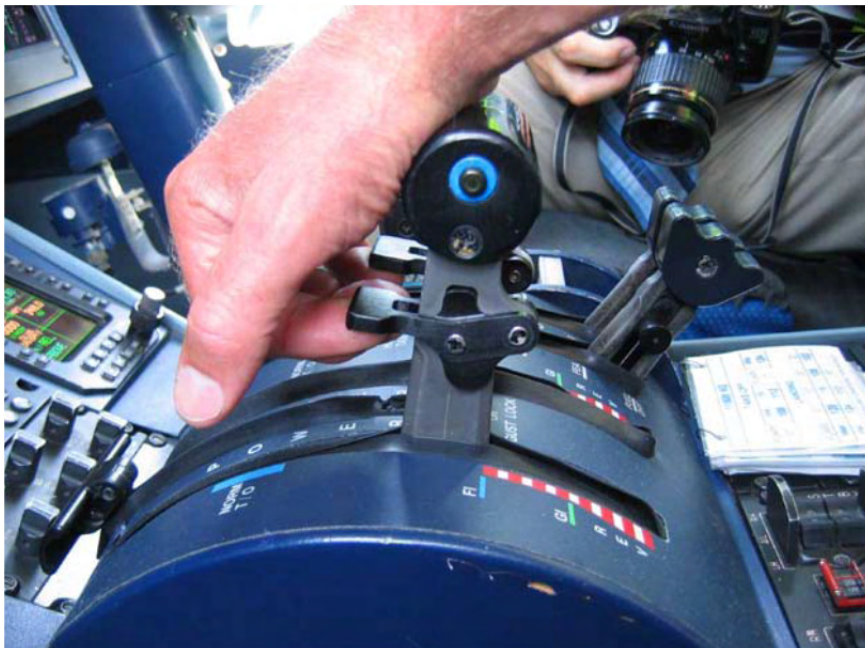
Power Lever und Latches Source: AAIB

| Aug 2006 | The AAIB published the Bulletin S7/2006. It stated that it was not possible for the crew to move the power levers back from FI into the BETA position. The Bulletin included the following safety recommendation:

The SB arranged for a modification of the power lever tracks and introduction of a crew aural alerting device in case the latches are pulled in a position which causes a blockage of the power levers.

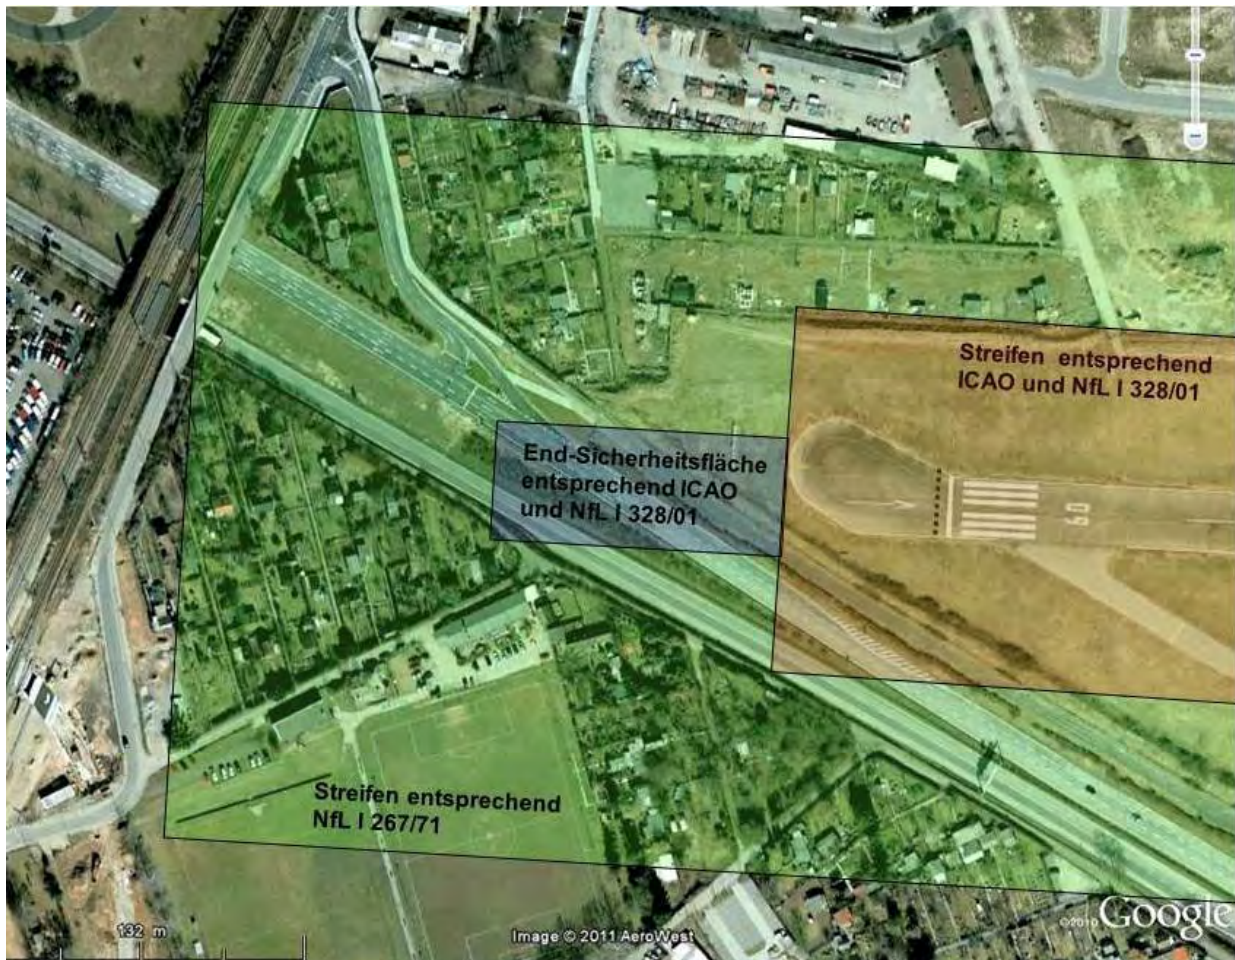
Intended safety areas of runway 27 at EDFM

safety areas have to have at least a length of 90 m. Furthermore, a length of 120 m was recommended. The width of these areas was to be the same as that of the strip or at least twice the runway width. Objects which could be dangerous to aircraft should not be within the strip or the safety areas.

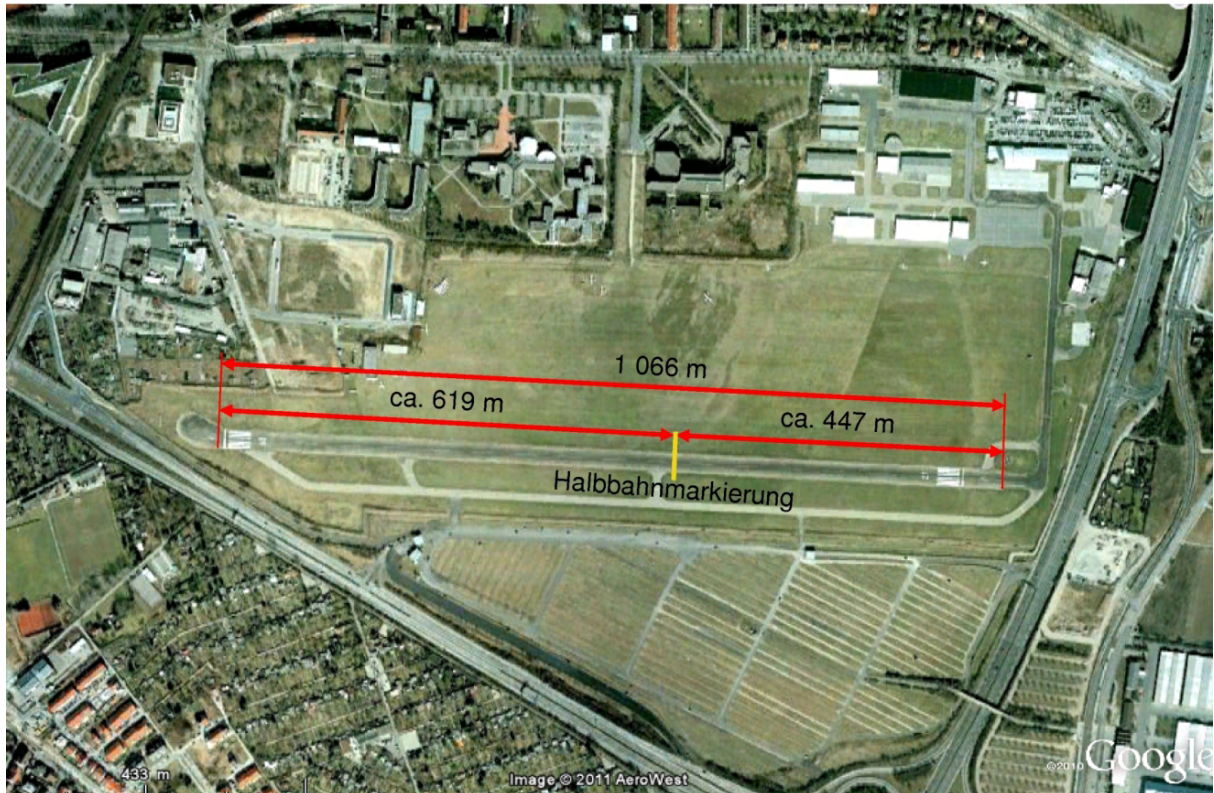
Runway markings at EDFM

In spite of the conclusion that from a flight operational point of view the approach to Mannheim City was difficult the runway markings did not comply with the respective regulations. There was neither the required aiming point marking nor the recommended touchdown zone marking. Such markings would have given the crew some support concerning the distance and the glideslope and, if necessary, been an

additional visual indication whether the approach was stabilised or not. The required but missing aiming point marking was therefore a safety deficit. The landing zone markings would have improved the safety level of the runway and the existing safety deficit caused by the missing safety areas would have been somewhat lessened.

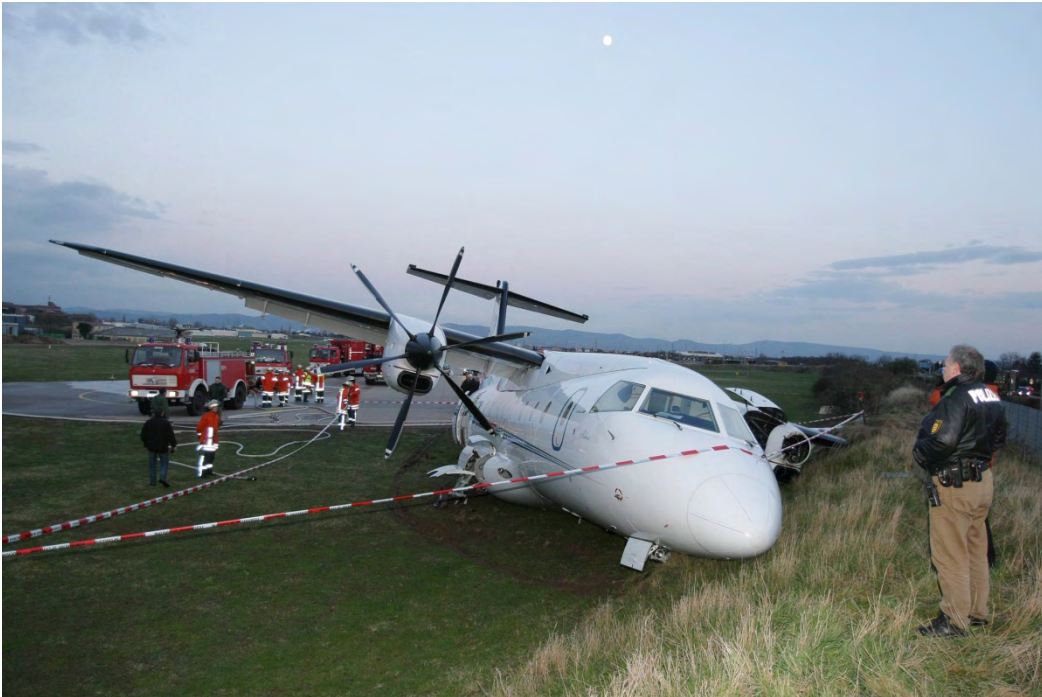
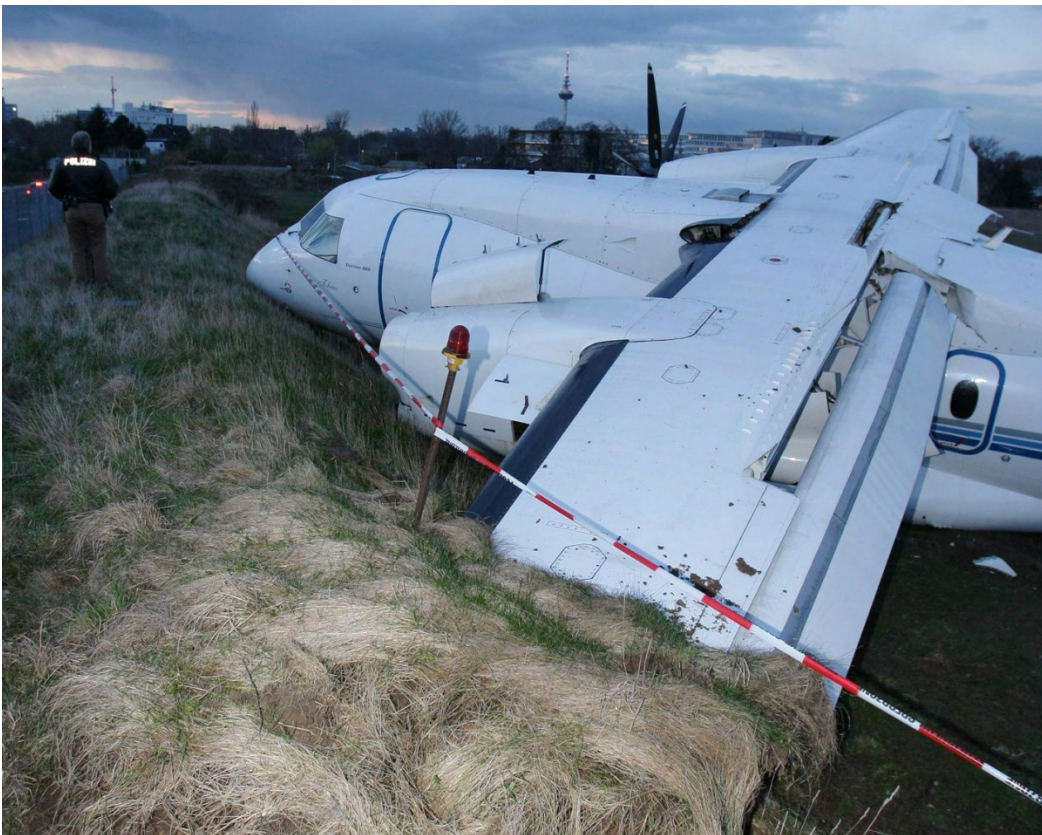
Accident site

The airplane was found south of the localizer antennas beyond runway 27. The aircraft nose had contact with an earth wall. The airplane axis was about parallel to the runway and the airplane had a tilted position to the left. The left wing stuck in the earth wall. The left landing gear was buckled. The propeller had been severed from the left engine and lay behind the cockpit beneath the fuselage. Flaps and spoilers were extended. The wing to body fairing was severely damaged.

The power levers for the engines were free. The connection to the engines was severed. The condition lever of the right engine was free. It was no longer connected with the engine. The condition lever of the right engine was jammed. It was in the front third position.

The runway was dry. None of the touch-down traces found on the runway could be assigned to the accident aircraft. On the last 150 m of runway 27 deep-black, continuous skid marks were visible which could be assigned to the accident aircraft. After the runway end the skid marks crossed a utility shaft (electrical equipment). This utility shaft was open and the concrete lid lay about 5 m to the side. Parts of the wheel well doors and the left propeller were found in the immediate vicinity of the utility shaft.
