Accident  
on 24 December 2000  
at Tahiti Faaa Airport  
to the DC10-10  
registered N132AA  
operated by Hawaiian Airlines

**REPORT**  
**n-aa001224a**

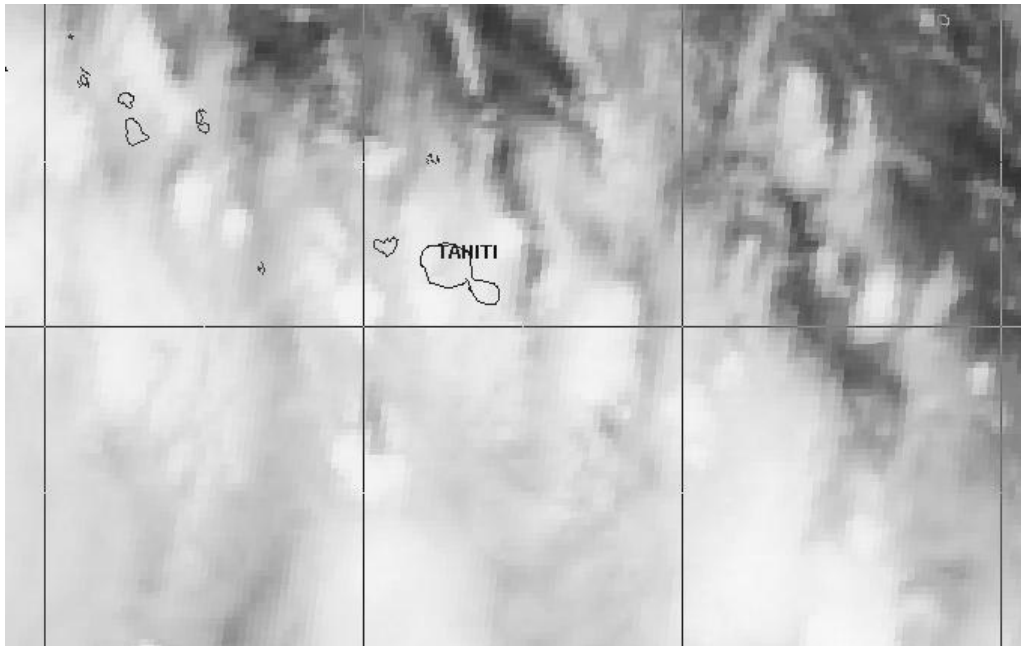
**Figure 1 – Infra-red satellite photo taken by GOES 10 on 24/12/00 at 10 h 52**

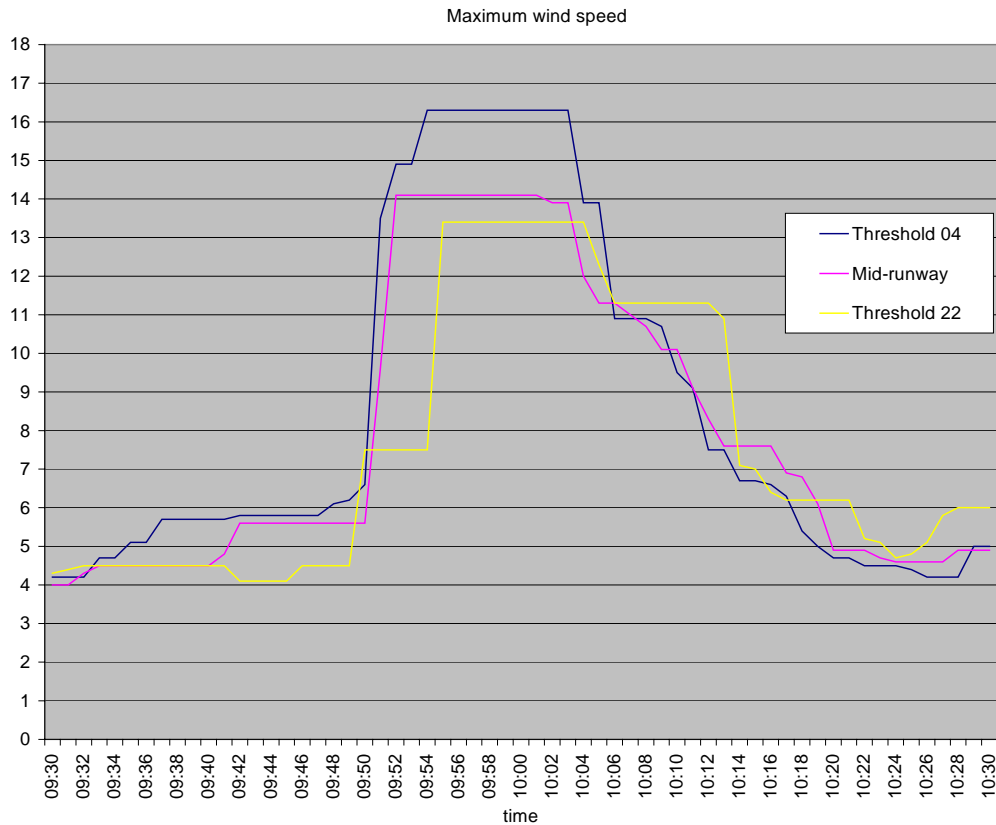
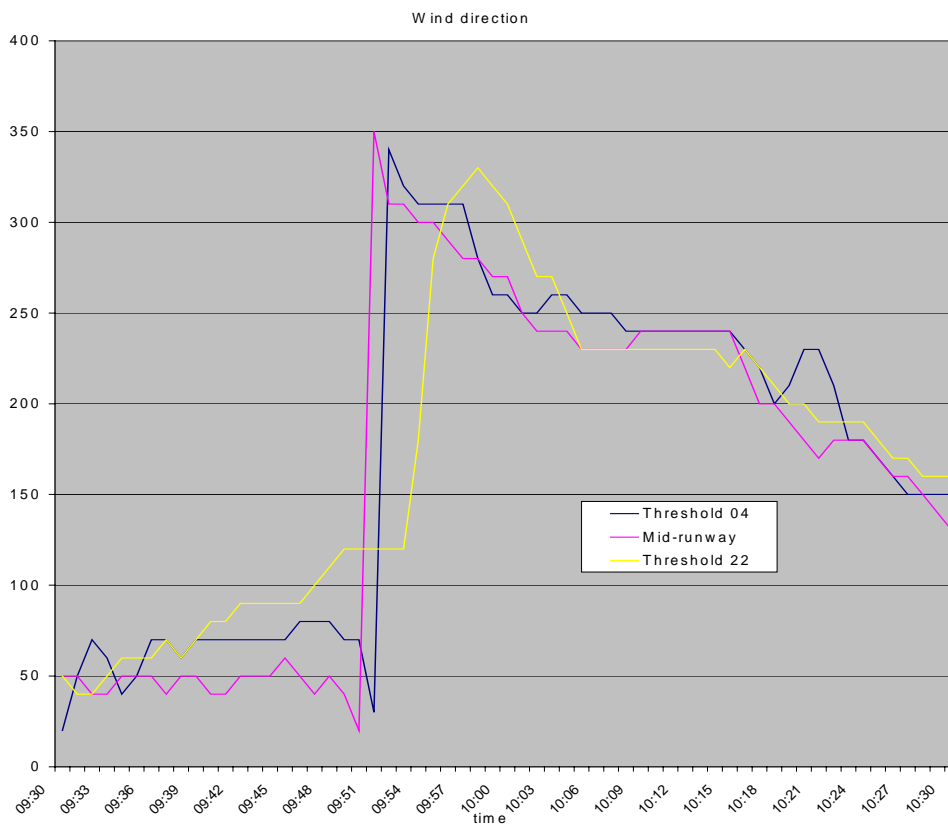
Between 9 h 47 min and 9 h 56 min, the wind speed increased rapidly, reaching 5.8, 6.1, 6.2, 6.6, 13.5, 14.9, 14.9, 16.3, 16.3 and 16.3 m/s at threshold 04, with a significant variation in direction. Between 9 h 52 and 9 h 53 min, the wind direction was 330° at threshold 04 while it was 310° at the meteorological station and 120° at threshold 22.

The variations in wind speed and direction indicate the presence of turbulent wind and windshear characteristic of a storm. The recordings also indicate that the stormy period lasted about fifteen minutes.

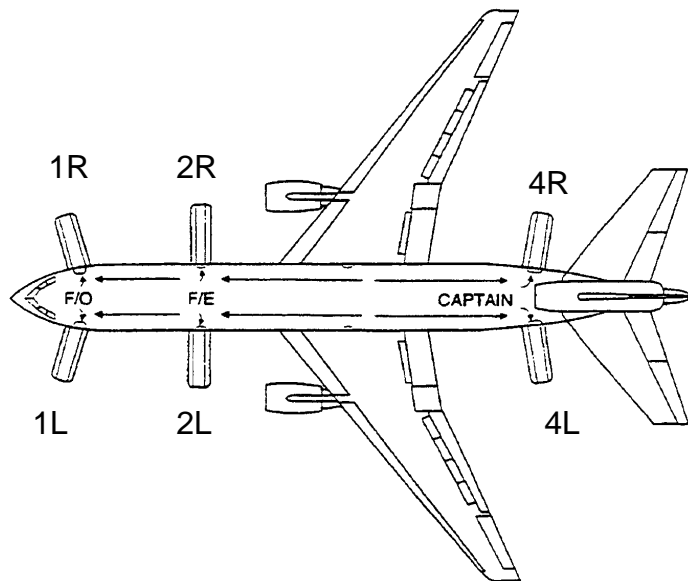
Given the sloping position of the airplane, the evacuation was carried out via the right center door emergency slide (2R) which was the only one considered to be usable. The slide at the left center door (2L) was also deployed but it seemed that the depth of the water was about fifteen meters. The lighting conditions made it difficult to evaluate the situation and advice was taken from the firefighters not to evacuate the passengers via that door. The end of the right slide was tied up to the sea wall located

at the end of the runway so as to give the passengers the shortest walk possible through the water, which was shallow on that side. The passengers were greeted by the firefighters, who had taken care to remove the barbed wire coils that were protecting the aerodrome against intruders from that side.

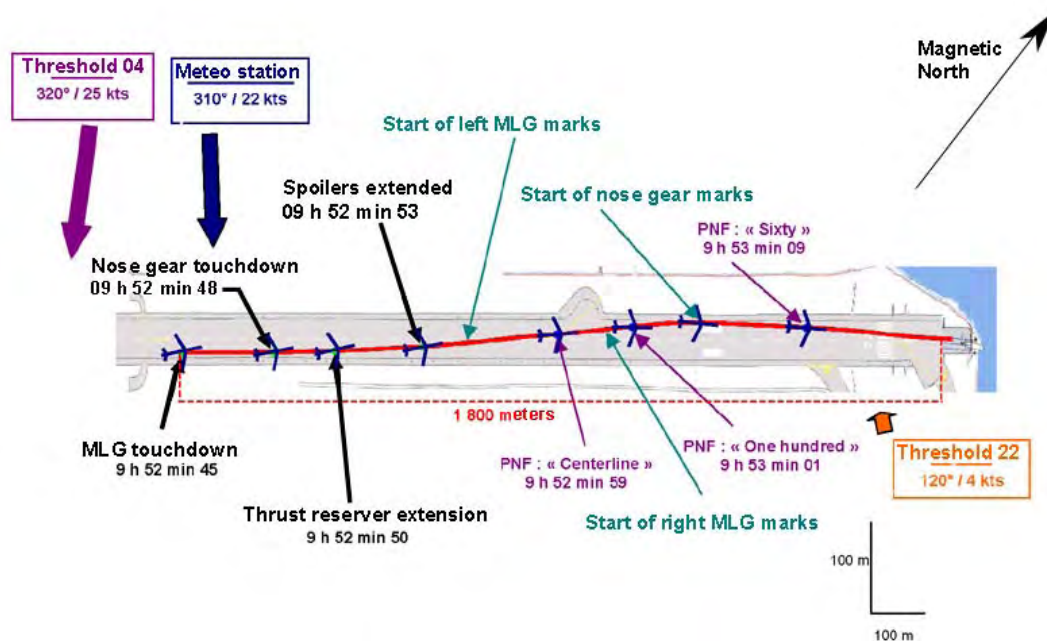
### Ground track determined from recorded FDR data

The landing roll, compared with the airplane's magnetic heading, indicates that the airplane started sliding to the right for eleven seconds from touchdown of the main gear, then slid to the left, between 9 h 53 min and 9 h 53 min 13 s.

*Note: The winds indicated above correspond to those at 9 h 53 min averaged over the last two minutes at thresholds 04 and 22 and the meteorological station. Threshold 04 is not included due to the scale chosen.*

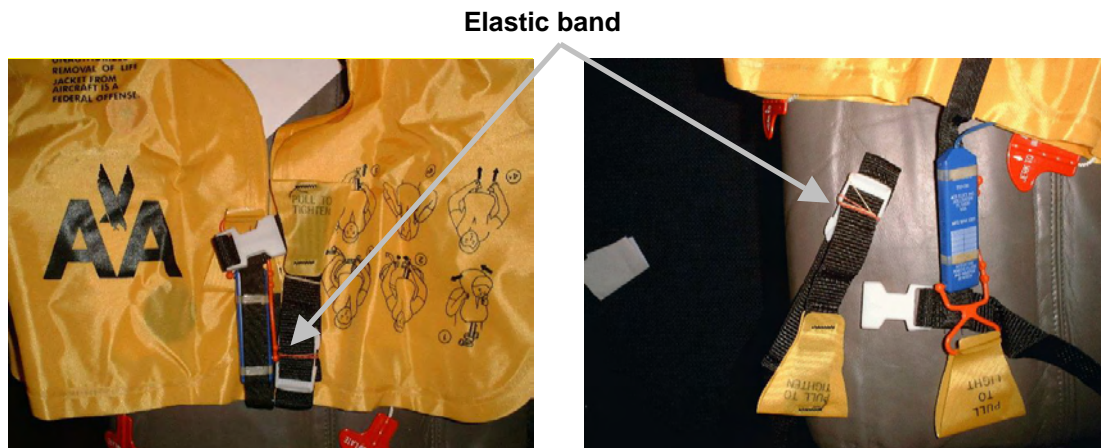
On some of the life jackets, when the passenger put it on and pulled the “Pull to tighten” tag, the elastic band installed during packing to maintain the adjustment slack was placed in the male part of the attachment mechanism, thus preventing it from locking into the female part.

If the wearer managed to attach the male and female parts by forcing them, he could not pull the excess strap through the locking buckle and thus adjust the life jacket.
