**Air Accidents Investigation Branch**

**Report on the accident to  
Boeing 747-121, N739PA at  
Lockerbie, Dumfriesshire, Scotland  
on 21 December 1988**

The report concludes that the detonation of an improvised explosive device led directly to the destruction of the aircraft with the loss of all 259 persons on board and 11 of the residents of the town of Lockerbie. Five recommendations are made of which four concern flight

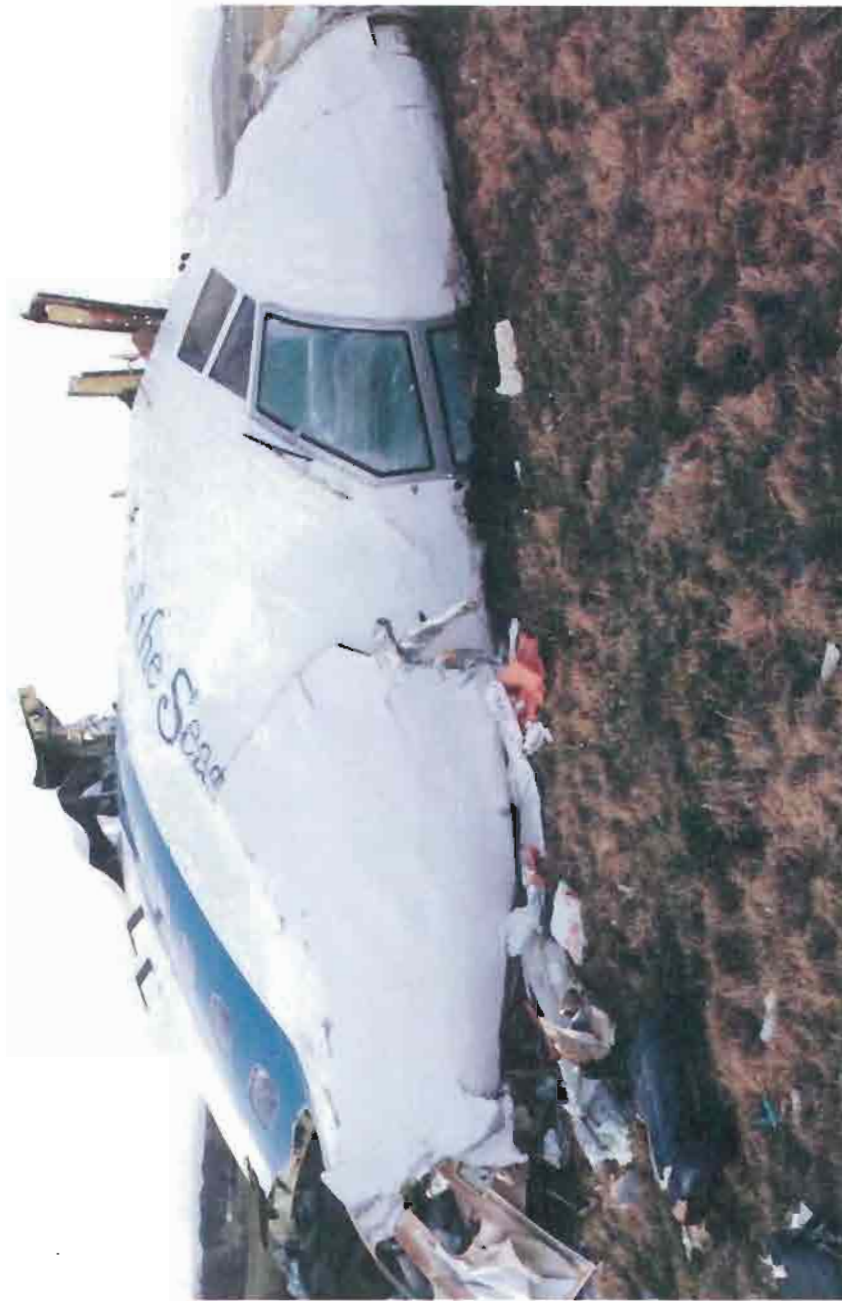
Figure B-9

The complete fuselage forward of approximately station 480 (left side) to station 380 (right side) and incorporating the flight deck and nose landing gear was found as a single piece [Appendix B, Figure B-9] in a field approximately 4 km miles east of Lockerbie at OS Grid Reference 174808. It was evident from the nature of the impact damage and the ground marks that it had fallen almost flat on its left side but with a slight nose-down attitude and with no discernible horizontal

velocity. The impact had caused almost complete crushing of the structure on the left side. The radome and right nose landing gear door had detached in the air and were recovered in the southern trail.

Examination of the torn edges of the fuselage skin did not indicate the presence of any pre-existing structural or material defects which could have accounted for the separation of this section of the fuselage. Equally so, there were no signs of explosive blast damage or sooting evident on any part of the structure or the interior fittings. It was noted however that a heavy, semi-elliptical scuff mark was present on the lower right side of the fuselage at approximately station 360. This was later matched to the intake profile of the No 3 engine.

Photograph of nose and flight deck

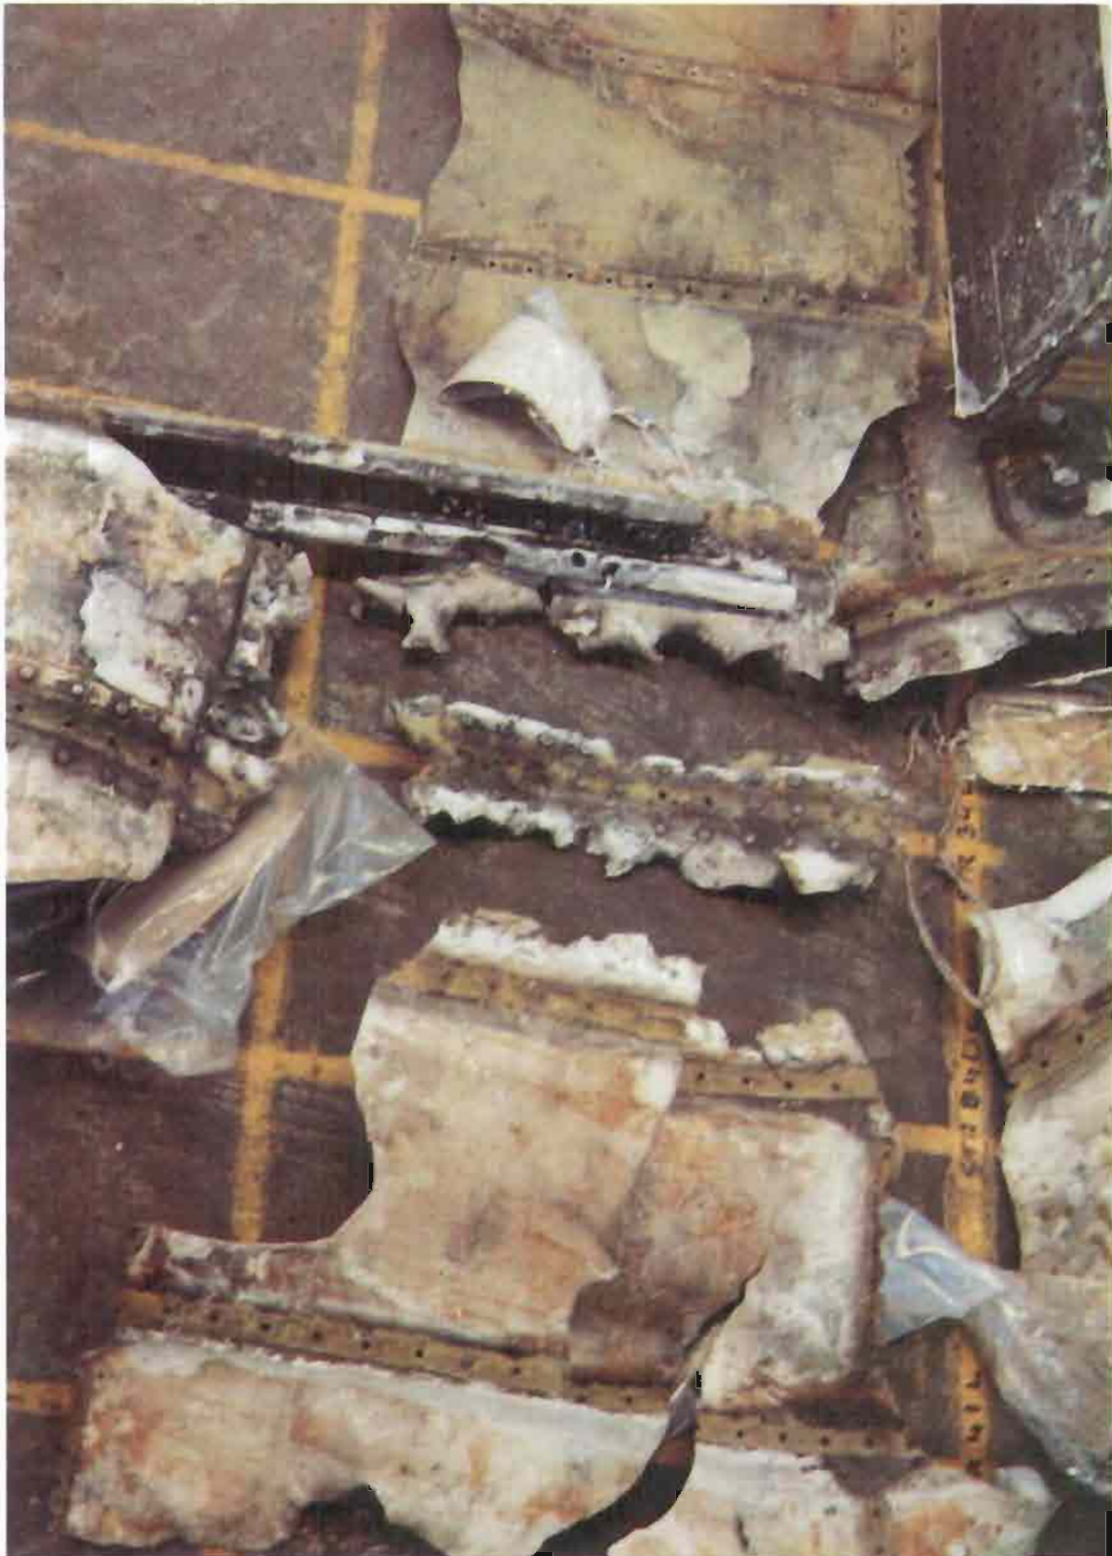
Figure B-15

The reconstruction revealed the presence of damage consistent with an explosion on the lower fuselage left side in the forward cargo bay area. A small region of structure bounded approximately by frames 700 & 720 and stringers 38L & 40L, had clearly been shattered and blasted through by material exhausting directly from an explosion centred immediately inboard of this location. The material from this area, hereafter referred to as the 'shatter zone', was mostly reduced to very small fragments, only a few of which were recovered, including a strip of two skins [Appendix B, Figure B-15] forming part of the lap joint at the stringer 39L position.

Surrounding the shatter zone were a series of much larger panels of torn fuselage skin which formed a 'star-burst' fracture pattern around the shatter zone. Where these panels formed the boundary of the shatter zone, the metal in the immediate locality was ragged, heavily distorted, and the inner surfaces were pitted and sooted - rather as if a very large shotgun had been fired at the inner surface of the

fuselage at close range. In contrast, the star-burst fractures, outside the boundary of the shatter zone, displayed evidence of more typical overload tearing, though some tears appeared to be rapid and, in the area below the missing panels, were multi-branched. These surrounding skin panels were moderately sooted in the regions adjacent to the shatter zone, but otherwise were lightly sooted or free of soot altogether. (Forensic analysis of the soot deposits on frame and skin material from this area confirmed the presence of explosive residues.) All of these skin panels had pulled away from the supporting structure and had been bent and torn in a manner which indicated that, as well as fracturing in the star burst pattern, they had also petalled outwards producing characteristic, tight curling of the sheet material.

Detail of shatter zone of fuselage

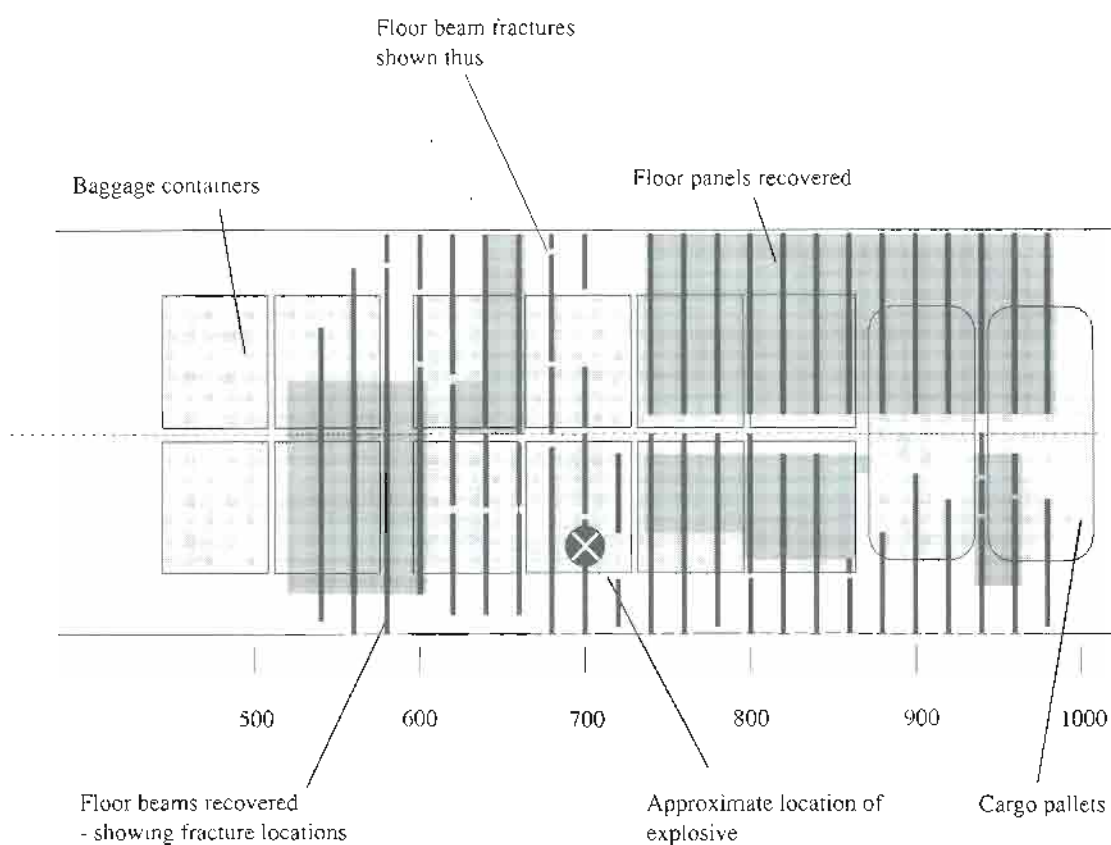
**Figure B-18**

**Plot of floor damage in area of explosion**  
 (structure & floor panel details based on those items recovered, identified, and incorporated into the three-dimensional reconstruction)

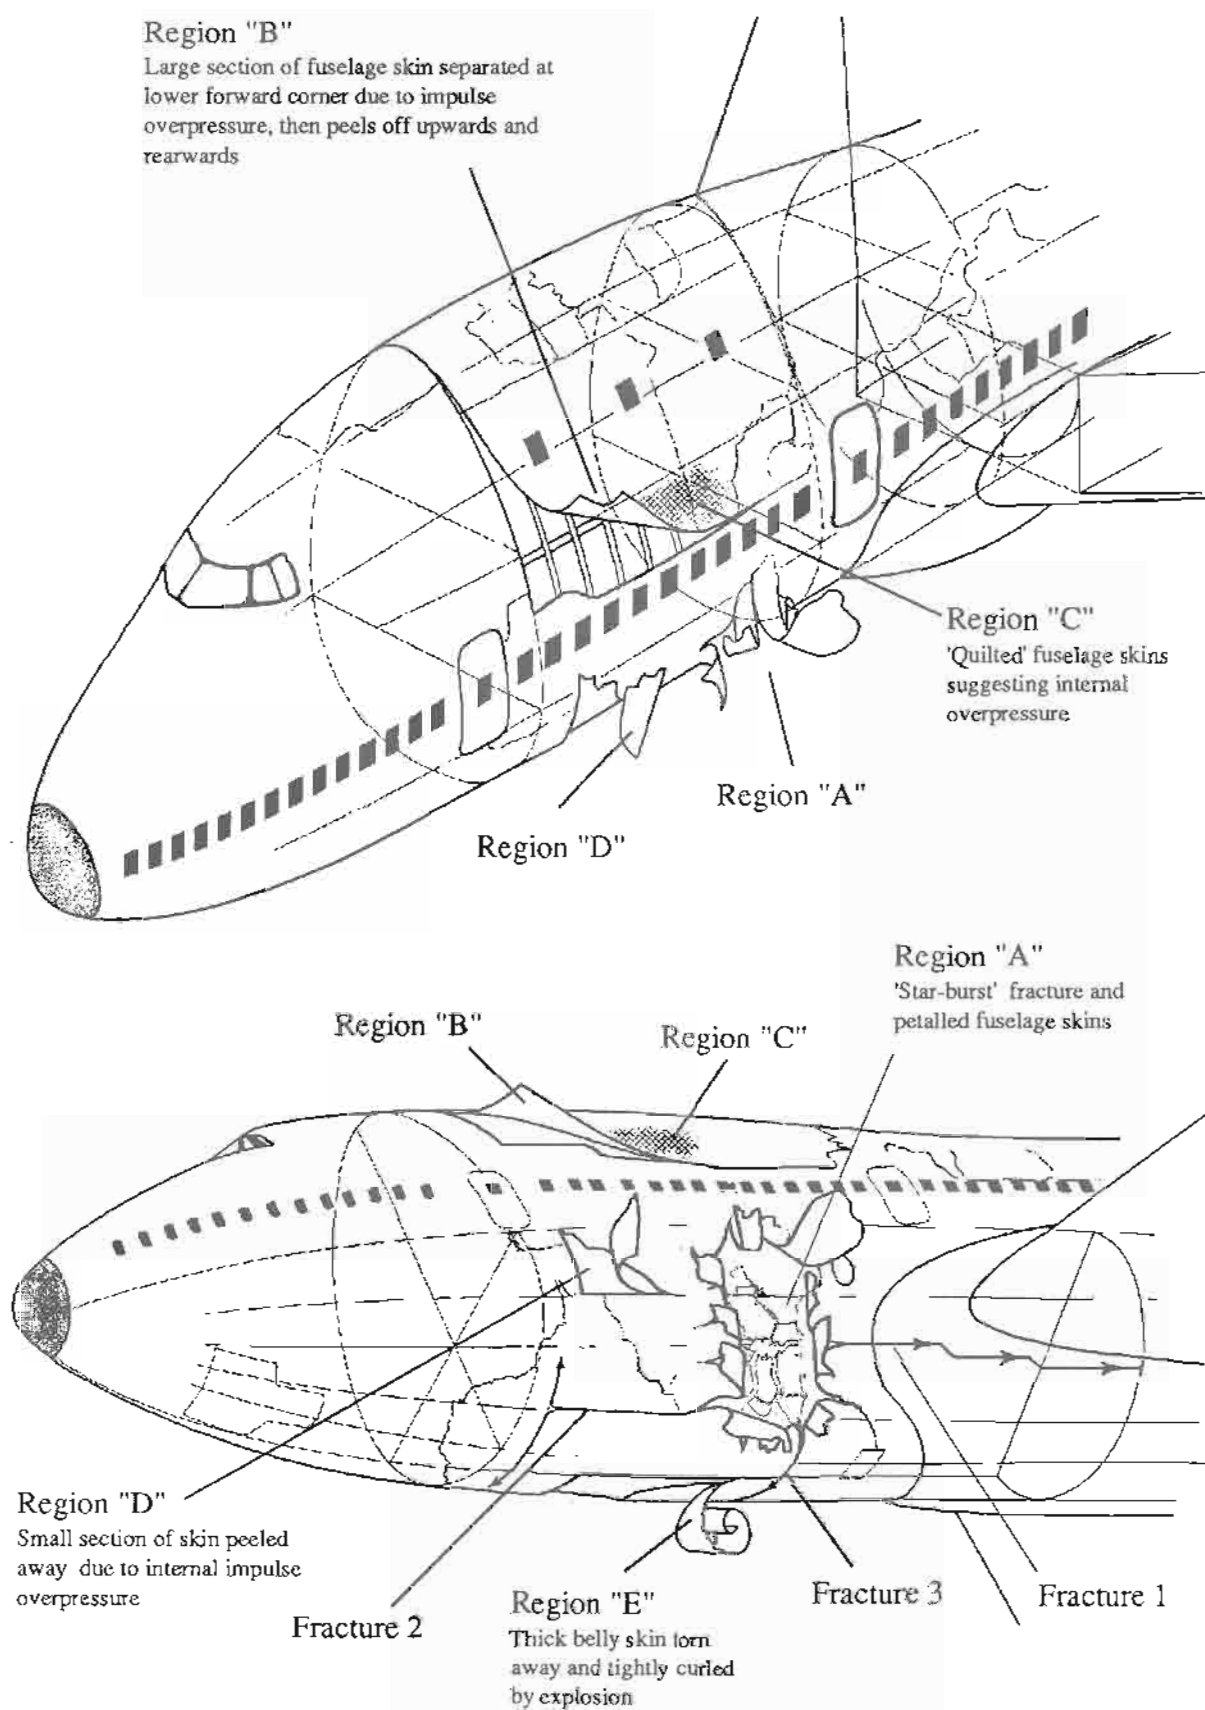
**Figure B-19**

**Explosive Damage - left side**  
(schematic representation)

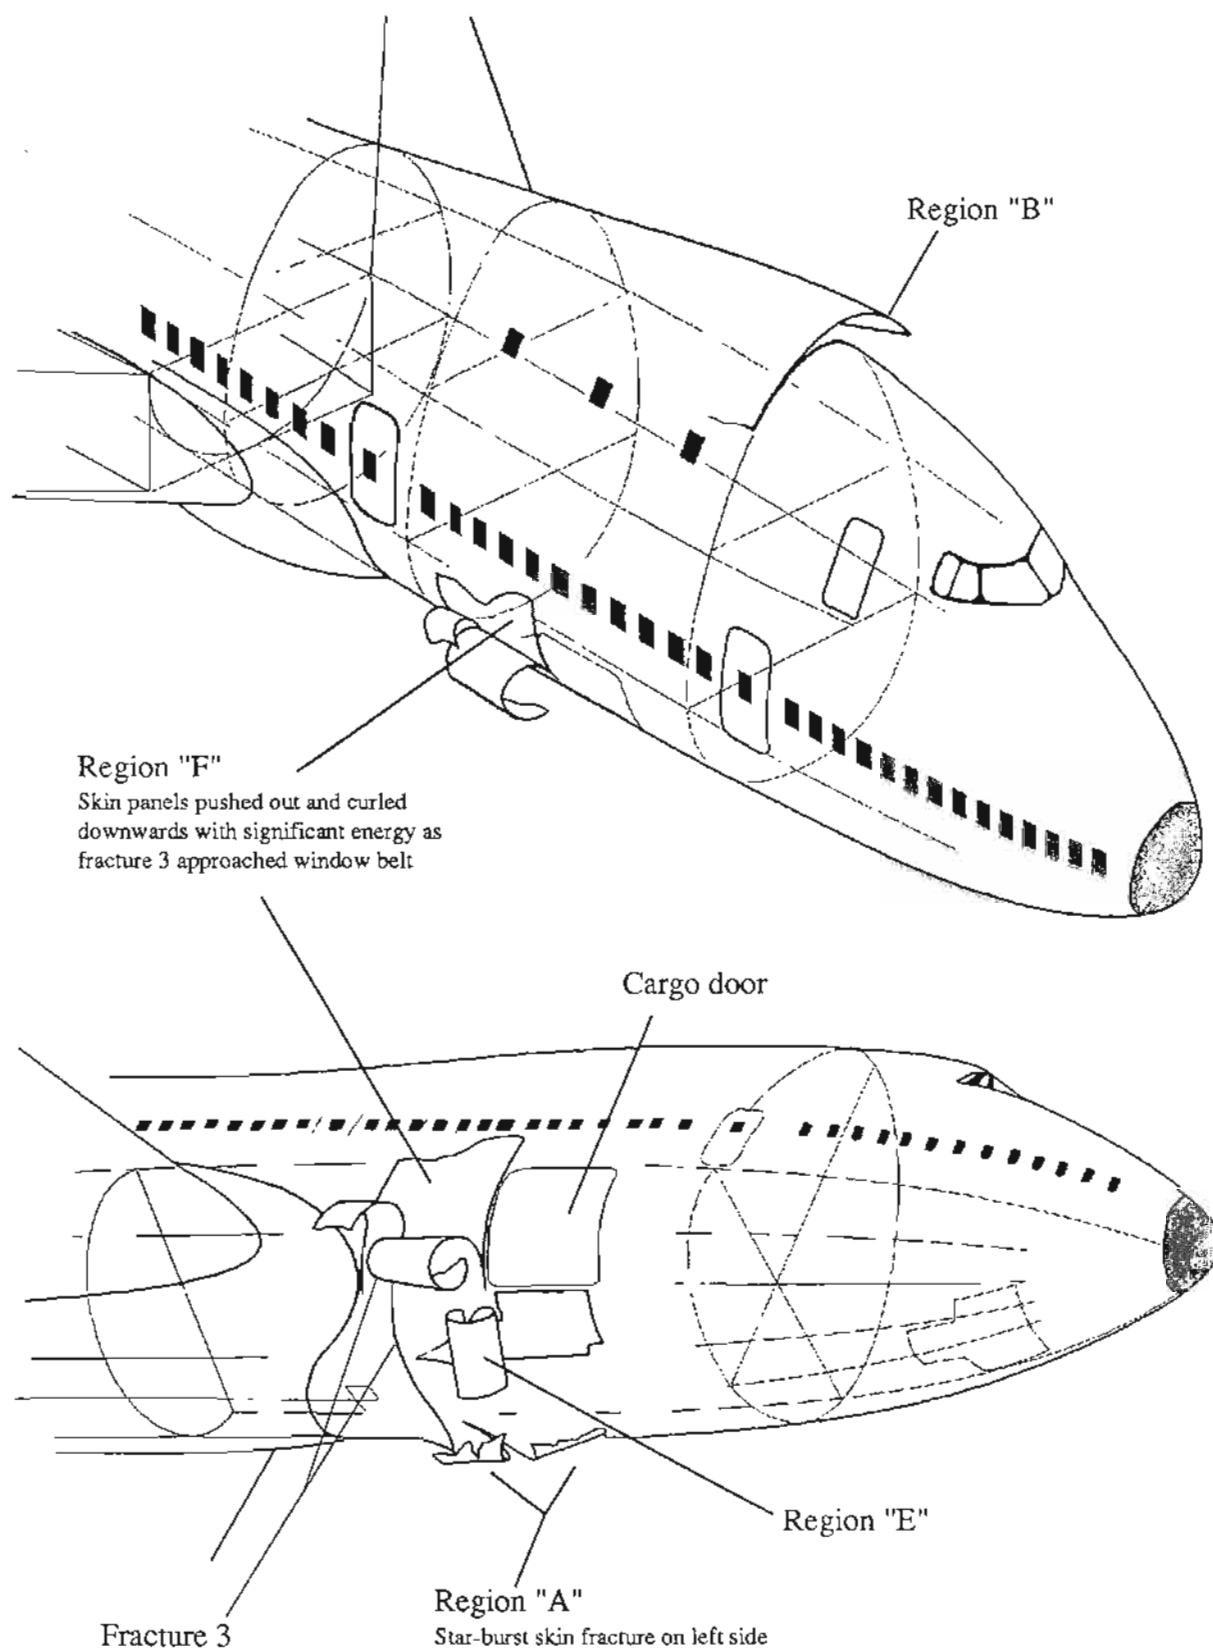
**Figure B-20**

**Explosive Damage - right side**  
(schematic representation)

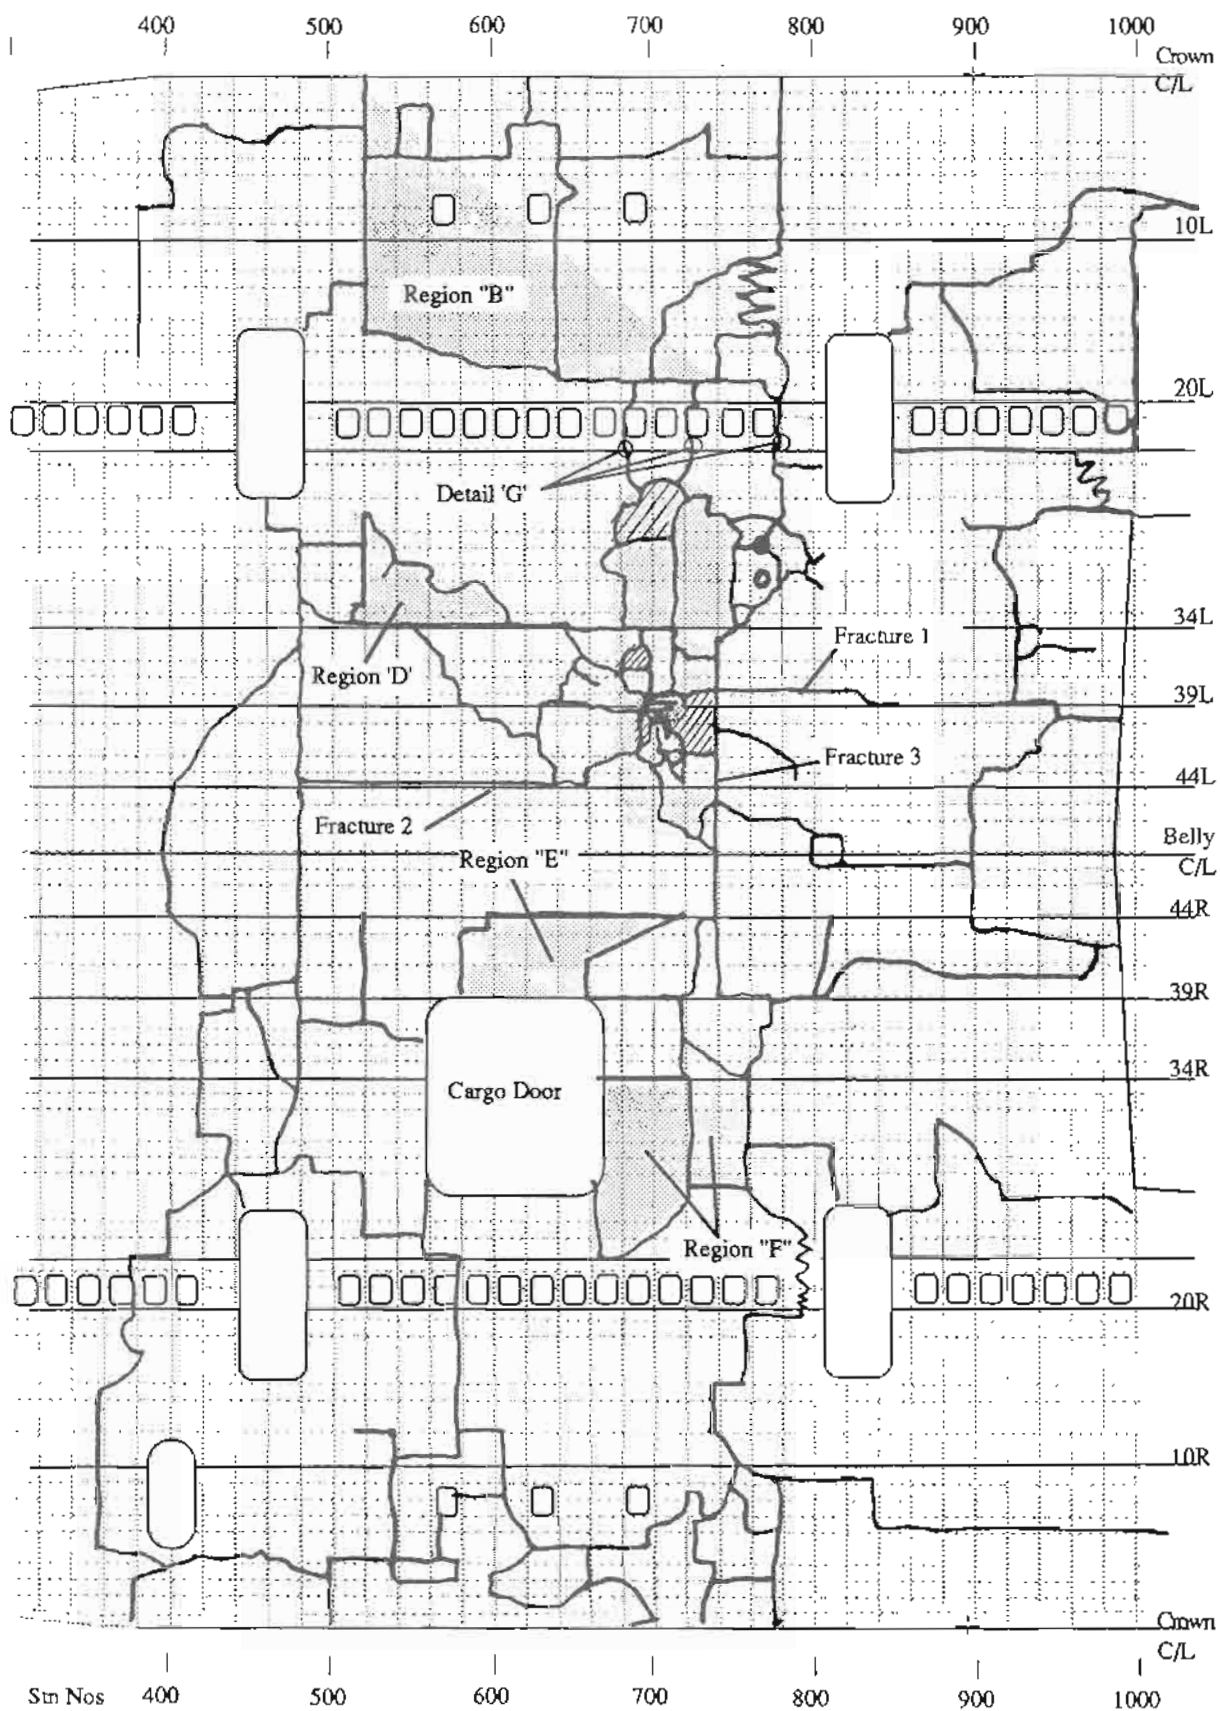
**Figure B-21**

Appendix B, Figure B-21 shows a plot of the fractures noted in the fuselage skins between stations 360 and 1000.

**Skin Fracture Plot**

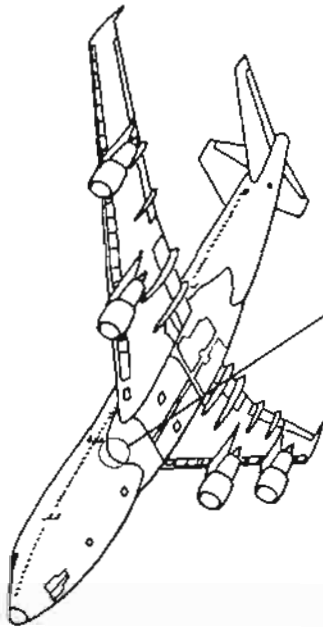
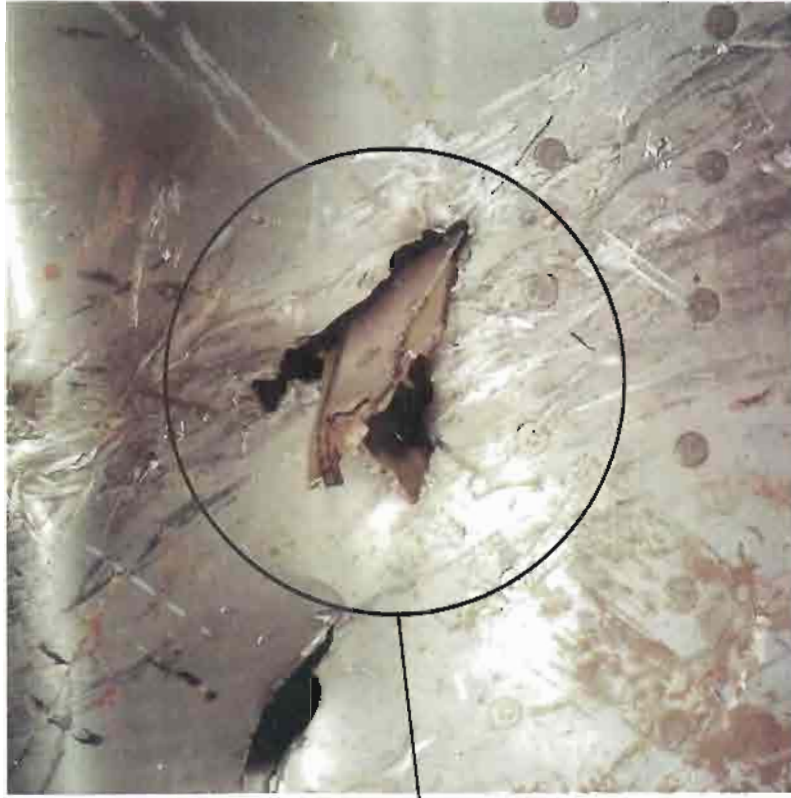
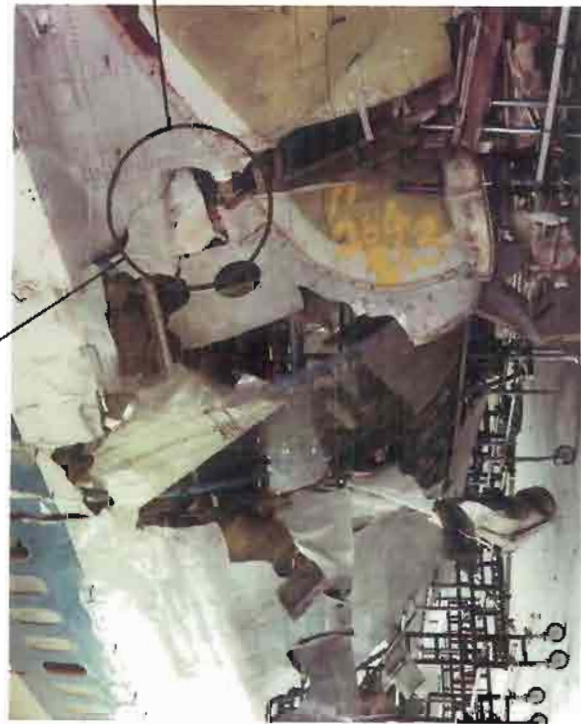
Figure B-22

Spar cap embedded in fuselage

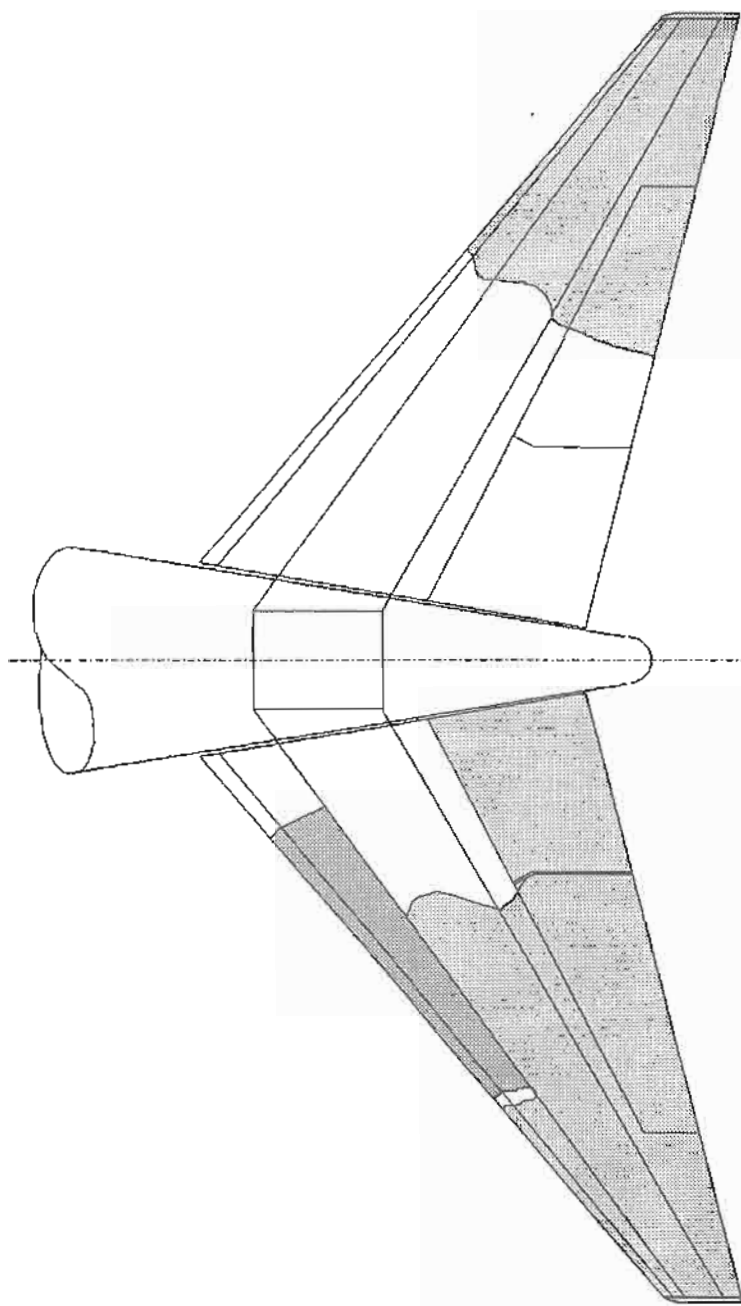
**Figure B-23**

### **Initial Damage to Tailplanes**

(shaded areas denote wreckage recovered from southern wreckage trail)

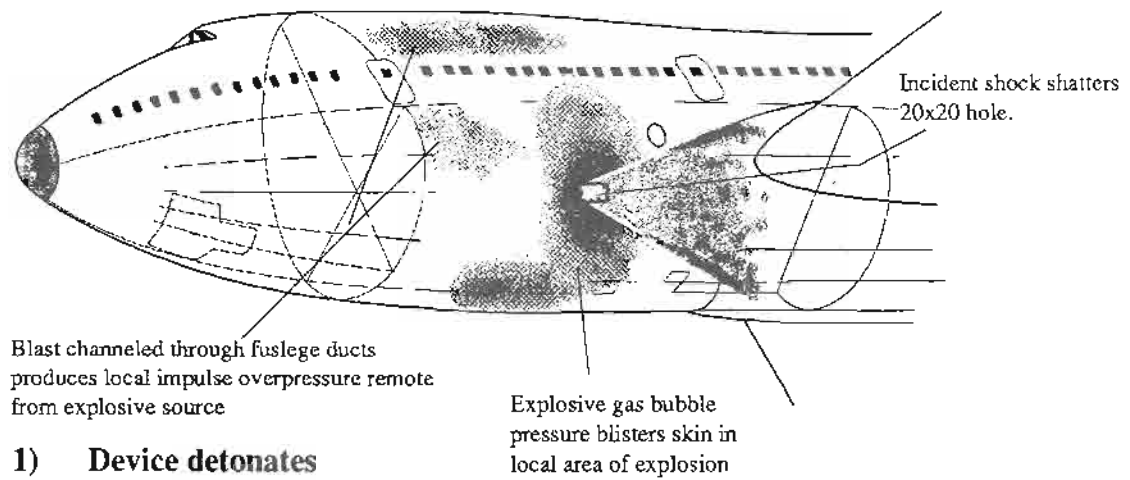
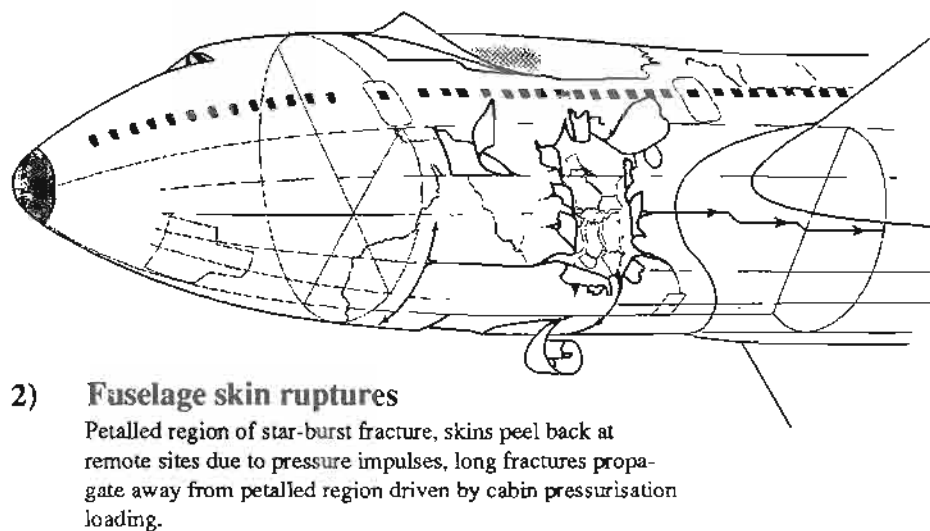
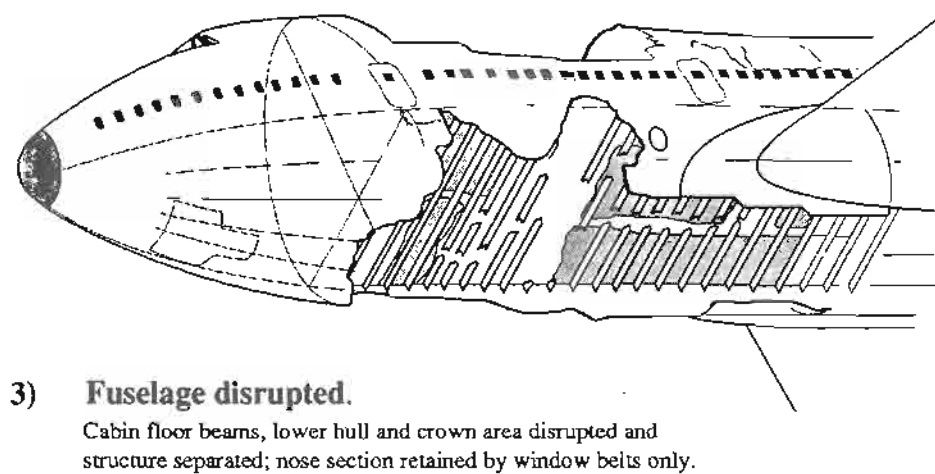
**Figure B-24**

**Fuselage Initial Damage Sequence**  
(schematic representation)

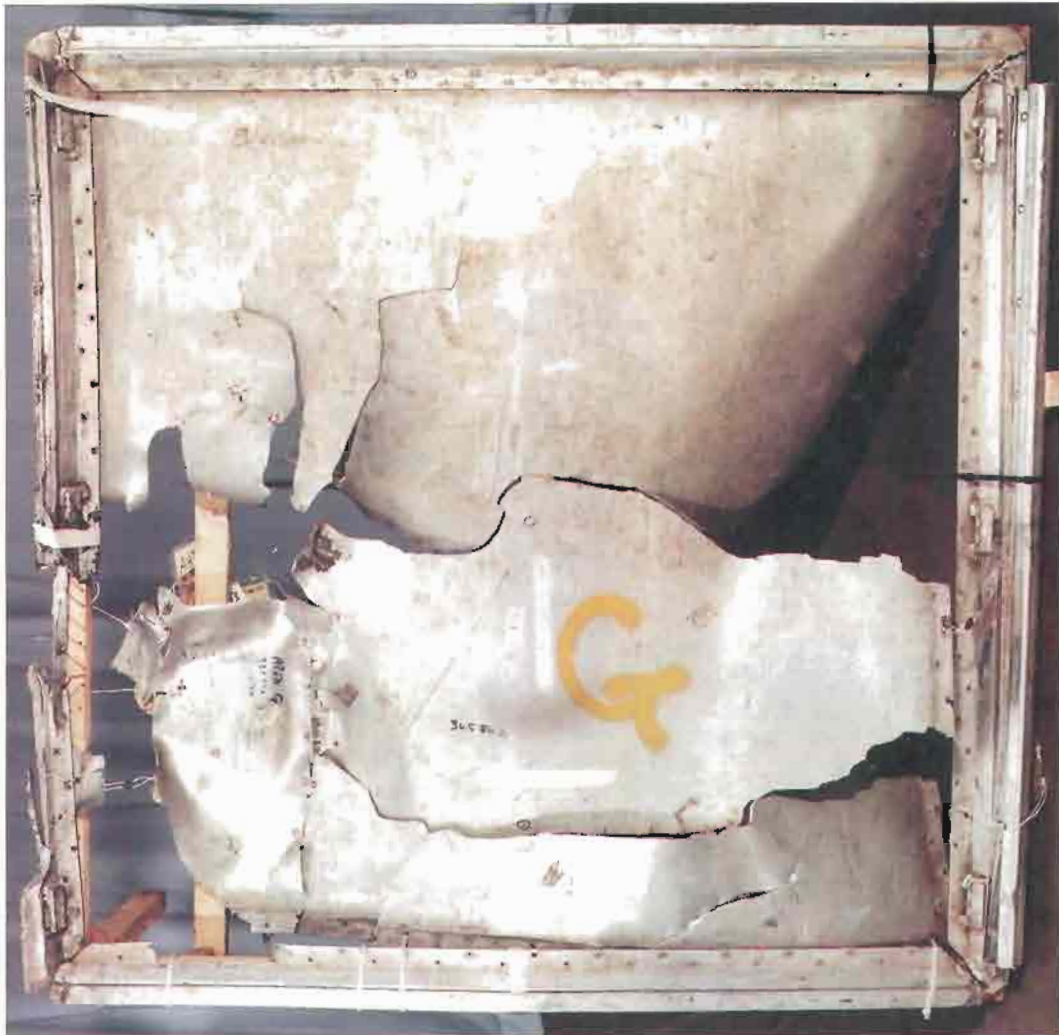
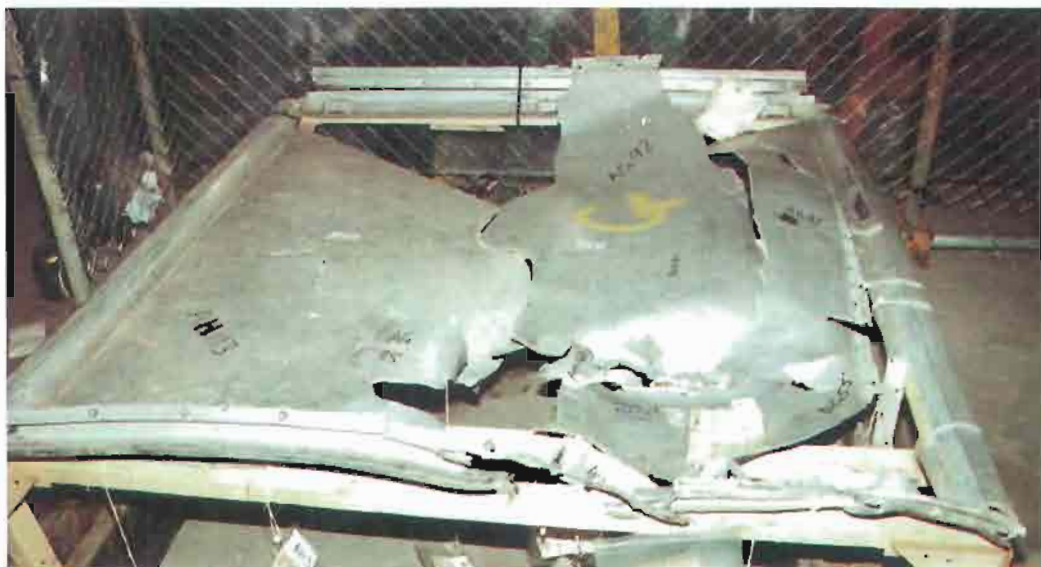
Figure F-3

Detail of Damage to Container Floor

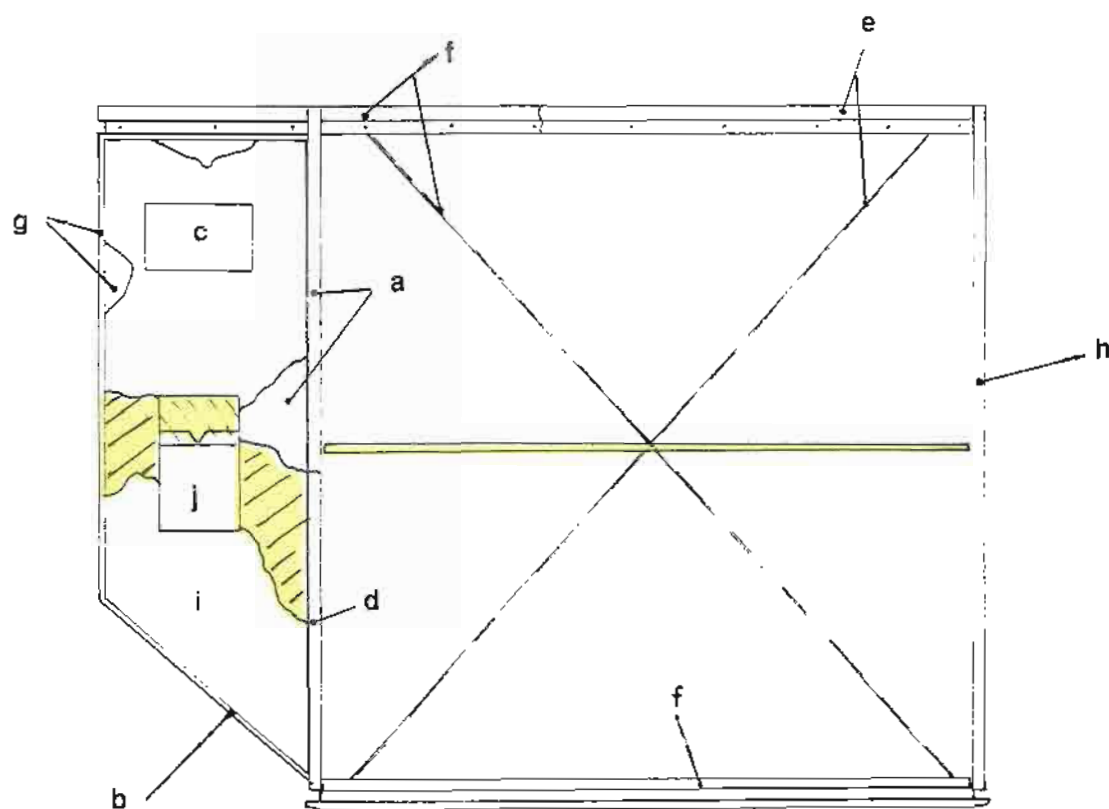
**Figure F-5**

- a Curtain aperture left side vertical edge member, upper half
- b Sloping face edge member
- c Container manufacturer's data plate containing burnt piece of material which itself contained a fragment of circuit board
- d Curtain aperture left side vertical edge member, lower half
- e Upper edge member, right half, attached to roof edge member and one curtain bar
- f Upper edge member, left half, attached to roof edge member, cutrain wire and lower curtain bar
- g Left edge vertical member
- h Curtain aperture right side vertical member
- i Left side lower skin section adjoining sloping face
- j Soot stained plastic sheet

**Aft face of container AVE 4041 PA, view  
looking forward**

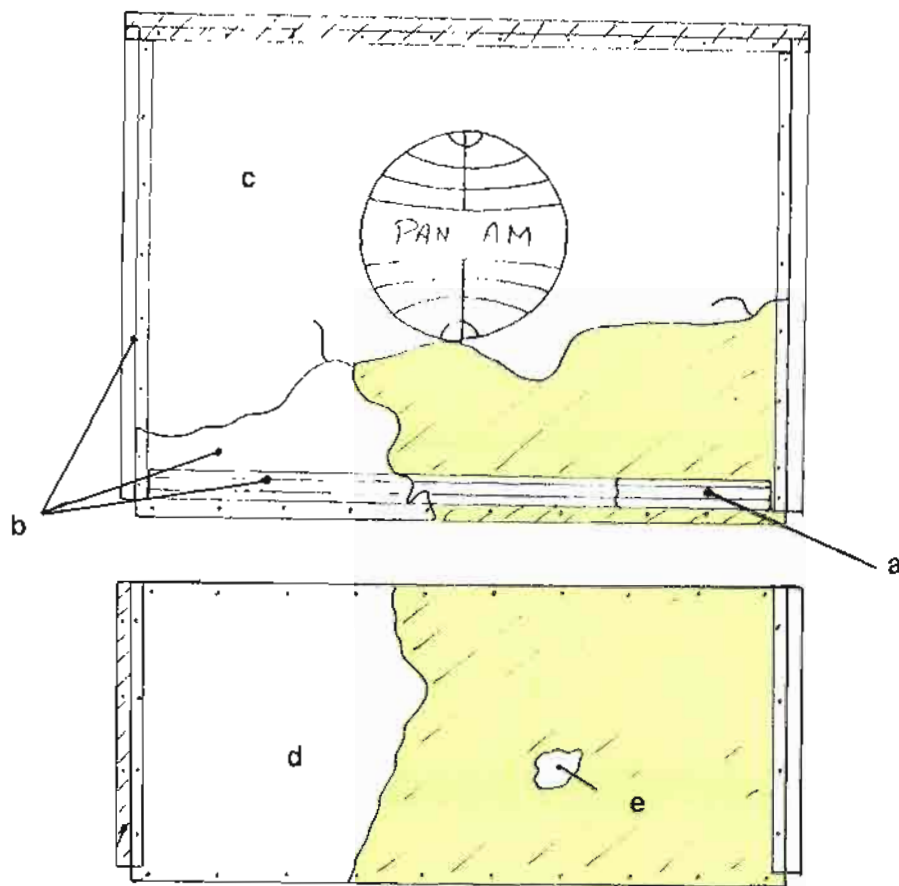
**Figure F-6**

- a Stiffener section from base of vertical face
- b Vertical face forward edge member, lower stiffener section and skin fragment
- c Distorted upper section of vertical face skin
- d Forward section of sloping face skin, severely distorted
- e Fragment of container skin, provisionally thought to be part of sloping face skin.

**Outboard faces of AVE 4041**

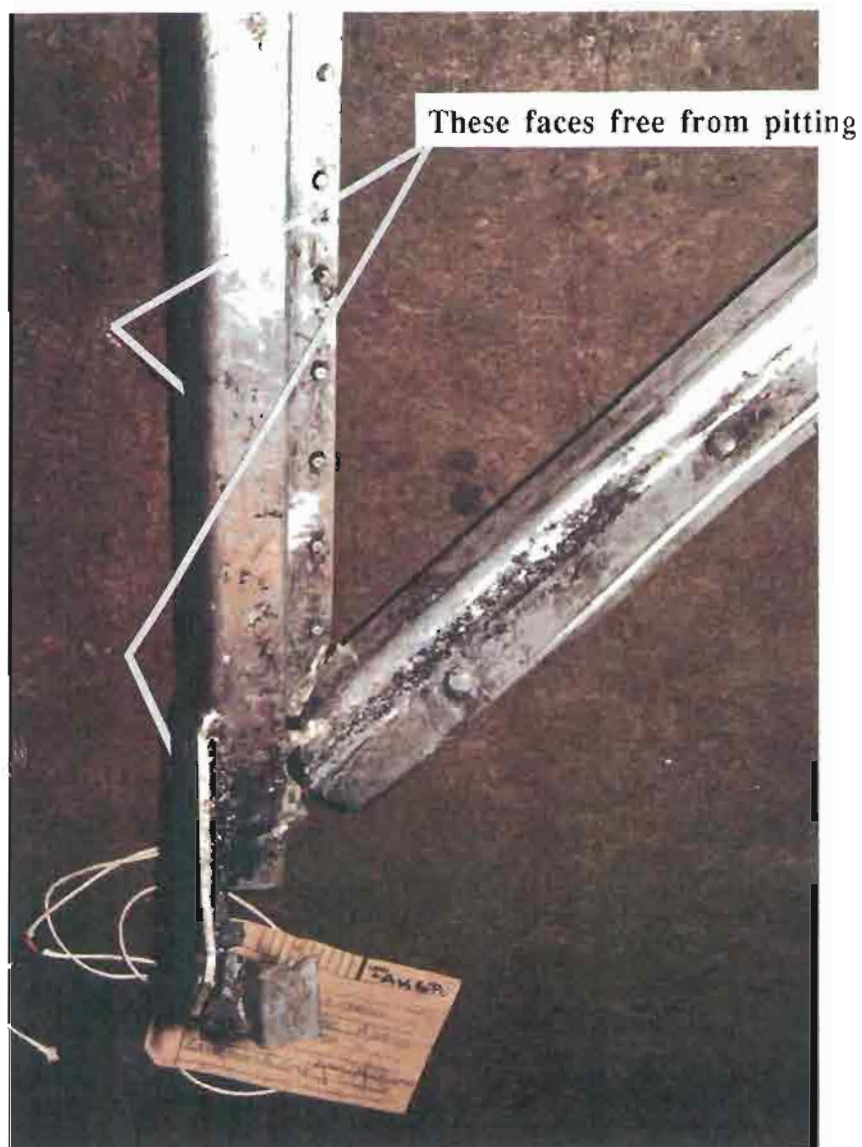
**Figure F-9**

**Detail of items from aft face of container  
AVE 4041 PA showing evidence of blast  
damage**

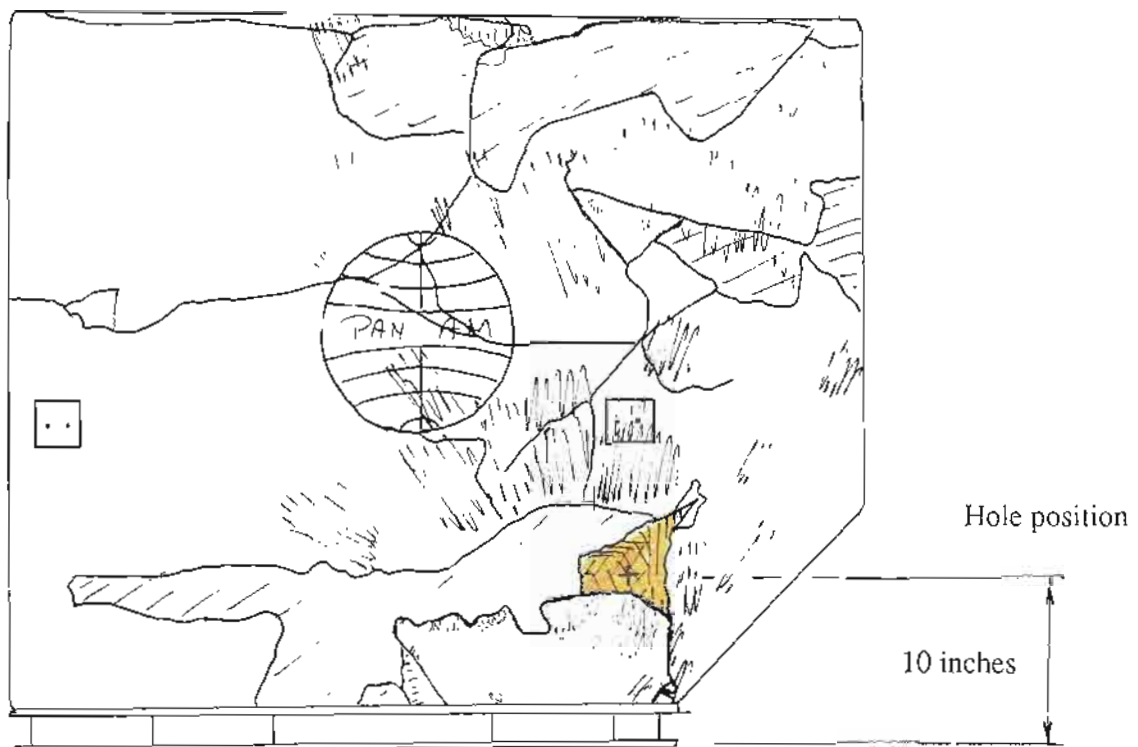
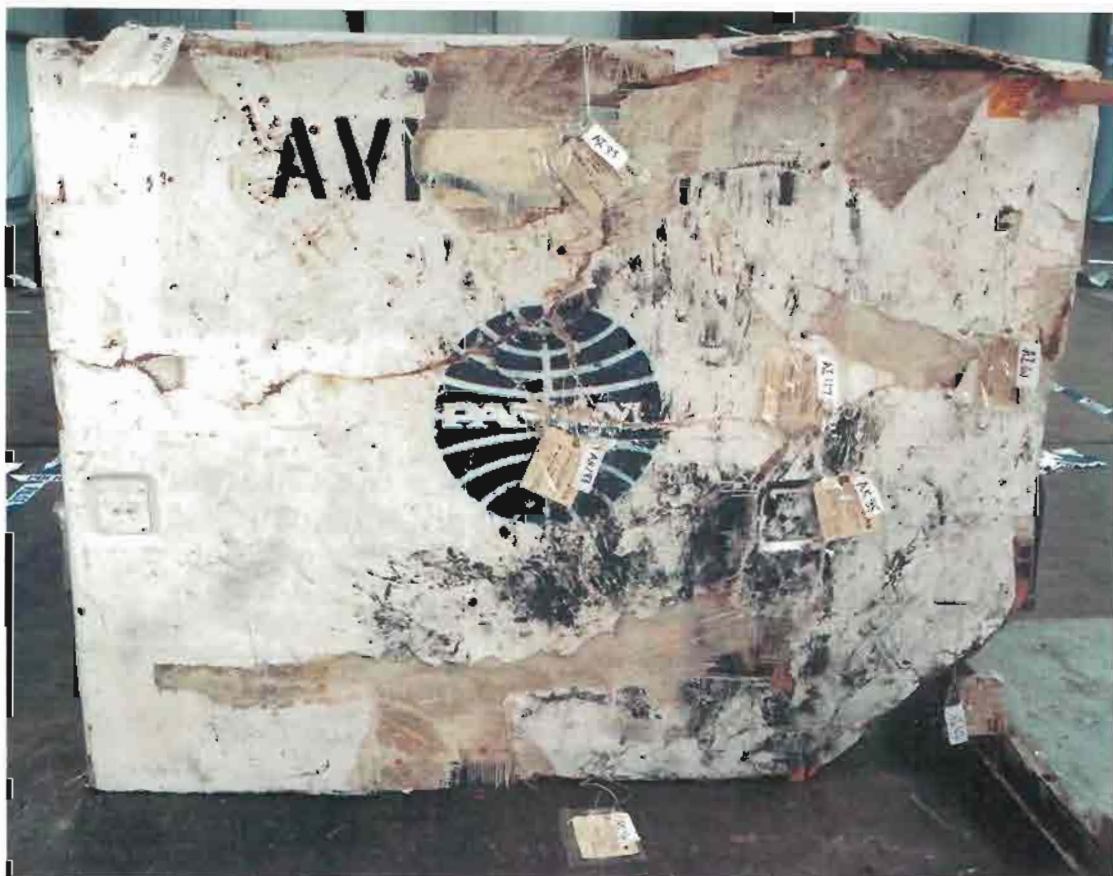
Figure F-10

Blast damage to the forward face of container 7511 was as a direct result of hot gases/fragments escaping from the aft face of container 4041. No evidence was seen to suggest that more than one IED had detonated on Flight PA103.

Forward face of container AVN 7511 PA,  
view looking aft
