AIRCRAFT ACCIDENT INVESTIGATION REPORT

**China Airlines
Airbus A300B4 – 622R, B-1814
Da-Yuang, Tao-Yuang
February 16, 1998**

May 18, 2000

Civil Aeronautics Administration

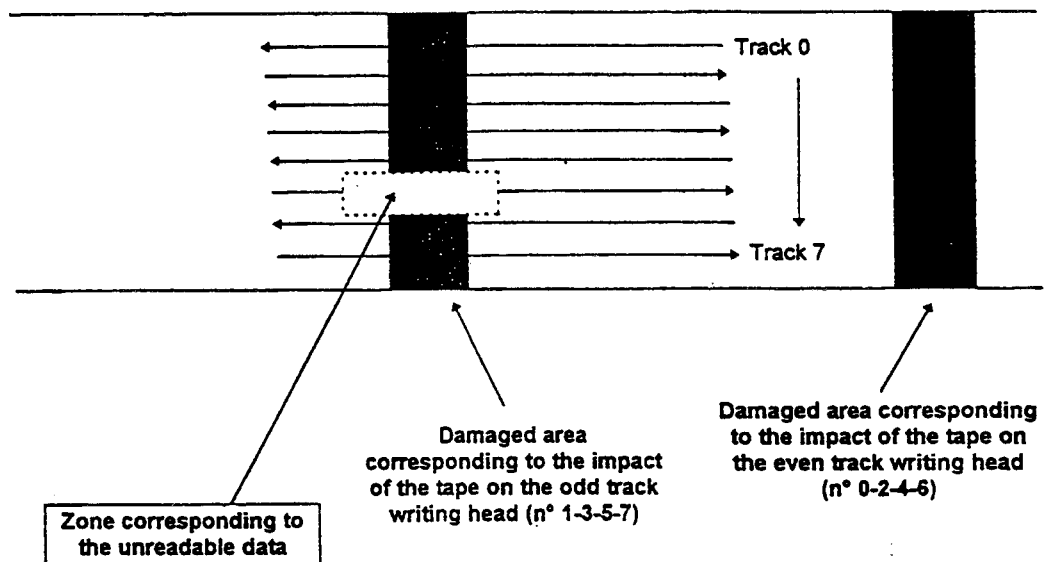
This confirmed that the part of the tape damaged due to the impact was unreadable using the UFDR Copy Recorder and seemed to cover between one and two seconds of data (taking into account the length of damaged tape).

Due to the UFDR data structure on the tape (direction of reading/writing on each track), the part of the tape that had to be analyzed was found as shown in the following diagram:

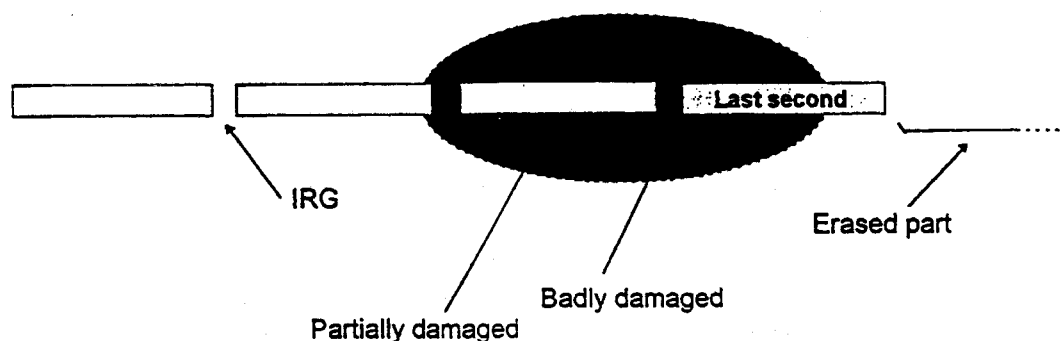
The UFDR writes blocks of 784 bits of data (corresponding to 1 second). Each block is separated by an IRG (Inter Record Gap). The last second written on the tape is followed by a blank area corresponding to the erasure of the track by the erasure head of the recorder. In consequence, the following diagram shows the structure of the zone to be examined:

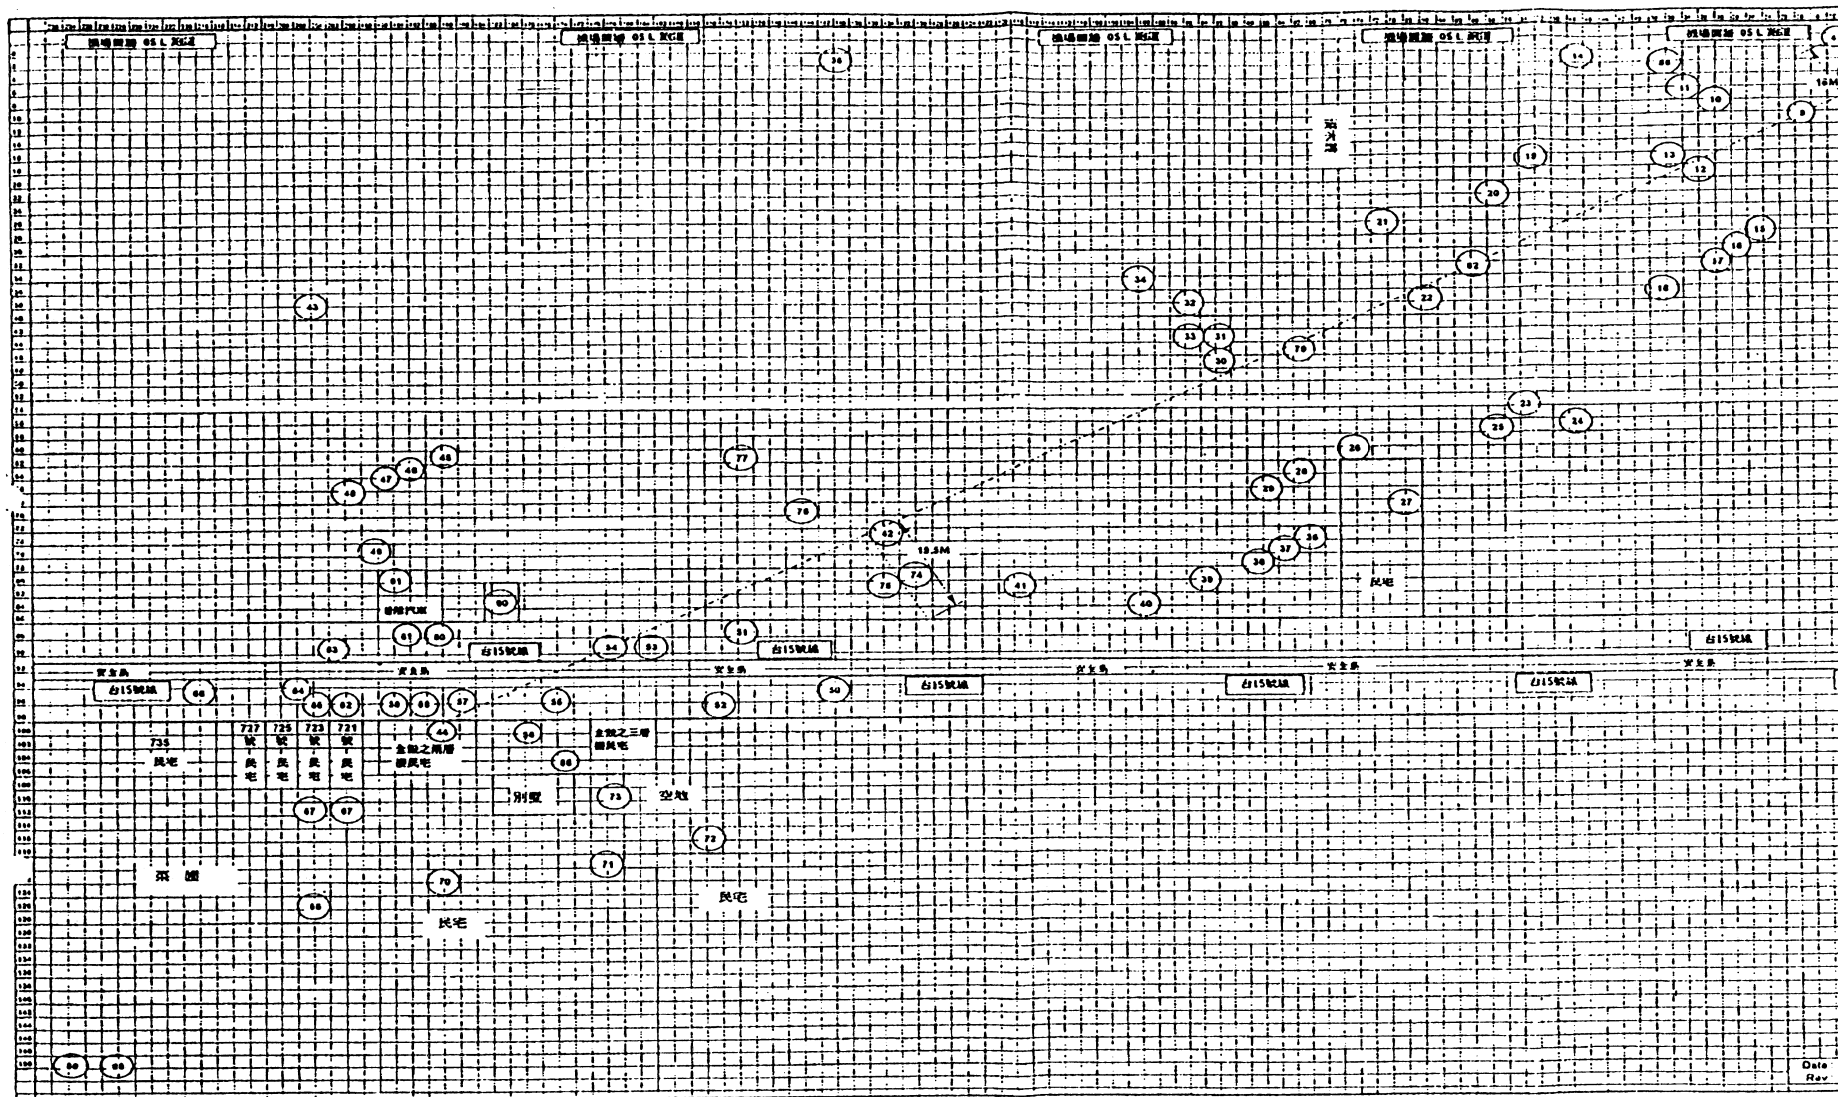
Appendix 8 Wreckage Distribution Map

The aircraft hit the ground on waste land and broke up progressively. Some parts came to rest on the highway No. 15 alongside the field, and some others badly damaged several multi-storied buildings on the far side of the highway.

Going further along the wreckage path, two holes were found approximately equidistant from the triangular mark. Due to the shape and the distance (16 meters), these two traces were identified as having been made by the engines. The fan cases of each engine were found in front of these holes on the wreckage path.

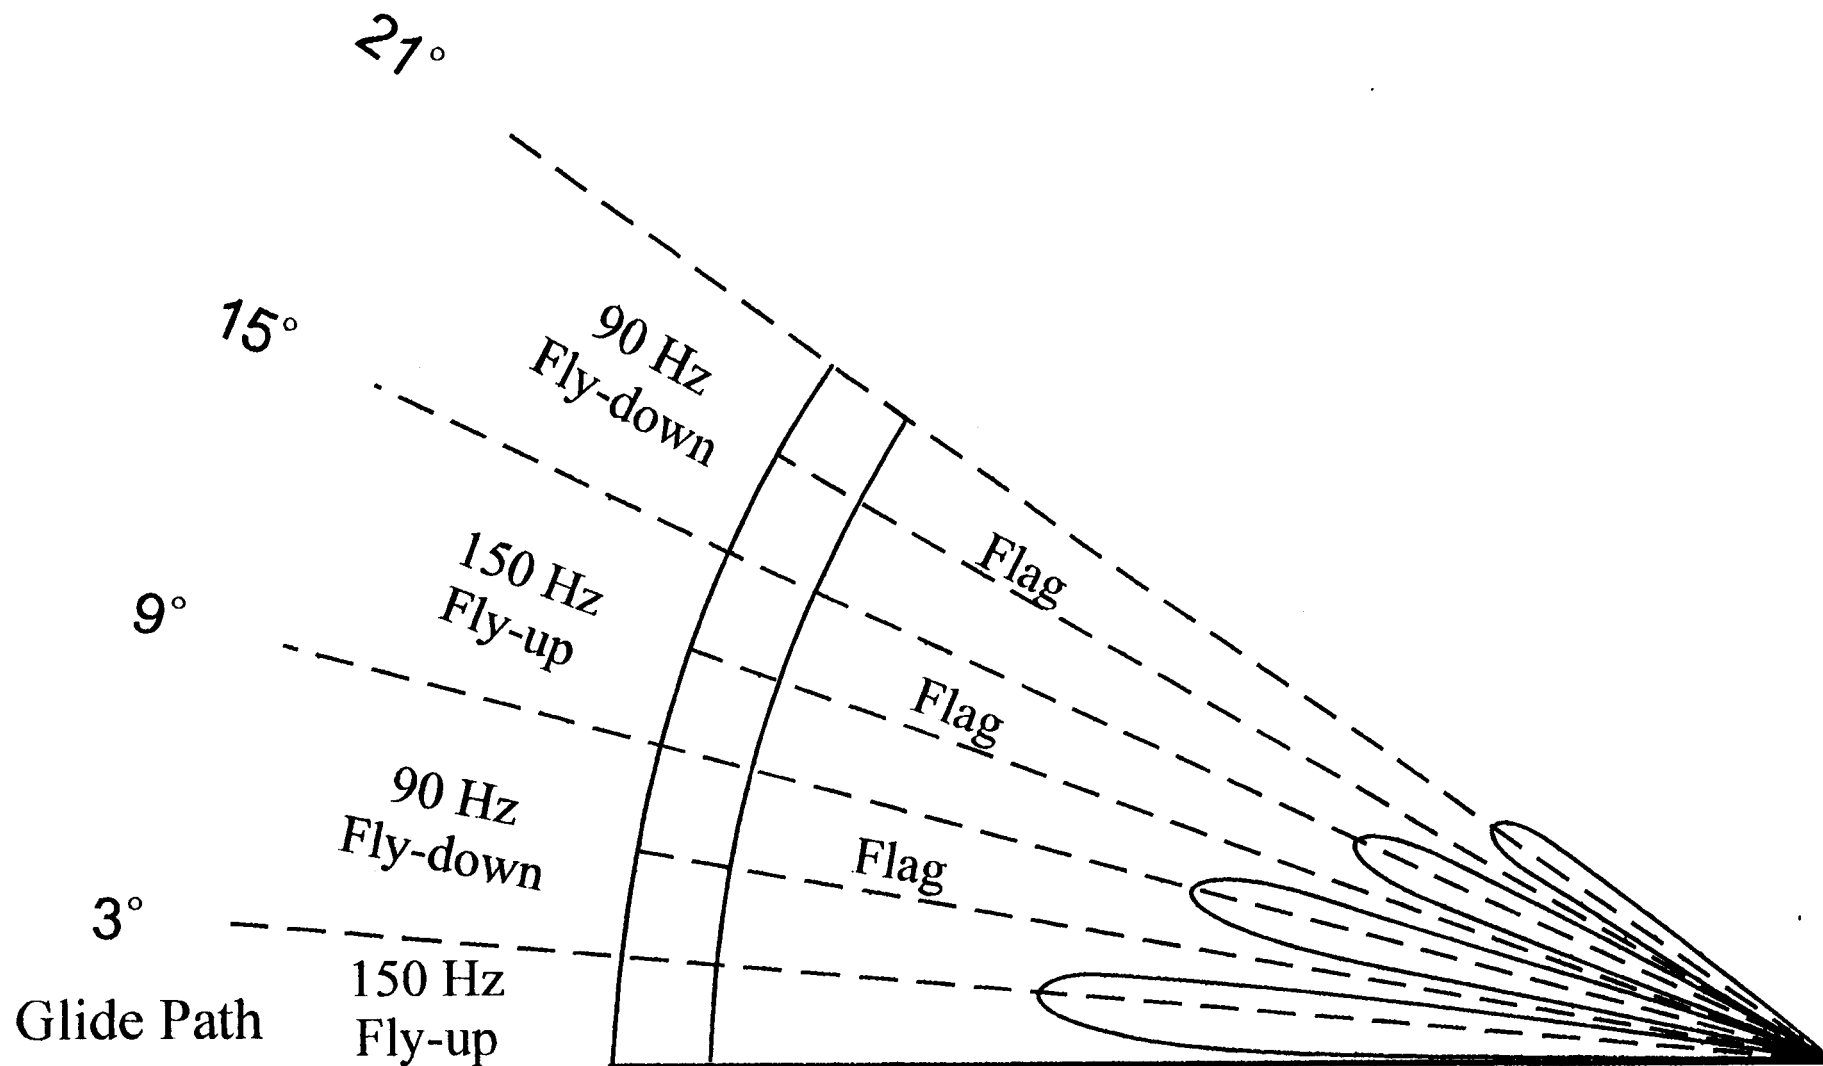
B-1814 Approach Diagram Relevant to the Glide Slope

At 12:05:04 UTC, it is noted that the auto pilot considering that the aircraft was below the glide slope began bring the nose up to level off as the glide slope deviation passed in the 'normal range' of the 'fly up' indication, and attempted to maintain speed by increasing thrust because of the decreasing speed caused by the increasing angle of attack.

- (13) The meteorological conditions at CKS airport at the time of accident would normally require a CAT I approach.
- (14) The aircraft over-flew the outer marker at 12:04:02 UTC, 1000 ft higher than the published minimum altitude.
