AIRCRAFT ACCIDENT REPORT

Controlled Flight into Terrain

Ilyushin IL-76 TD, RDPL-34141
Baucau, Timor-Leste
31 January, 2003

Australian Transport Safety Bureau

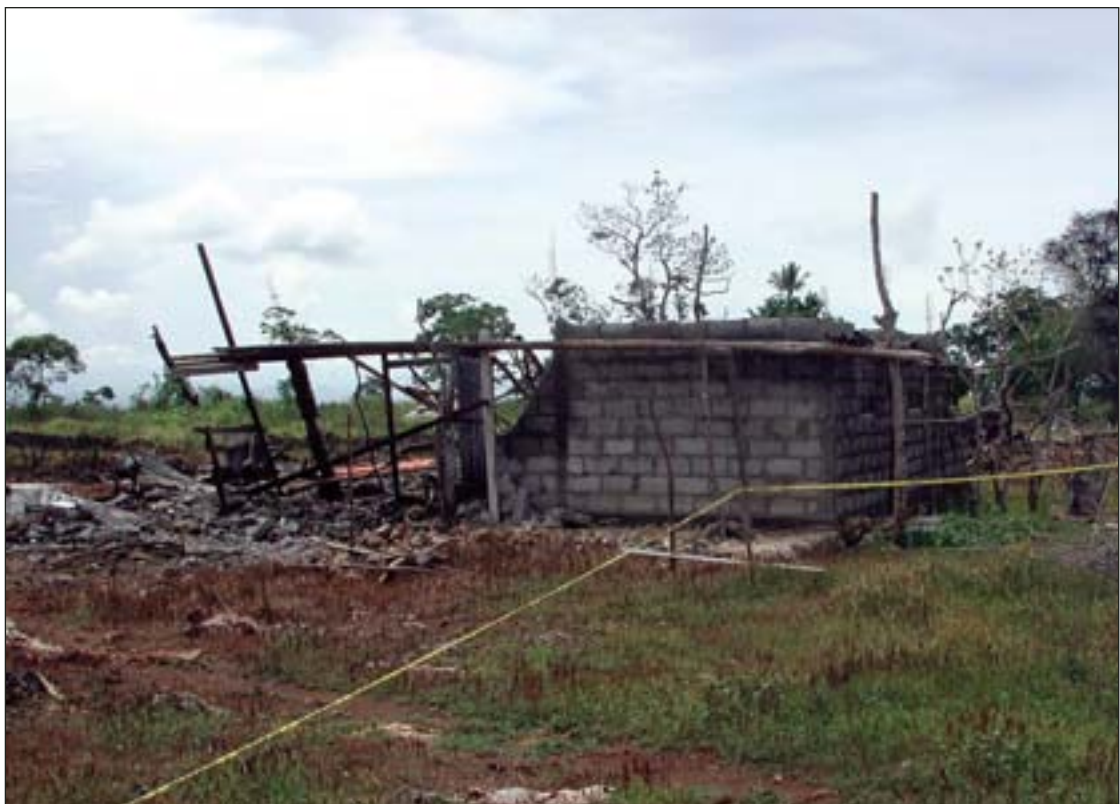
FIGURE 6:
Partially constructed house struck by the aircraft during the impact sequence

During the impact sequence, the right wingtip of the aircraft struck a partially constructed house to the left of the centreline of the wreckage trail, about 190 m from the first impact point (see Figure 6). The house, which was occupied at the time by its owner, was severely damaged. The owner of the house was physically uninjured by the impact.

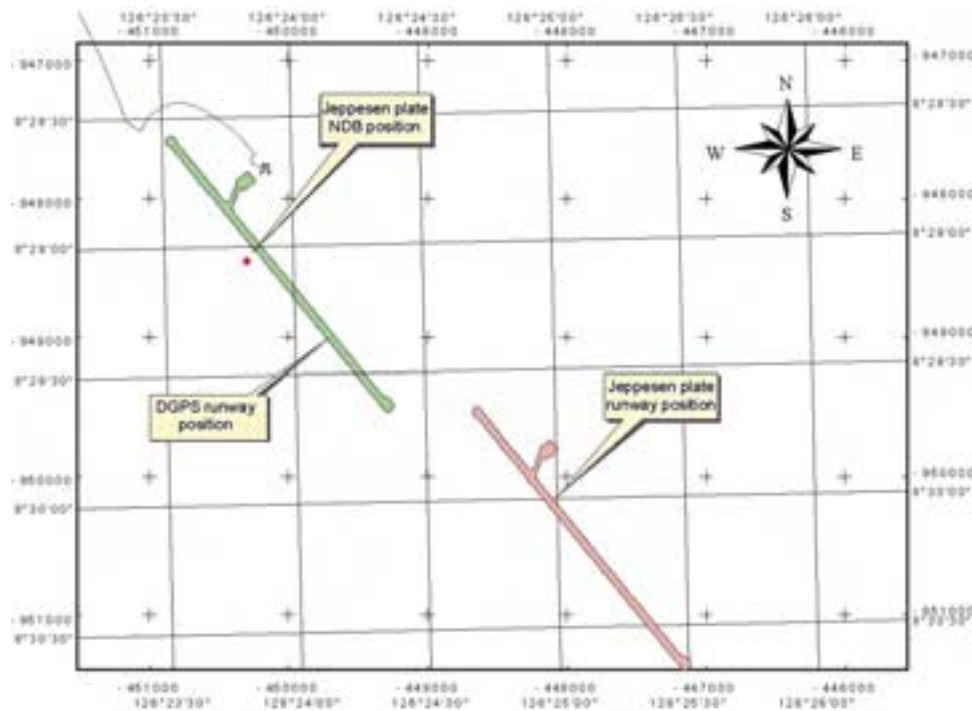
FIGURE 12:
Actual vs. depicted runway position

The Jeppesen aerodrome chart depicted the threshold of runway 14 as being about 0.9 NM (1,700 m) southeast of the NDB. The Jeppesen runway 14 and 32 NDB approach charts also depicted the runway in that position, relative to the NDB. During the investigation the actual threshold of runway 14 was found to be about 1.35 NM (2,500 m) northwest of where it was depicted on those charts. The runway heading for runway 14 at Baucau was depicted as 135 degrees magnetic on the Jeppesen aerodrome chart. CAD did not publish an aerodrome chart for Baucau, and the runway heading was not included on CAD Baucau NDB approach charts. Following the occurrence, runway 14 was surveyed and the actual runway heading was determined to be 139 degrees magnetic.

The Australian accredited representative and his team were unable to locate the aerodrome reference point (ARP) in the position where it was depicted on any of the Jeppesen aerodrome chart. Using the DSTO GPS, the threshold elevation of runway 14 was determined to be 519 m (1,703 ft) AMSL. Subsequent to the accident, the UN commissioned another survey of Baucau, which revealed that the threshold elevation of runway 14 was 516 m (1,694 ft) AMSL.

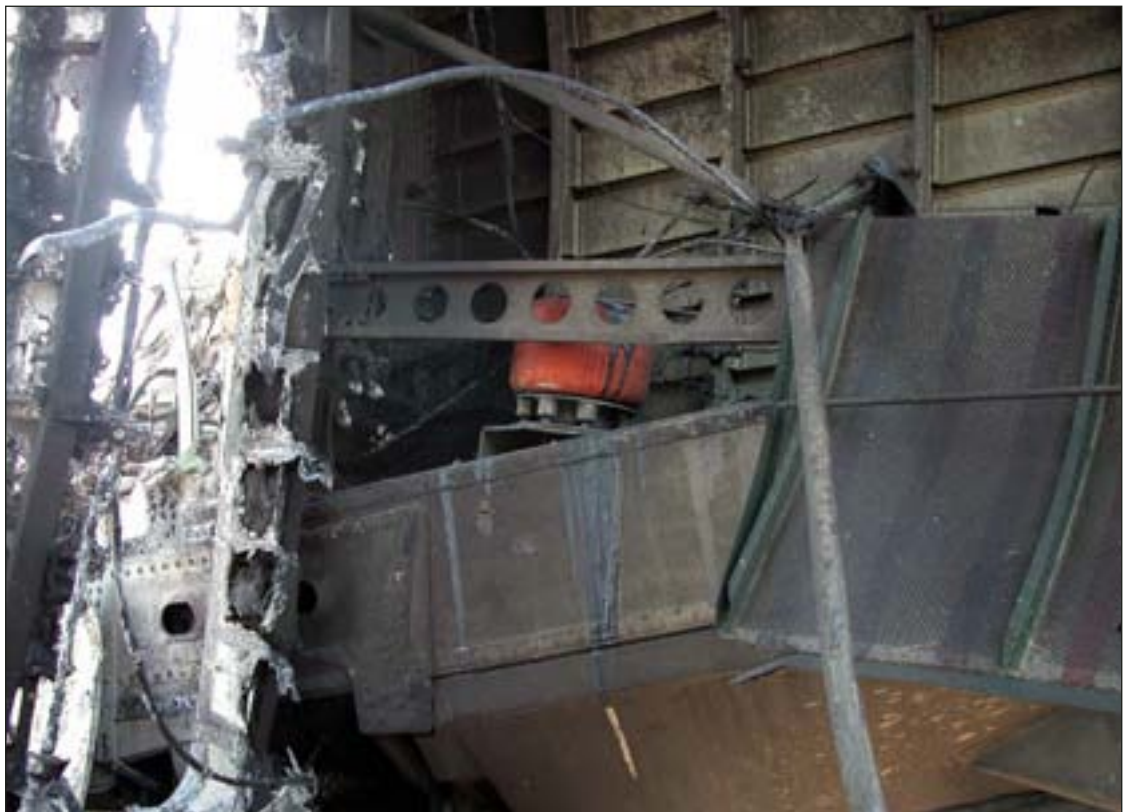
FIGURE 13:
Flight data recorder before recovery from the aircraft wreckage

The casing of the FDR storage unit was sooted from the post-impact fire, but revealed no evidence of heat or structural damage (see Figure 13). Examination of the recorded data revealed that the FDR had operated normally until impact.

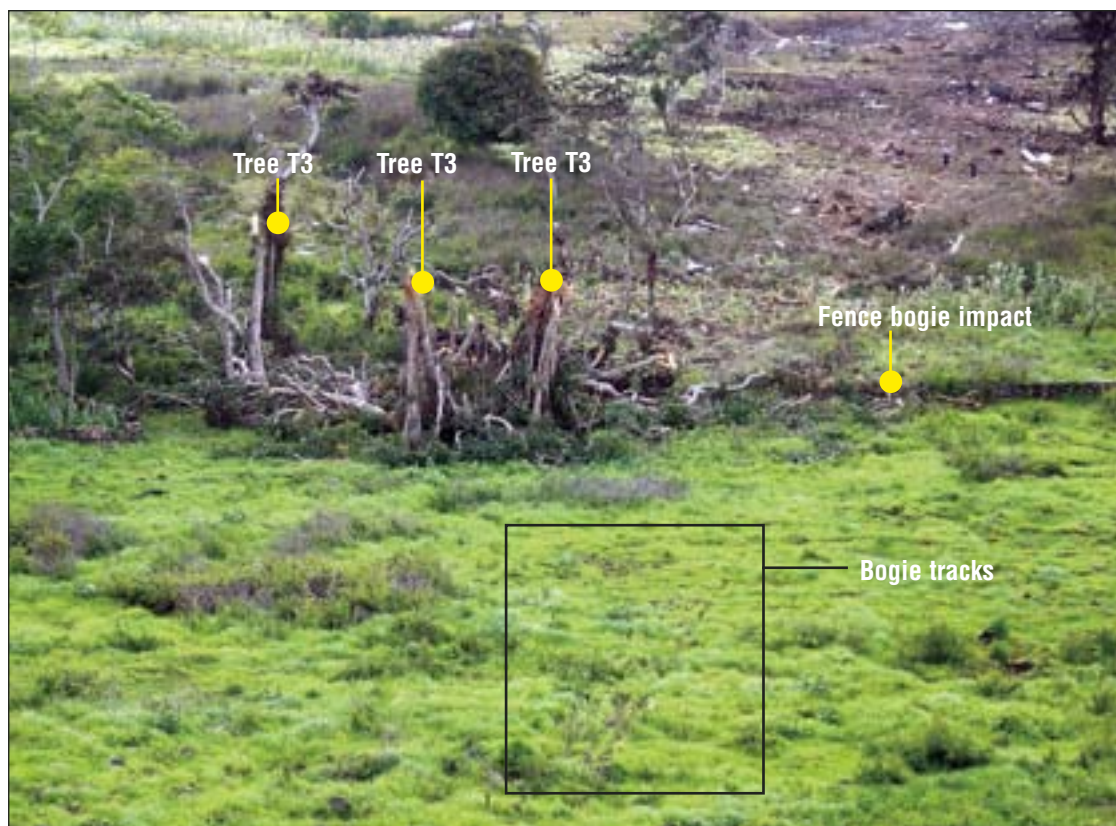
FIGURE 21:
The group of trees at the initial impact area

The first marks in the wreckage path were a single set of ground marks on slightly rising ground, consistent with ground contact of one of the main landing gear bogies. Those marks ran for about 39 m (128 ft) on a track of about 130 degrees magnetic. A single main landing gear bogie had impacted a 1.2 m (3.9 ft) high stone fence about 1m above the ground, nearly in line with, and 41 m (135 ft) from where the initial ground marks ended. Pieces of the lower cockpit windows and a windshield wiper blade were located not far down track from the fence that had been struck by the main landing gear bogie.

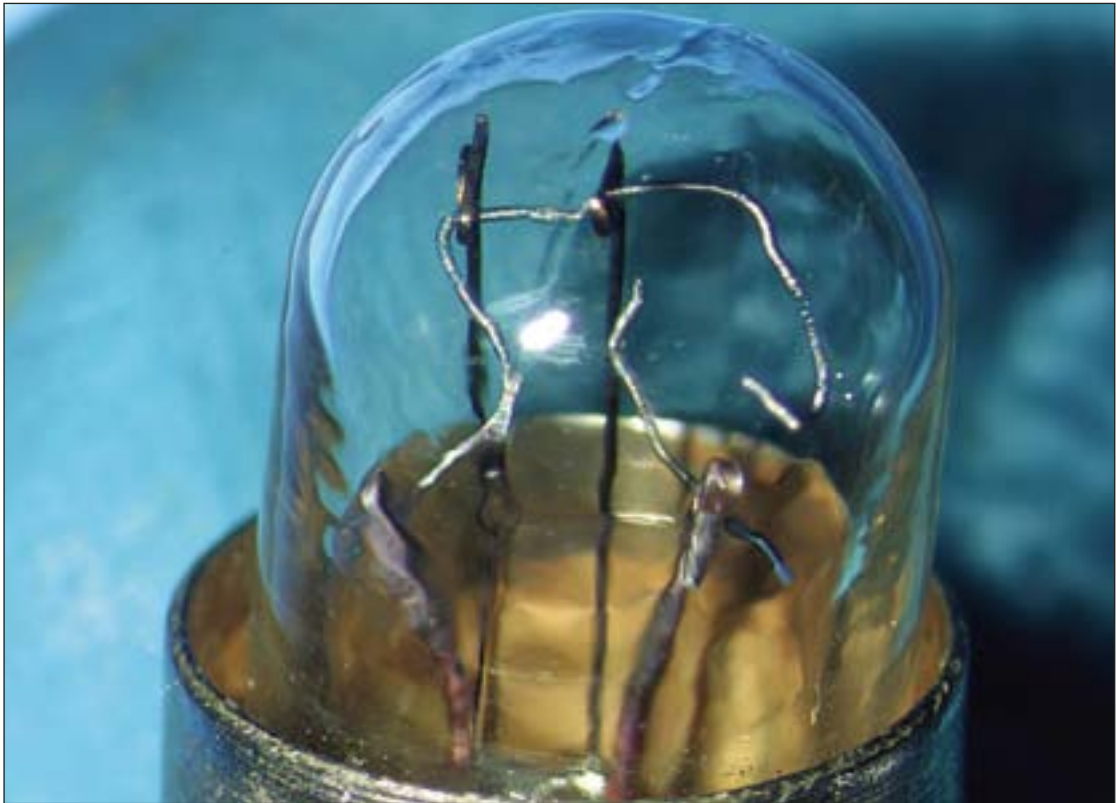
FIGURE 30:
Damaged light bulb filament from the PB-150 radio altimeter indicator

The glass face of the indicator was undamaged, however the rear part of the instrument casing had been damaged, and the gear train assembly within the instrument was not intact. The reference bug adjustment knob was jammed due to damage, and could not be rotated to move the bug. The small light bulb located behind the amber lens inscribed with the delta (Δ) symbol on the reference bug adjustment knob was removed and examined to determine whether it was illuminated at the time of impact (see Figure 30).

The globe envelope was unbroken, and displayed no signs of discolouration. The bulb filament was not severely stretched, and was fractured in one location. The coils had remained mostly symmetrical, and showed little evidence of gross stretch or distortion. The filament was also only slightly elongated.

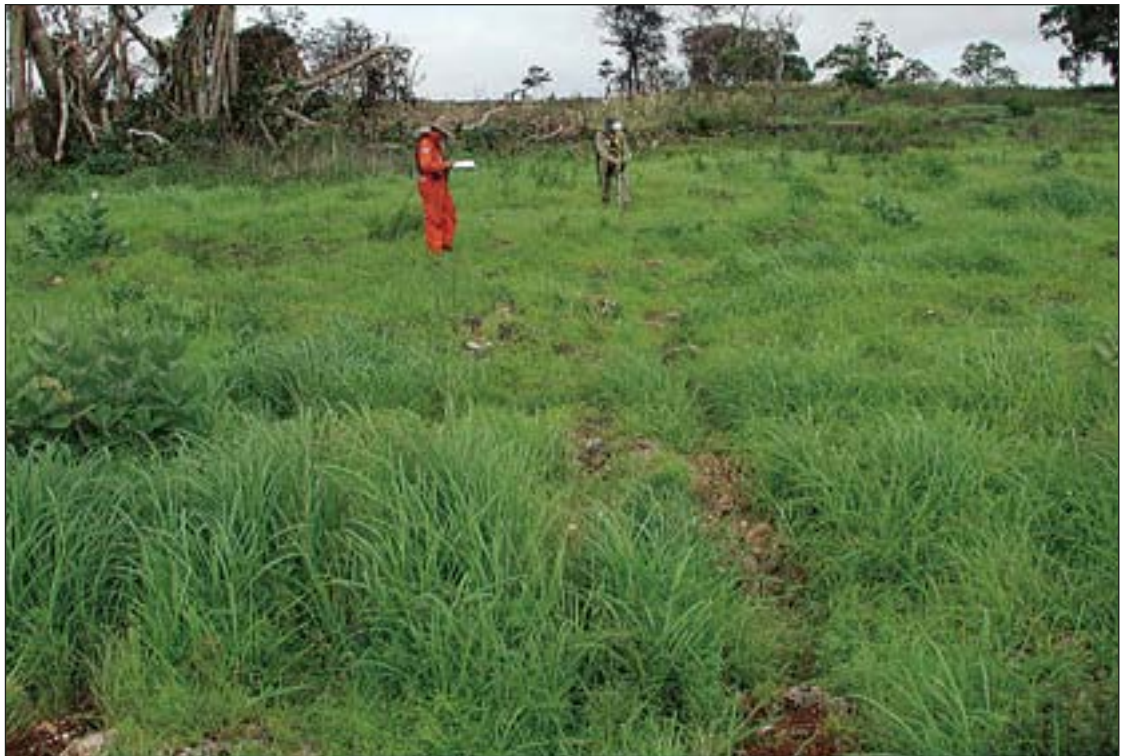
FIGURE F.1:
Witness scars at the first point of ground contact

The distance between ground witness marks indicated that they had been produced by one of the main landing gear bogies. The impressions in the ground also indicated that the aircraft had been in a slightly nose-up attitude during the period that the main landing gear bogie was in contact with the ground. That notion was substantiated by the fact the ground marks were of an even depth along the rising ground, and by the fact that there was no evidence of contact with the ground by the nose landing gear.

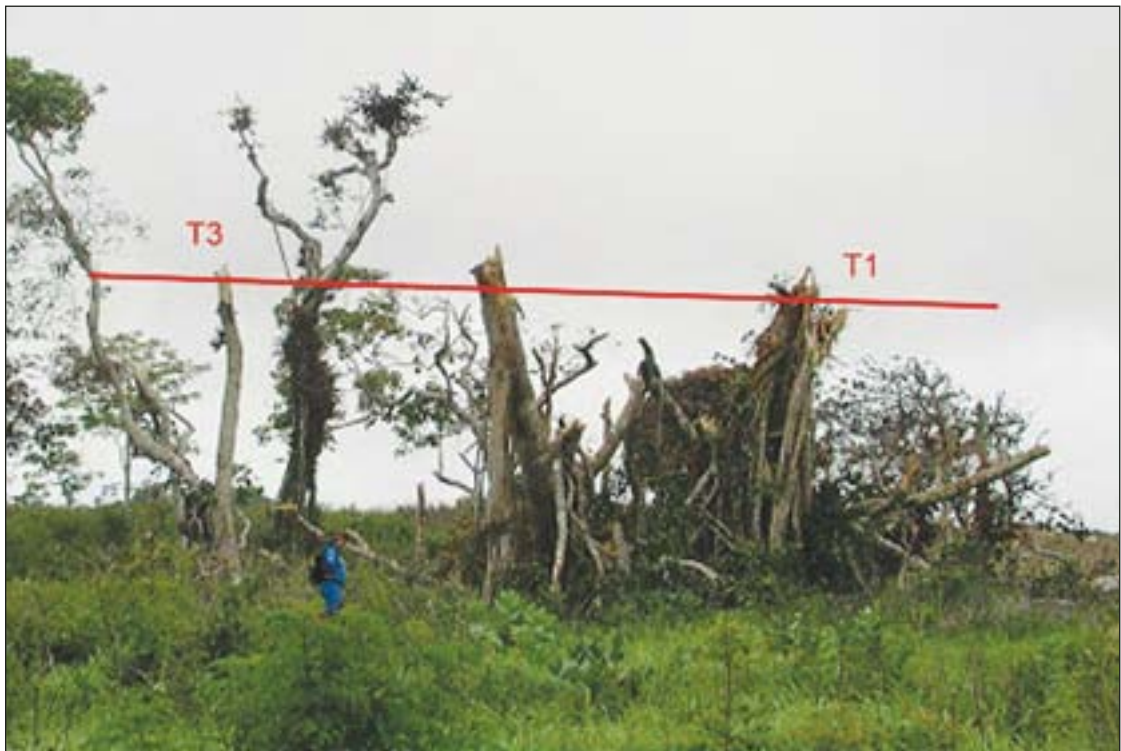
FIGURE F.2:
Impacted trees

Under those circumstances, the perpendicular distance between the left main landing gear bogie and tree T1 when it was abeam that tree would have been 11 m. That would have resulted in the left wing striking tree T1 just outboard of the outboard engine (engine number-1). The furthestmost damaged tree, T3, would therefore have been struck by the left wing about 1 m inboard from the wing tip. That was consistent with a piece of the outboard aileron and various other pieces of the wing having been found directly under the trees. Engine fan blades were also found in the vicinity of the trees and extending away from the trees in the direction in which the aircraft had travelled.

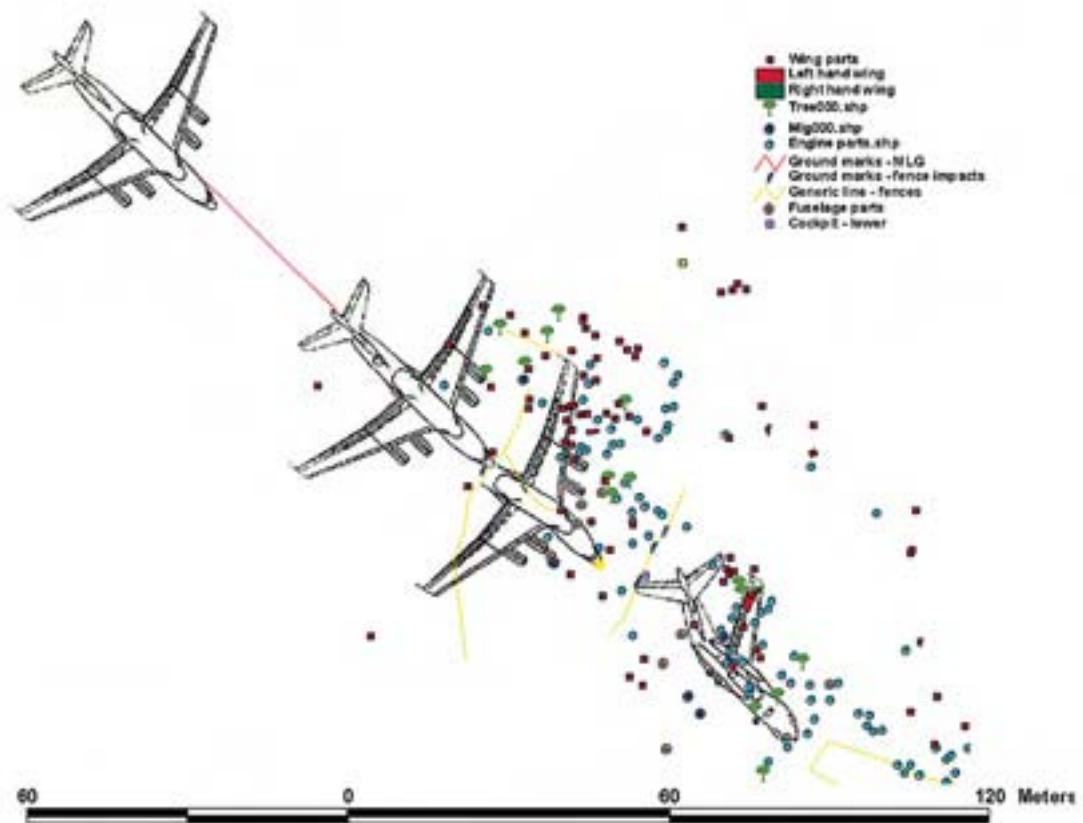
FIGURE F.3:
Initial break-up sequence

The airframe would have experienced considerable structural loads because of the deceleration force when the left wing impacted the trees, and from the resultant sudden and violent yaw to the left. The combination of those structural loads, asymmetric aerodynamic lift, and the subsequent roll to the left, seems likely to have initiated the partial separation of the aft-most fuselage section from the main body of the aircraft.
