## **TECHNICAL REPORT**

**A-070/2004**

Accident of aircraft  
BOEING B-737,  
registration PH-BTC,  
at Barcelona Airport  
(Spain), on 28  
November 2004

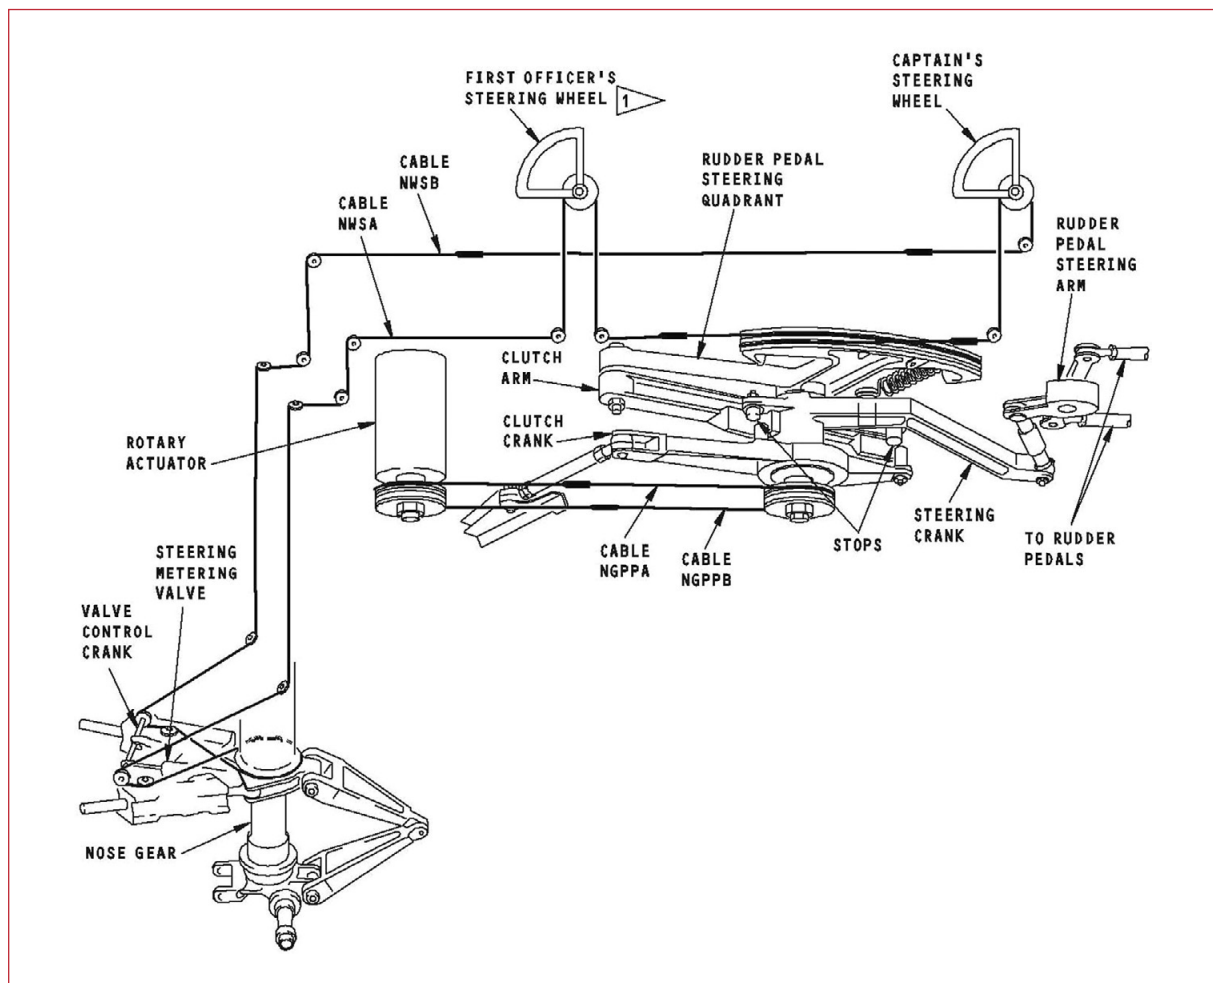
Figure 1.6.1. NWS mechanism from the AMM. Cable NWSB (on the right side of the NLG when looking in the direction of the flight) was found broken after the accident

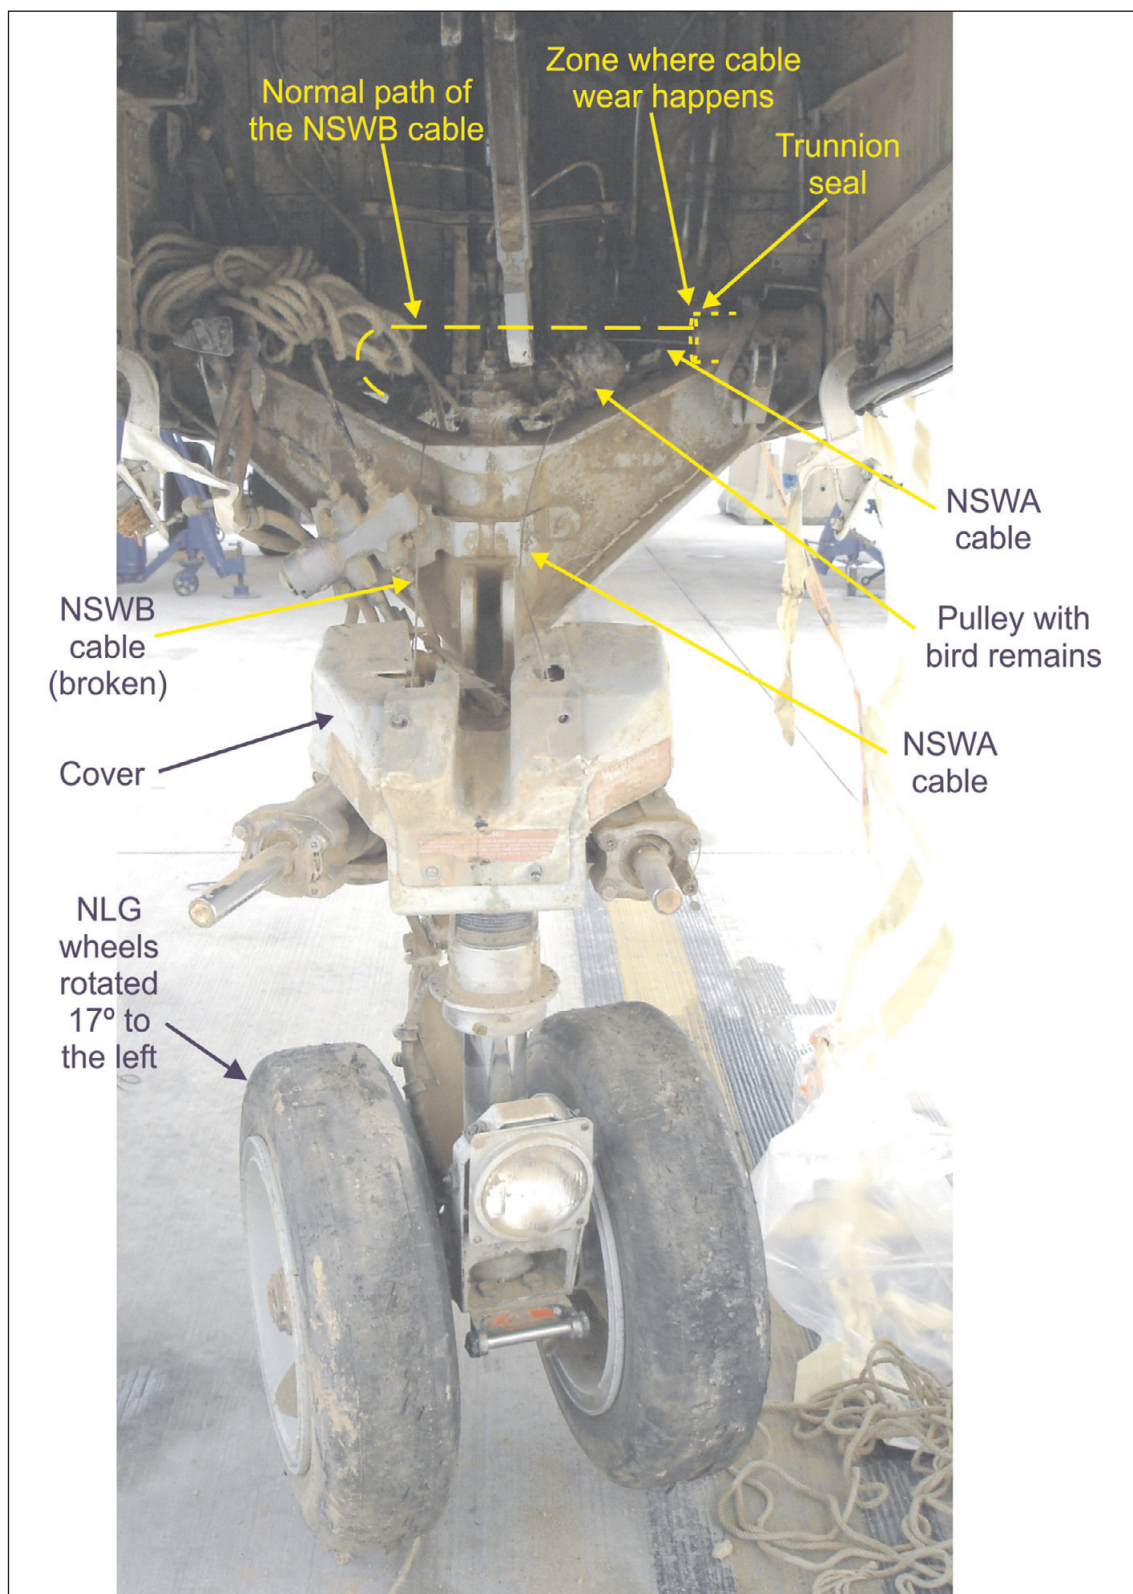
There had been a service history of wear observed on the stainless steel cables. This was traced to be due to the rubbing of the cable against sand particles that had been trapped by lubricating grease produced as the cable passed in and out the pressurized zone through the trunnion pressure seal. Therefore, the Fleet Team Digest 737-FTD-32-03008 (last revised on 24 September 2004) issued by the manufacturer stated that grease should not be put in that area. The AMM also contained a statement «Do not grease stainless steel (CRES) cables, it may be only cleaned with a clean rag...».

**Figure 1.6.2.** View of the front part of the NLG after aircraft recovery. The NSWB cable was found broken. The NSWA cable did not break, although it was also worn in the zone of the trunnion seal and its pulley had bird remains

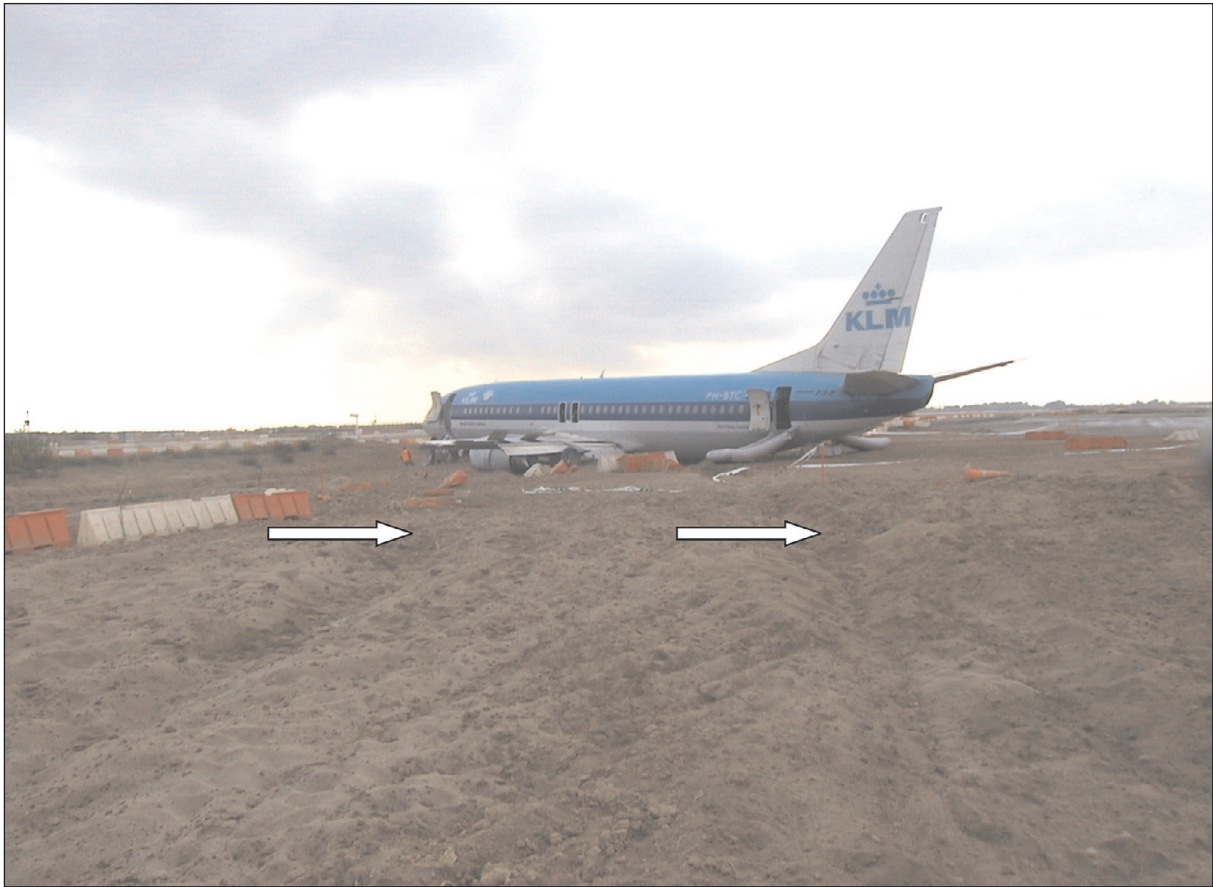
The aircraft exited the surface of runway 25R and went through another paved area under construction of some 10 m in width after jumping a step of approximately 10 cm of height. After passing over a trench around 20 cm deep, it then entered an unprepared zone covered mostly by sand and the landing gear dragged through the unprepared surface. The aircraft crossed a plastic fence line and suffered some damage from iron bars that were supporting construction signaling nets. The NLG and the LH MLG hit a buried pipeline that probably made them collapse and detach, respectively (see white arrows in the attached Photo 1.12.1).

Photo 1.12.1. Buried pipe noted in the tracks of the LH MLG and NLG

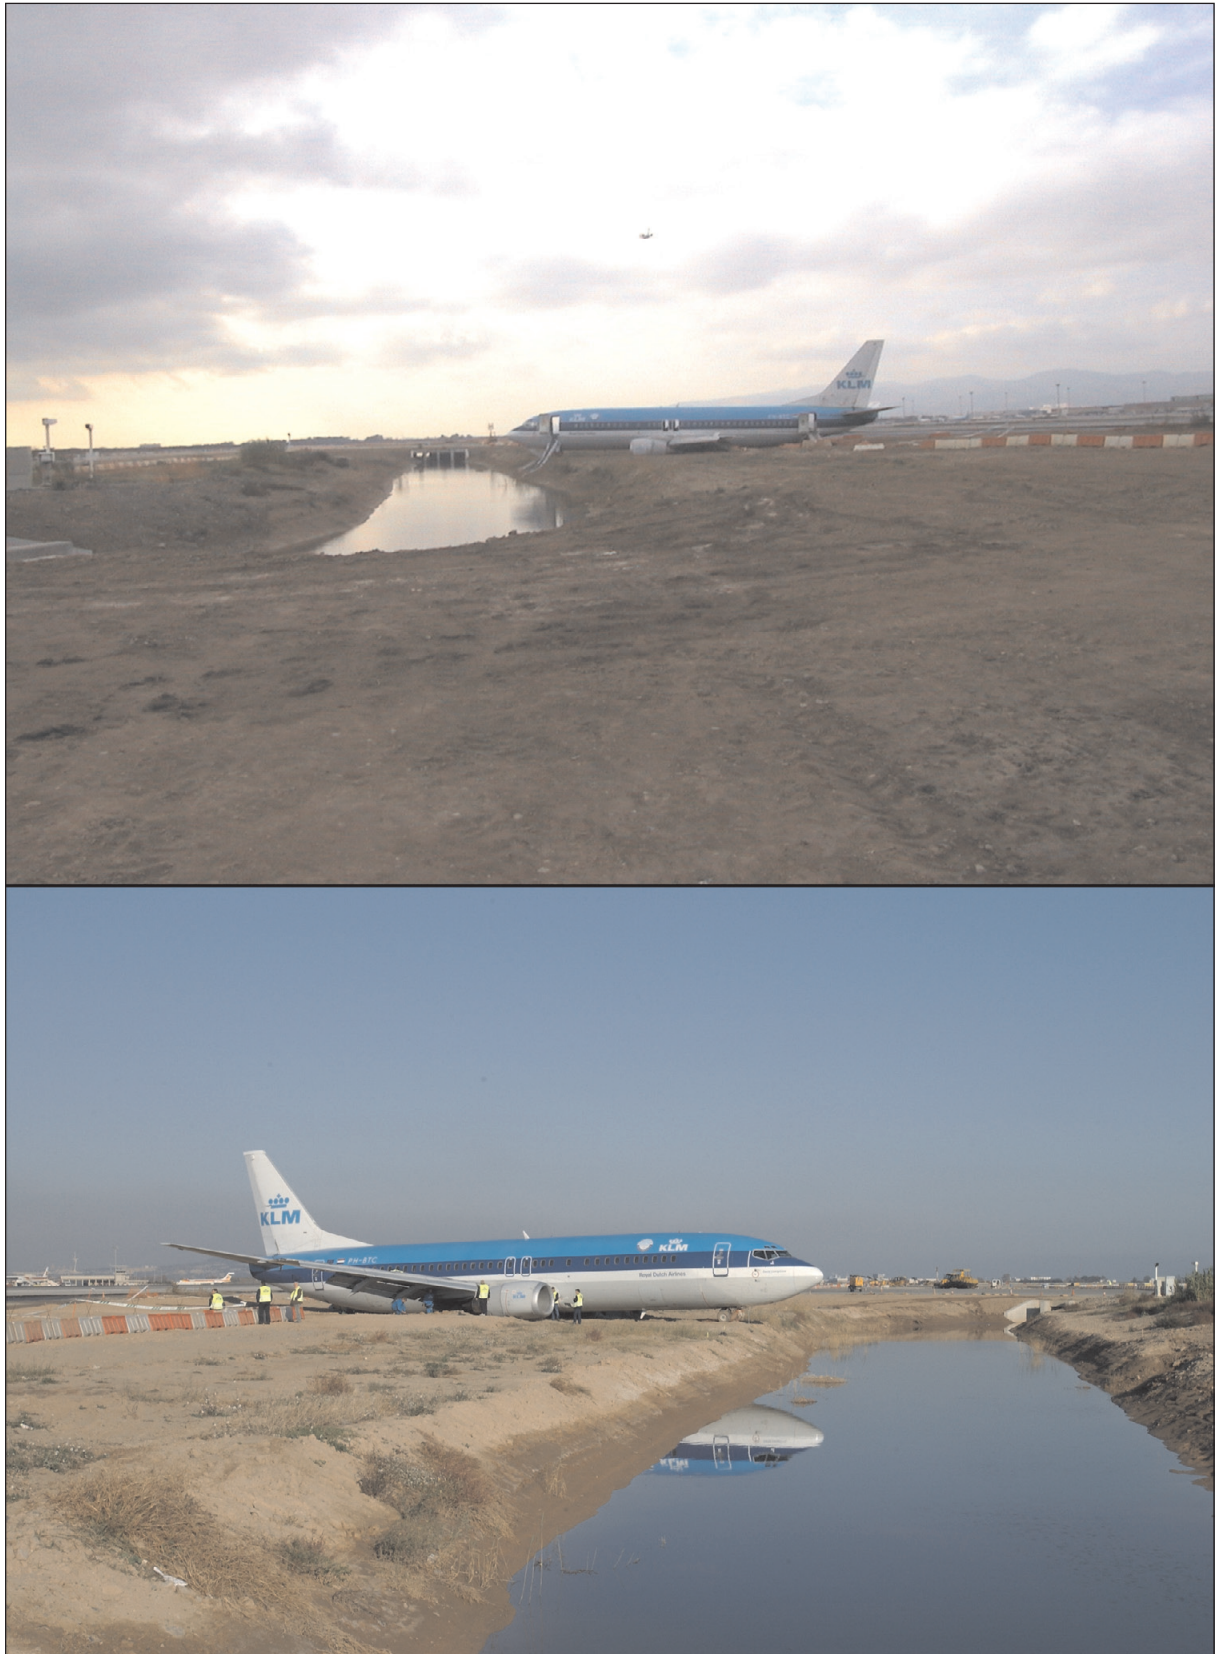
The aircraft came to a stop close to the edge of a rain drainage canal that ran approximately parallel to runway 25R. The canal was approximately 15 m wide, and 2.5 m high from the surface of the water. The water depth was approximately 1.5 m.

Photo 1.12.1.2. Final position of the aircraft close to the edge of the canal

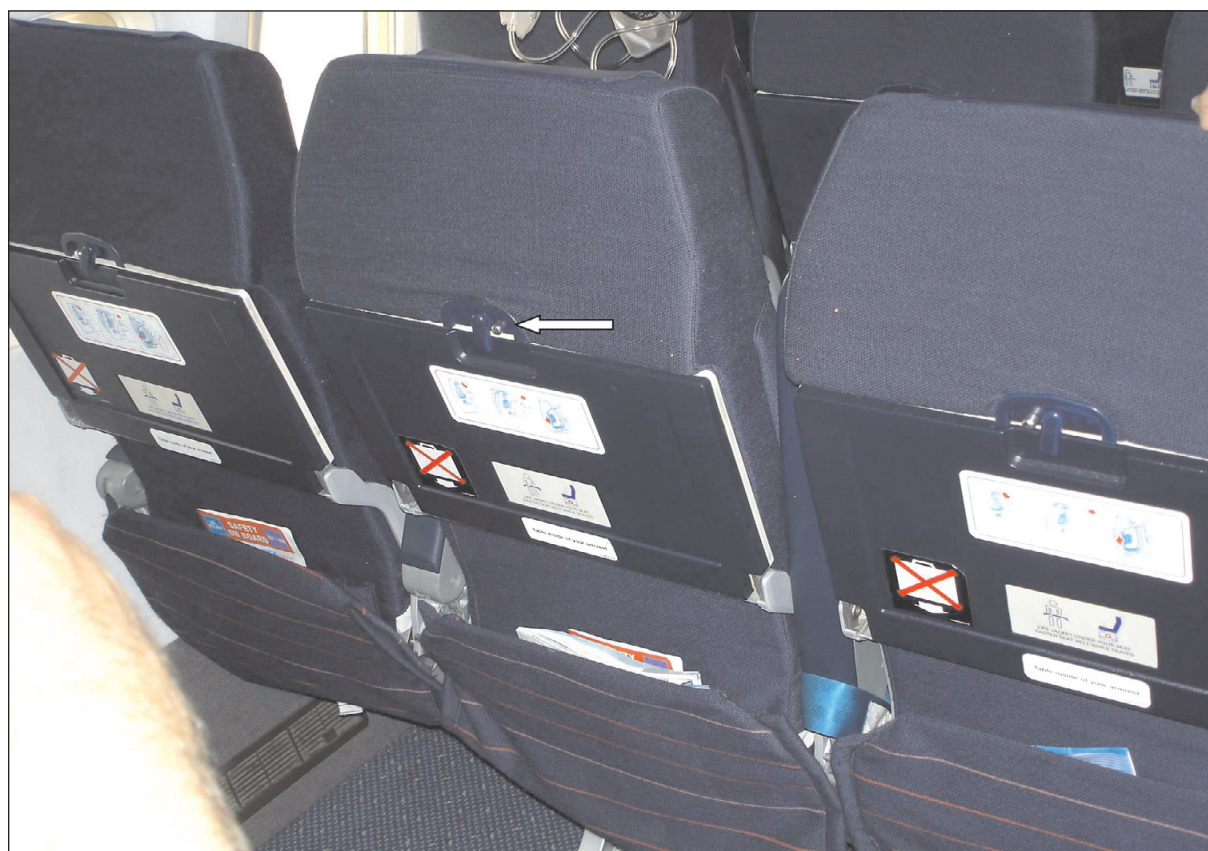
The meal tray table of the back of seat 10B (in front of seat 11B), which was located in the forward left hand emergency exit passageway, was found to have the restrain pin on its right hand side (i.e. towards the aisle). Therefore, the normal escape path of the passengers towards the type III emergency exit could easily release the tray (see Photo 1.15.1.1, white arrow in central seat back).

**Figure 1.15.1.1.** The latch of the meal table of the centre seat may rotate towards the sense of the Type III emergency exit escape path (to the left of the photo) and therefore it could be released during the emergency evacuation

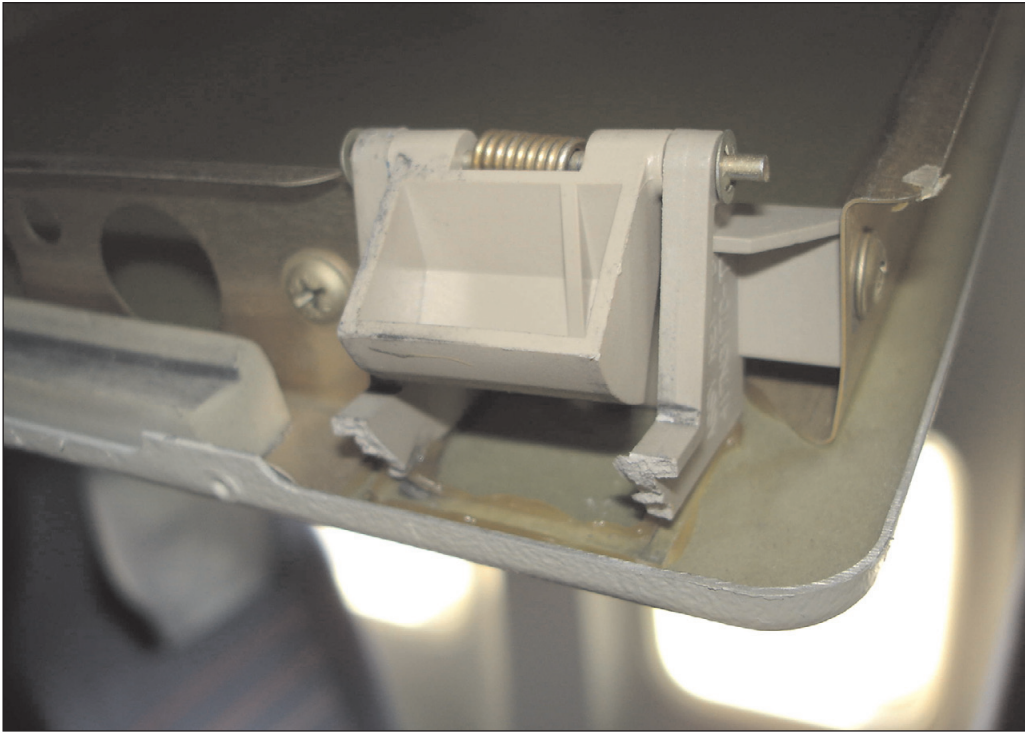
It was found that a lot of latches of the PSU panels were broken apparently due to lateral inertia loads towards the left of the aircraft or by the bending and torsion of the fuselage (see Photo 1.15.1.3).

Figure 1.15.1.3. Detail of a PSU panel latch broken on the left side of the aircraft

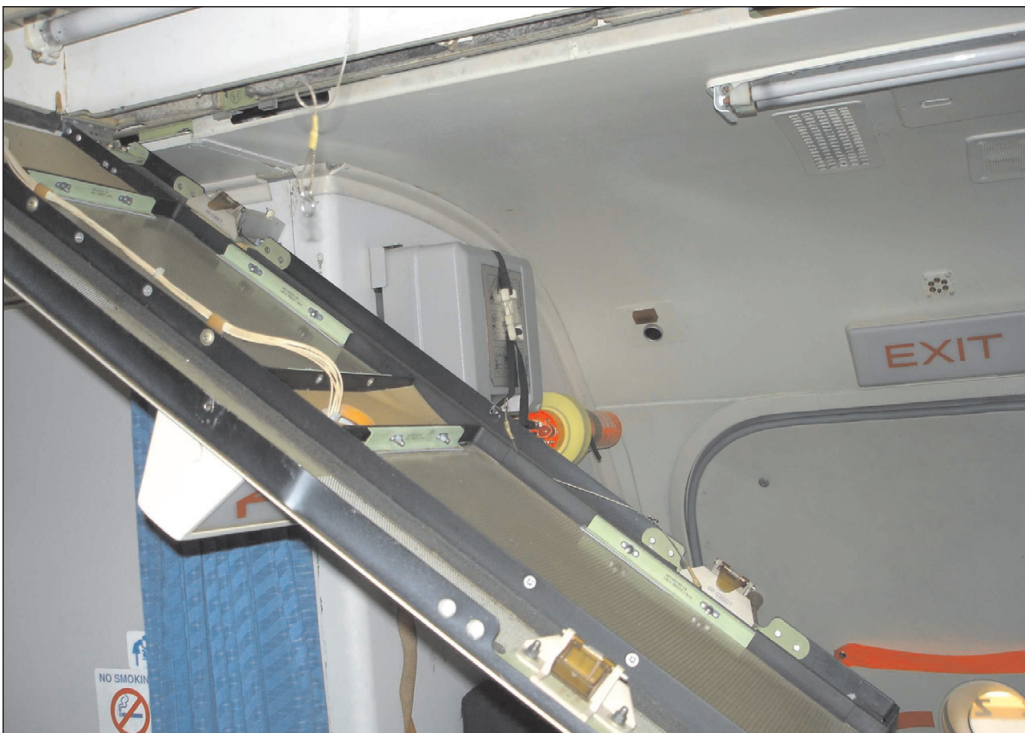
Figure 1.15.1.4. Ceiling panel in the rear cabin attendant compartment. During the inspection after the accident it was found closed, but witnesses stated that it opened after the aircraft came to a stop, therefore obstructing the path towards emergency exits L2 and R2. The lanyard released. The hook is at the end of the lanyard assembly

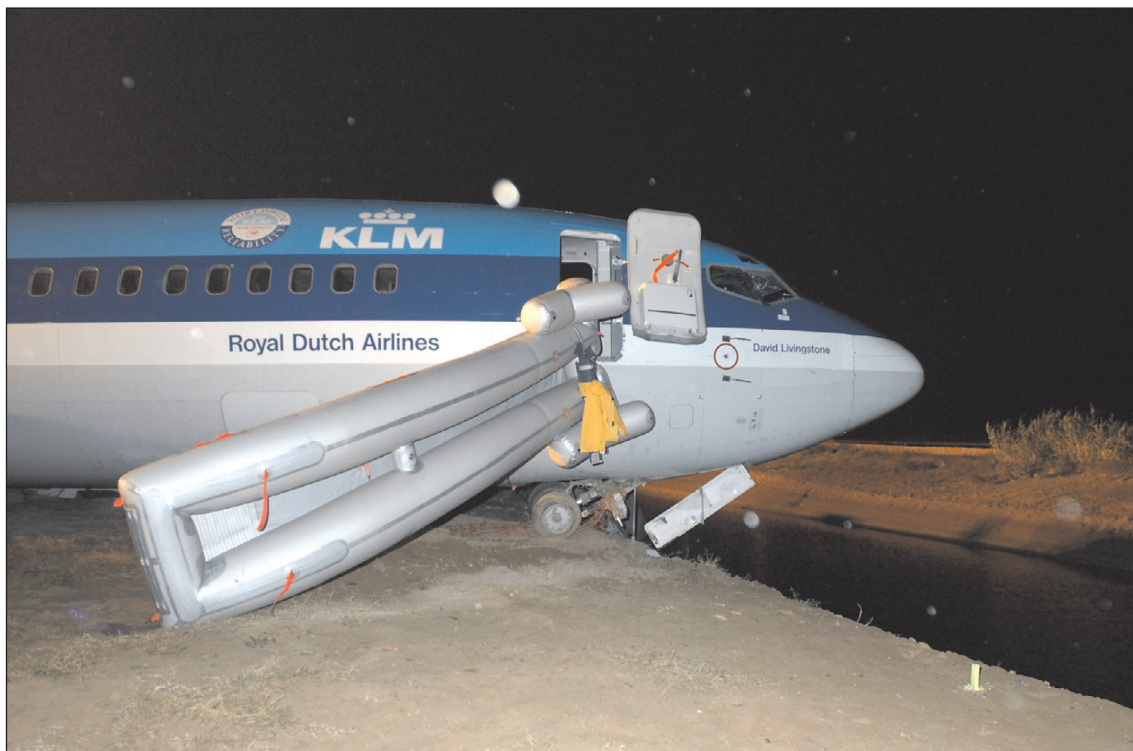
All the escape slides were found inflated, but the 1R slide was found twisted rearwards (i.e. front edge up and rear edge down) in a way that would have prevented its use for evacuation (see Photo 1.15.2).

Figure 1.15.2. Escape slide of door 1R was twisted

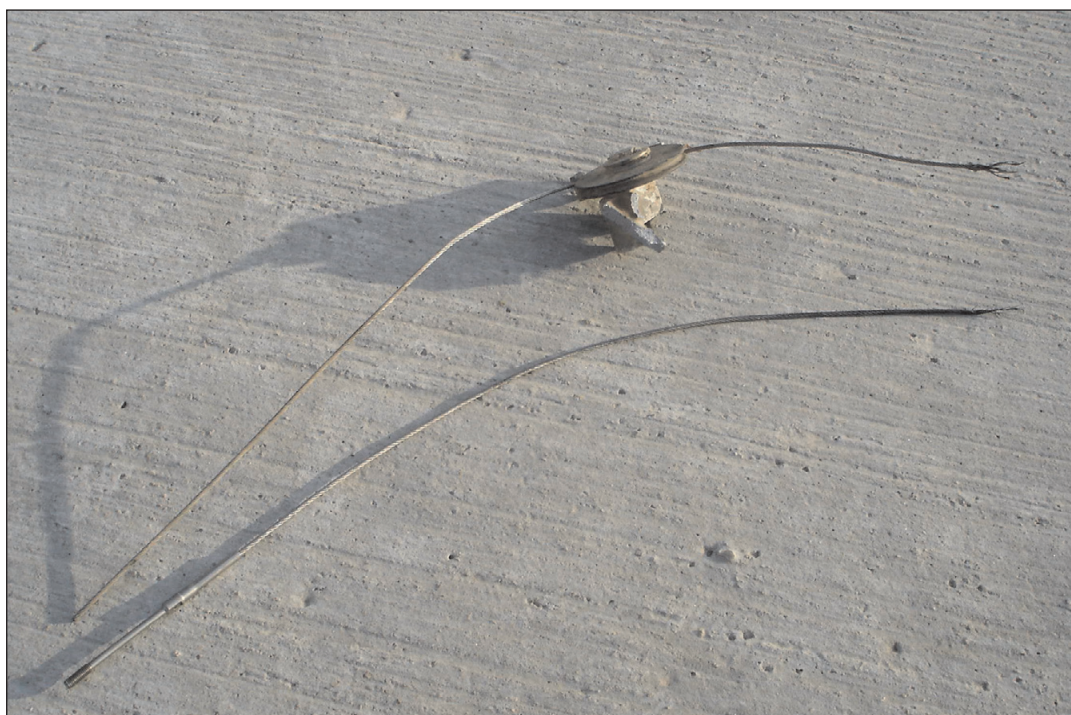
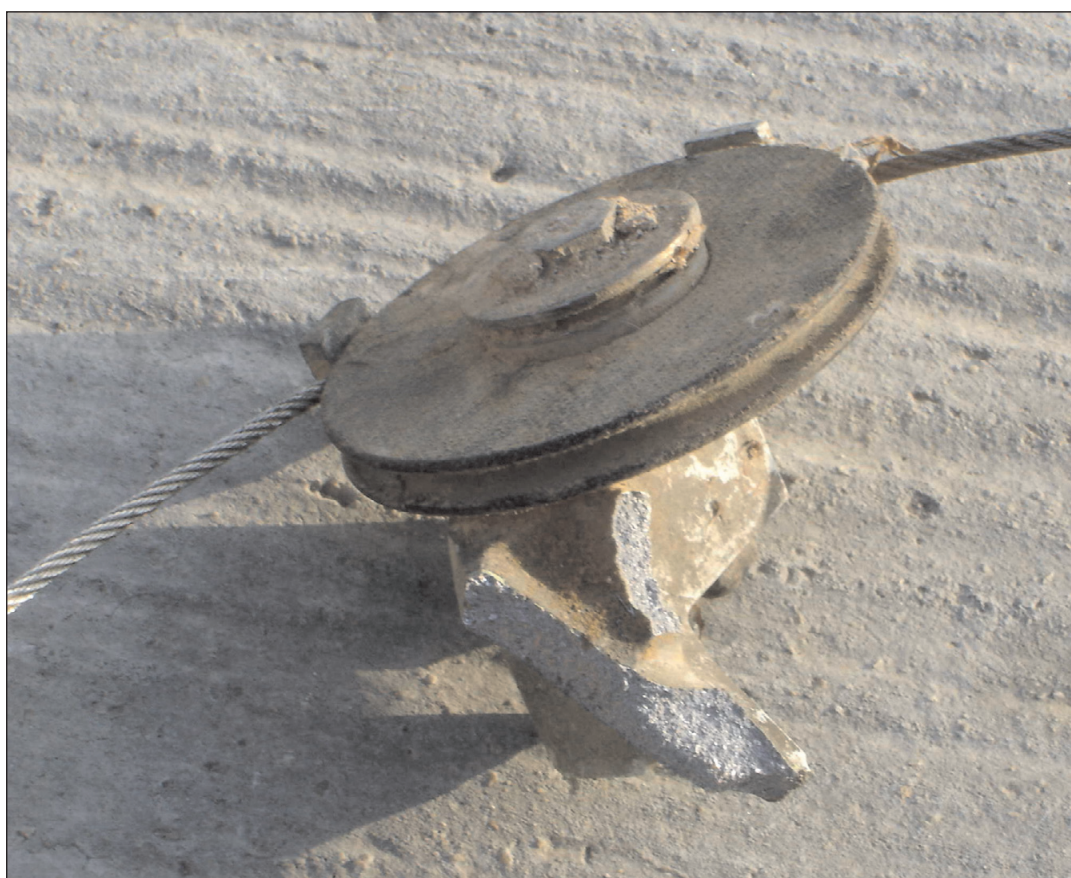
Photos 1.6.2.1 and 1.6.2.2. Each part of the broken cable was sent to a laboratory

eter was 0.29 mm, and it was made of 304 stainless steel. The laboratory concluded that the seven wires from the core strand failed by ductile overload. The six outer strands showed severe wear. Approximately 5 wires from each outer strand were worn-through completely; the other wires were thinned severely. Wear damage was observed over a length of approximately 80 mm. No corrosion was observed. Their conclusion was that «It is obvious that severe wear preceded the failure of the cable. The wear of the outer strands was so severe that nearly all load had to be carried by the core strand. A relatively low load was sufficient to cause cable failure».
