NATIONAL TRANSPORTATION SAFETY BOARD

AIRCRAFT ACCIDENT REPORT

IN-FLIGHT ICING ENCOUNTER AND LOSS OF CONTROL
SIMMONS AIRLINES, d.b.a. AMERICAN EAGLE FLIGHT 4184
AVIONS de TRANSPORT REGIONAL (ATR)
MODEL 72-212, N401AM
ROSELAWN, INDIANA
OCTOBER 31, 1994

VOLUME 1: SAFETY BOARD REPORT

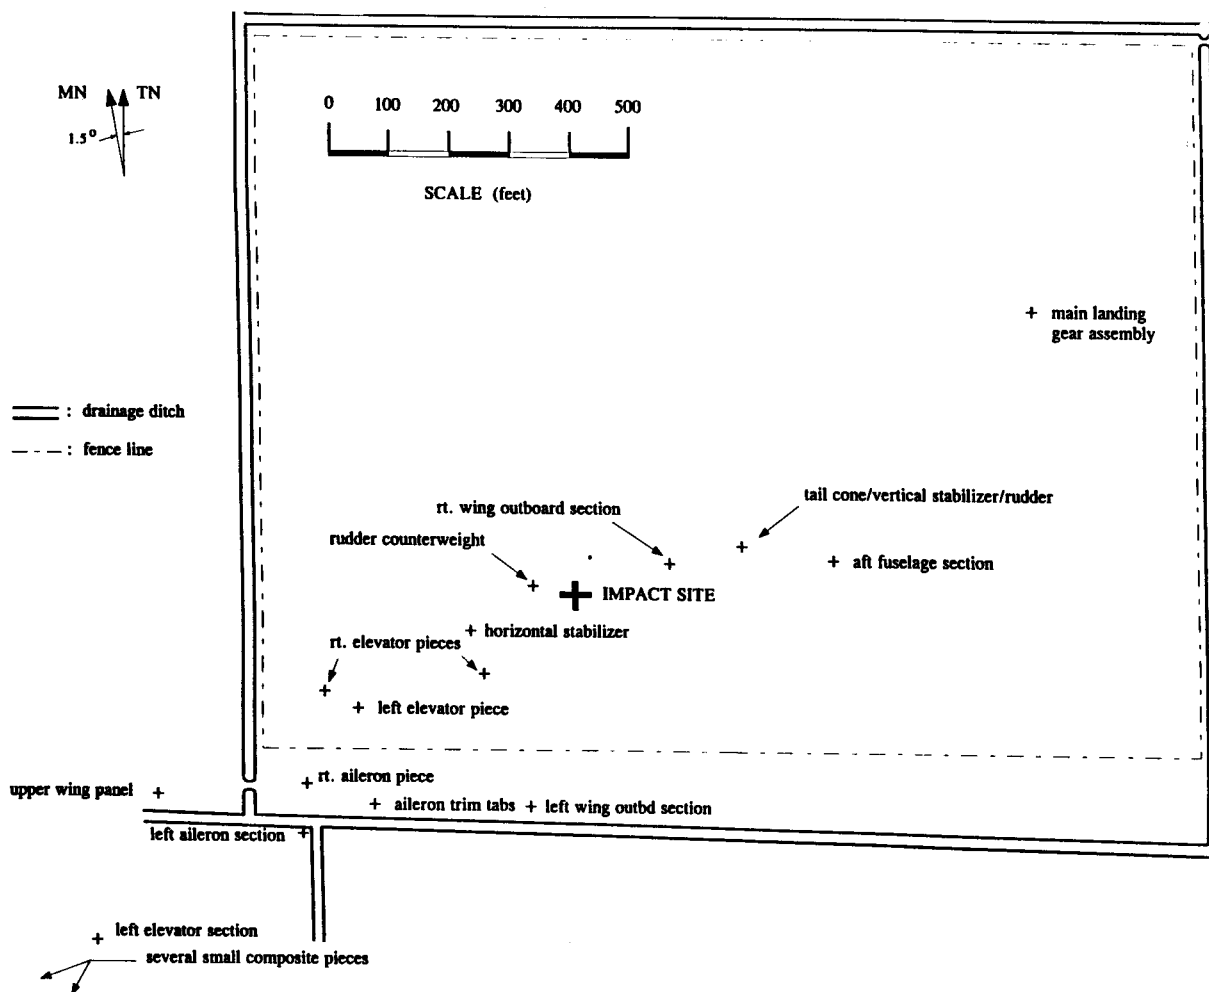
Figure 10a.--Wreckage distribution diagram.

Two smaller impact craters, consistent with the size of the left and right engines, were found on both sides of the larger, main impact crater (the size and orientation of the three craters, identified as crater 1, crater 2A, and crater 2B, are shown in Figure 10b). Most of the human remains, as well as portions of the

airplane structure and components, were located to the east-northeast of the impact craters. Portions of the wings and empennage were found to the south and southwest of the craters. The first major airplane structure found in the debris field, located farthest southwest from the impact craters, was a portion of the left elevator. Numerous small lightweight pieces of composite material were found about 1,000 feet southwest of the elevator. The last pieces in the debris field, farthest northeast from the impact craters, consisted of a main landing gear assembly (main landing gear wheel and tire) a portion of the flightcrew/passenger oxygen bottle, and two hydraulic pumps located in the lower section of the airplane.

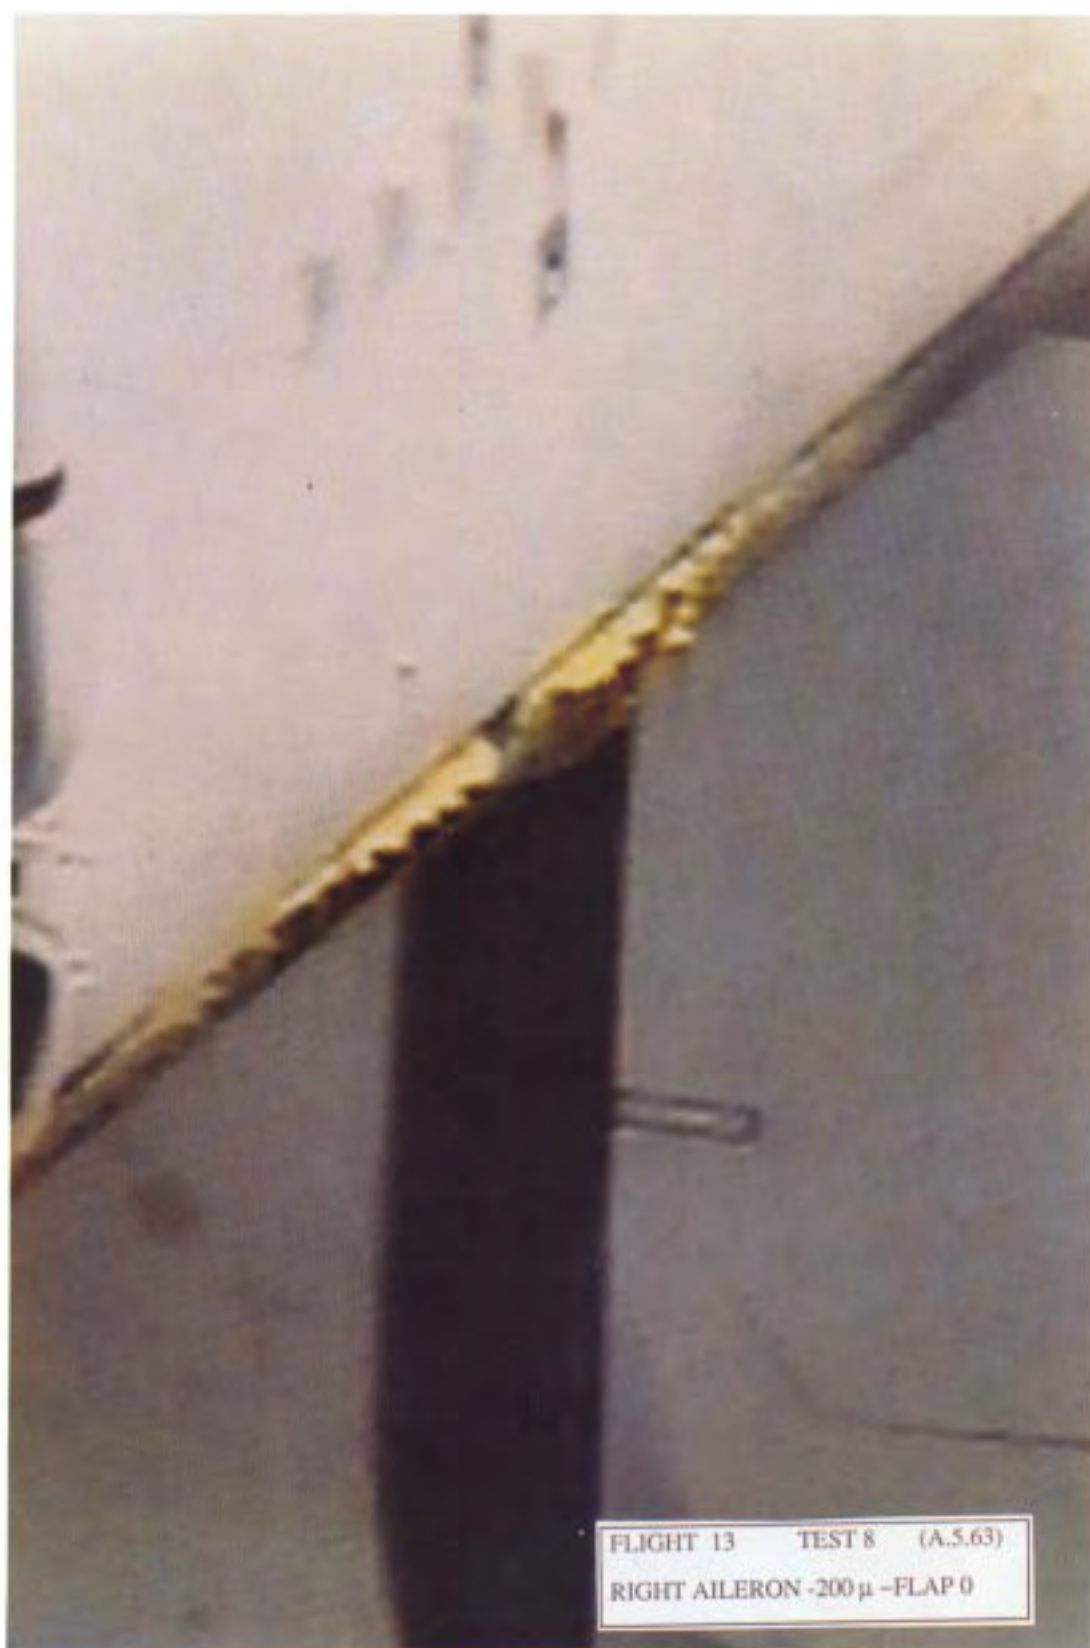
FLIGHT 13 TEST 8 (A.5.63)
RIGHT AILERON -200 μ -FLAP 0

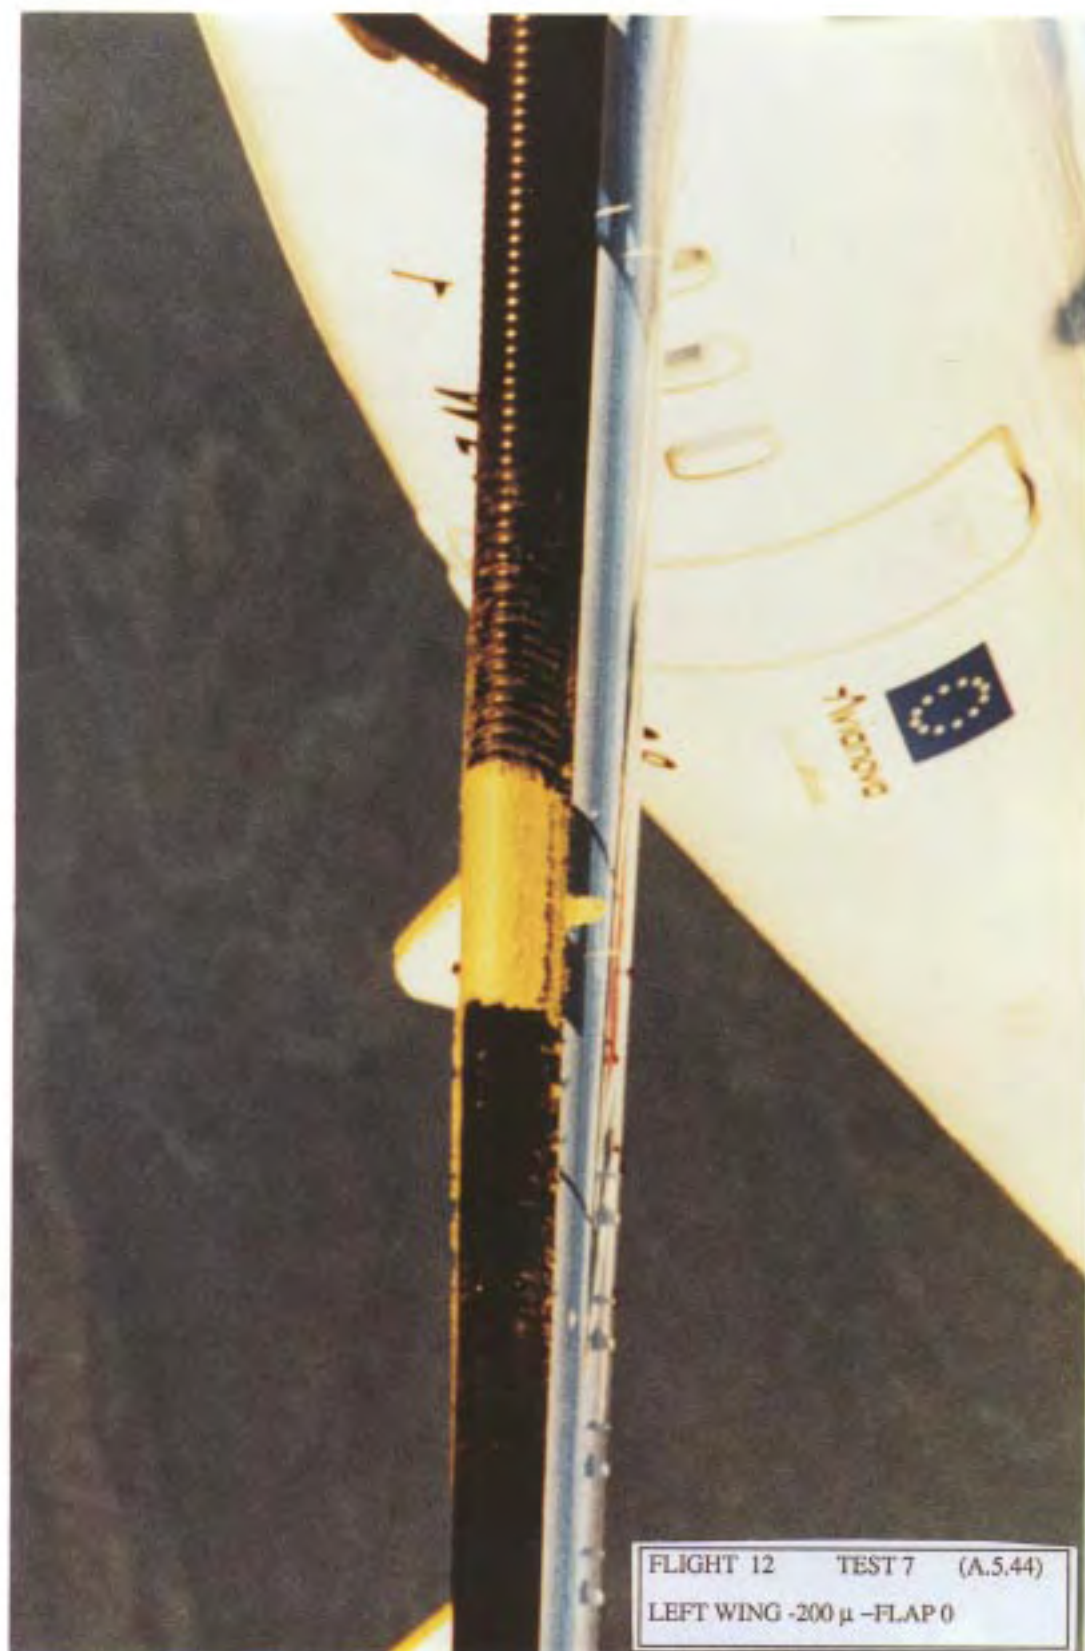
FLIGHT 12 TEST 7 (A.5.44)
LEFT WING -200 μ -FLAP 0

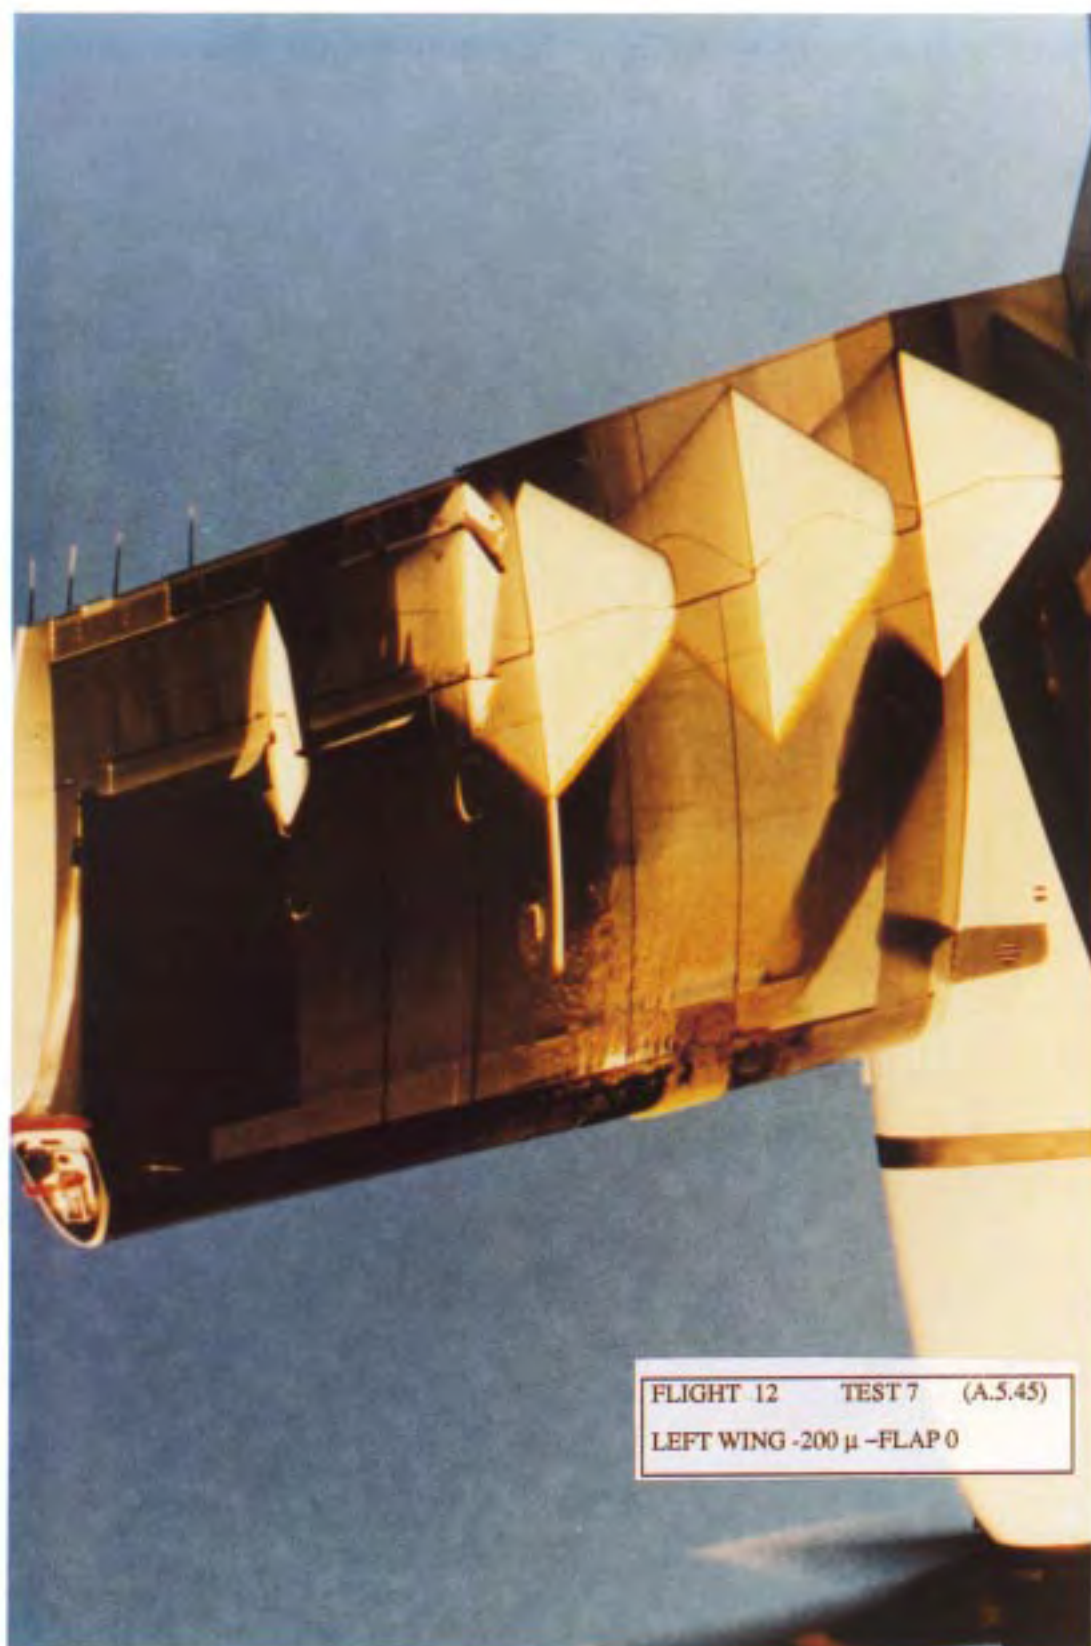
FLIGHT 12 TEST 7 (A.5.45)

LEFT WING -200 μ -FLAP 0

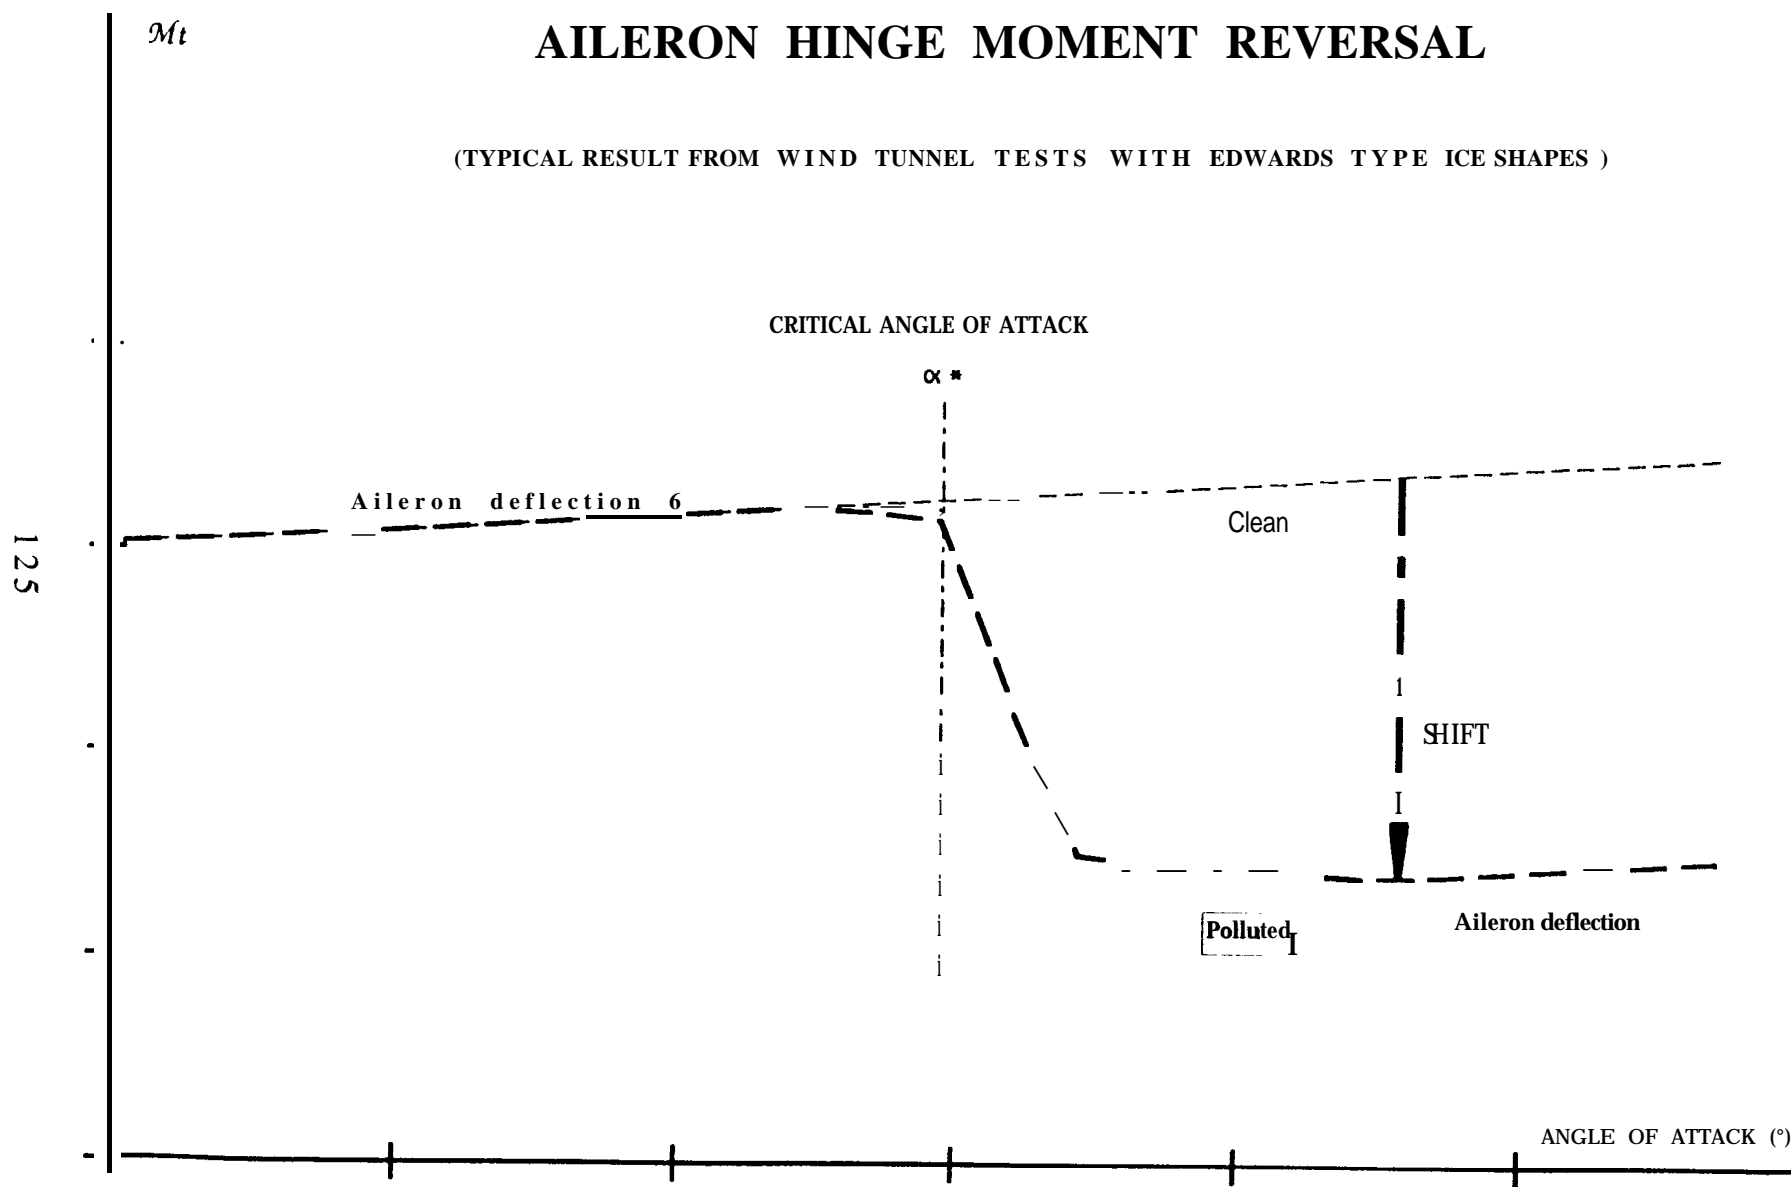
FIGURE 13 : HINGE MOMENT REVERSAL IDENTIFICATION

(TYPICAL RESULT FROM WIND TUNNEL TESTS WITH EDWARDS TYPE ICE SHAPES)
