FINAL REPORT

HCL 49/01	Accident	
Aircraft Type:	Dassault Falcon 20	Aircraft Registration: D-CBNA
Engine(s):	2 CF 700-2D2	Type of Flight: Charter, IFR
Crew:	2- fatal injuries	Passengers: 1- fatal injuries
Place:	4.5 nm SW of Narsarsuaq (BGBW)	Date and Time: 05.08.2001 0443 UTC

Synopsis

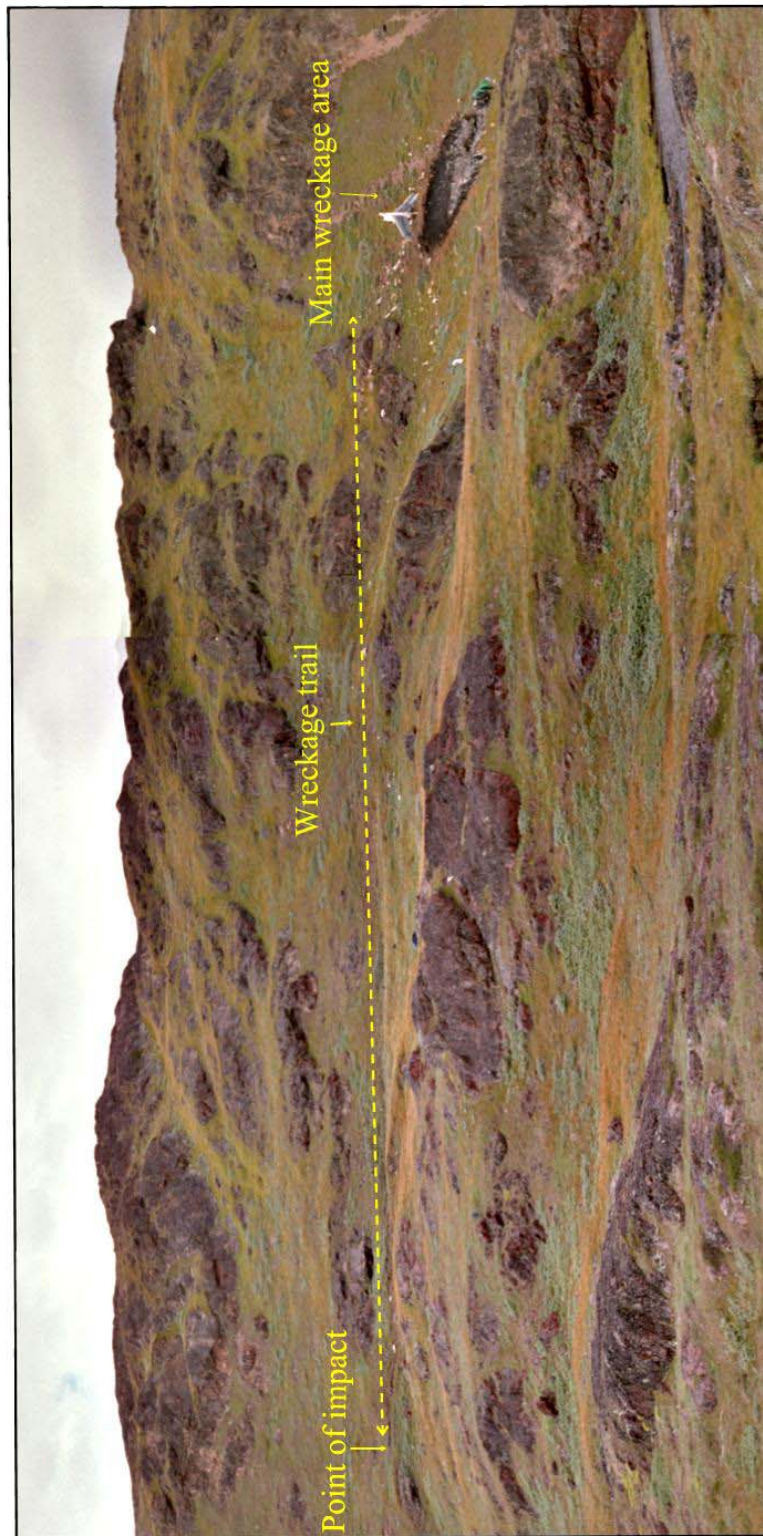
Enclosure 2

1.12.1.1 Examination of the ground scars and the debris pattern revealed that the aircraft impacted mountainous terrain at 61 07 194N 045 33 595W and at an elevation of about 700 msl in a wings-level attitude. The wreckage trail track had a direction of approximately 110 degrees magnetic. The wreckage pattern observed was consistent with a controlled shallow descent. The wreckage trail was approximately 165 metres long by 30 metres wide.

1.12.1.3 The aircraft started to break up from the beginning of the wreckage trail. During the break up, the cargo exited the aircraft and was spread over a relatively large area of the last part of the wreckage trail. No cargo tie-down rings or any other sign of use of cargo net were found within the accident area.

wreckage trail. When the aircraft came to a stop, the fuselage, the right wing and the cockpit caught fire. The fuselage, the right wing and the cockpit were burned out.

1.12.1.5 The two engines were found separated from their respective mounted positions on the aircraft. The starboard engine was located 40 metres SW of the main wreckage site. The port engine was located within the main wreckage area.

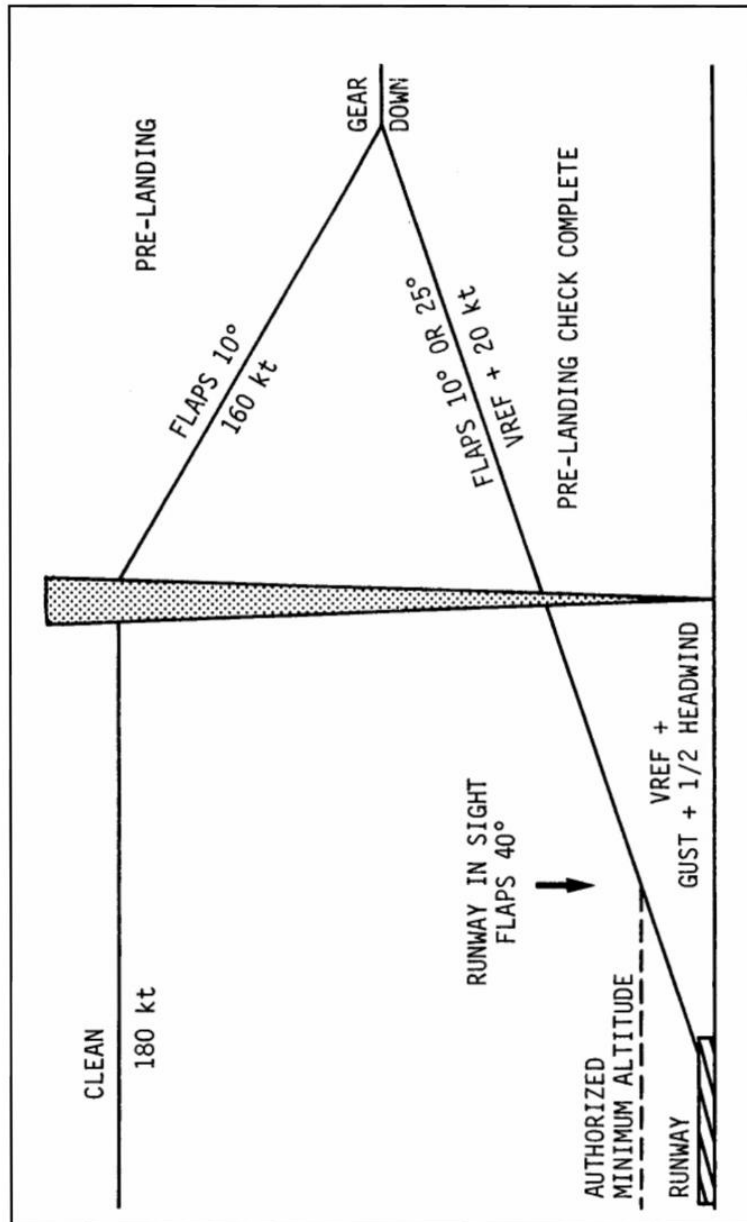
Enclosure 3

2.2.6 With reference to the flight crew's reporting and their call outs, the AAIB assumes that the aircraft had a initial sink rate of approximately 2300 feet per minute (FL 195 – FL 130) and an average initial ground speed of approximately 280 knots (pilot reporting: "10 nm out of NA" – flight crew call out: "6 nm"). Based on these assumptions, the aircraft passed NA at approximately 0439 hrs at an altitude of approximately 8700 feet. At station passage, the aircraft was still above the reported broken cloud layer, and the AAIB believes that the flight crew initiated the NDB/DME approach procedure. On the outbound leg, the aircraft came below the reported broken cloud layer. The aircraft seems to have had a high airspeed on the outbound leg (flight crew call outs: "6 nm and 8 nm" which versus time is equal to a relative ground speed of approximately 277 knots"). This indicates that the initial approach procedure was not flown in accordance with the Operator's SOP for a two-engine VOR/ADF approach.

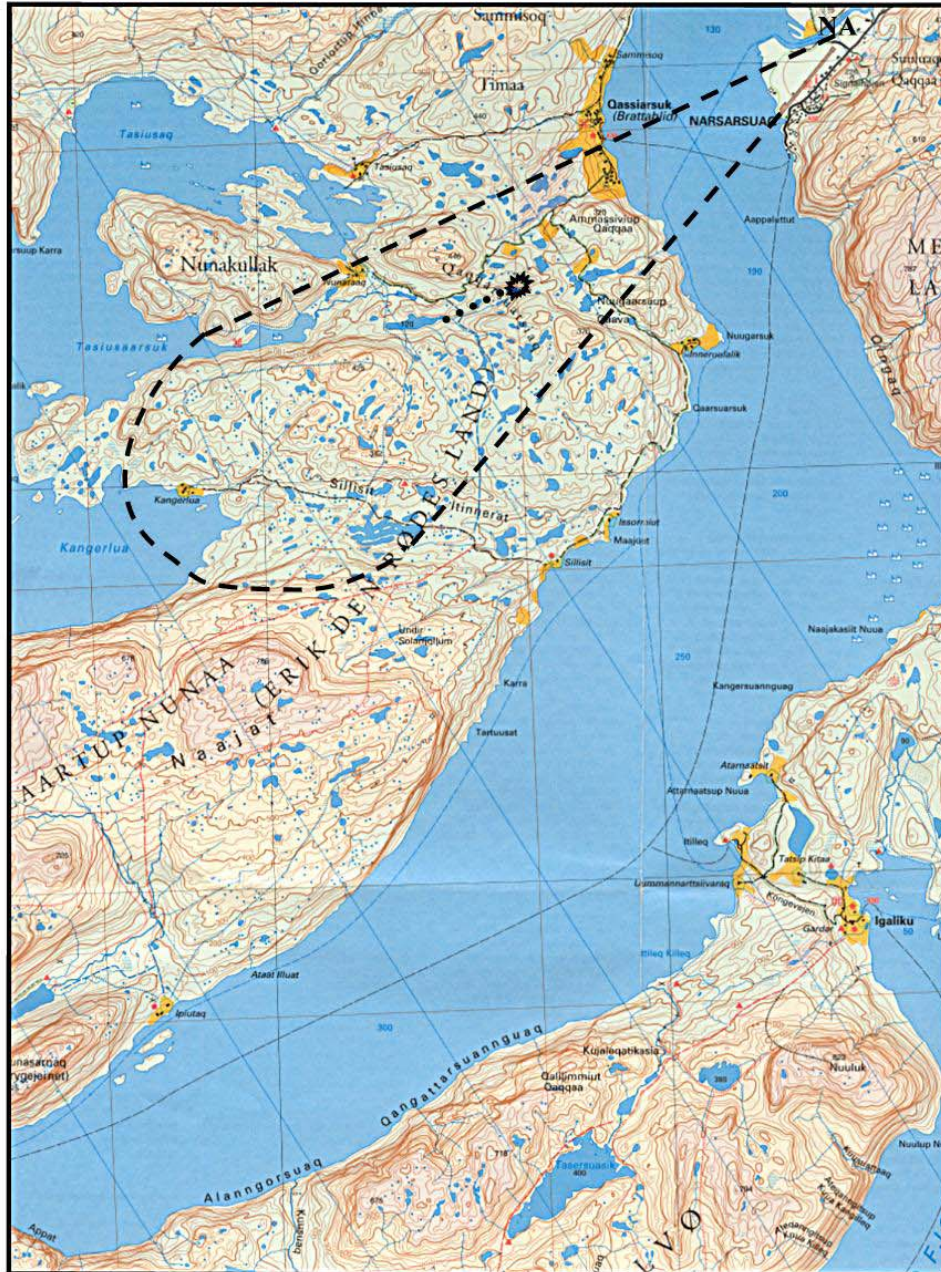
Enclosure 4

- NDB/DME approach procedure
- The aircraft's assumed final approach track
- ★ The accident site
