Crash During a Nighttime Nonprecision Instrument  
Approach to Landing  
UPS Flight 1354  
Airbus A300-600, N155UP  
Birmingham, Alabama  
August 14, 2013

NTSB/AAR-14/02  
PB2014-107898

# Aircraft Accident Report

**Abstract:** This report discusses the August 14, 2013, accident involving an Airbus A300-600, N155UP, operating as UPS flight 1354, which crashed short of runway 18 during a localizer nonprecision approach to runway 18 at Birmingham-Shuttlesworth International Airport, Birmingham, Alabama. The captain and first officer were fatally injured, and the airplane was destroyed. Safety issues relate to the need for clear communications to flight crews about weather conditions, between dispatchers and flight crews, and between flight crewmembers; off-duty time management, fatigue awareness, and counseling; use of the continuous descent final approach technique; standardized guidance; and altitude alerts. Safety recommendations are addressed to the Federal Aviation Administration, UPS, Airbus, and the Independent Pilots Association.

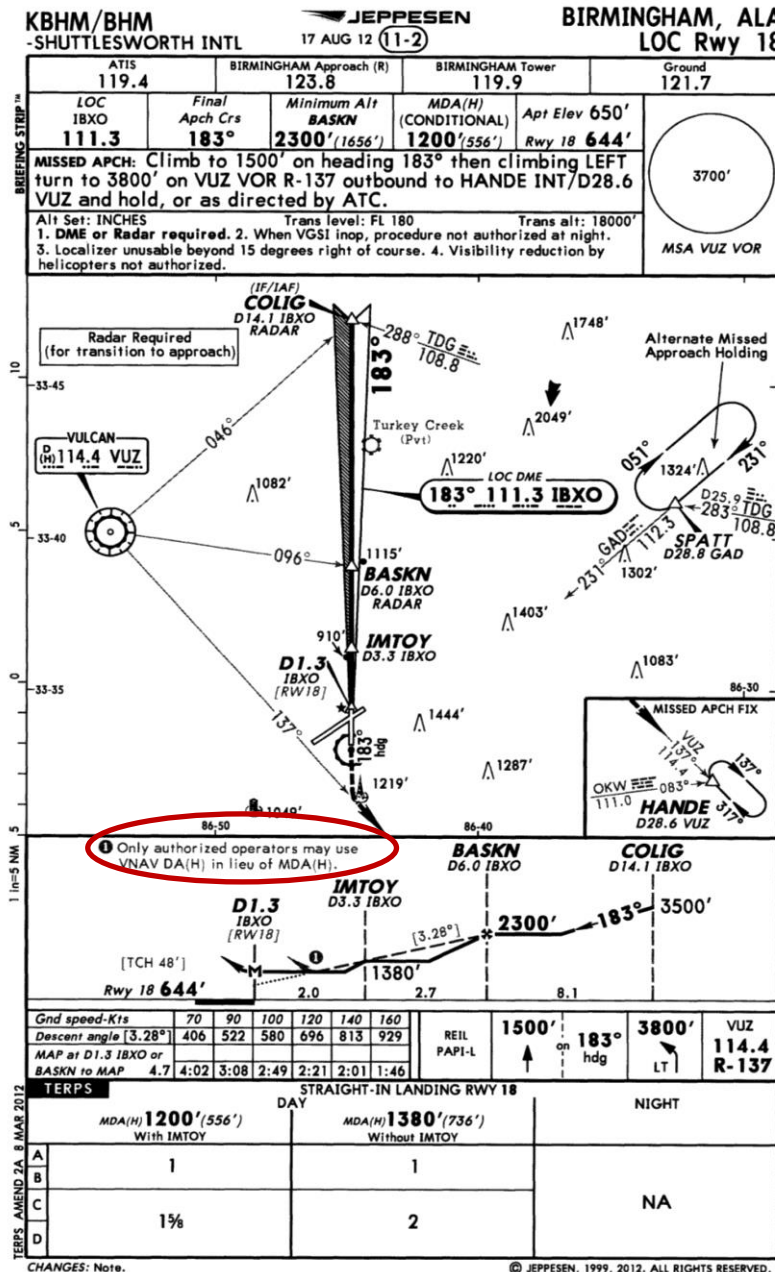
<sup>4</sup> Jeppesen indicated that at the time of the accident, this note regarding the localizer approach was a publishing error and was corrected after the accident.

**Figure 2.** Instrument approach chart for the localizer approach for runway 18 at BHM at the time of the accident with the ball note circled in red.

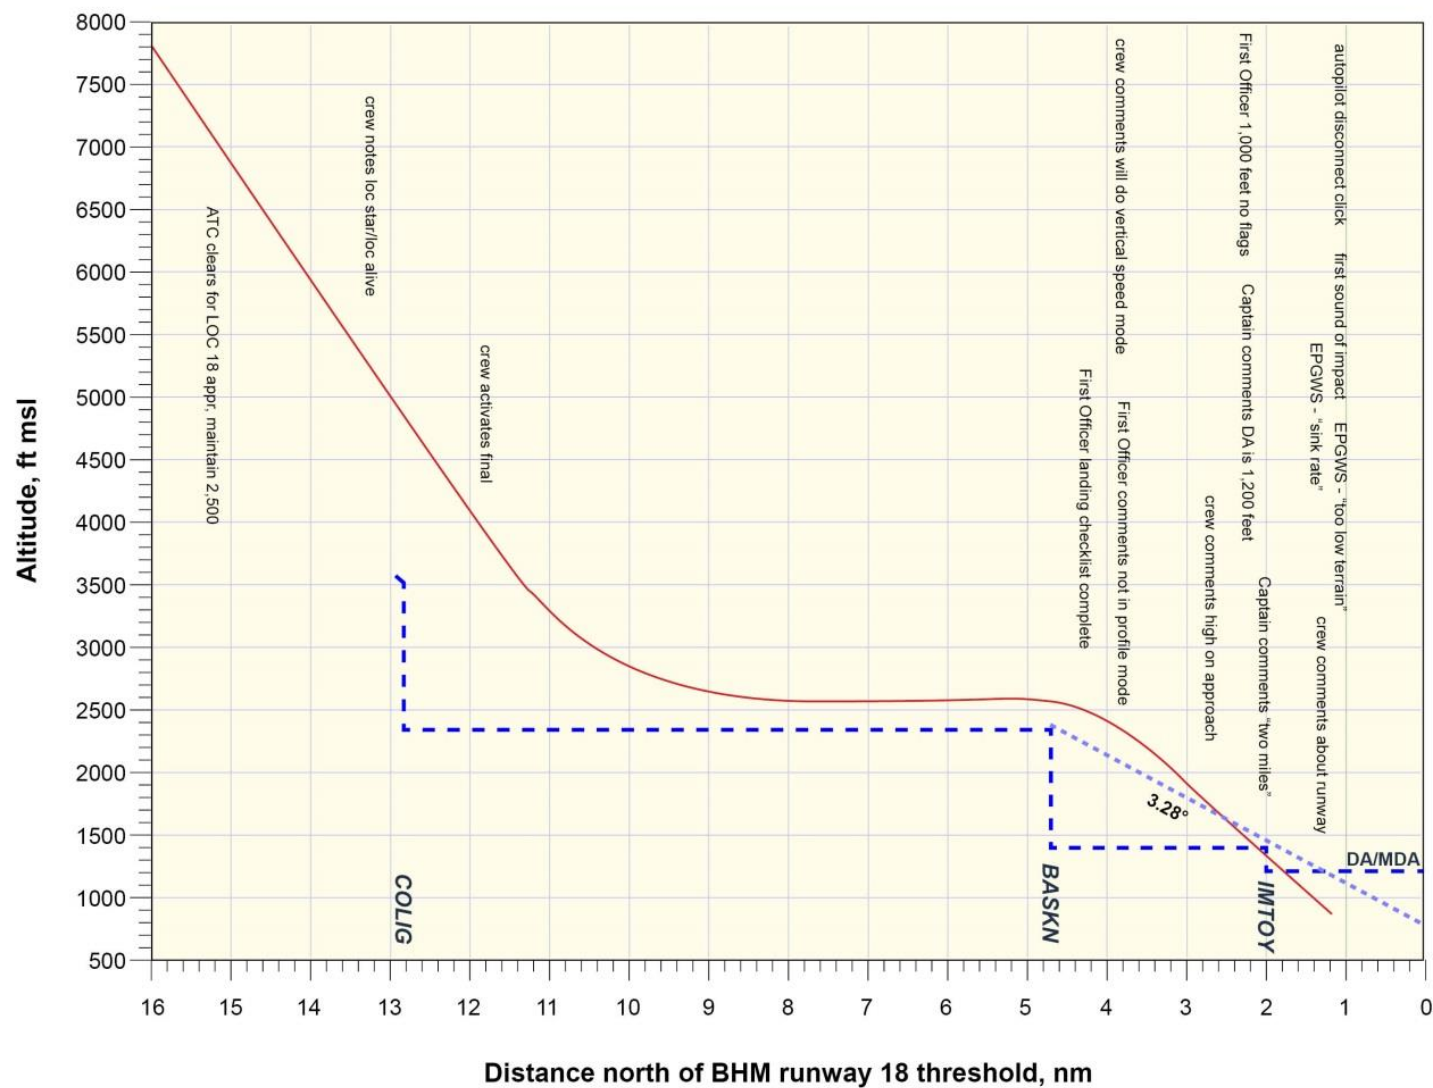
1 **Figure 3.** UPS flight 1354's actual descent and altitudes.

As the airplane neared the BASKN FAF, the controller cleared the pilots to land on runway 18, and the first officer performed the Before Landing checklist. The airplane approached BASKN at an altitude of 2,500 ft msl, which was 200 ft higher than the FAF's minimum crossing altitude and contrary to the UPS A300 Pilot Training Guide (PTG) recommendation that the airplane descend to the FAF crossing altitude before intercepting the profile path. Because the approach was still sequenced for a direct-to-KBHM course, the airplane continued flying toward BASKN at 2,500 ft and did not capture the desired profile glidepath. During this time, the captain changed the autopilot mode from the previously briefed profile approach to vertical speed mode,<sup>20</sup> initially setting the vertical descent rate to about 700 ft per minute (fpm), then increasing it to 1,000 fpm; however, he did not brief the first officer about the autopilot mode change.

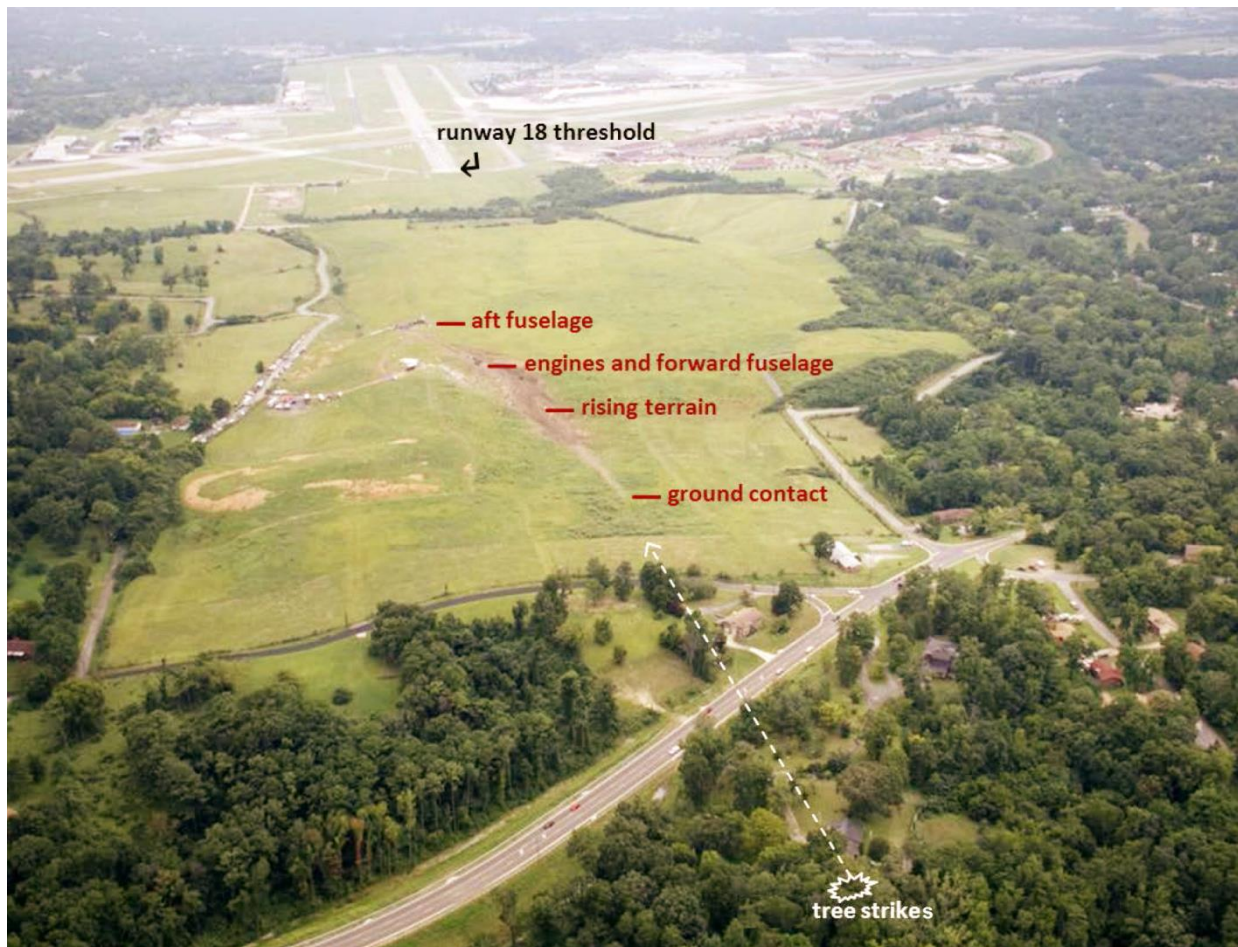
Postaccident examination revealed that the airplane struck several trees and ingested tree debris into both engines during its descent toward runway 18. Pieces of airplane wreckage associated with the initial impacts were found about 1 1/4 miles (mi) north of the runway threshold and consisted mostly of small fragments of left wing, engine nacelle, and engine inlet material. The airplane struck more trees, a power pole, and power lines before it impacted downsloping terrain in a large gulley north of the runway 18 threshold. The debris path continued to the bottom of the gulley and up the adjacent side. Figure 4 is an overhead photograph of the wreckage path.

**Figure 4.** Overhead photograph of the wreckage path.

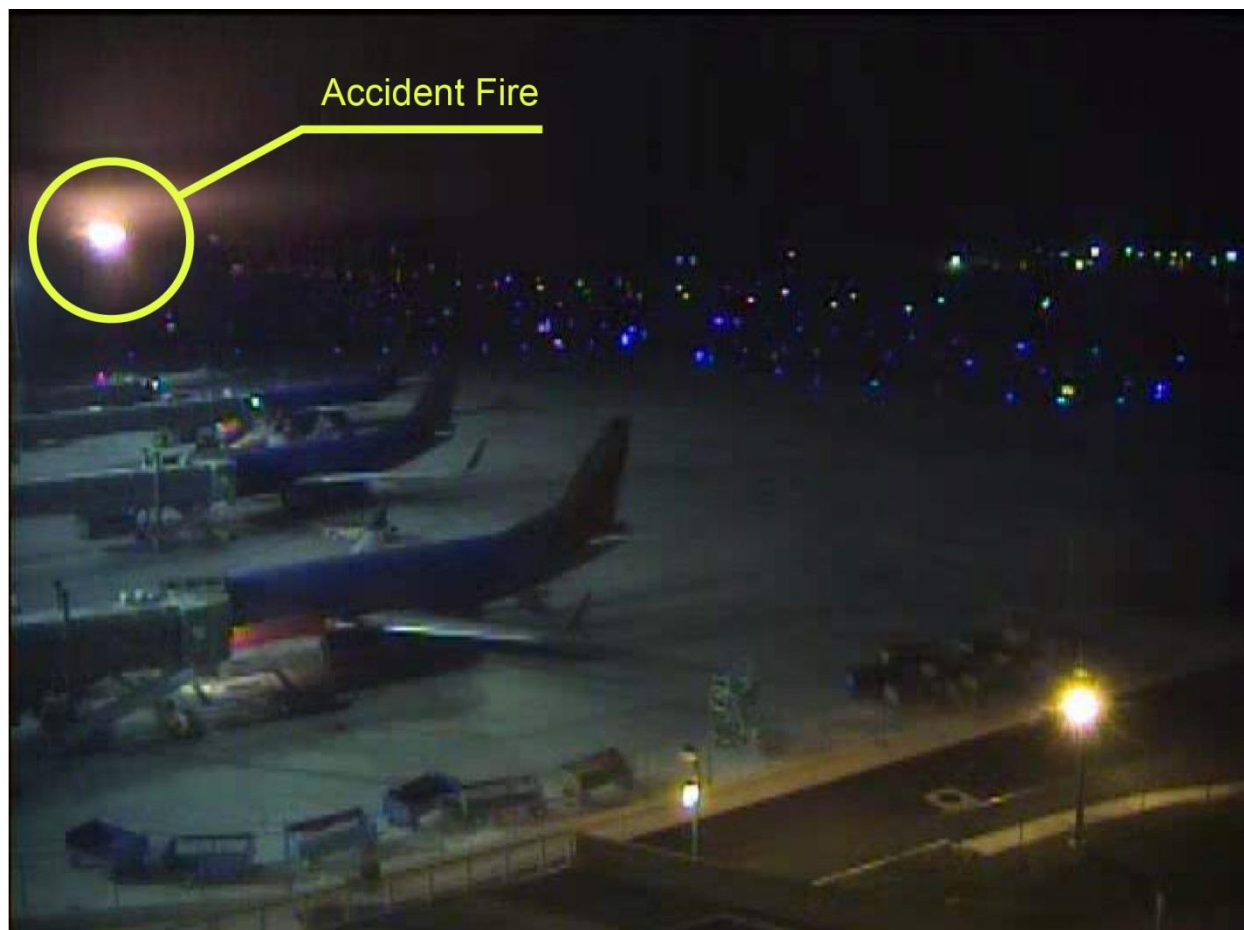
The airplane was destroyed by impact forces and postcrash fire. Images recorded by several surveillance video cameras based at the airport showed the fire associated with the airplane's ground impact and the presence of low clouds above the impact area (see figure 5). The forward fuselage was largely intact; however, the lower portion of the fuselage, especially under the cockpit, sustained severe impact damage. The left wing was highly fragmented. The right wing, aft fuselage, and tail sustained significant fire damage. For additional wreckage information, see section 1.12.

**Figure 5.** Still-frame photograph from an airport surveillance video camera showing the fire.

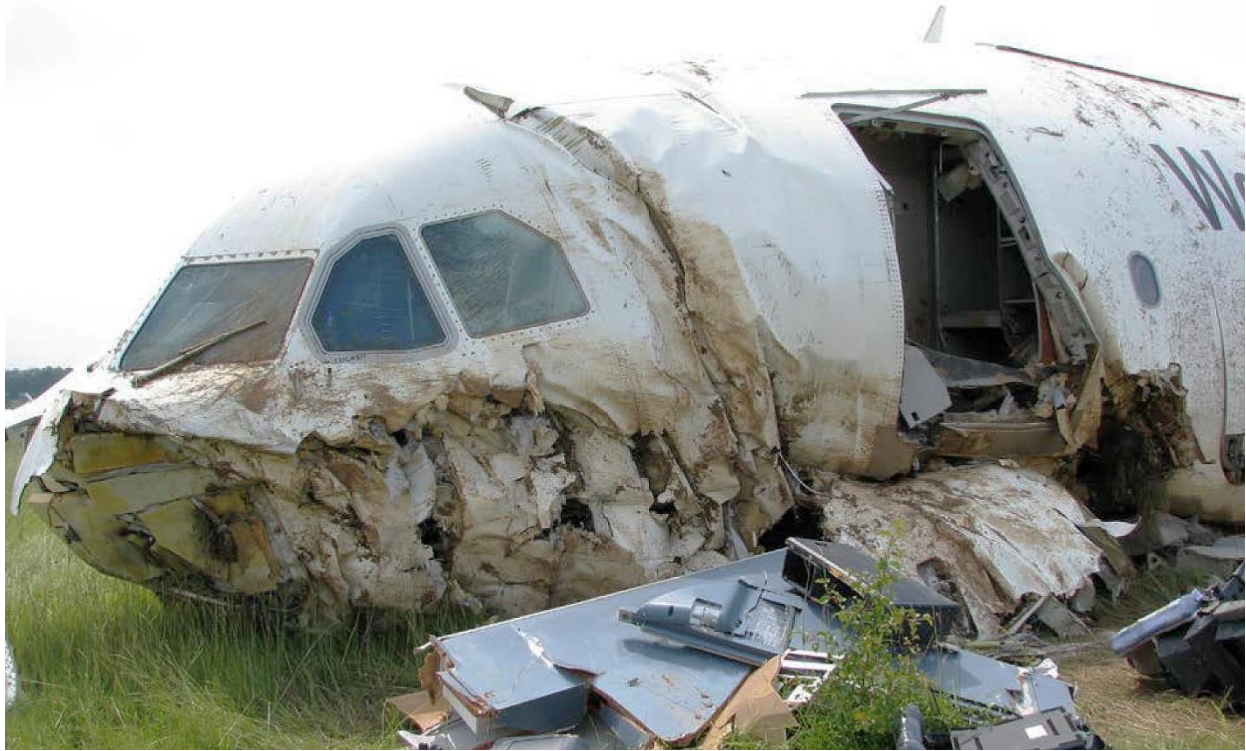
Two major portions of wreckage were found in the main debris field. The forward fuselage was located about 4,061 ft from the runway 18 threshold on the top of the southern ridge of the gulley and was displaced slightly to the left side of the main debris field as viewed

**Figure 13.** Photograph of the left side of the forward fuselage.

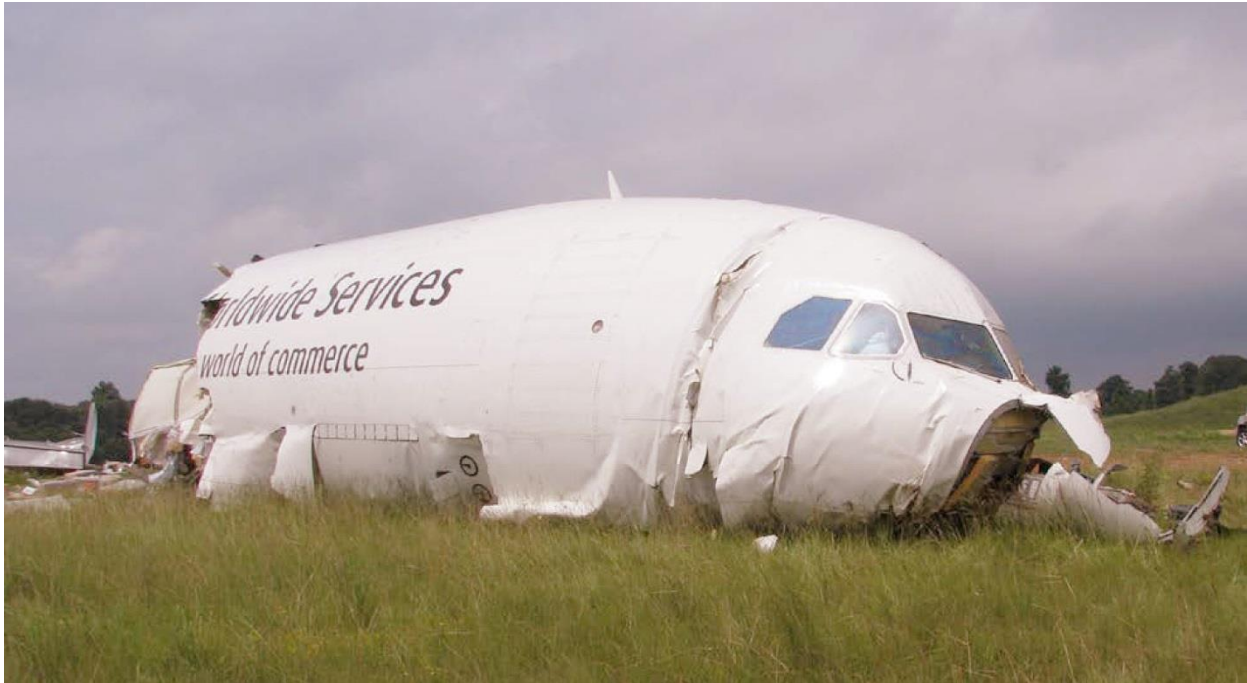
**Figure 14.** Photograph of the right side of the forward fuselage.

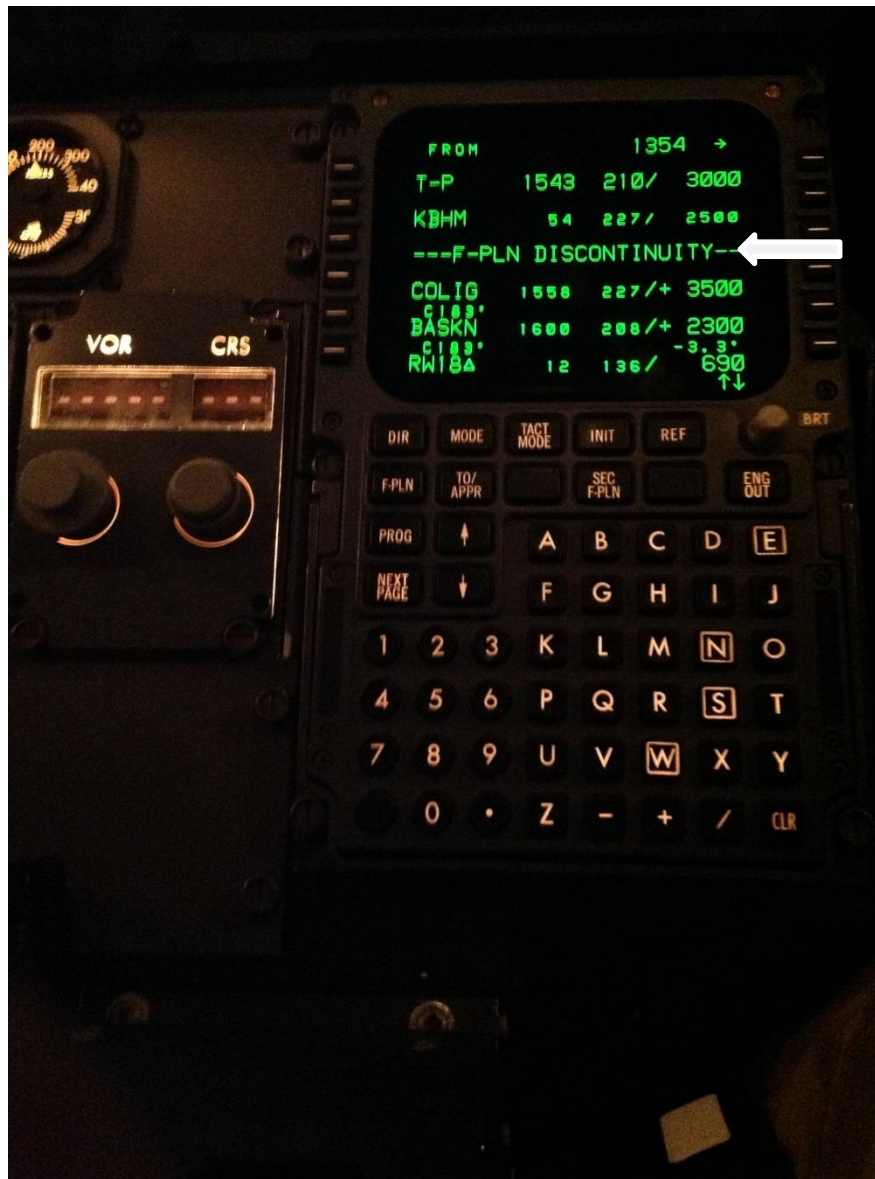
The NTSB conducted simulator testing in an A300 simulator at the UPS training facility on December 4, 2013. During the testing, NTSB investigators entered the accident airplane's decoded flight plan data and the BHM localizer 18 approach into the simulator FMC. The accident flight was simulated from 280 nm north of BHM to the point of impact. The flight plan was consistent with the flight crew navigating directly to KBHM. The localizer 18 approach did not have a feeder route from KBHM; the last waypoint in the active flight plan that the airplane flew while navigating directly to BHM was KBHM. As a result, a F-PLN DISCONTINUITY was created before the first waypoint (COLIG) of the approach and was visible on each of the simulators CDUs (see figure 16). The ND also showed the active routing (directly to KBHM) and the approach routing, as entered in the FMC, with the F-PLN DISCONTINUITY still in the active flight plan (see figure 17).

**Figure 16.** Photograph of the A300 simulator CDU showing the flight plan discontinuity message (indicated by white arrow).

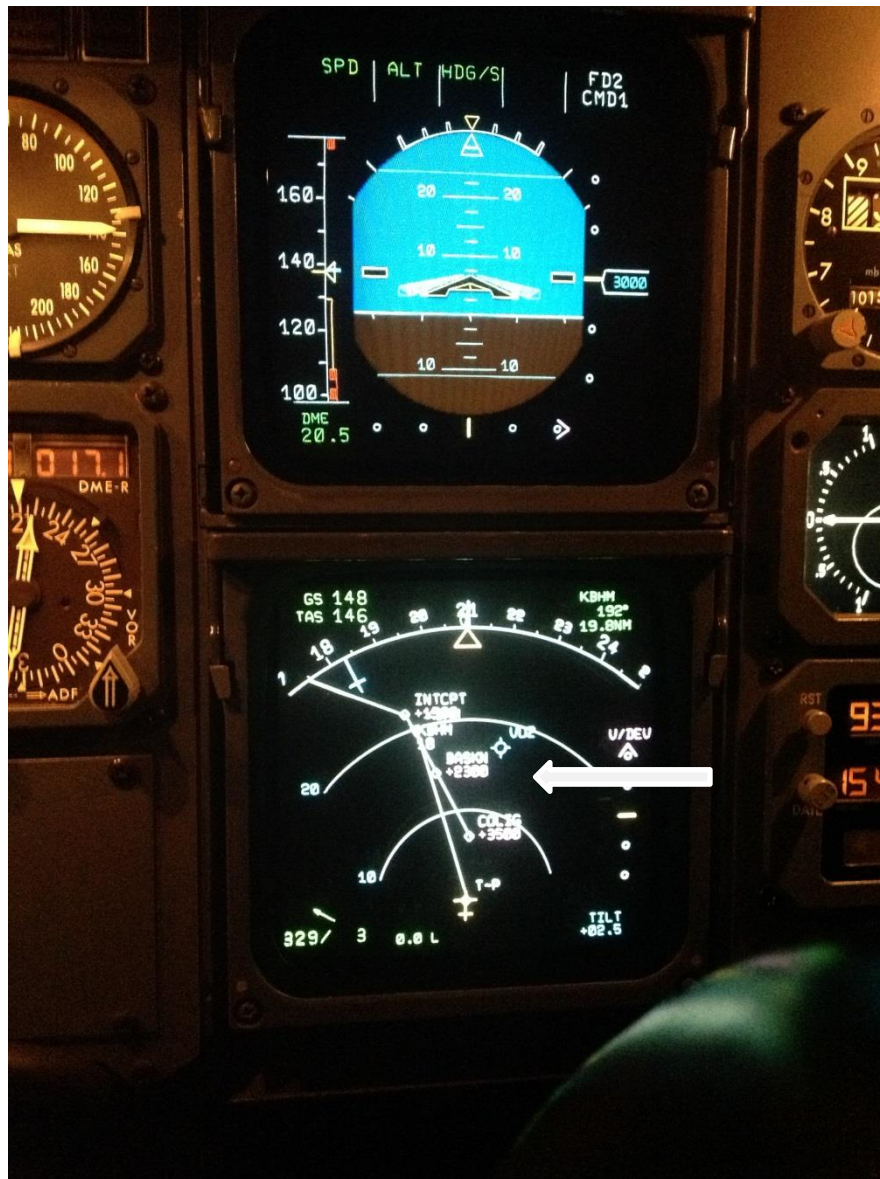
**Figure 17.** Photograph of the A300 simulator PFD and ND with the flight plan discontinuity (direct to KBHM) in the active flight plan indicated by white arrow.

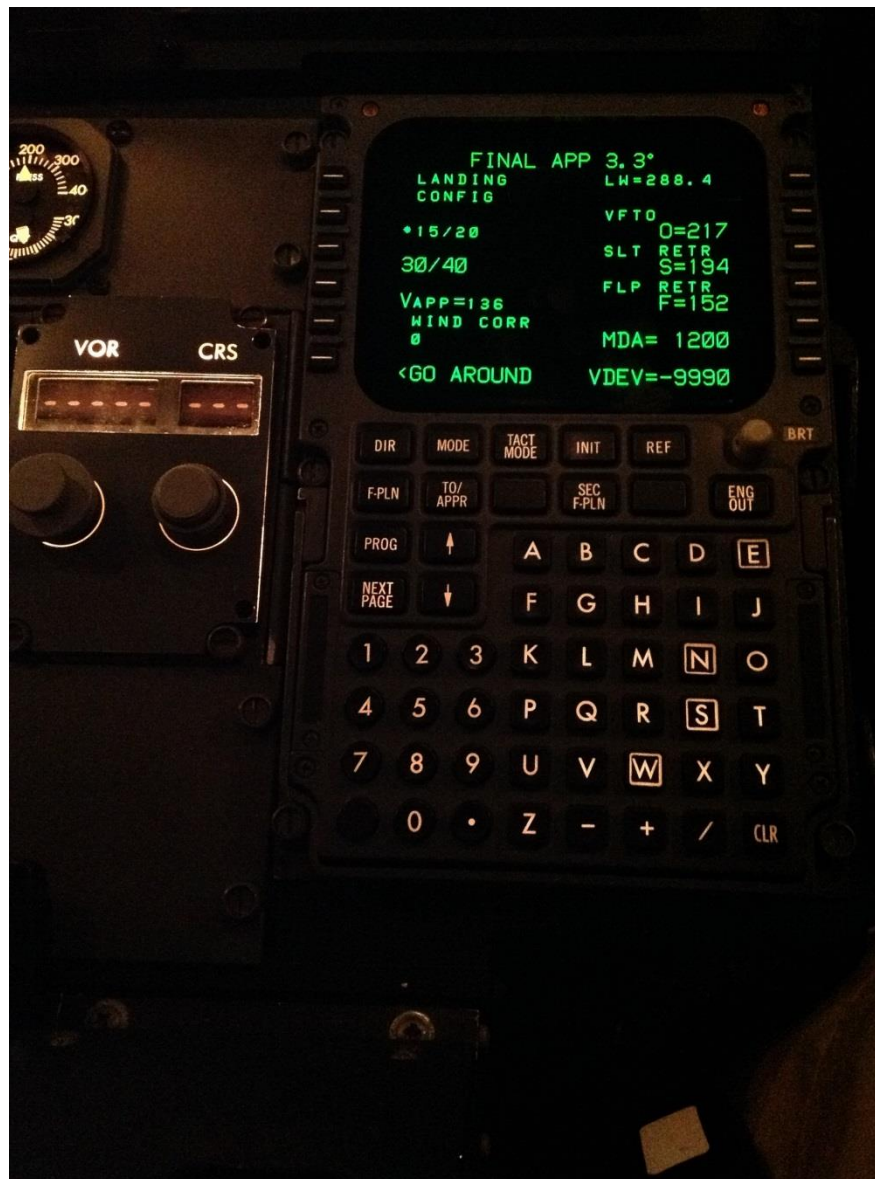
**Figure 18.** Photograph of the CDU FINAL APP page with the flight plan not verified.
