AVIATION INVESTIGATION REPORT

A12A0082

RUNWAY OVERRUN

VOLGA-DNEPR AIRLINES
ILYUSHIN IL-76TD-90VD, RA-76511
ST. JOHN'S, NEWFOUNDLAND AND LABRADOR
13 AUGUST 2012

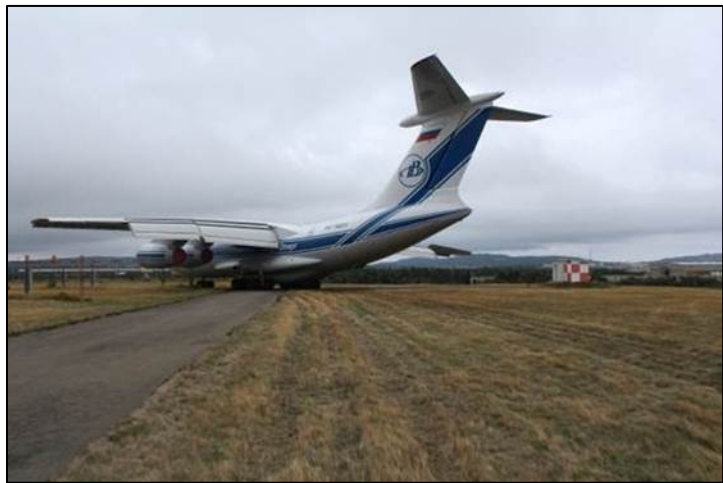
Just prior to departing the end of the runway, the crew manoeuvred the aircraft to the right of the centreline to avoid the multiple rows of approach lights. The aircraft damaged 5 runway threshold lights and came to rest on the Runway 11 localizer service road about 50 feet from the localizer antenna, on a heading of about 064°M (Photo 1).

Photo 1. Occurrence aircraft in overrun area

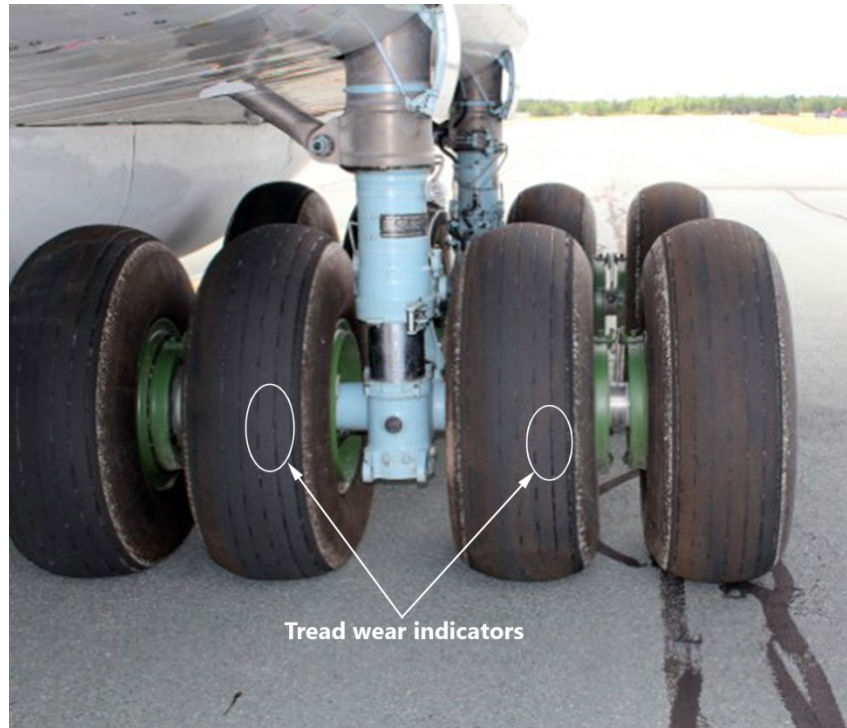
Prior to departing Prestwick Airport, Scotland, the condition of the tires was checked in accordance with the AMS requirement. No unacceptable damage was noted, and all of the tires were considered serviceable. Although the main wheel tires met the serviceability requirements, the Transportation Safety Board of Canada (TSB) noted that all 16 tires were worn to, or below, the tire tread wear indicators (Photo 2).

Photo 2. Right-side tires of the occurrence aircraft (after occurrence)

The tire/wheel positions are numbered from 1 to 8, from the left front row to the right front row, and 9 to 16, from the left rear row to the right rear row. A visual examination of the tires after the overrun identified signs of reverted rubber hydroplaning on 8 main tires: 2, 3, 5, 8, 10, 11, 14, and 15.

In this occurrence, all 16 of the main tires were worn in excess of 80%. Using tires that are more than 80% worn reduces wet runway traction, thereby increasing the risk of hydroplaning and possible runway overruns.
