Accident  
on 25 December 2003  
at Cotonou Cadjèhoun  
aerodrome (Benin)  
to the Boeing 727-223  
registered 3X-GDO  
operated by UTA  
(Union des Transports Africains)

**REPORT TRANSLATION**  
**3x-o031225a**

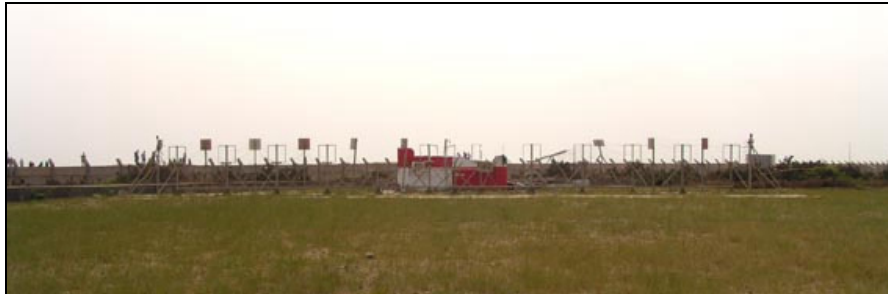
The airplane damaged the localizer antennas, which were about a hundred and fifteen meters from the end of the runway, then destroyed the reinforced concrete building housing the electronic equipment bays.

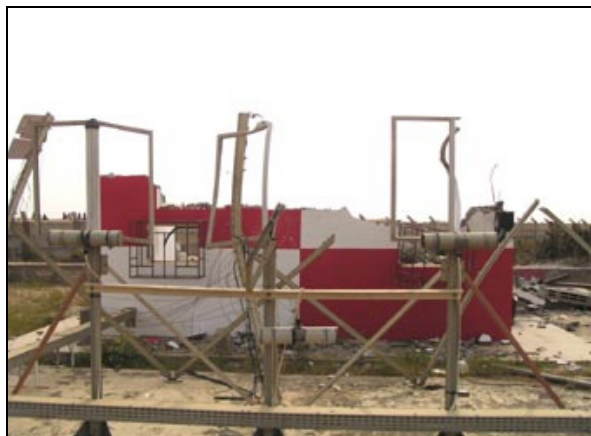
The photo below shows the north wall of the building with a black mark on the right side caused by the right inner tire. This mark was one meter twenty from the ground.

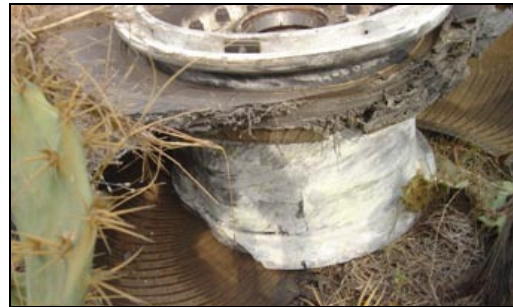
A part of the airplane's tail and some steps from the retractable ventral stairs were also found among the debris inside the building. The right main landing gear and its outer right wheel were found fifteen and eighteen meters southwest of the building respectively. The rims showed marks of the wheels' collision with the building.

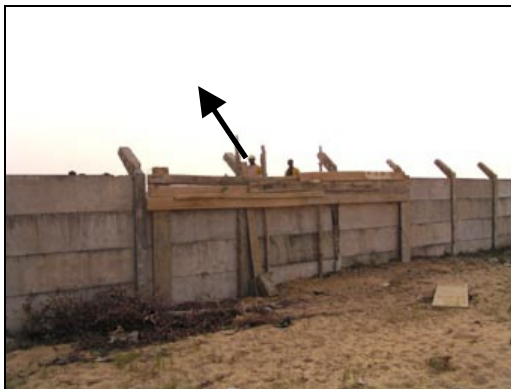
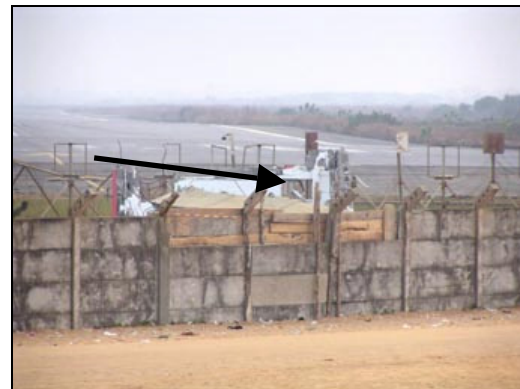
A part of the aerodrome boundary wall located on the runway extended centerline, at a distance of thirty-five meters from the localizer building, was damaged.

Some small debris from the lower part of the fuselage, a part of a flap and a landing gear door were also found near the damaged part of the wall.

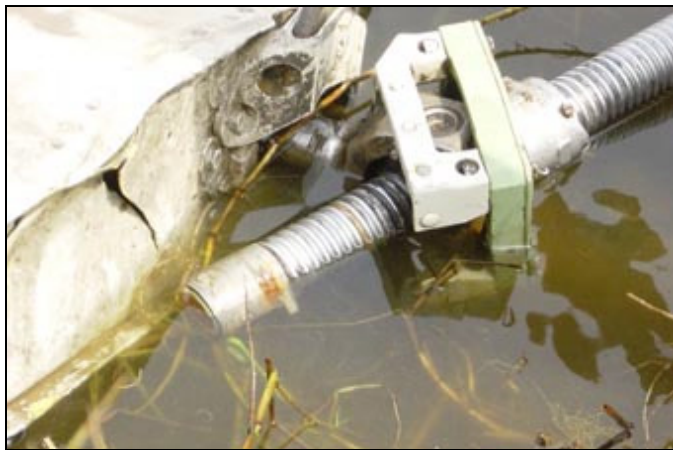
Beyond, near the opposite bank but in the water, a part of the right inner flap ②, with its screwjack and, a few meters away, a piece of the right wing with a part of the outer right aileron ③ were found.

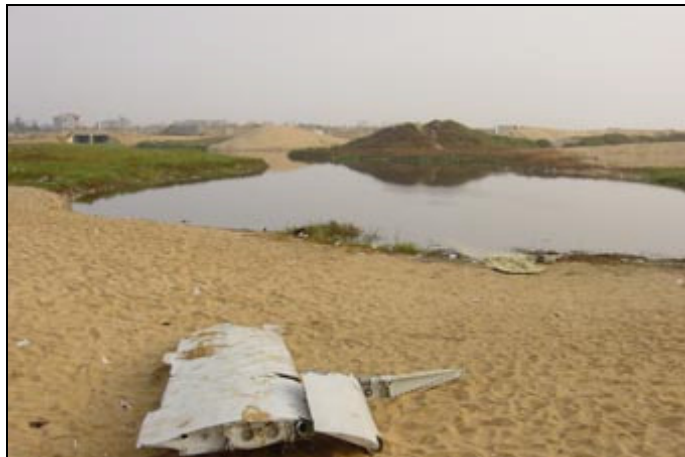
On the left bank of the canal, a part of the skin of the right wing ④ was found, then, five meters away, another part of the right wing with a leading edge slat ⑤.

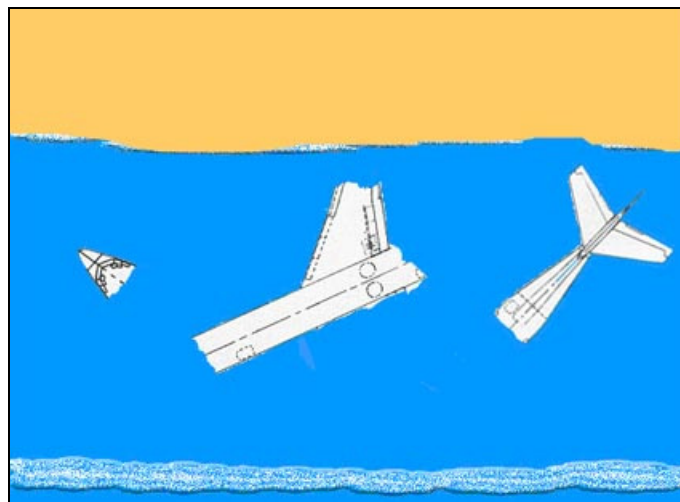
The main part of the airplane had turned over and only the lower part of the fuselage and the underside of the left wing were visible. Both of the outer engines had separated from the tail.

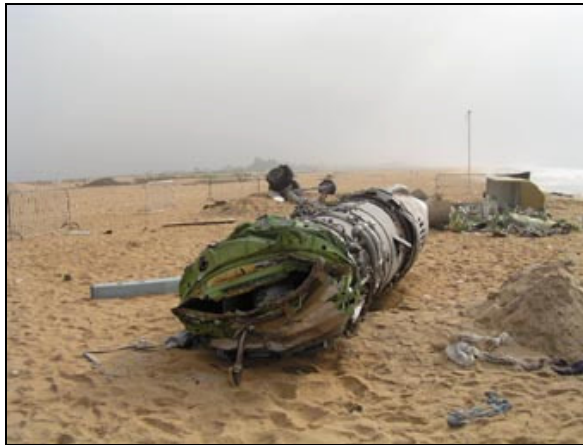
##### **Right engine**

The majority of engine 3 was intact. The thrust reverser was still attached to the engine, in the retracted position. No damage due to a fire or an uncontained burst was noted.

The visible part of the low pressure turbine did not show any signs of malfunction.

The nose cowl was crushed and twisted. The visible fan blades were intact, with the exception of a blade that had marks from an impact with a hard object on its leading edge. The visible main stage blades were severely damaged. One of them had broken off just above its base and the others were generally broken off about halfway up and bore impact marks on their leading edges.

Inside the engine, a part of the main stage was covered in sand in which blade fragments, a piece of honeycomb structure and a flattened oil tank were found.

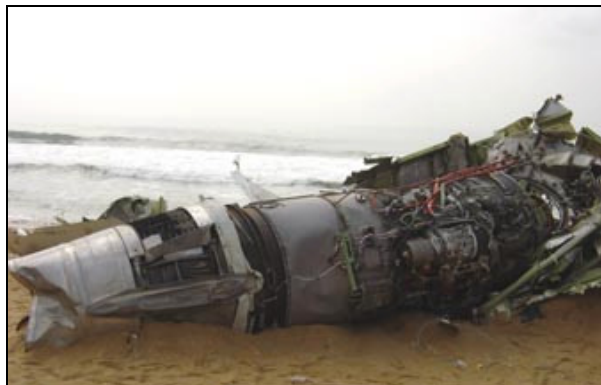
##### **Central engine**

The visible parts of engine 2 showed no signs of damage due to a fire or an uncontained burst. The nose cowl was missing. The thrust reverser, in the retracted position, and the exhaust section were intact. The last stage low pressure turbine blades were intact, which indicated that the turbine assembly was intact. The nose dome was slightly dented and pushed in. The compressor blades were not all visible due to the damage to the air intake channel, and the visible main stage blades were relatively lightly damaged.

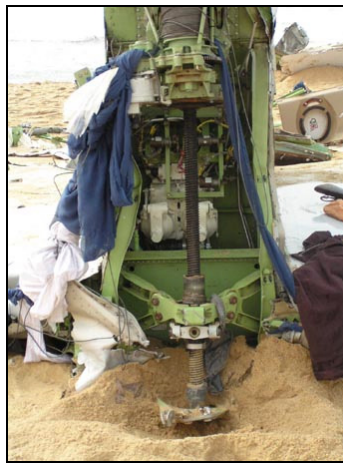
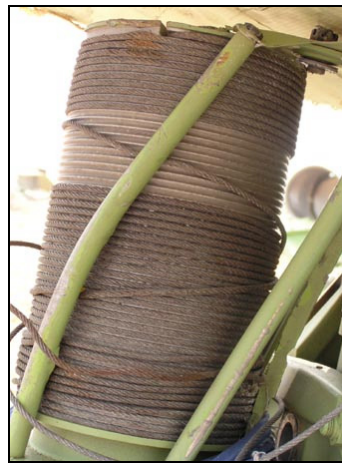
## **Tail**

During recovery operations, the tail broke in two, the rudder and the central engine in one part and the stabilizer and the elevator in the other. The stabilizer jackscrew was intact; its drive cables were broken.

The position of the jackscrew did not make it possible to validate the position of the stabilizer, the cause and the sequence of the cable ruptures being undetermined.

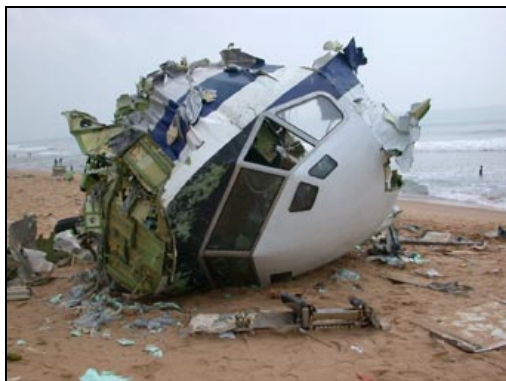
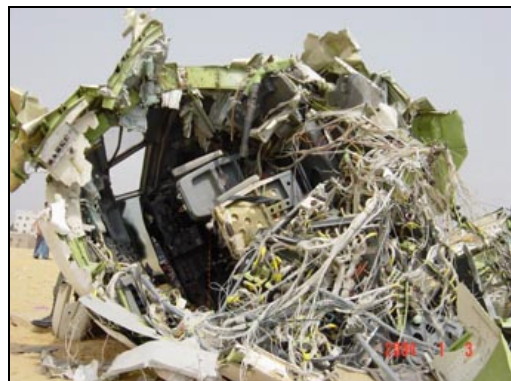
## **Cockpit**

The cockpit was not very damaged, except for the Flight engineer's panel and a large part of the equipment. There was a strong compression mark on the floor and the skin of the partition and the outer right side of the fuselage. The nose gear had been ripped off.
