**Air Accidents Investigation Branch**

**Report on the serious incident to  
Airbus A319-131, G-EUOB  
during the climb after departure  
from London Heathrow Airport  
on 22 October 2005**

I have the honour to submit the report by Mr A P Simmons, an Inspector of Air Accidents, on the circumstances of the serious incident to Airbus A319-131, registration G-EUOB during the climb after departure from London Heathrow Airport on 22 October 2005.

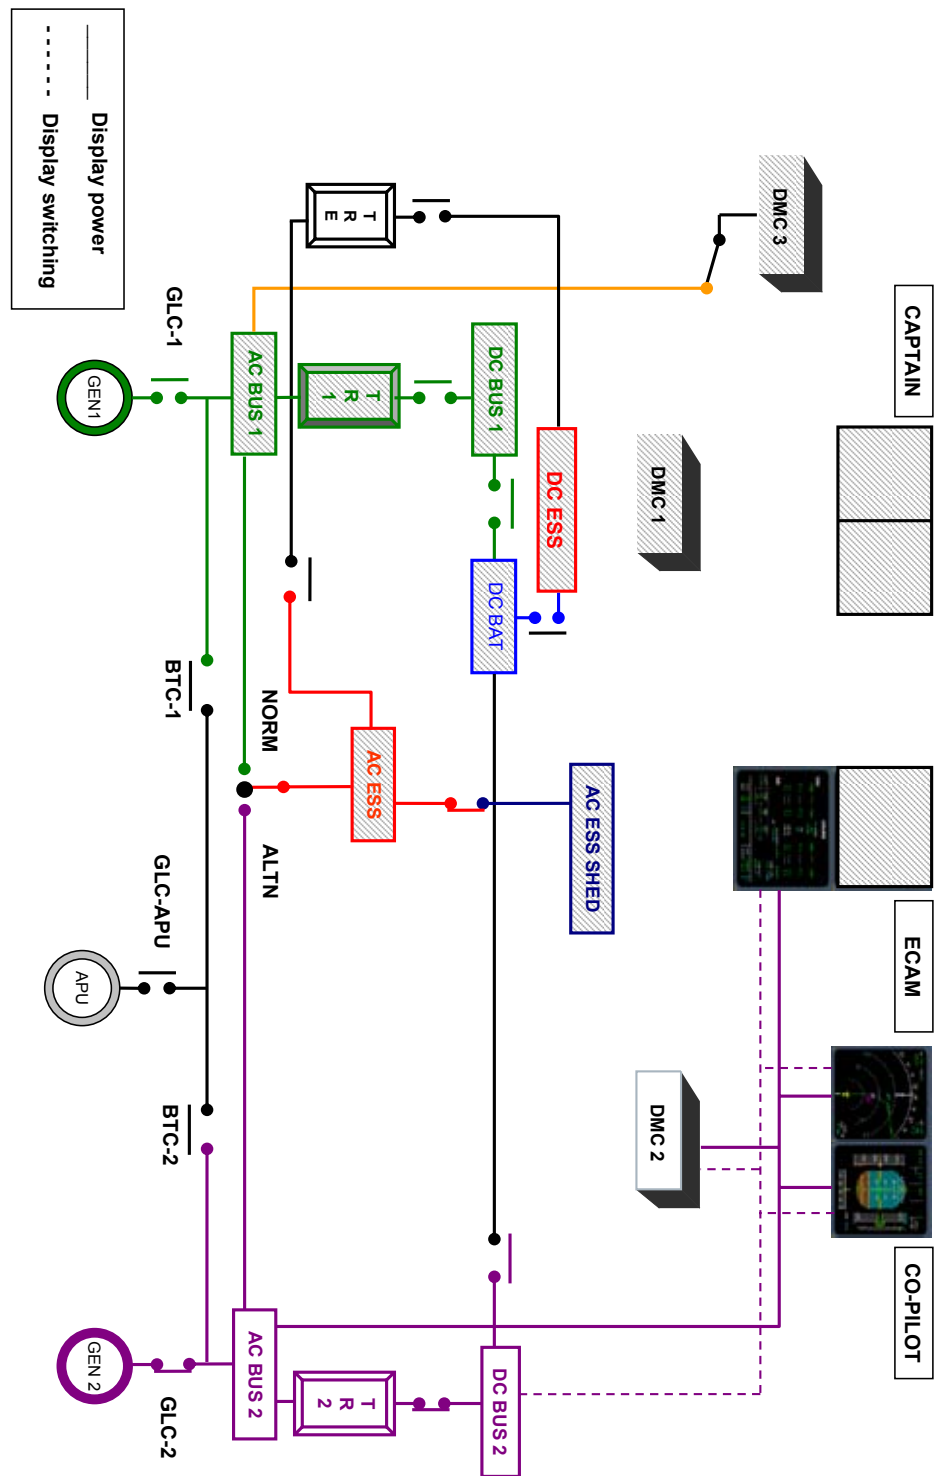
**Figure 6**  
EIS Effects following AC BUS 1 Failure

The normal EIS power supply configuration is shown in Figure 5. The expected effect on the EIS displays due to an AC BUS 1 failure is shown in Figure 6. Figure 7 shows the EIS power supply configuration after selection of the AC ESS FEED switch to 'ALTN'.

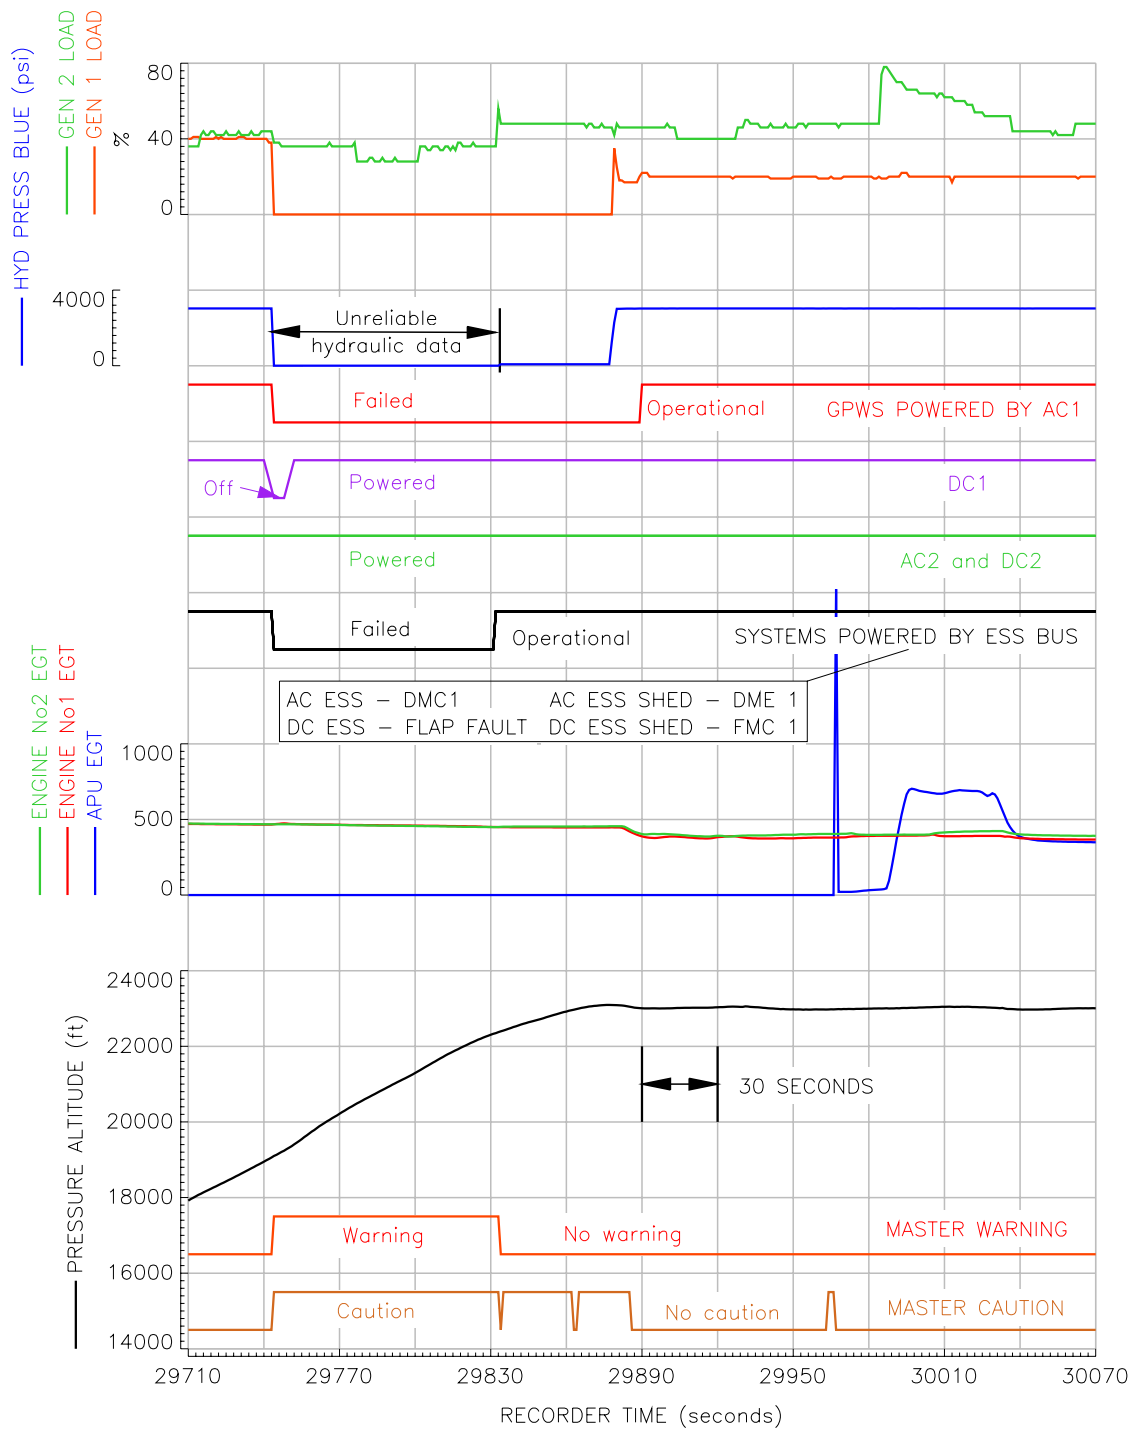
**Figure 9**

The loss of Enhanced Ground Proximity Warning System (EGPWS) data, amongst others, indicates a loss of power to the AC BUS 1. The continued operation of the DAR shows that AC BUS 2 remained powered. The AC ESS SHED bus was reliably recorded as failed. The AC ESS bus parameter showed one sample of definite loss of power before becoming an unreliable parameter, however, parameter failures of systems powered by AC ESS point to the loss of this bus for the same period as the AC ESS SHED bus. Other parameters directly relating to power proved unreliable during this period.

The DC BUS 1 showed a temporary failure for between 4 and 12 seconds (this parameter is sampled every four seconds). The continued good FMC2 and accelerometer data indicate that DC BUS 2 remained healthy throughout. Loss of FMC1 data points to the loss of power on the DC ESS SHED bus. Flap parameters reported by the Slat Flap Control Computer (SFCC) 1 became invalid indicating that the DC ESS bus lost power.

DAR derived data showing the power available on the aircraft.  
Note: the yellow and green hydraulic systems were unaffected.

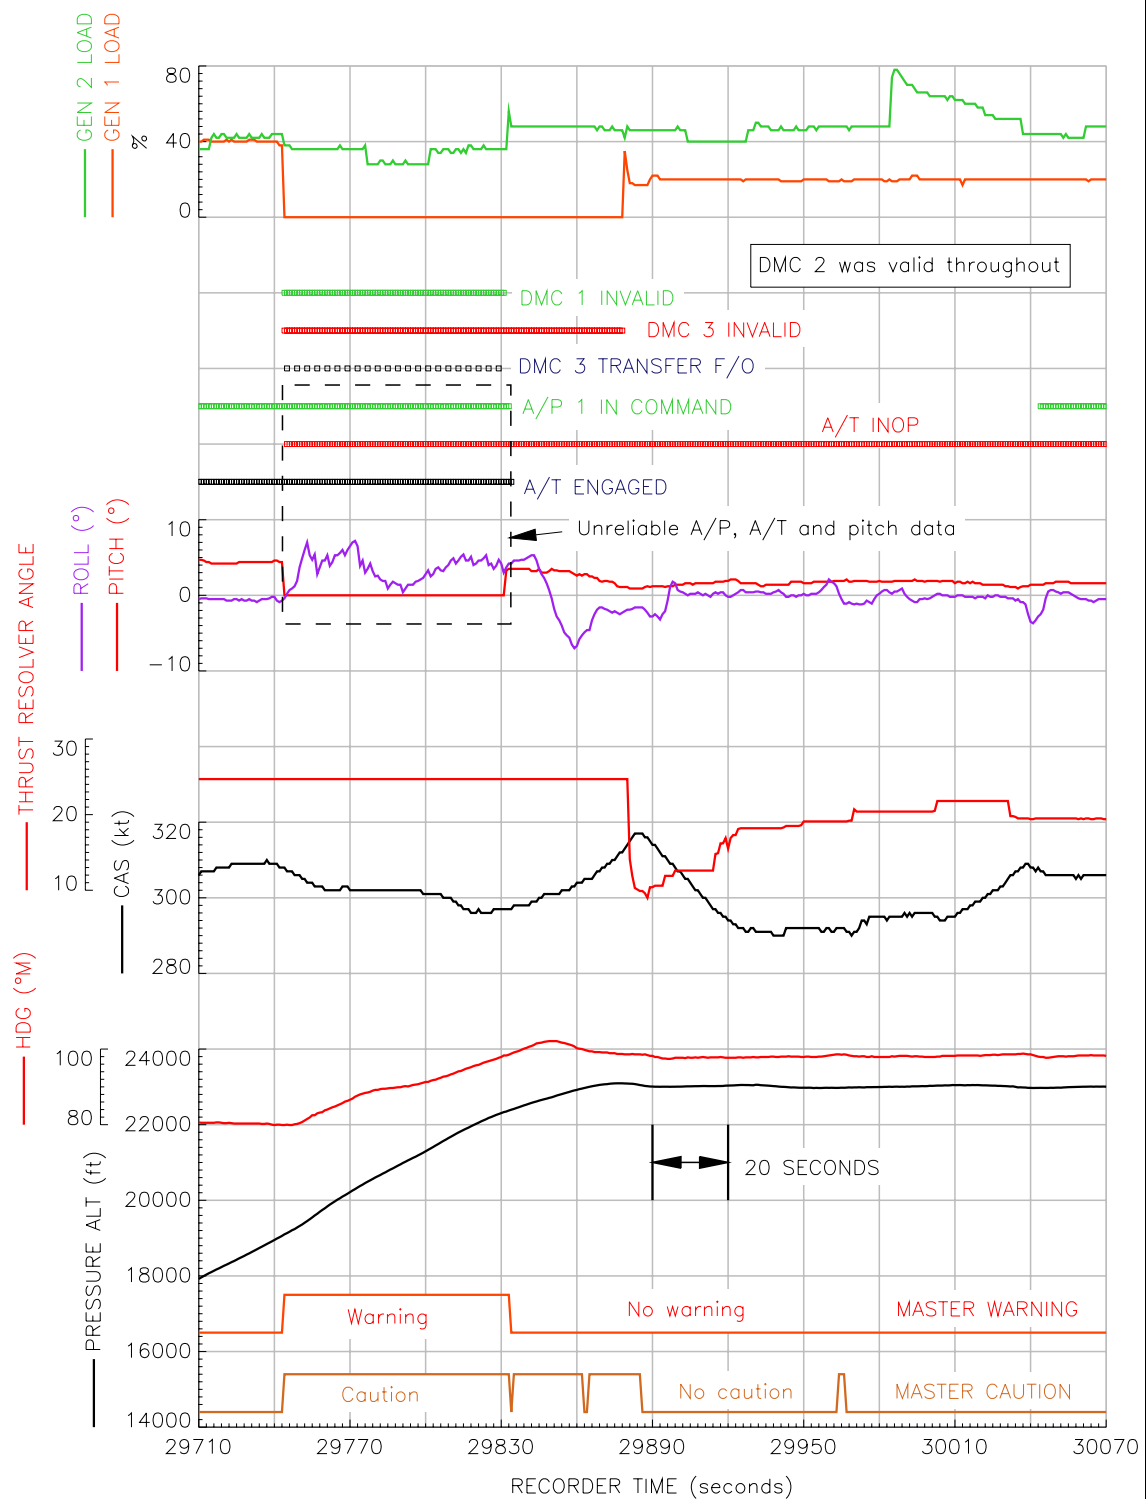
**Figure 10**

DAR derived data showing the parameters relating to the control of the aircraft.
