# AIRCRAFT ACCIDENT INVESTIGATION REPORT

ALL NIPPON AIRWAYS FLIGHT 391  
AIRBUS A321 - 131, JA104A  
HAKODATE AIRPORT, HOKKAIDO, JAPAN  
JANUARY 21, 2002

September 26, 2003

Aircraft and Railway Accidents Investigation Commission  
Ministry of Land, Infrastructure and Transport

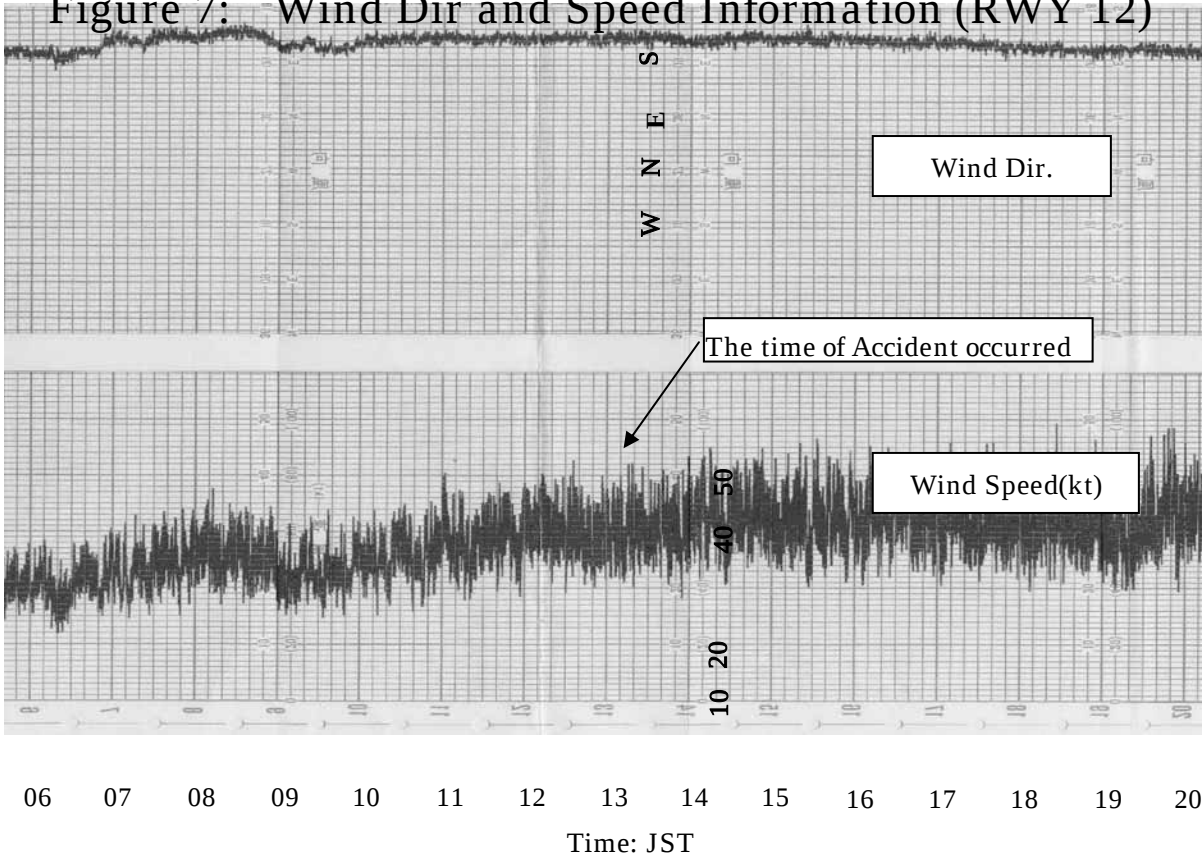
Figure 7: Wind Dir and Speed Information (RWY 12)

According to the wind condition chart shown in Figure 7, it is considered that this gusty strong wind condition was continued until evening of the day of the accident occurred.

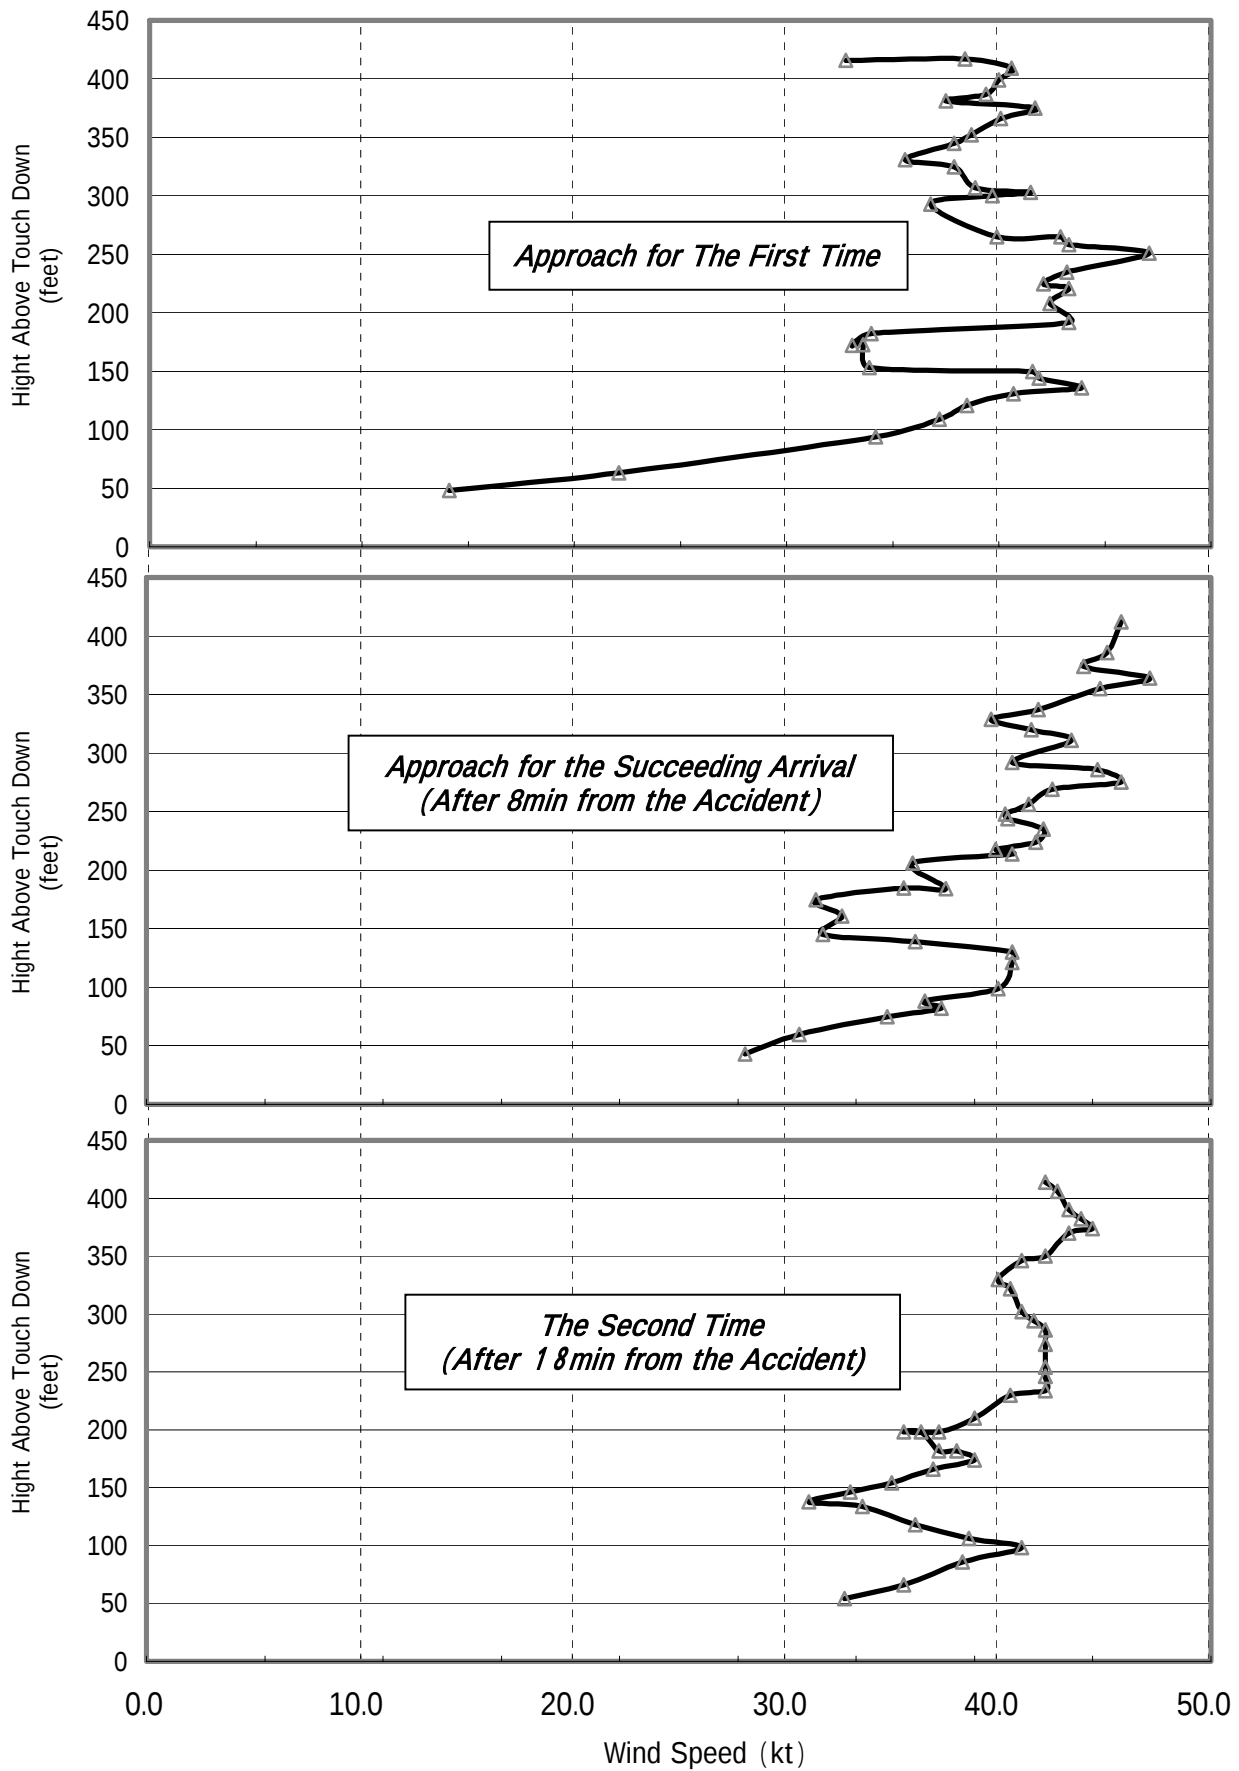
Figure-9 Wind Speed on the Final Approach

Judging from the near-ground wind speed measurements along the approach course to Hakodate Airport recorded between the approach on which the wind shear encounter occurred and the second approach of the same aircraft, shown in Figure 9, regarding wind conditions that would cause an aircraft to abruptly descend and trigger a wind shear warning, it is considered that there was localized air mass with a wind speed 10kt greater than the surroundings from 250–100ft above ground level, and below 100ft AGL there was a wind shear with a marked decrease in wind speed with decreasing altitude. It is considered possible that wind conditions like these arose due to a combination the strength and direction of a wind passing over the terrain in the vicinity of the airport at the time affecting the surface boundary layer that was developing along ground surfaces.

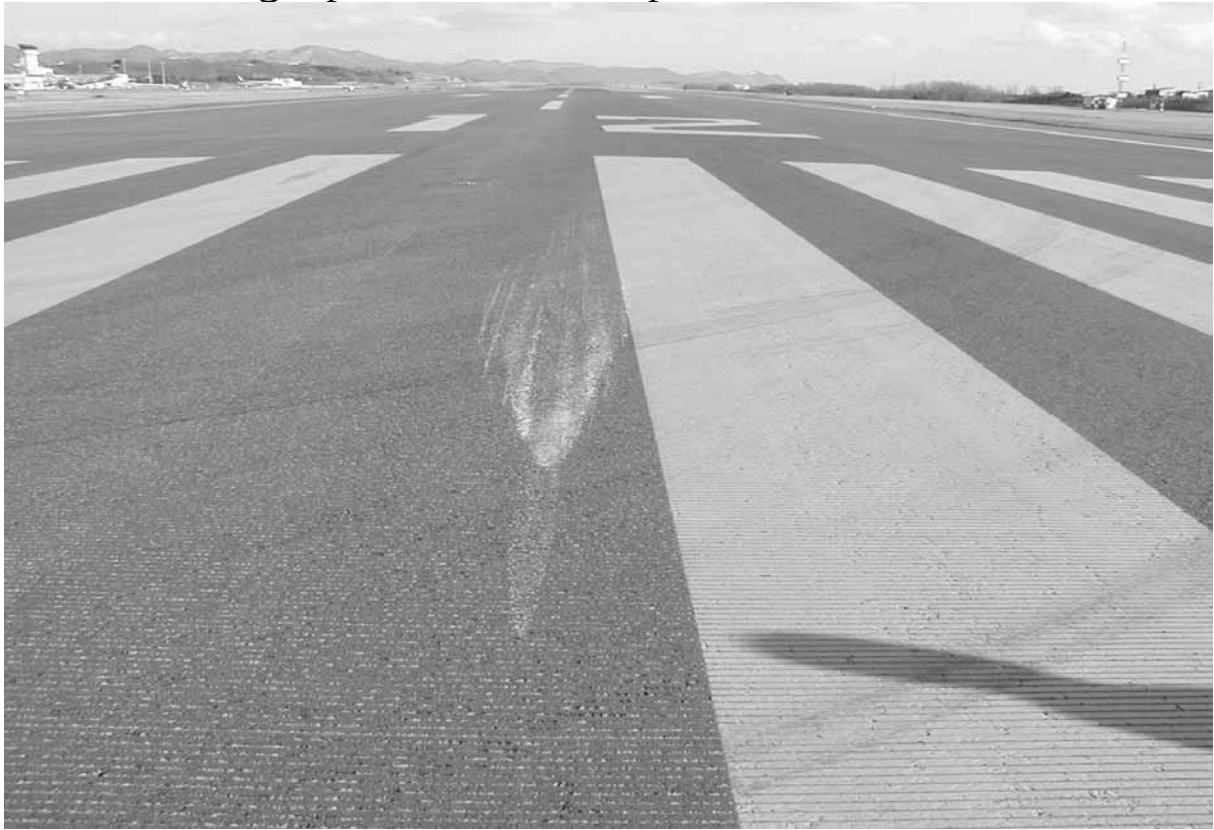
Markings with a width of approximately 80cm were found on the runway at Hakodate Airport, thought to have been left by the contact of the lower surface of the aft fuselage of the accident aircraft. These started at a point 14.0m along runway 12 from approach end threshold, continued along the runway for a length of 15.9m from the approach threshold. However, there was no damage to the runway.

Photograph-2: The scrape marks on RWY 12

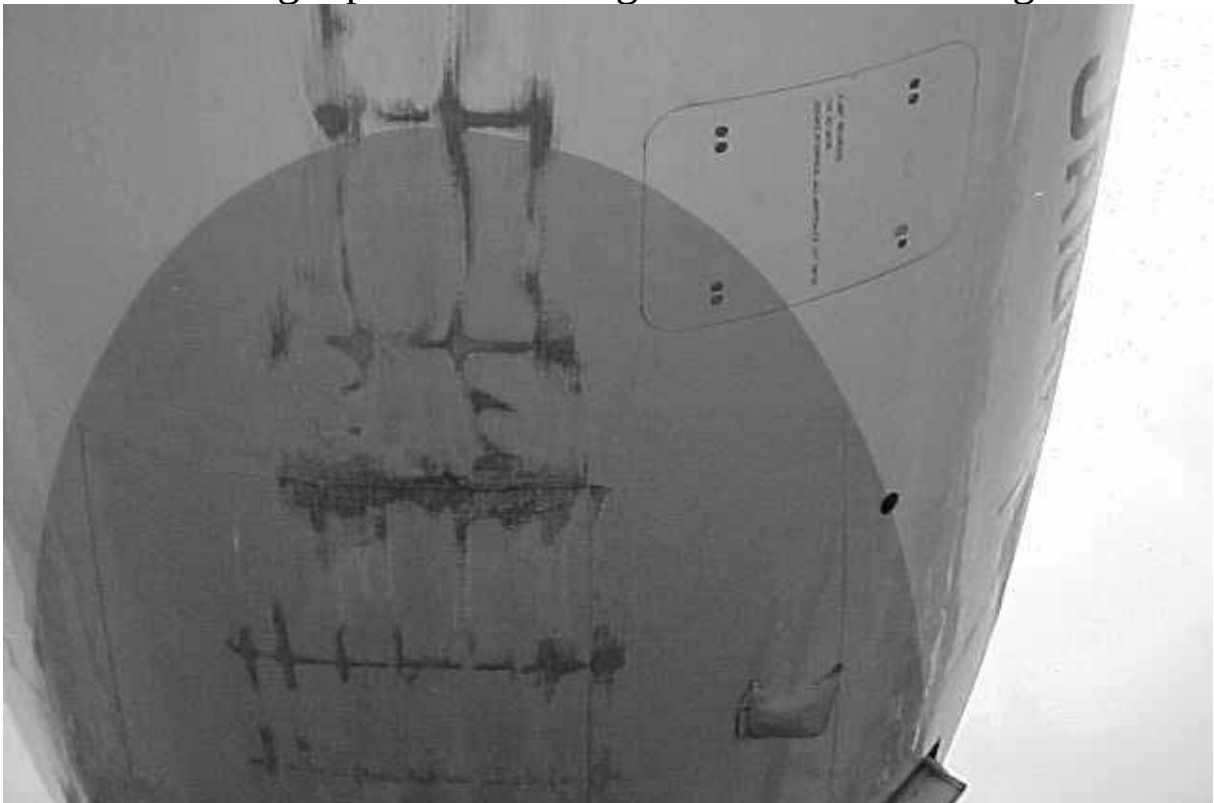
There was deformation of the ten frames (#63-#72) associated with the skin panels on which abrasions were found, and seven of these (#63, #65-#70) were found to have cracks. Four stringers that cross the cracked frames (stringer #: S41R-S39L) were also deformed.

Photograph-3: Damage of the Aft Fuselage

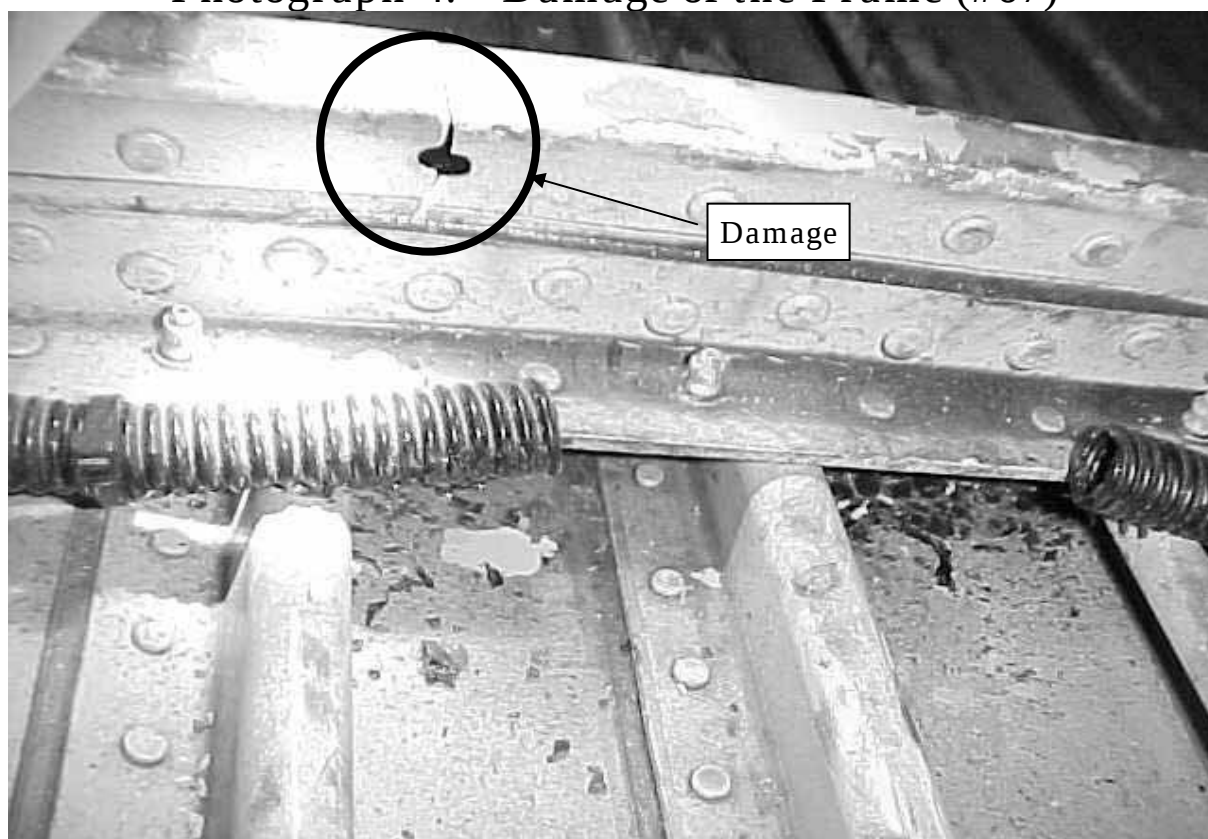
Photograph-4: Damage of the Frame (#67)

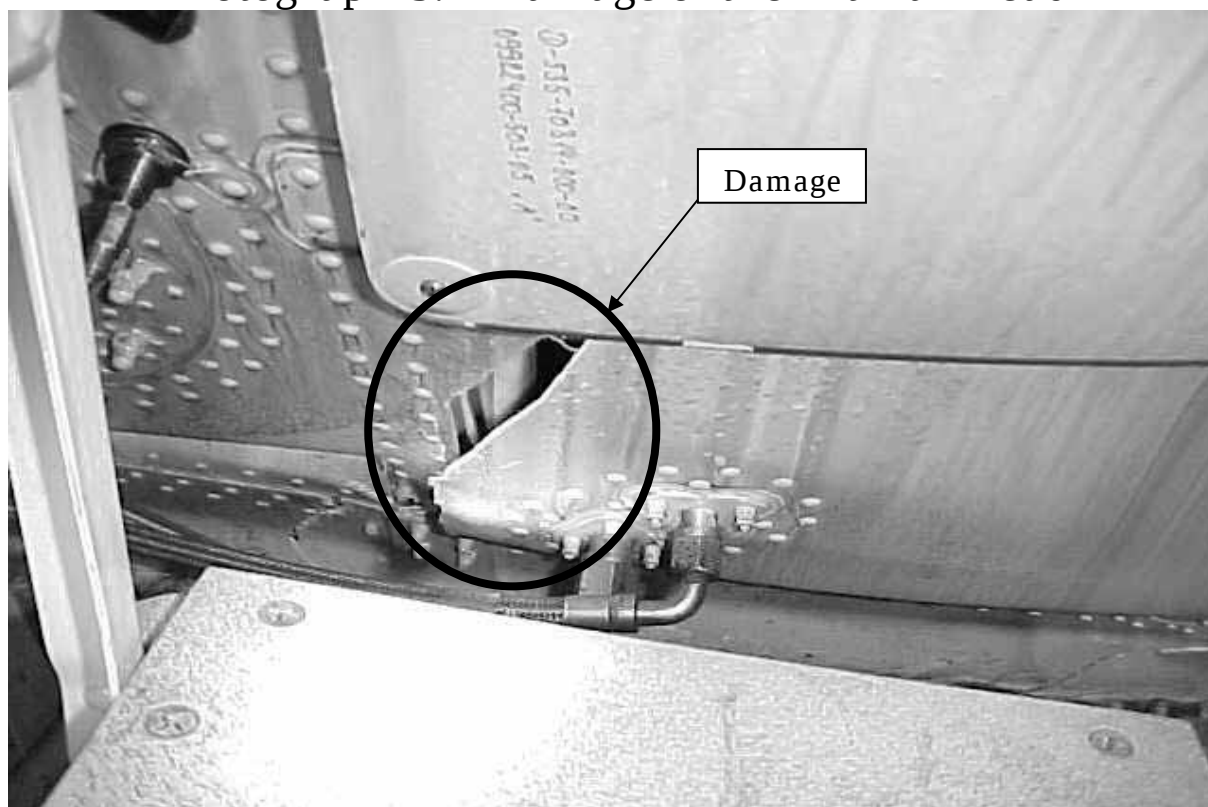
Cracks were found in two locations on the lower part of the aft pressure bulkhead.

Photograph-5: Damage of the Aft Bulkhead
