AIRCRAFT ACCIDENT REPORT

MD-11F, Registration [REDACTED]
King Khalid International Airport – Riyadh
Kingdom of Saudi Arabia

Abnormal Runway Contact (ARC)

15 Sha'aban 1431 H – 27 July 2010 G

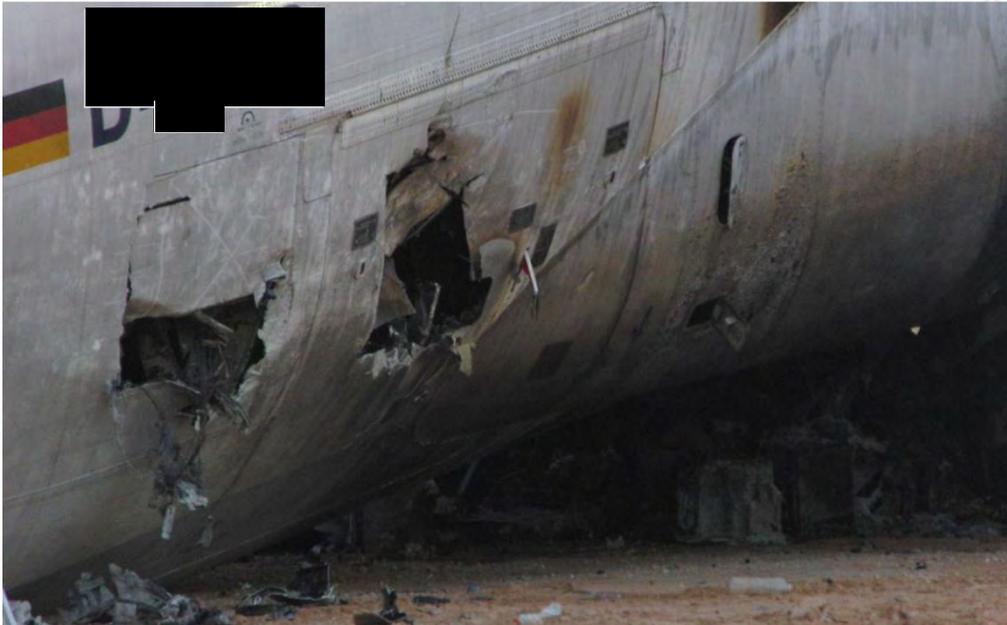
Figure 2: Access to the Flight Recorders

The Cockpit Voice Recorder (CVR) and the Digital Flight Data Recorder (DFDR) were located just aft of the lower center cargo door at Fuselage Station (FS 1801). Since this cargo door could not be opened to access the recorders and a lot of debris from the fire fell in this area, the firefighters used high powered metal cutting saws to cut through both the lower center cargo door and the fuselage aft of this cargo door (Figure 2). Both flight recorders were recovered.

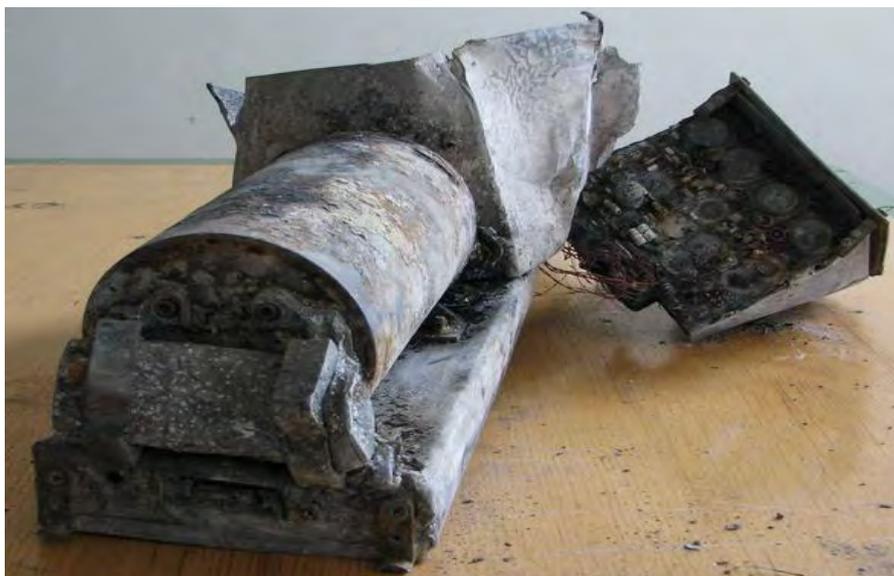
Figure 3: DFDR Unit

The recorder chassis and the Underwater Locator Beacon (ULB) had been destroyed by the fire. The Crash Survival Memory Unit (CSMU) showed minor mechanical damage with strong influence of fire on the painting and on the surface (Figure 3).

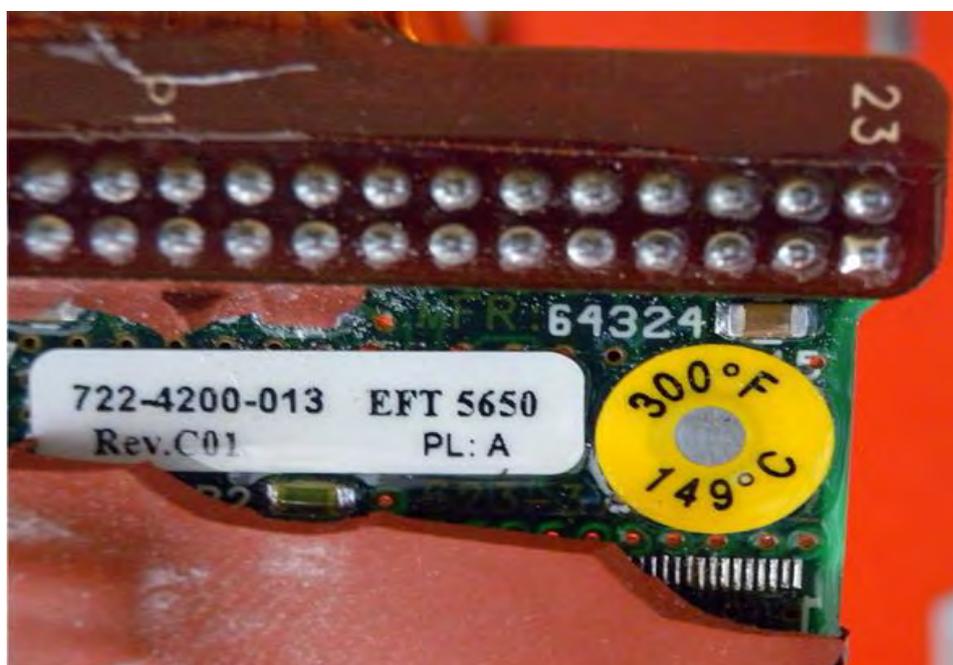
Figure 4: DFDR Memory Board

The memory board showed no damage and its temperature indicator was of a grey color indicating some heat exposure, but not critical (Figure 4).

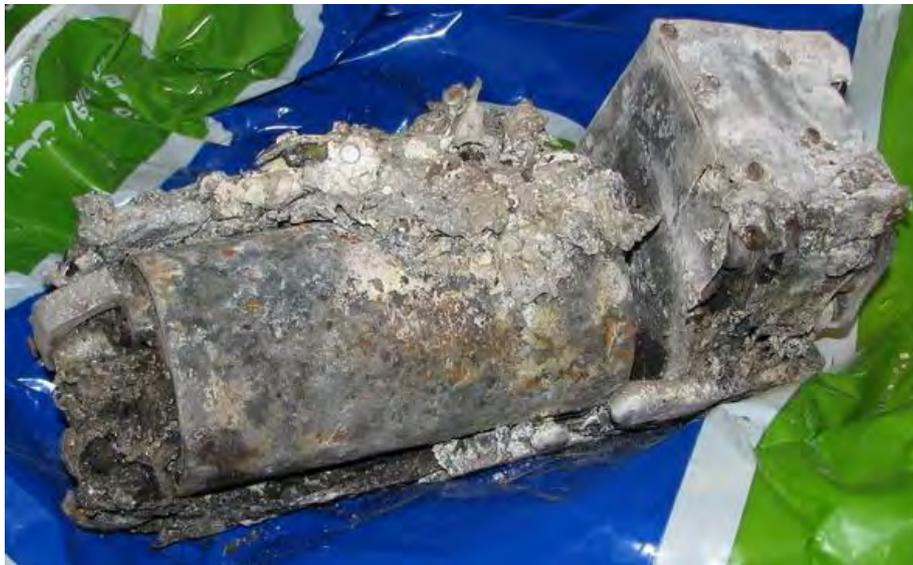
Figure 5: CVR Unit

The recorder chassis and the ULB had been destroyed by fire. The CSMU showed minor mechanical damage, strong influence of fire on the painting and on the surface and, attached molten material of unknown origin (Figure 5).

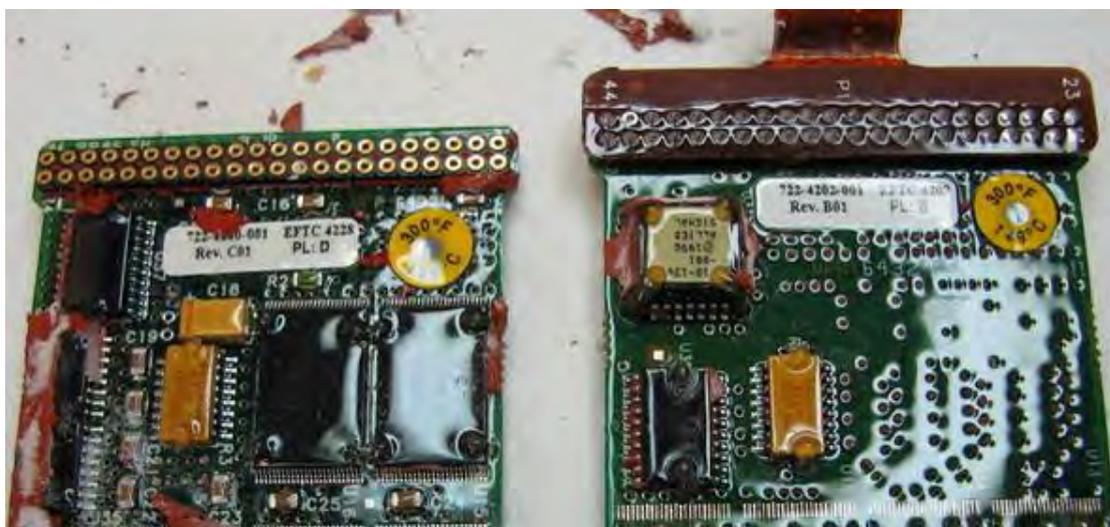
Figure 6: CVR Memory Board

The memory board showed no damage and its temperature indicator was of a grey color indicating some heat exposure, but not critical (Figure 6).

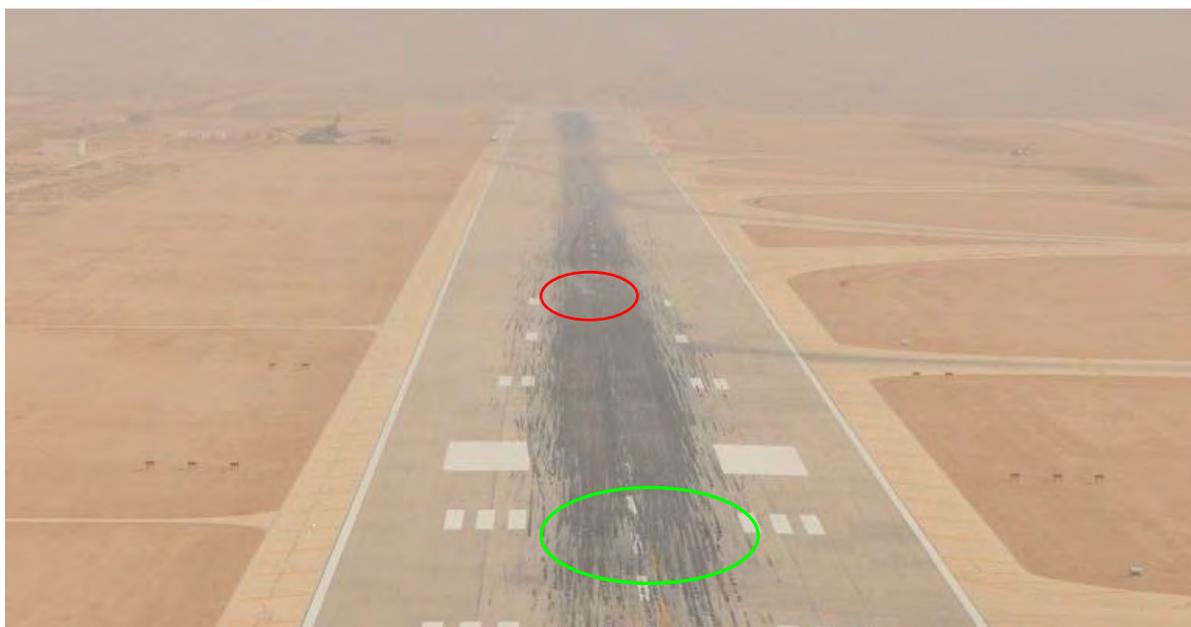
Figure 7: General View of Wreckage Trail

The aircraft landed on Runway 33L at the 945 foot runway mark (green circle). The aircraft bounced following the first touchdown, touched down a second time and bounced a second time. A third and final touchdown at the 3200 foot runway mark (red circle) resulted in the aft section of the fuselage to rupture just aft of the wing. The aircraft continued down the runway with the tail dragging until it departed the left side of the runway at the 7400 foot runway mark, where the nose gear collapsed. After departing the runway, the aircraft traveled through a gravel area before it came to rest at the 8800 foot runway mark on a heading of 310°, 300 ft left of runway 33L centerline, across from taxiway exit A5 (Figures 7 and 8 and, Figure 3 of Appendix C). A fire started after the rupture of the aft fuselage.

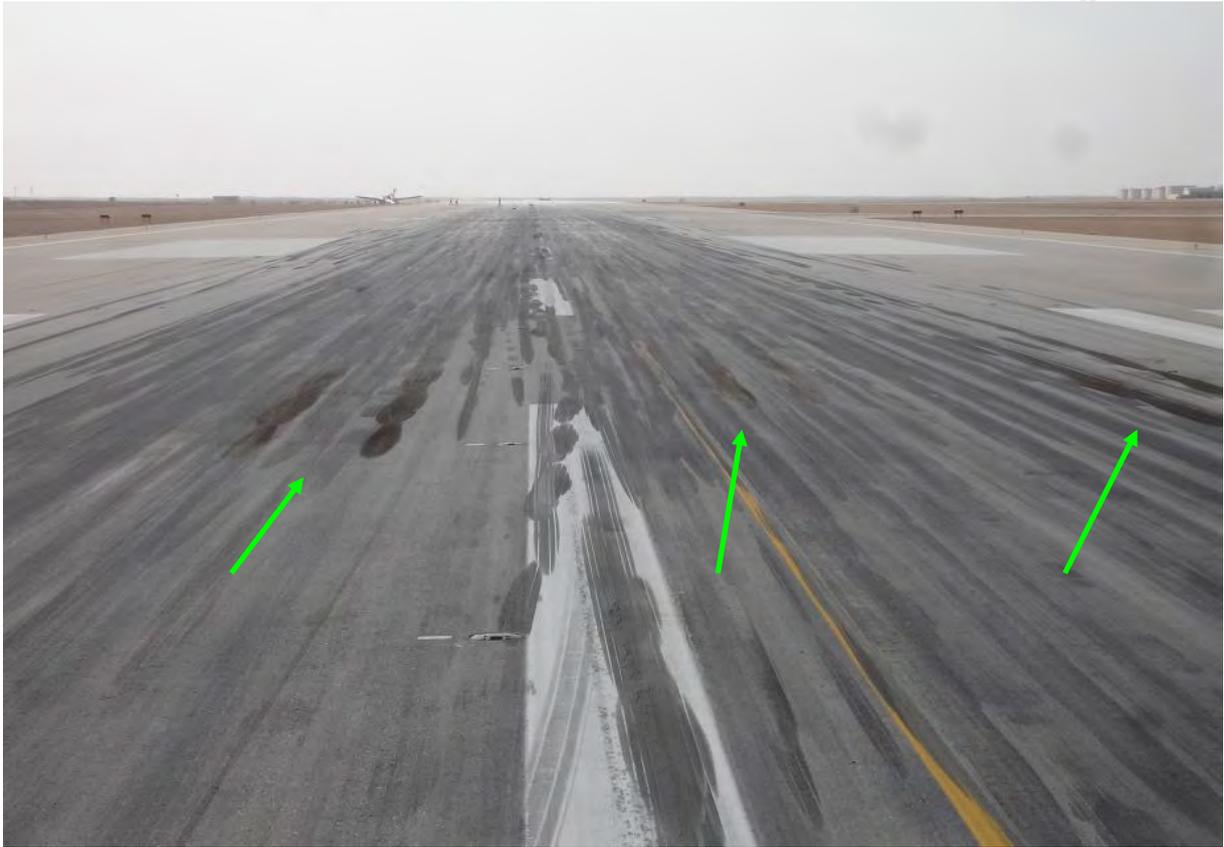
Figure 9: First Touchdown

- Six parallel stripes of rubber residue were found 945 ft from the runway threshold indicating that the aircraft touched down with the two main landing gears and the centre landing gear. (Figure 7 - green circle and Figure 9 – green arrows);

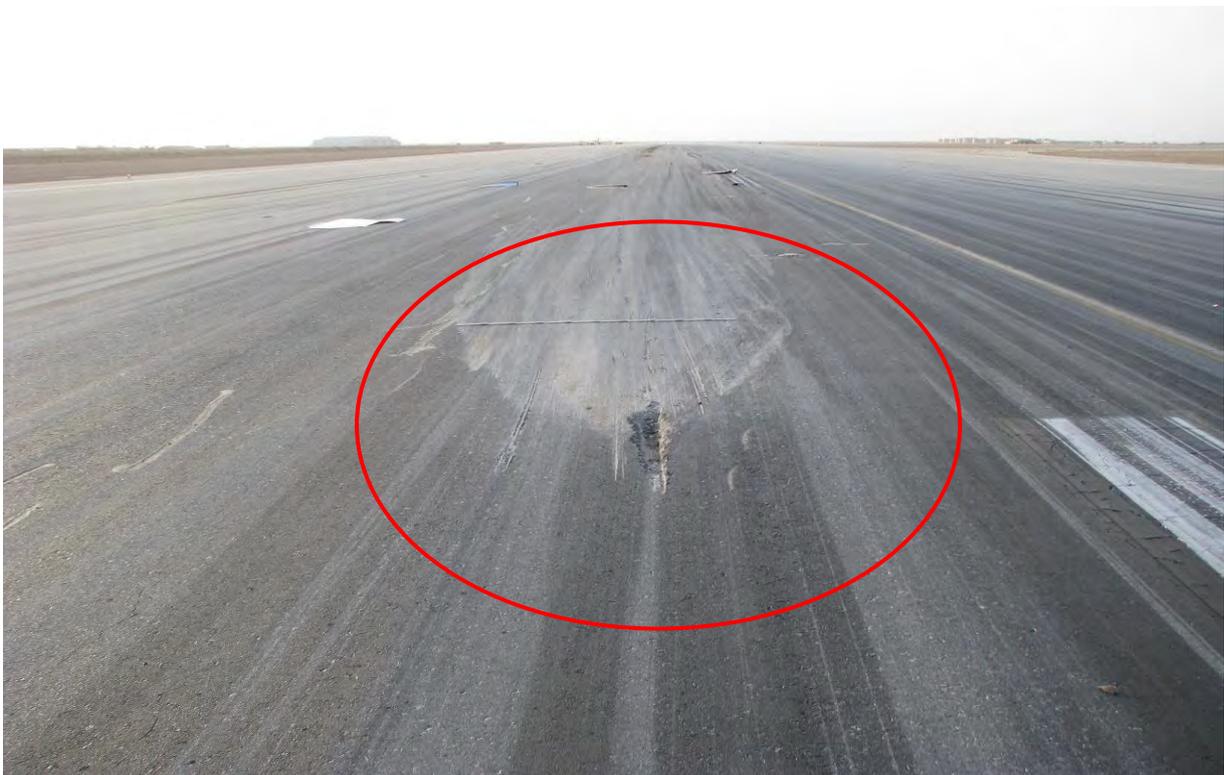
Figure 10: Tail Impact following Rupture of Fuselage

The runway scars and the condition of the wreckage indicated that after the last touchdown, the rear section of the fuselage behind the wing ruptured and collapsed, folding towards the runway about a “hinge” on the bottom of the fuselage in the area of the rupture.

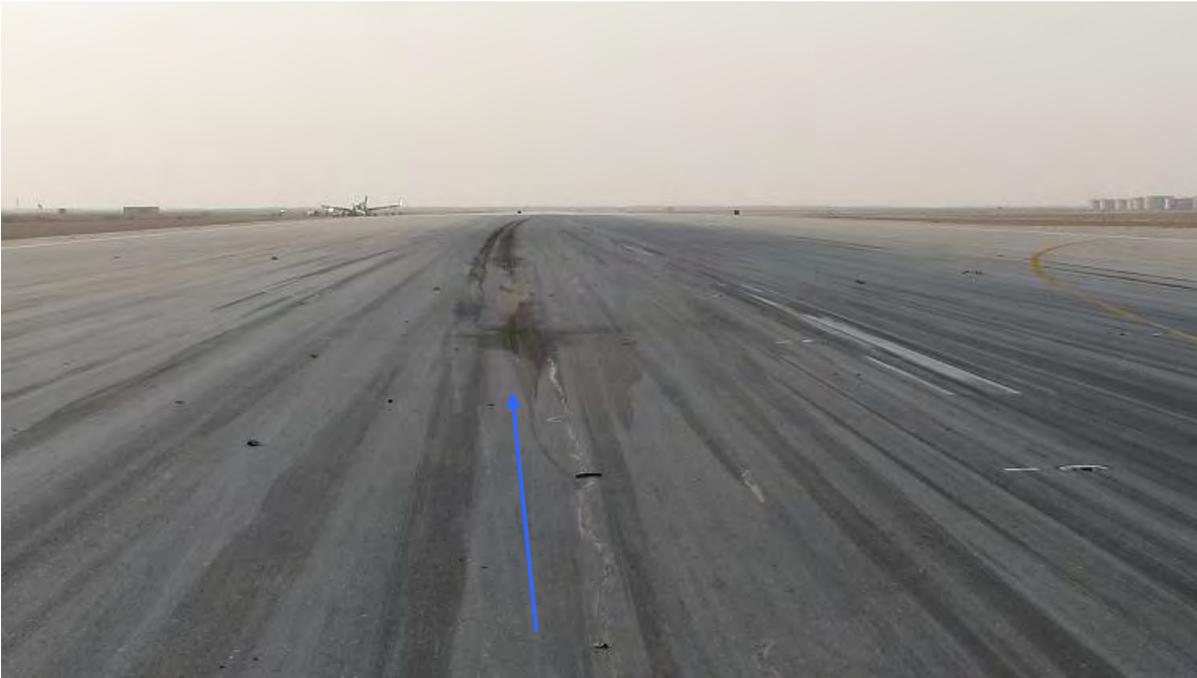
Figure 11: Centre Gear

- Starting at a point 3,500 ft from the threshold and slightly left of the runway centreline, two parallel stripes of rubber residue were found. The lateral distance of the stripes indicated that the traces came from the centre landing gear. (Figure 11 - blue arrow);

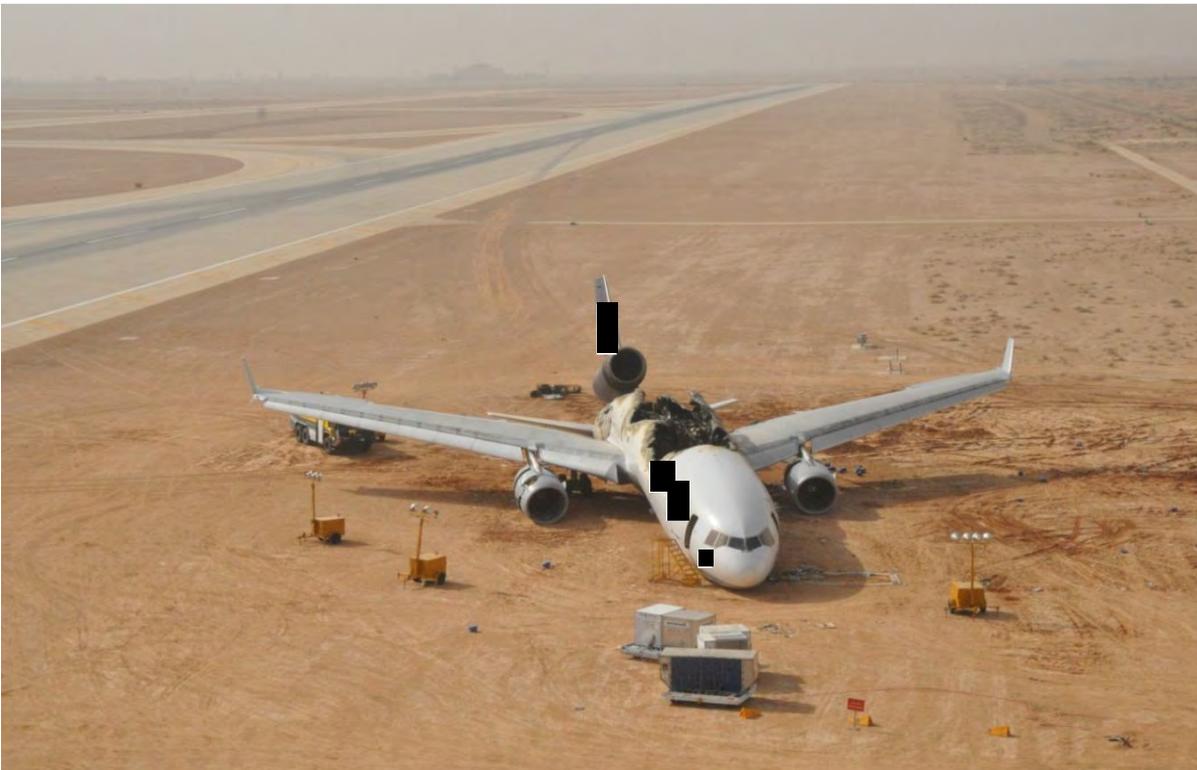
Figure 12: Main Wreckage

- Trace of the aircraft (off the runway). This trace leads directly to the main wreckage (Figure 12); and
- Main wreckage located 8800 ft from the threshold and 300 ft to the left of the runway centreline (Figure 12).

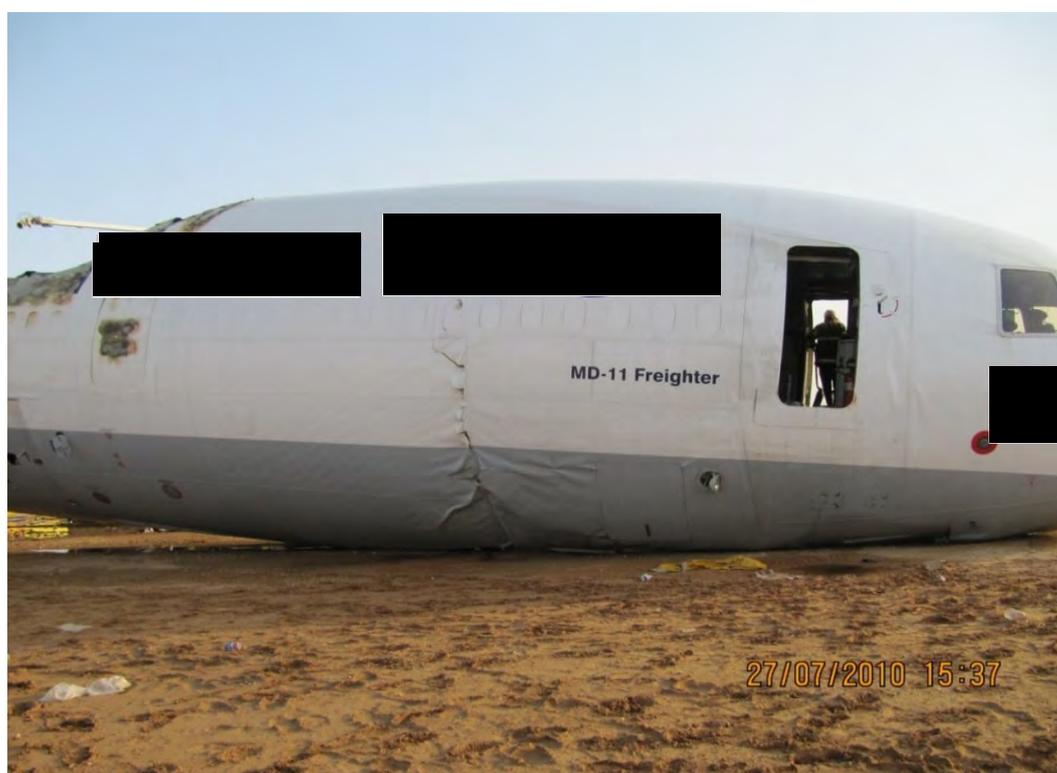
Figure 13: Buckling of Right Forward Fuselage

There was fuselage buckling at FS 595 on the right side of the fuselage from the windows down. This buckling was severe and included skin tears and deformation. Less severe skin buckling was noted at various locations on the lower half of the fuselage from FS 595 forward to approximately FS 410 (Figure 13).

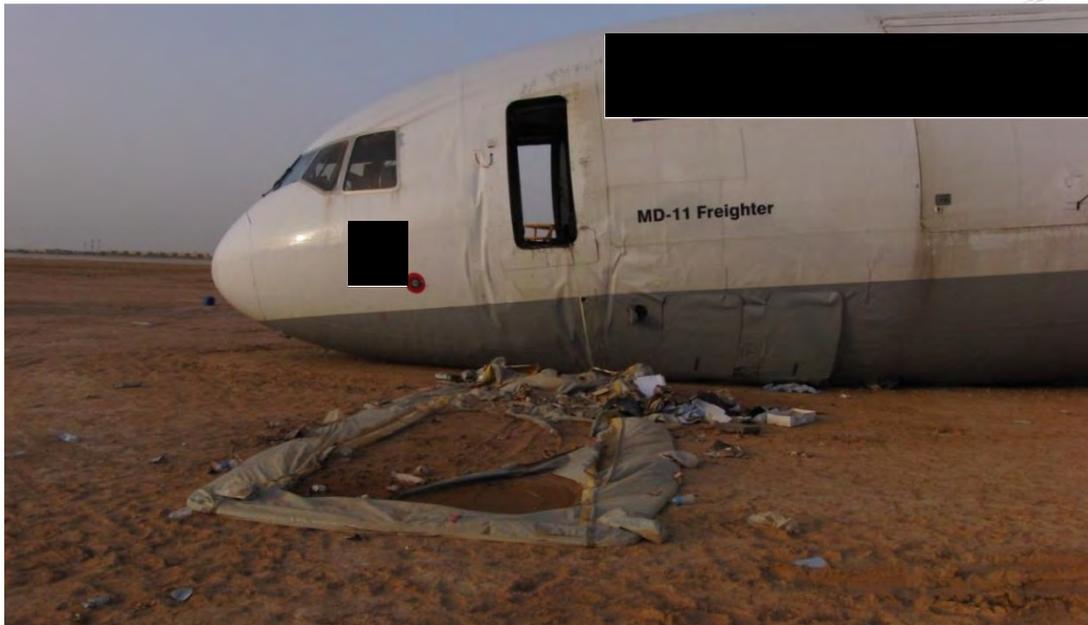
Figure 14 : Buckling of Left Forward Fuselage and Deflated Slide

The aircraft fuselage was ruptured into two (2) major sections. The rupture was located at Fuselage Station (FS) 1441 just aft of the wing. The forward half section was supported by the main landing gear, which remained in the down position. The nose gear had collapsed aft and had punctured the forward lower cargo compartment, causing some crush damage to the lower fuselage and allowing the nose to rest on the ground. The nose gear was missing both tires, the right wheel and half of the left wheel. The slide had been activated at the L1 door. The slide was deflated and was resting on the ground detached from the aircraft (Figure 14).

The left side of the fuselage showed skin buckling from FS 595 forward to FS410 (Figure 14).

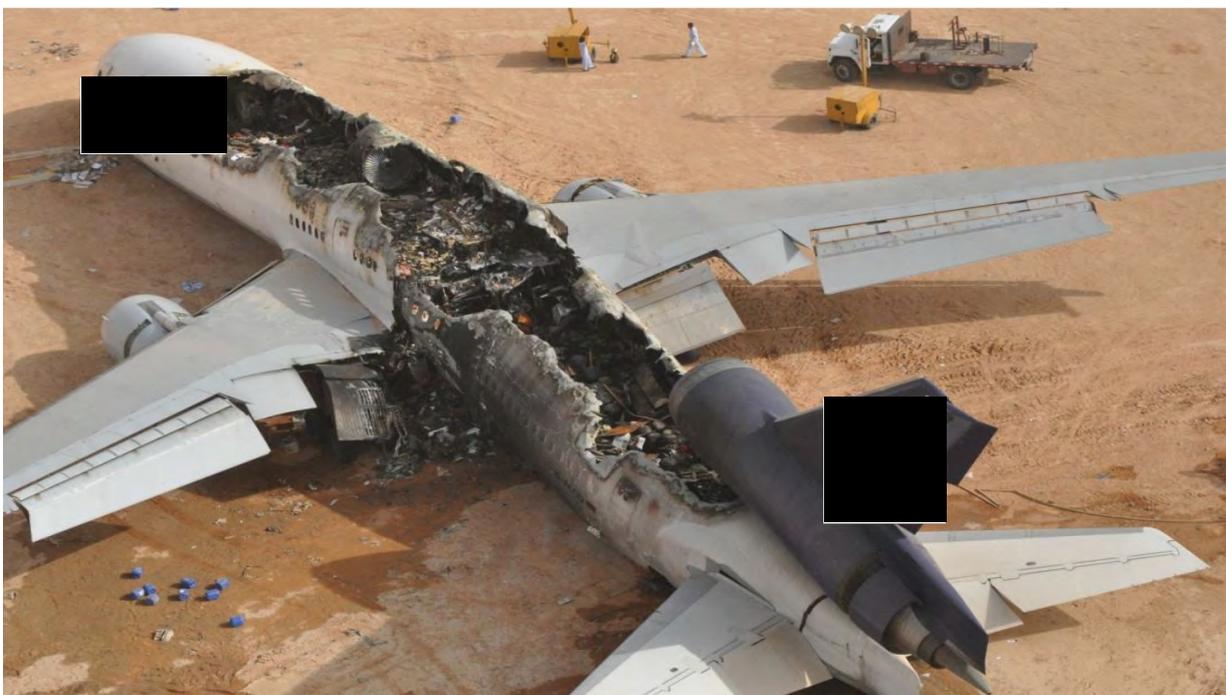
Figure 15: Fire Damage – Main Cargo Compartment

The top of the fuselage was burned through starting at FS 789 aft to the no.2 engine mount at FS 1986 (Figure 15). The fire consumed much of the cargo in the main deck compartment with the least amount of fire damage located at the forward end near the cockpit. The cockpit exhibited light soot deposits and the forward lower cargo compartment was undamaged by fire; the only damage to this compartment was from the nose gear which punctured through the floor. The aft lower cargo compartment was not accessed as the main deck cargo floor had collapsed into this area and it was filled with burned debris.

The left wing root area displayed significant fire damage. The structure and skin on the lower half of the fuselage in the main gear area was largely consumed by the fire (Figures 15, 23 and 24).

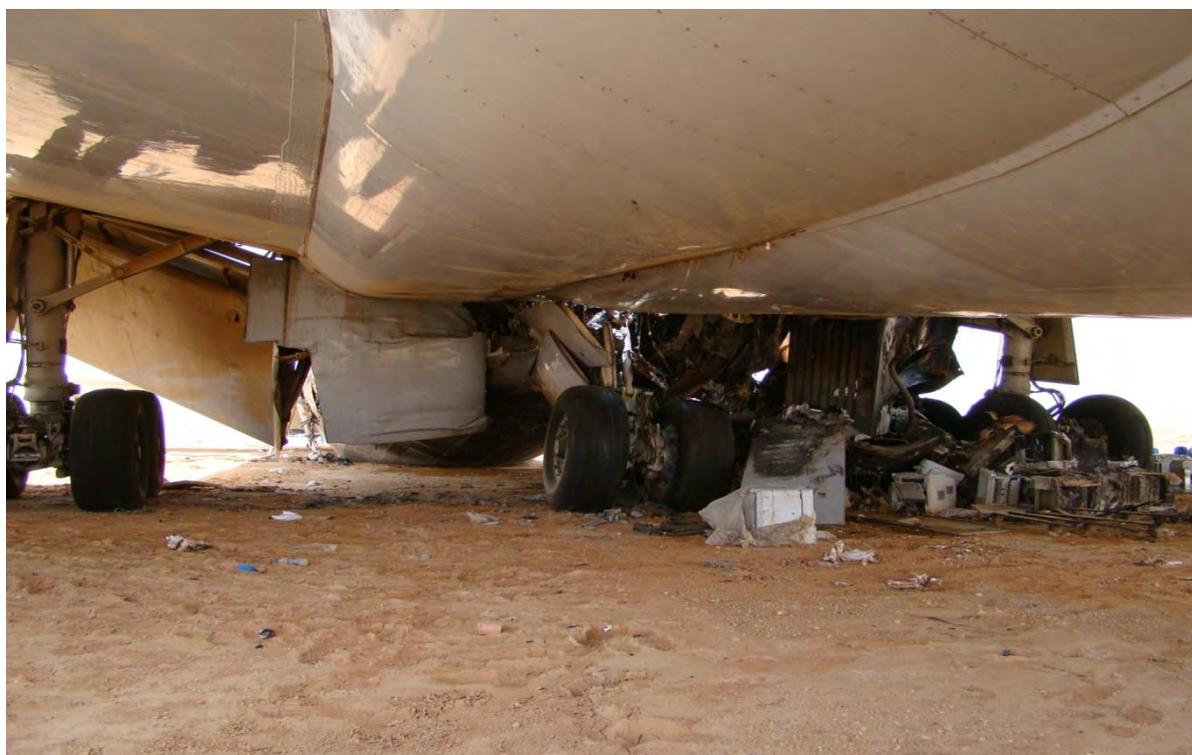
Figure 16: Main Landing Gear

The left main landing gear remained intact (Figure 16). The wing rear spar, upper fixed brace, upper side brace, lower side brace, lock links, strut (PN NRG6719-501, S/N BFGS 01027) and truck had no visible damage that would suggest gear failure or strut over-compression. The chrome extension on the strut measured 4.75 inches (in.) and the paint below the chrome did not demonstrate signatures of strut over-travel. All four (4) tires were inflated.

The center main landing gear remained relatively intact; however, the aircraft structure surrounding the gear attach points was largely consumed by fire. The gear sat slightly forward and to the right of the normal down and locked position. The strut (no visible data plate), gear braces and truck had no visible damage that would suggest gear failure or strut over-compression. The chrome extension on the strut measured 9.5 in. and the paint below the chrome did not demonstrate signatures of strut over-travel. The two (2) tires were inflated.

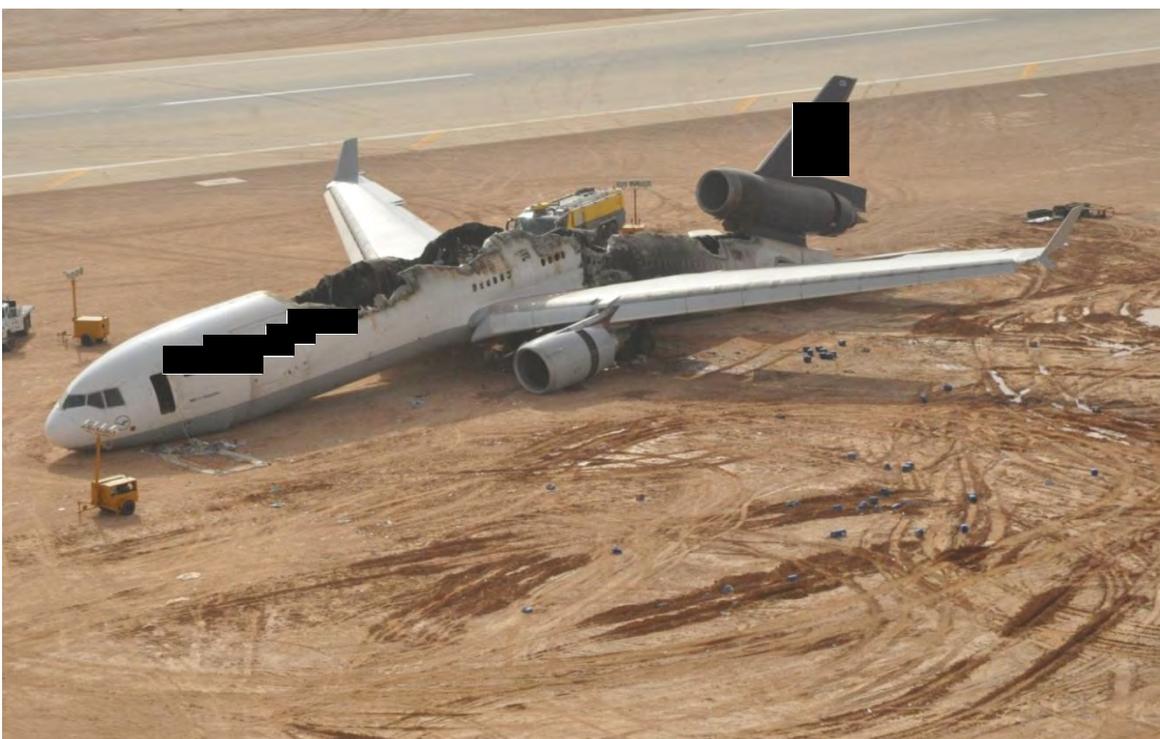
Figure 17: Extended Leading Edge Slats

The left wing was mostly undamaged with the exception of fire damage on the aft inboard area. The inboard flap was damaged by fire and remained attached to the wing at the outboard end only. The flap actuator was covered in soot with some shiny chrome extension on the piston near the actuator housing. The inboard aileron was in a downward position and also demonstrated some discoloration due to fire. The outboard flap was extended and appeared to be at or near the end of the flap tracks. The outboard aileron was slightly up and the leading edge slats were fully extended (Figures 17 and 18).

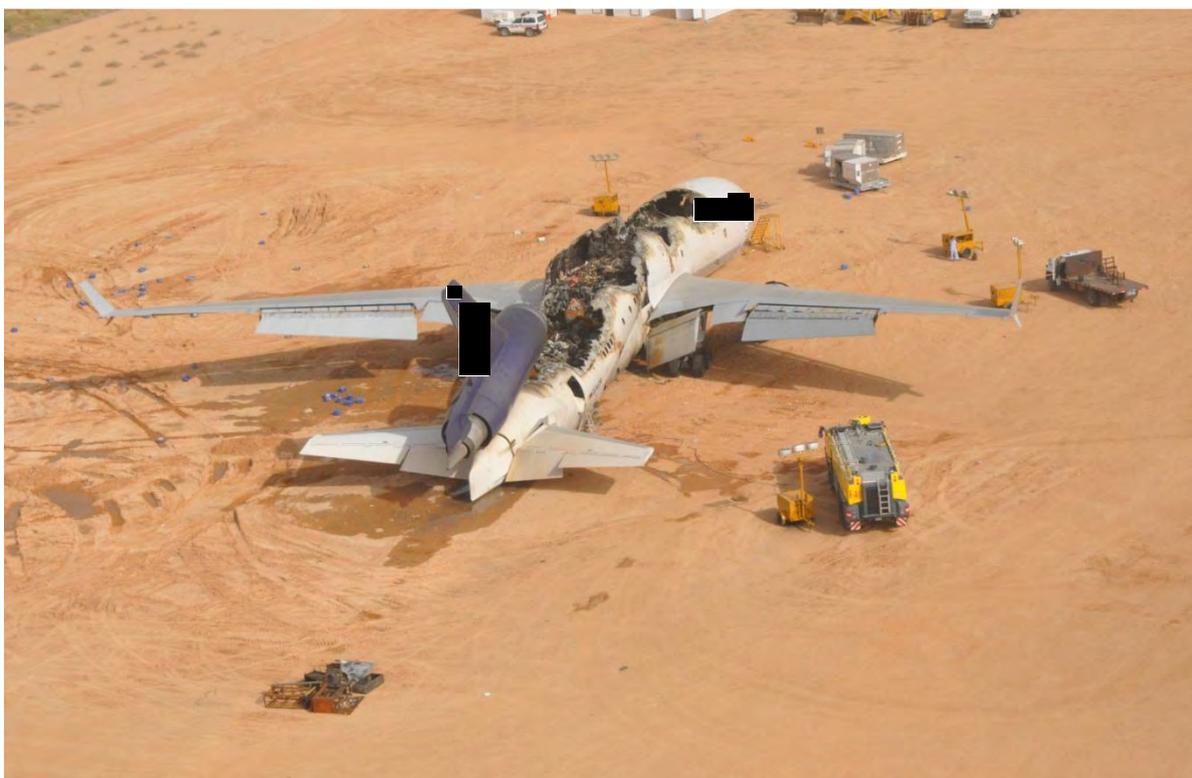
Figure 18: Position of Flight Control Surfaces

The right wing was mostly undamaged with the exception of the aft inboard area, which damage was not as extensive as to the left wing. The inboard flap remained attached to the wing at the outboard end only. The inboard side of the flap was tucked under the trailing edge of the wing. There was some damage to the trailing edge of the wing in this area that appeared consistent with the flap being torn out from the wing. The inboard aileron was in a downward position. The outboard flap was extended and appeared to be at or near the end of the flap track. The outboard aileron was slightly up and the leading edge slats were fully extended (Figures 17 and 18).

The right horizontal stabilizer leading edge measured 12 in. below the reference line on the fuselage. The outboard elevator was in a slightly down/faired position, while the inboard elevator was in a mostly down position. The vertical stabilizer and the rudder appeared in good condition. The top half of the rudder was deflected more to the right than the lower half (Figures 17 and 18).

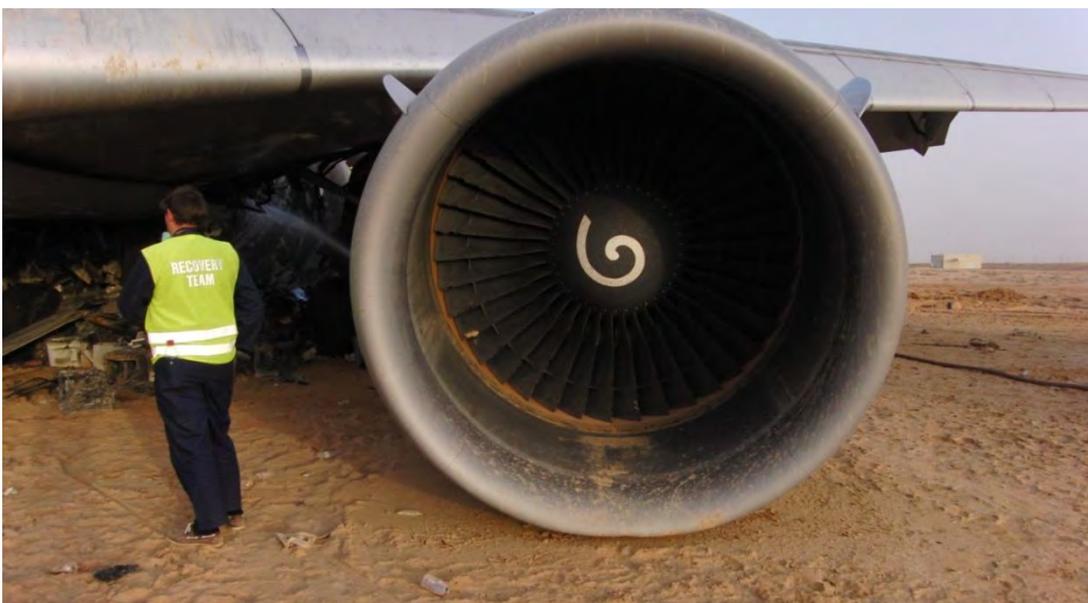
Figure 20: Left/No. 1 Engine

The engine remained attached to the wing with the front of the engine resting on the ground. The first row of fan blades had some damage on the leading edge of the blades. The first row of stator vanes was intact. Both reverser sleeves were extended and all blocker doors were closed. The reverser exhaust cascades appeared relatively clean, containing only a small amount of dirt and debris. A visual inspection revealed that the last row of turbine blades was in good condition and all blades were accounted for (Figure 20).

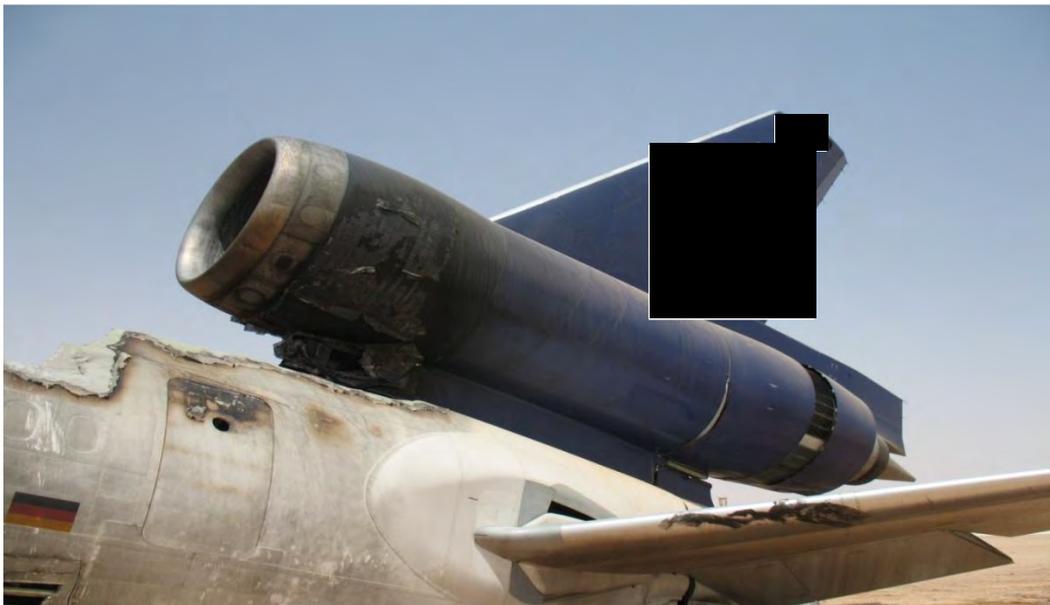
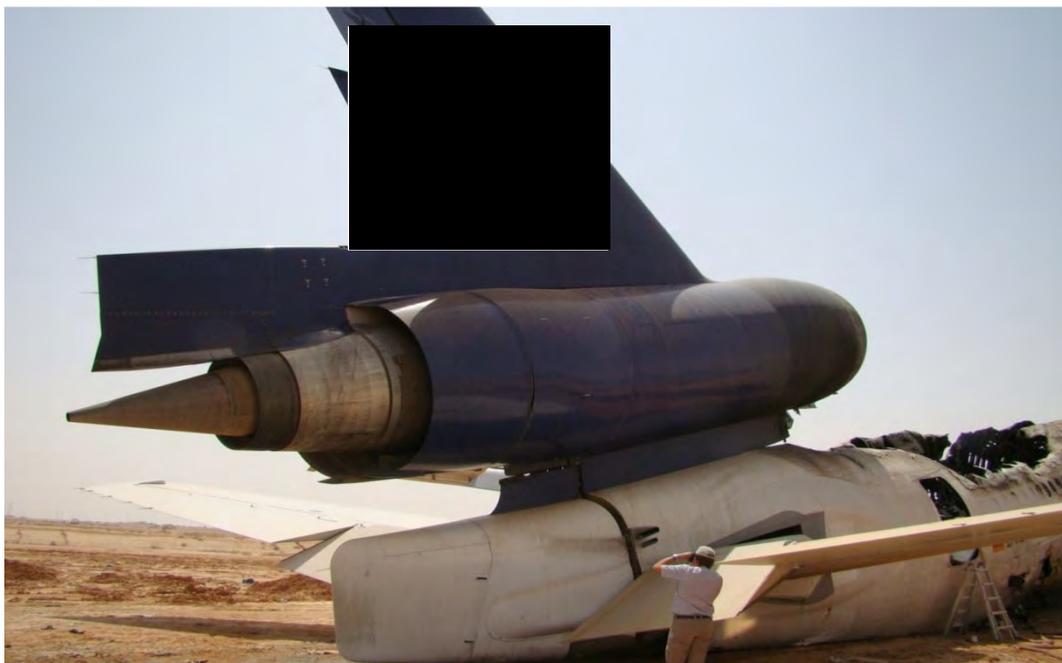
The forward section of the aft fuselage was supported off the ground by its remaining connection with the forward half of the fuselage at FS 1441. The tail section was resting on the ground and was deformed and buckled in various places on the lower half of the fuselage. Fire damage was extensive on the left side, with the most severe damage near the wing root and becoming less apparent near the tail. The tail cone was translated aft by 6 in. at FS 2162. This gap went around the entire circumference of the fuselage and engine pylon fairing, as well as the left side of the no. 2 engine nacelle (Figures 21a and 21b).

The engine was attached to the tail/vertical stabilizer. The inlet engine housing was damaged by the fire in the fuselage. There was a gap on the engine pylon fairing at FS 2162 and the left side of the engine nacelle was split at this location. The right side reverser sleeves were retracted and the blocker doors appeared open. The left side reverser sleeves were extended and the blocker doors were closed. There was a small amount of unidentified debris in the reverser exhaust. A visual inspection revealed that the last row of turbine blades appeared in good condition (Figures 21a and 21b).

The forward portion of the no. 2 engine cowling had heavy soot with the left side of the cowling exhibiting heavier damage than the right side. The forward edge of the engine mount showed evidence of melting (Figure 21a).

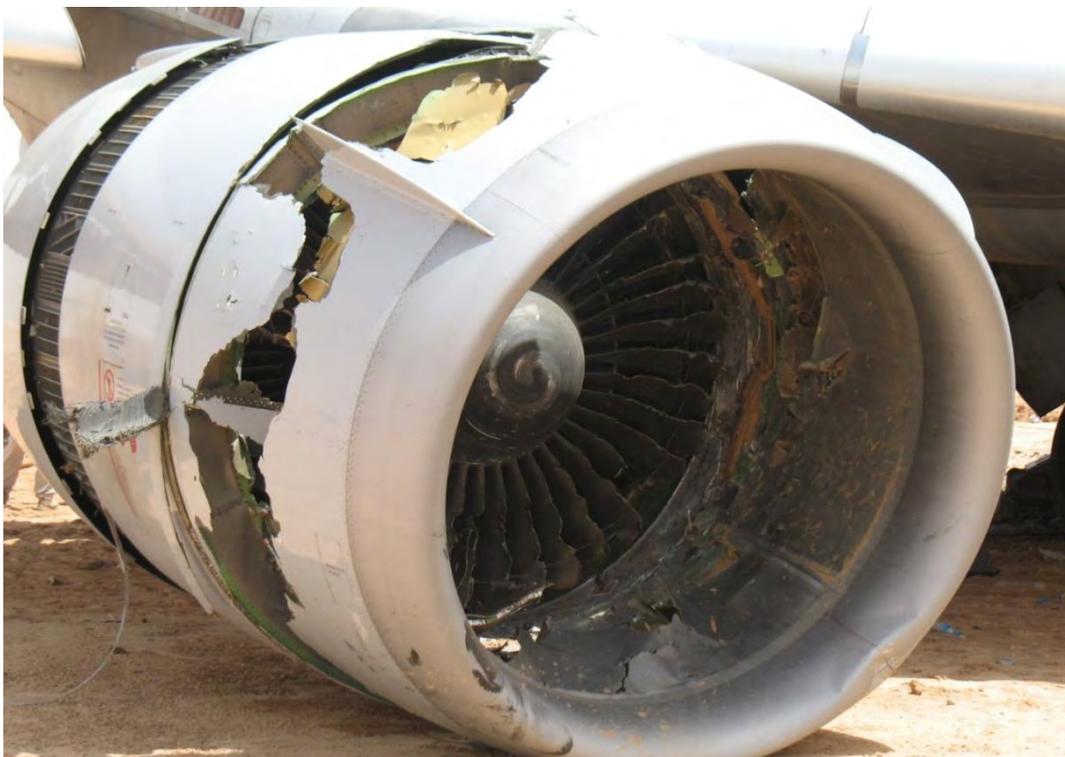
Figure 22: Right/No. 3 Engine

The engine remained attached to the wing with the front of the engine resting on the ground. The engine intake cowling was damaged and mostly separated from the engine. There was a seventeen (17) in. long black mark on the intake leading edge. There was one (1) ft by 1 ft piece of nose gear tire lodged in the outboard housing where the intake cowling had separated from the engine. The first row of the fan blades and stator vanes had sustained substantial damage. Both reverser sleeves were extended and all blocker doors were closed. The reverser exhaust cascade contained debris consisting of dirt, engine nacelle and tire material. A visual inspection revealed that the last row of blade vanes appeared in good condition (Figure 22).

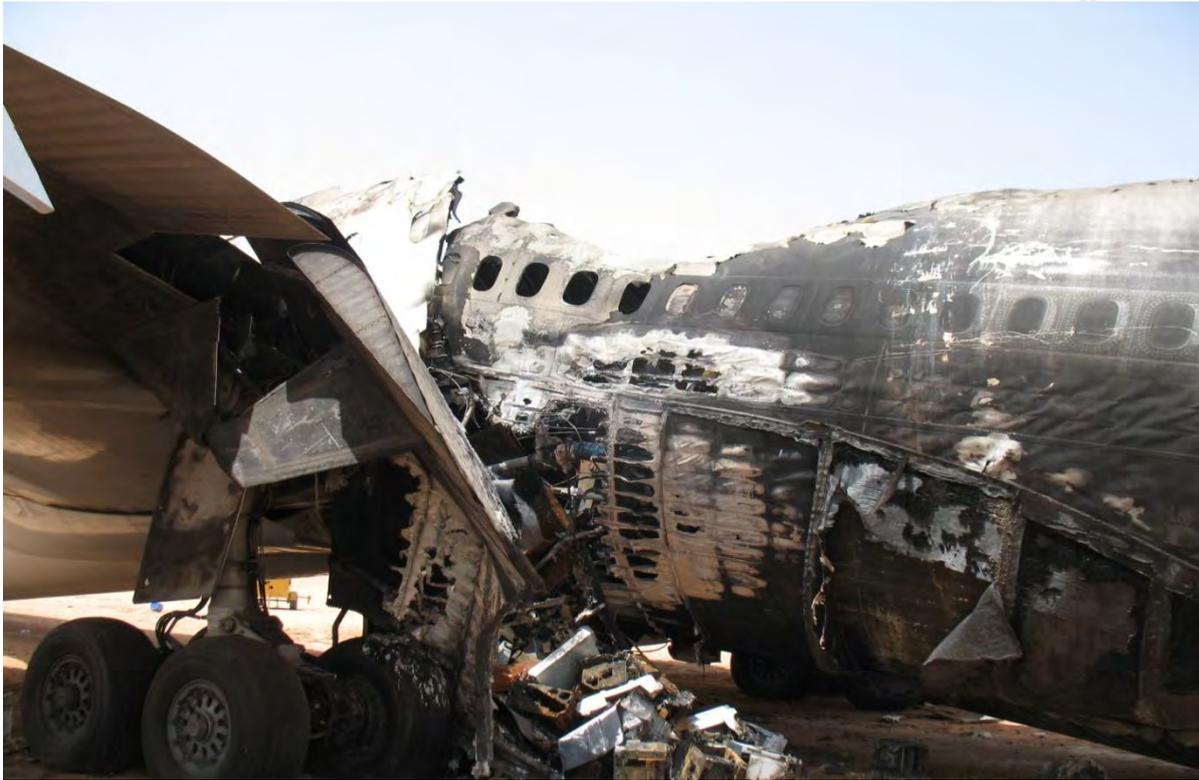
Figure 23: Area of Heaviest Fire Damage (Left Side)

The upper crown of this area of the fuselage was completely destroyed with all of the fuselage skin missing and most of the stringers either missing or melted. The fire damage extended down the sides of the fuselage to approximately half the height of the main cargo deck. In several places, the damage extended to the aft lower cargo deck. The upper edges of the remaining fuselage were melted with bubbled or missing exterior paint. The area of heaviest damage was located on the left side of the aircraft just aft of the wing where the aircraft fuselage ruptured. This area exhibited heavy melting of the fuselage as well as large areas of missing material which extended underneath the aircraft. In this area, the main cargo floor was damaged and as a result, several pieces of fire damaged cargo fell out of the aircraft after it came to rest. The center landing gear well shroud was melted, as was its upper structure (Figures 23 and 24).

The break in the no. 2 engine/APU fuel line and the tail tank fuel transfer line resulted in fuel being sprayed into the left wheel well area, which likely fed the initial fire. Due to the heavy damage from the fire, the ignition source could not be determined.
