Strong turbulence in cruise, momentary loss of control of the flight path by the crew

Aircraft	Airbus A330-200 registered F-GZCG
Date and time	27 February 2012 at 00 h 48 ⁽¹⁾
Operator	Air France
Place	In cruise at FL360 over Tanzania
Type of flight	Public transport Scheduled international passenger service
Persons on board	Captain (PF); Co-pilot (PNF)
Consequences and damage	A passenger and a cabin crew member sustained minor injuries

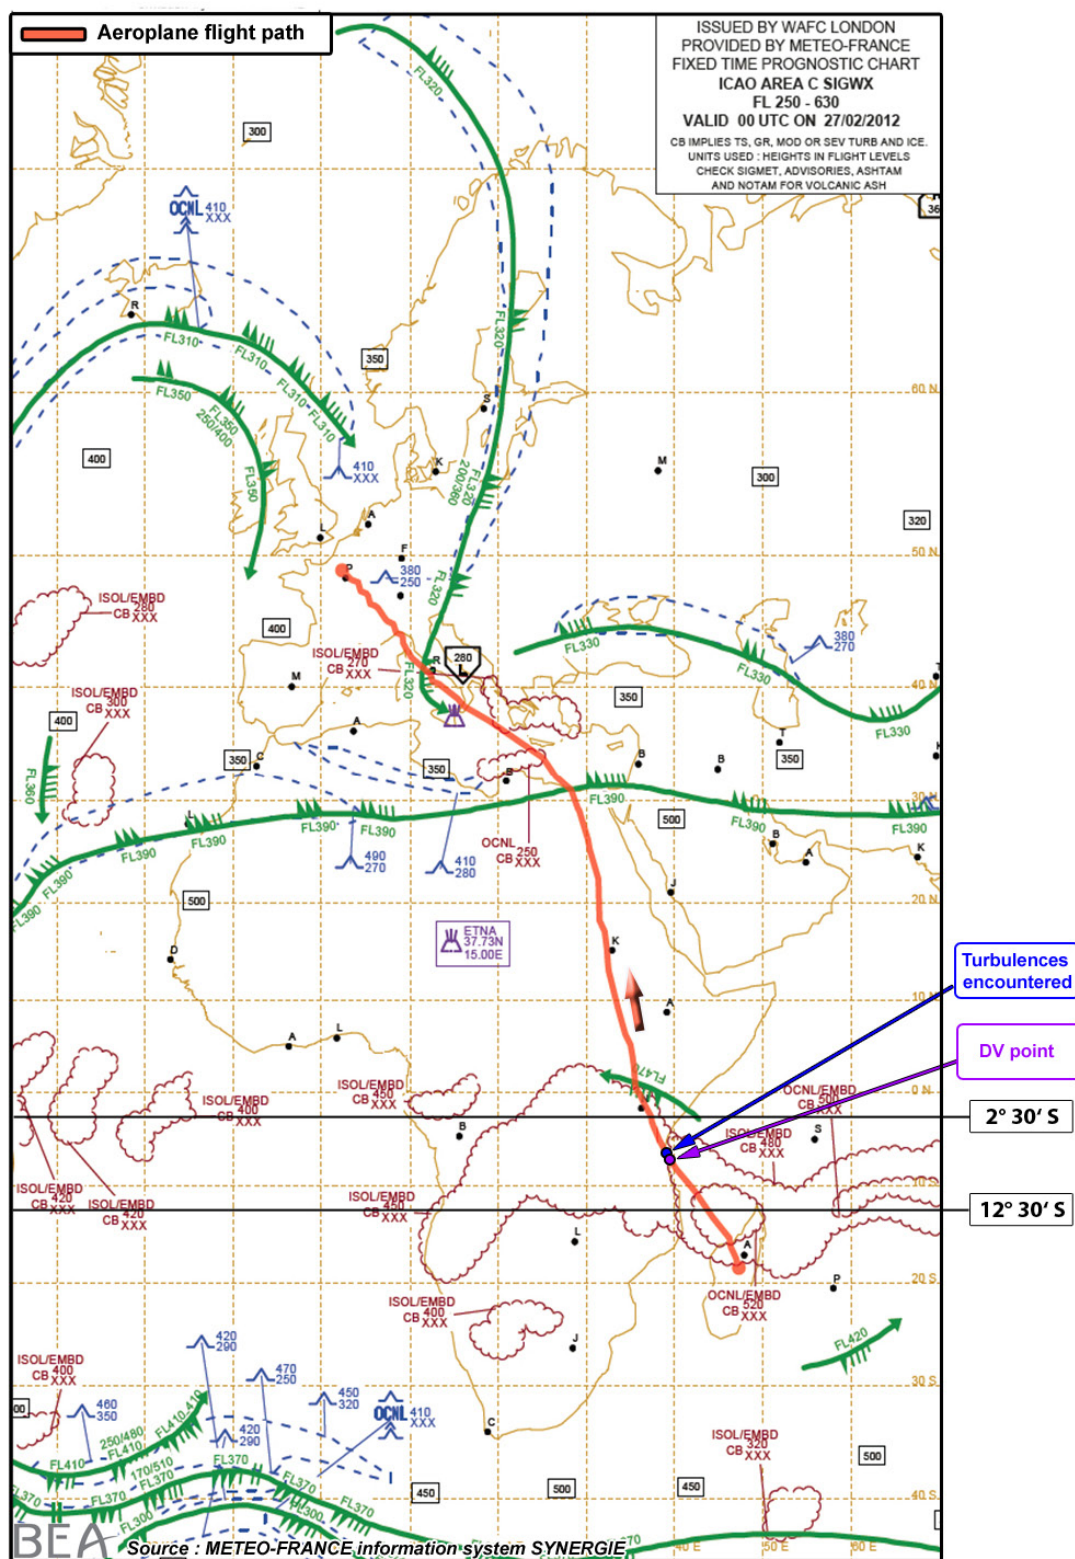
Figure 1: SIGWX chart of 00 h 00

The weather information available to the crew initially showed the presence of isolated cumulonimbus in the region where the turbulence occurred.

The 00 h 00 SIGWX chart was available in the flight dossier; the flight path specified in the flight plan was indicated on it.

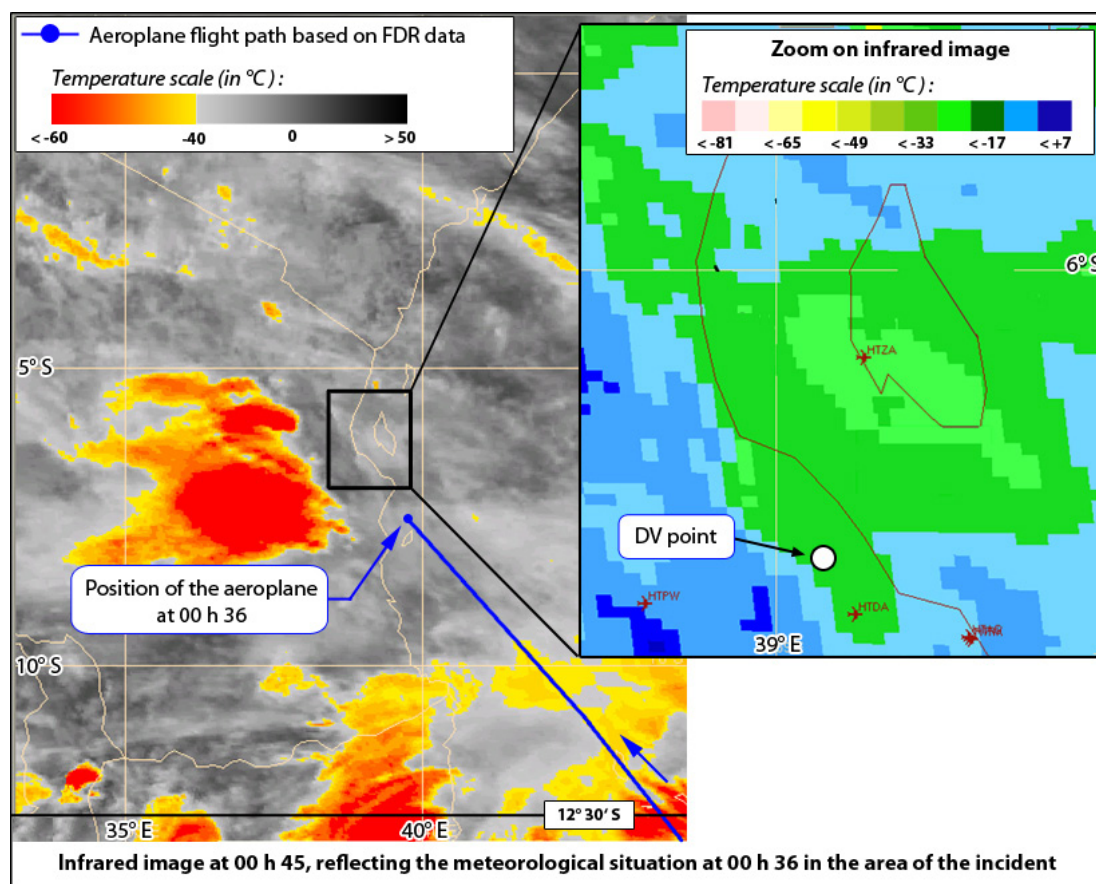
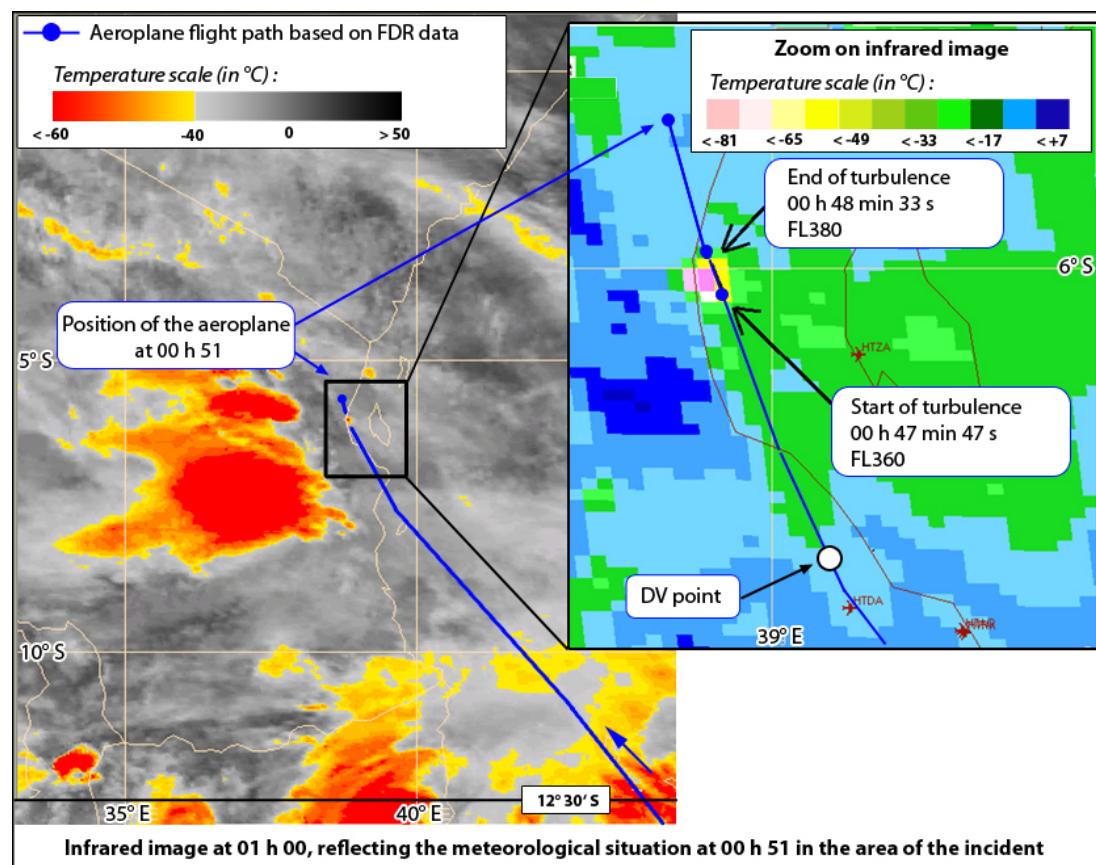
Figure 2: IR images and position of the aeroplane

On the image corresponding to the situation at 00 h 36, there is cloud cover whose top is located around FL280/300 (dark green). The cell was probably building up, but still undetectable by radar at that time. On the image corresponding to the situation at 00 h 36, cloud tops can be observed between FL360 and FL450 (pink dots). For this reason, the relatively small convective cell is not visible on the image at 00 h 45 but is easily detectable on the image at 01 h 00.

It is therefore a case of particularly rapid development of an isolated thunderstorm cell. The development of this cell into a large convective cluster within a few hours may suggest the presence of strong updraughts and severe turbulence. In addition, this rapid growth could explain the violent phenomena encountered, related to the dynamism and not to the size of the cell.
