# Aircraft Accident Report

**Operator:** Sita Air Pvt. Ltd.

**Aircraft Type and Model:** Dornier 228-202(K)

**Registration:** 9N-AHA

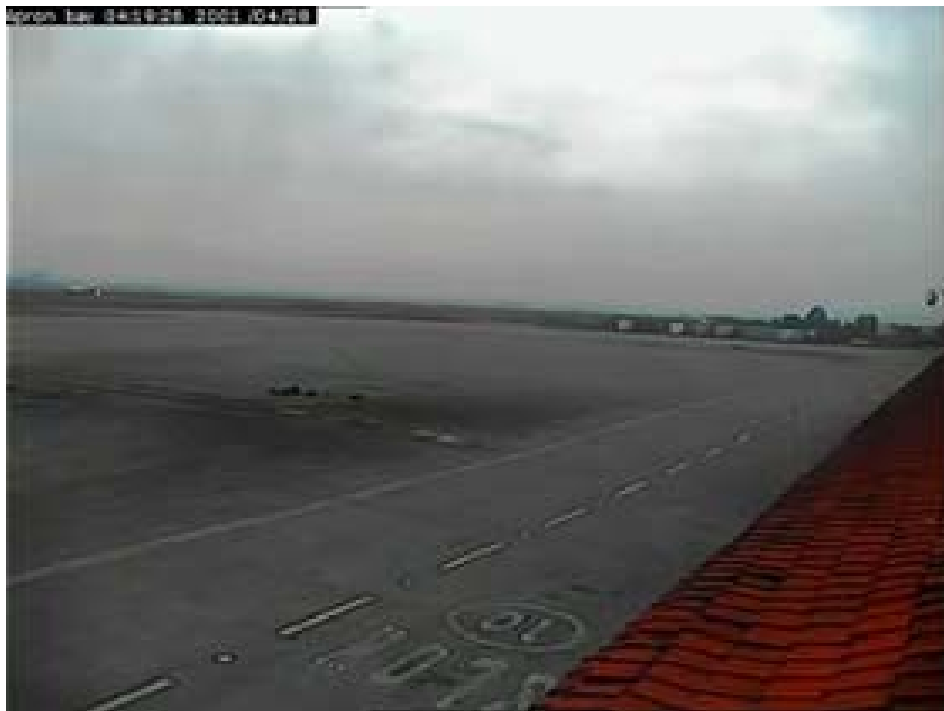
**Figure 1.1-1**  
CCTV image five seconds before the aircraft left the ground

A CCTV camera on an airport building recorded the flight from approximately 10 seconds before the aircraft left the ground until impact. Approximately 5 seconds before the aircraft left the ground, what appeared to be a flash appeared in the region of the right engine for one frame of video<sup>3</sup>. Following analysis, the flash was considered to represent a real event rather than being an artefact of the recording process (Figures 1.1-1 and 1.1-2).

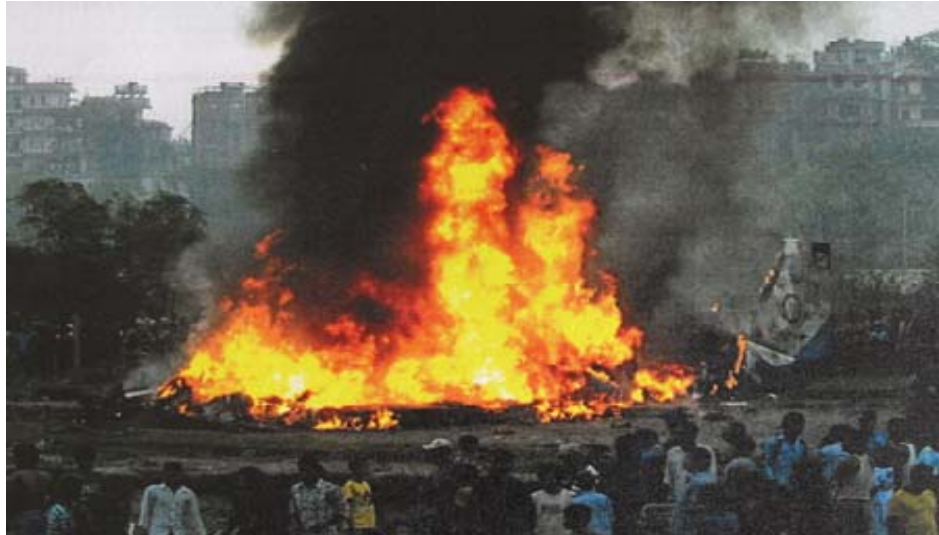
**Figure 1.12-2**  
Post-impact fire showing tail section remains pointing towards north-west  
(Copyright AFP/GETTY)

The aircraft struck the ground on the banks of the Manohara river, 420 m south-east of the threshold of Runway 02 (Figure 1.12-1). The impact crater and ground marks indicated that the aircraft struck the ground in the approximate direction of 124 °M<sup>6</sup>. There was a large post-impact fire which consumed most of the aircraft, but the tail section was mostly intact and only minimally affected by fire. The wreckage was moved by rescue personnel so it was difficult to establish an accurate impact attitude, but the small size of the main wreckage field (approximately 17 m in diameter) indicated a steep impact with high vertical speed. Photographs taken by the media shortly after the accident revealed a large post-impact fire and showed the tail section, upright, with the front pointing towards the north-west (Figure 1.12-2) – opposite to the direction of travel at impact. This suggested that the aircraft hit the ground in a near vertical attitude with its upper surface facing towards the north-west, but with some horizontal speed towards the south-east.

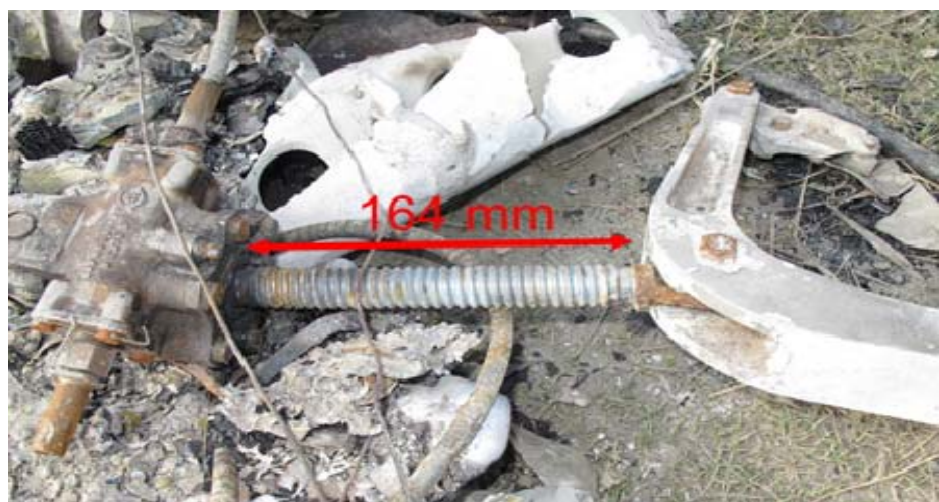
**Figure 1.12-3**  
One of the flap jack actuators

A preliminary examination of the wreckage was carried out onsite. The wings, cabin and cockpit had been severely consumed by fire but parts remained recognisable. Three flap jack actuators were identified and their extension was measured at 164 mm which corresponded to a flap position of  $20^\circ$  which is 'Flaps 2' (Figure 1.12-3). The main landing gear was found to be in the retracted position.

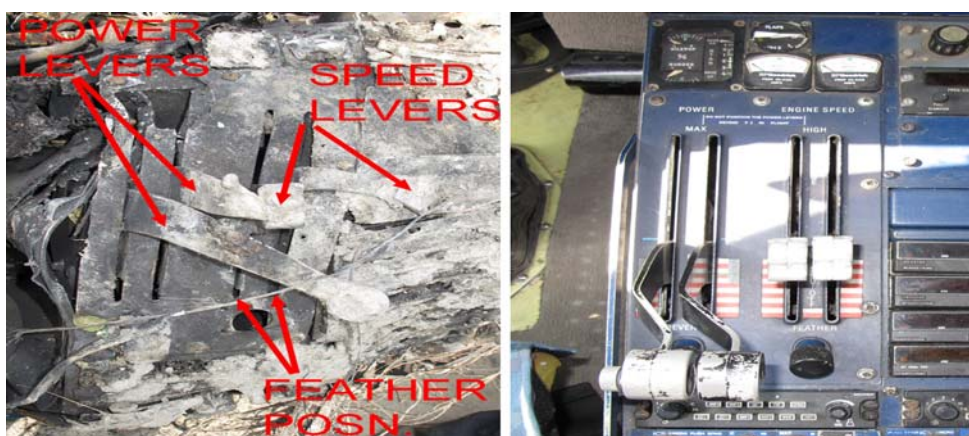
**Figure 1.12-4**

The left engine power lever was found in the approximate flight idle position but was bent to the side (Figure 1.12-4). The right engine power lever was slightly forwards of the flight idle position. Due to the separation of the engines from the wing and the impact forces within the cockpit, the power levers could have moved during the impact sequence. The left speed lever was in a mid position, the right speed lever was slightly forward of a mid position and both levers were bent sideways. Both levers could have moved during the impact sequence, but if they had been in the gated feather position prior to impact then it is unlikely that they would have moved. Both engine fire levers were in the unselected position. The flap lever was in the Flaps 1 position.

Power and speed (rpm) levers – accident aircraft 9N-AHA (left); another Dornier 228 (right) with power levers in ground idle position and speed levers in fuel shutoff position

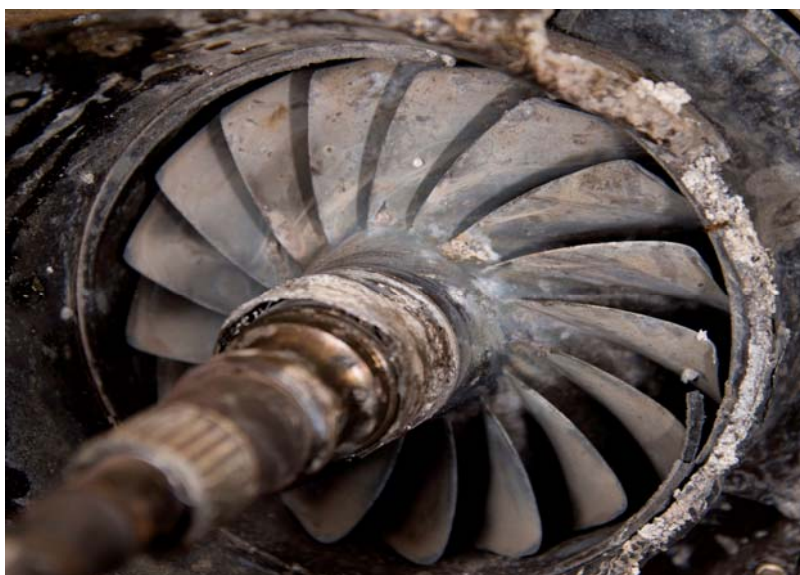
**Figure 1.12-5**

The left engine had separated into two main sections, the gear case and the power sections. Both had suffered fire and impact damage. The first stage compressor impeller blades were bent back opposite to the direction of rotation (Figure 1.12-5) and there was corresponding rotational scoring through 360° on the surrounding shroud. There was no impact damage to the leading edges of the first stage compressor blades. There was scoring on the tips of the second stage compressor blades and corresponding rotational scoring on the surrounding shroud, and there was also rotational scoring in the turbine section of the engine. This evidence indicated that the engine was rotating at impact. The combustion chamber and plenum were undamaged and the fuel nozzles were in place with no blockages. The three stages of the turbine section were undamaged apart from rotational scoring, but the test result did not confirm the metal spray in the form of aluminum deposits on the suction (back) faces of the turbine rotors and stators of all three stages. These metal spray deposits were determined to be material from the compressor shroud which has an aluminium coating. The rotational scoring of the shroud which occurred during impact would have released aluminium particles into the combustion chamber, where they melted and then re-solidified when they struck the turbine stators and rotors. This evidence indicated that the combustion chamber was lit at impact and therefore the engine was operating at impact. The engine manufacturer could not determine a power setting at impact – the evidence was consistent with idle power, full power, or any power in between.

There was no evidence of bird remains inside the engine and a black ultra-violet light was also used to identify any protein remains inside the power section of the engine which could be indicative of bird remains, but none were found. There was also no odour of bird remains inside the engine.

The gearbox contained evidence of rotational scoring and no evidence of pre-impact failures. The propeller shaft and coupler had fractured, but metallurgical analysis determined that they had failed in bending overload with no evidence of fatigue.

Left engine first stage compressor impeller – blades bent back opposite to the direction of rotation

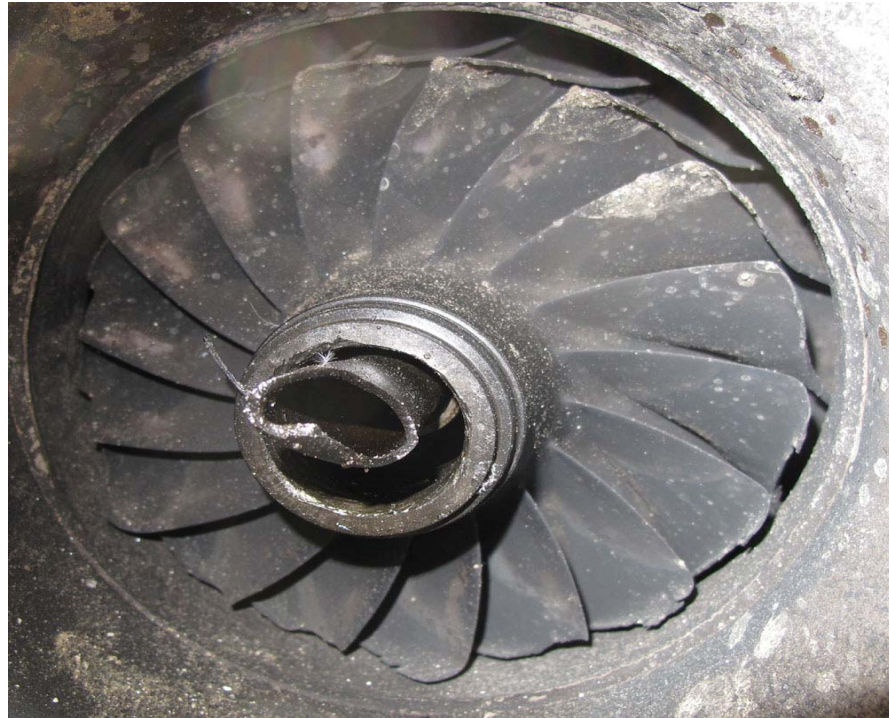
**Figure 1.12-6**

The right engine had separated into two main sections, the gear case and the power sections. Both had suffered fire and impact damage. The first stage compressor impeller blades were bent back opposite to the direction of rotation and there was corresponding rotational scoring through 360° on the surrounding shroud. Some parts of the impeller blade tips were missing and had a jagged appearance (Figure 1.12-6). One of the first stage compressor blades had leading edge damage near the tip. There was scoring on the tips of the second stage compressor blades and corresponding rotational scoring on the surrounding shroud, and there was also rotational scoring in the turbine section of the engine. This evidence indicated that the engine was rotating at impact. The combustion chamber and plenum were undamaged and the fuel nozzles were in place with no blockages. The three stages of the turbine section were undamaged apart from rotational scoring, but there were metal spray deposits on the suction (back) faces of the turbine rotors and stators of all three stages. There were also metal deposits on the leading edge and pressure (front) side of the first stage turbine rotor blades. These metal deposits were determined to be material from the compressor shroud. This evidence indicated that the combustion chamber was lit at impact and therefore the engine was operating at impact. The engine manufacturer could not determine a power setting at impact – the evidence was consistent with idle power, full power, of any power in between.

There was no evidence of bird remains inside the engine and a black ultra-violet light was also used to identify any protein remains inside the power section of the engine which could be indicative of bird remains, but none were found. There was also no odour of bird remains inside the engine.

Right engine first stage compressor impeller – blades bent back opposite to the direction of rotation

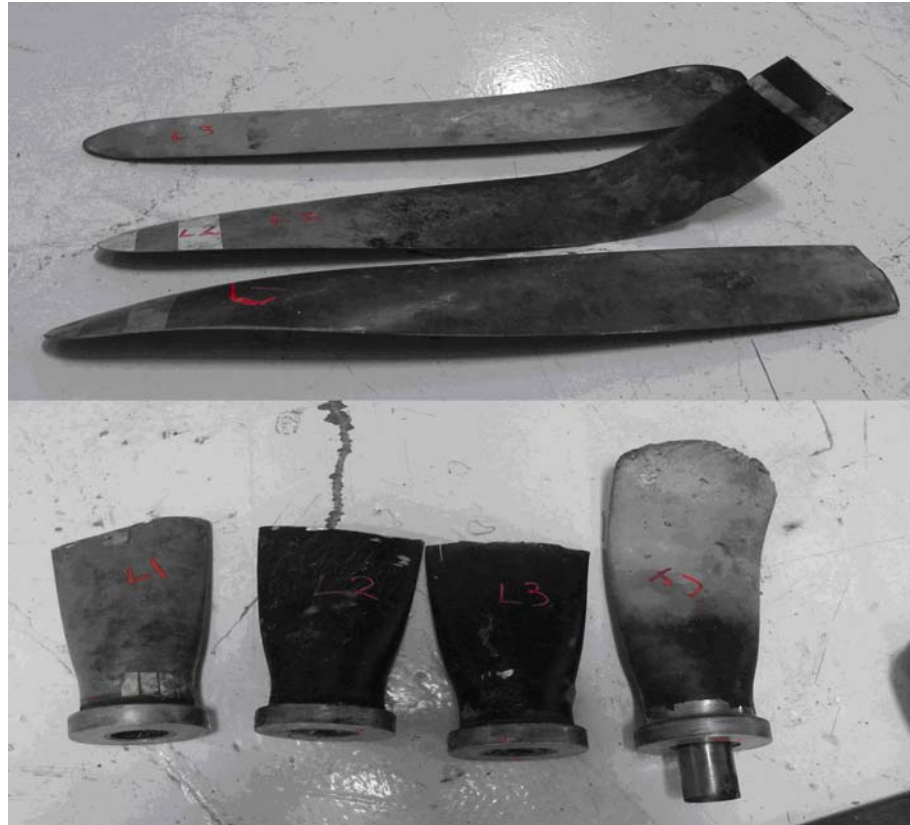
**Figure 1.12-7**

Examination of the hub unit revealed that the L3 hub arm had three adjacent blade butt impact marks caused by contact with the blade butt. These three marks suggested multiple impacts while the blade was changing pitch during the ground impact sequence. The location of the marks indicated that the blade had been in a normal operating position and then moved towards reverse pitch. The L2 blade butt had 1 mark indicating reverse pitch. The internal surface of the piston had an impact mark indicative of the piston being in a reverse pitch position. According to the propeller manufacturer it is common to see propeller blades being driven towards reverse pitch in an impact sequence. Compressive bending in the link arms and gouging of link screws that had made contact with the guide collar were also evidence of the propeller having been driven towards the low/reverse pitch position. It could be concluded that the left propeller was at a normal positive blade pitch angle at the time of impact – not feathered or in reverse pitch.

Based on the very mild damage to the propeller blades and the lack of significant twisting, tearing, or leading edge damage in the tip area, the propeller manufacturer concluded that the propeller was operating at low or no power at the time of impact. This evidence combined with the evidence of a normal positive blade pitch angle indicated that the engine was probably at low power and not ‘no power’, because a functioning NTS system would have driven the blade angle to a very high, near feather, pitch angle.

Left propeller blades – three blades cut near the butt to facilitate shipment

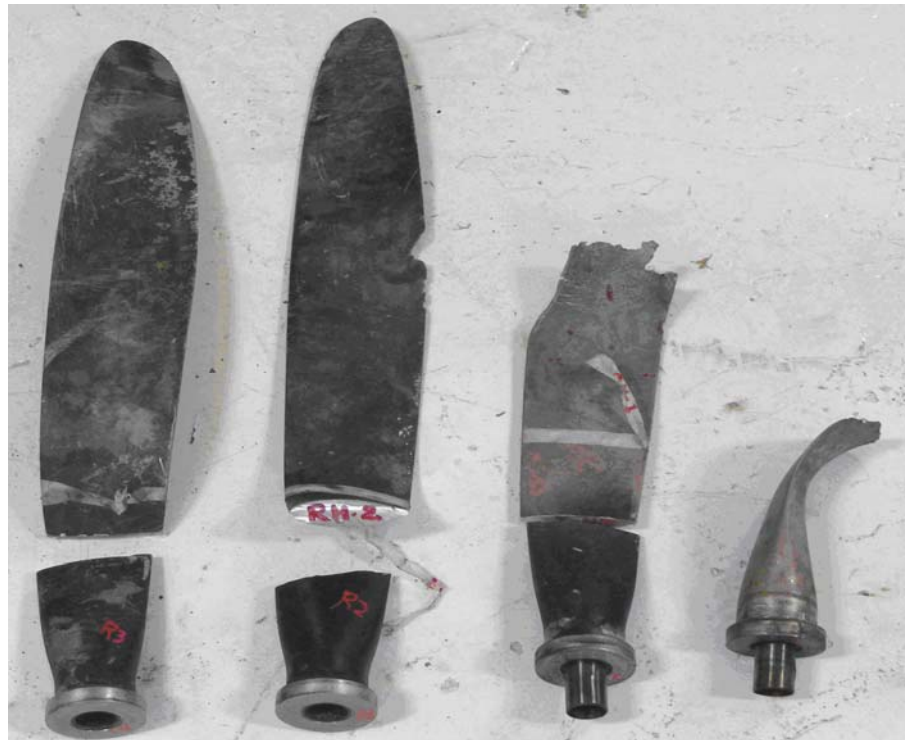
**Figure 1.12-8**

The right propeller blades were numbered R1 to R4. Blade R1 was missing its outer third where it had melted, and it could not be matched with any of the three separated tips. The blade was not bent or twisted and had no leading or trailing edge damage (Figure 1.12-8). Blade R2 was intact and had a 45° aft bend at  $\frac{1}{4}$  radius and no twist. Its leading edge was undamaged and its trailing edge contained a large gouge at mid-blade. Blade R3 was intact and had a 45° aft bend at  $\frac{1}{4}$  radius and slight additional forward bending at the outer  $\frac{1}{3}$  of the blade. Its leading edge had mild gouges at  $\frac{1}{3}$  blade and no trailing edge damage. Blade R4 was missing its outer two-thirds and could not be matched with any of the three separated tips. The blade was bent 45° forward at about 10 inches from the butt end. Its remaining leading edge and trailing edge were undamaged.

Examination of the hub unit did not reveal any hub arm impact marks and there were no marks on the propeller butts either to determine a blade angle. However, a fragment of the damaged spinner was deformed over the piston which provided an indication of piston position. This fragment was 4 inches from the guide collar which indicated that the piston was in a position representative of a blade angle of approximately 20° at the time the spinner was crushed. The low pitch stop is 15° and a typical blade angle at takeoff power is approximately 35°. The blade angle at feather is 76°. This evidence combined with the lack of significant blade twisting, tearing, or leading edge damage in the tip area, indicated that the engine was at low power.

Right propeller blades – three blades cut near the butt to facilitate shipment

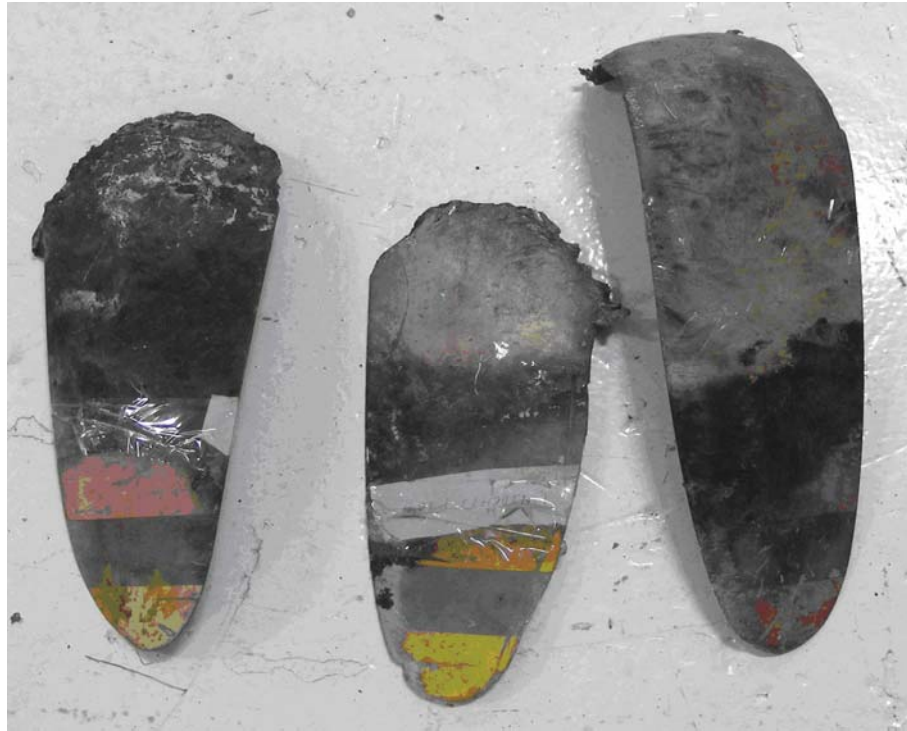
**Figure 1.12-9**

The three separated blade tips that could not be matched up are shown in Figure 1.12-9 - two of these were from the right propeller. There was no significant leading edge or trailing edge damage to any of these blade tips, but one blade tip had a leading edge nick and one had chordwise scratches.

Separated propeller blade tips that could not be matched to the separated blade ends, although two of these are from the right propeller

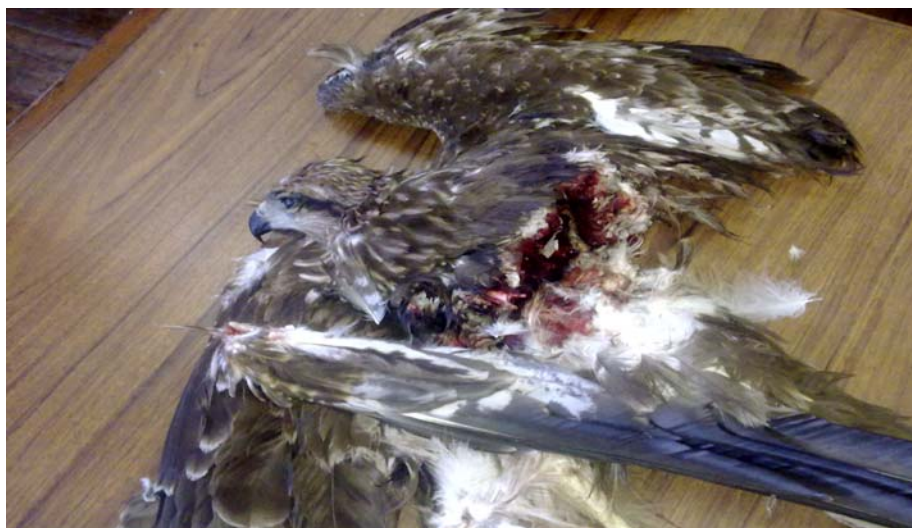
**Figure 1.18-2**

The total weight of the carcass was 695 g. There were no missing parts but the carcass body was broken into three parts: the largest part, weighing 460 g, included the head, body and right wing; the pelvic part, weighing (185 g) included the two legs; and the right wing, weighing 50 g. The bird appeared to have been cut or sliced through the propeller tips was examined in the national zoo laboratory.

The remains of the bird found on the runway were examined in national zoo lab
