# Investigation Report

Type of Occurrence:	Serious incident
Date:	8 January 2010
Location:	Nürnberg
Aircraft:	Transport aircraft
Manufacturer / Model:	Boeing / 737-800
Injuries to Persons:	None
Damage:	Minor damage to aircraft
Other Damage:	Minor crop damage
Information Source:	Investigation by BFU
State File Number:	BFU 5X002-10

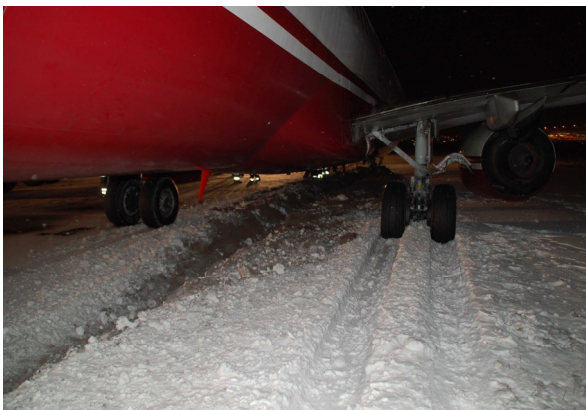
Main landing gear

The B738 came to a stop about 5 m to the right of the runway. The wheels of the nose and the main landing gears had sunk into the ground by about 15 cm. No other parts of the airplane had ground contact. The unpaved terrain clearly showed the tyre tracks of the landing gears until the stop. On the runway all three landing gears had left marks in the snow.

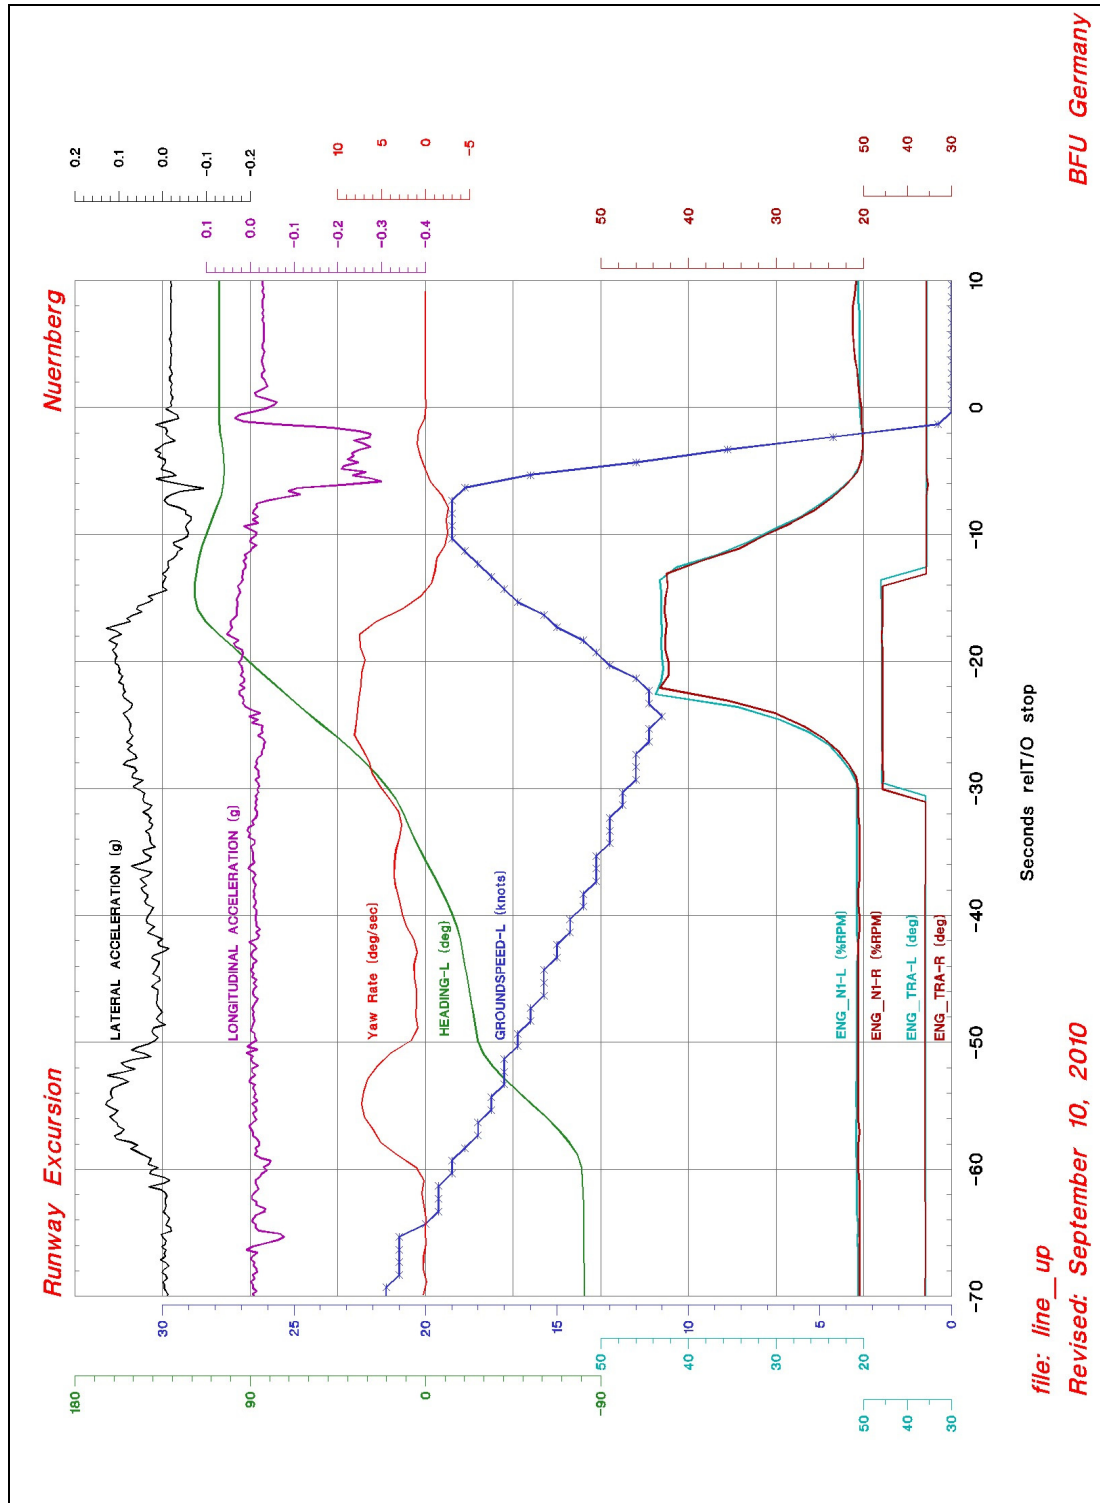
## Excerpt Flight Data Recorder

According to the Flight Data Recorder (FDR) both thrust levers were moved from about 36° to about 46° while passing a heading (HDG) of about 20° with a ground speed of about 12 kt. Thrust of both engines increased from about 21% N1 to about 43% N1. The recordings of the left and right N1 show that the engines accelerated with a difference of initially about 2% and later about 4%; the left engine showed the higher thrust values throughout. After that, N1 of the left engine remained at about 43.2% and of the right at about 42.5%; for the next 9 seconds both values remained constant.

About 43% N1 of the left engine was reached at HDG 73°; at that time ground speed was about 12 kt. The airplane accelerated in 12 seconds from about 12 kt to 19 kt ground speed. The heading of about 112° was passed with a ground speed of about 19 kt. During the acceleration phase the airplane passed a heading of about 120° with a ground speed of about 17 kt. Once these values were reached the thrust levers were pulled back to about 5° and within 9 seconds engine thrust decreased to about 21% N1. Within 6 seconds ground speed decreased from 19 kt to 0 kt.

Moreover, the engines ran with differing engine thrust settings whereby the left engine always had the higher values. Even though the difference was marginal with a slippery ground this can already have an influence on distance and direction.
