**TECHNICAL INVESTIGATION INTO THE ACCIDENT OF  
THE B737-800 REGISTRATION 5Y-KYA OPERATED BY  
KENYA AIRWAYS THAT OCCURRED ON THE 5<sup>th</sup> OF  
MAY 2007 IN DOUALA**

<b>Operator</b>	Kenya Airways Limited
<b>Aircraft</b>	Boeing 737-800; registration 5Y-KYA
<b>Date and time of accident</b>	Saturday 05 <sup>th</sup> May 2007 at 0008 (local time)
<b>Location of accident</b>	3.95570 N 9.75090 E (03 57 1883 N 009 44 58 E)

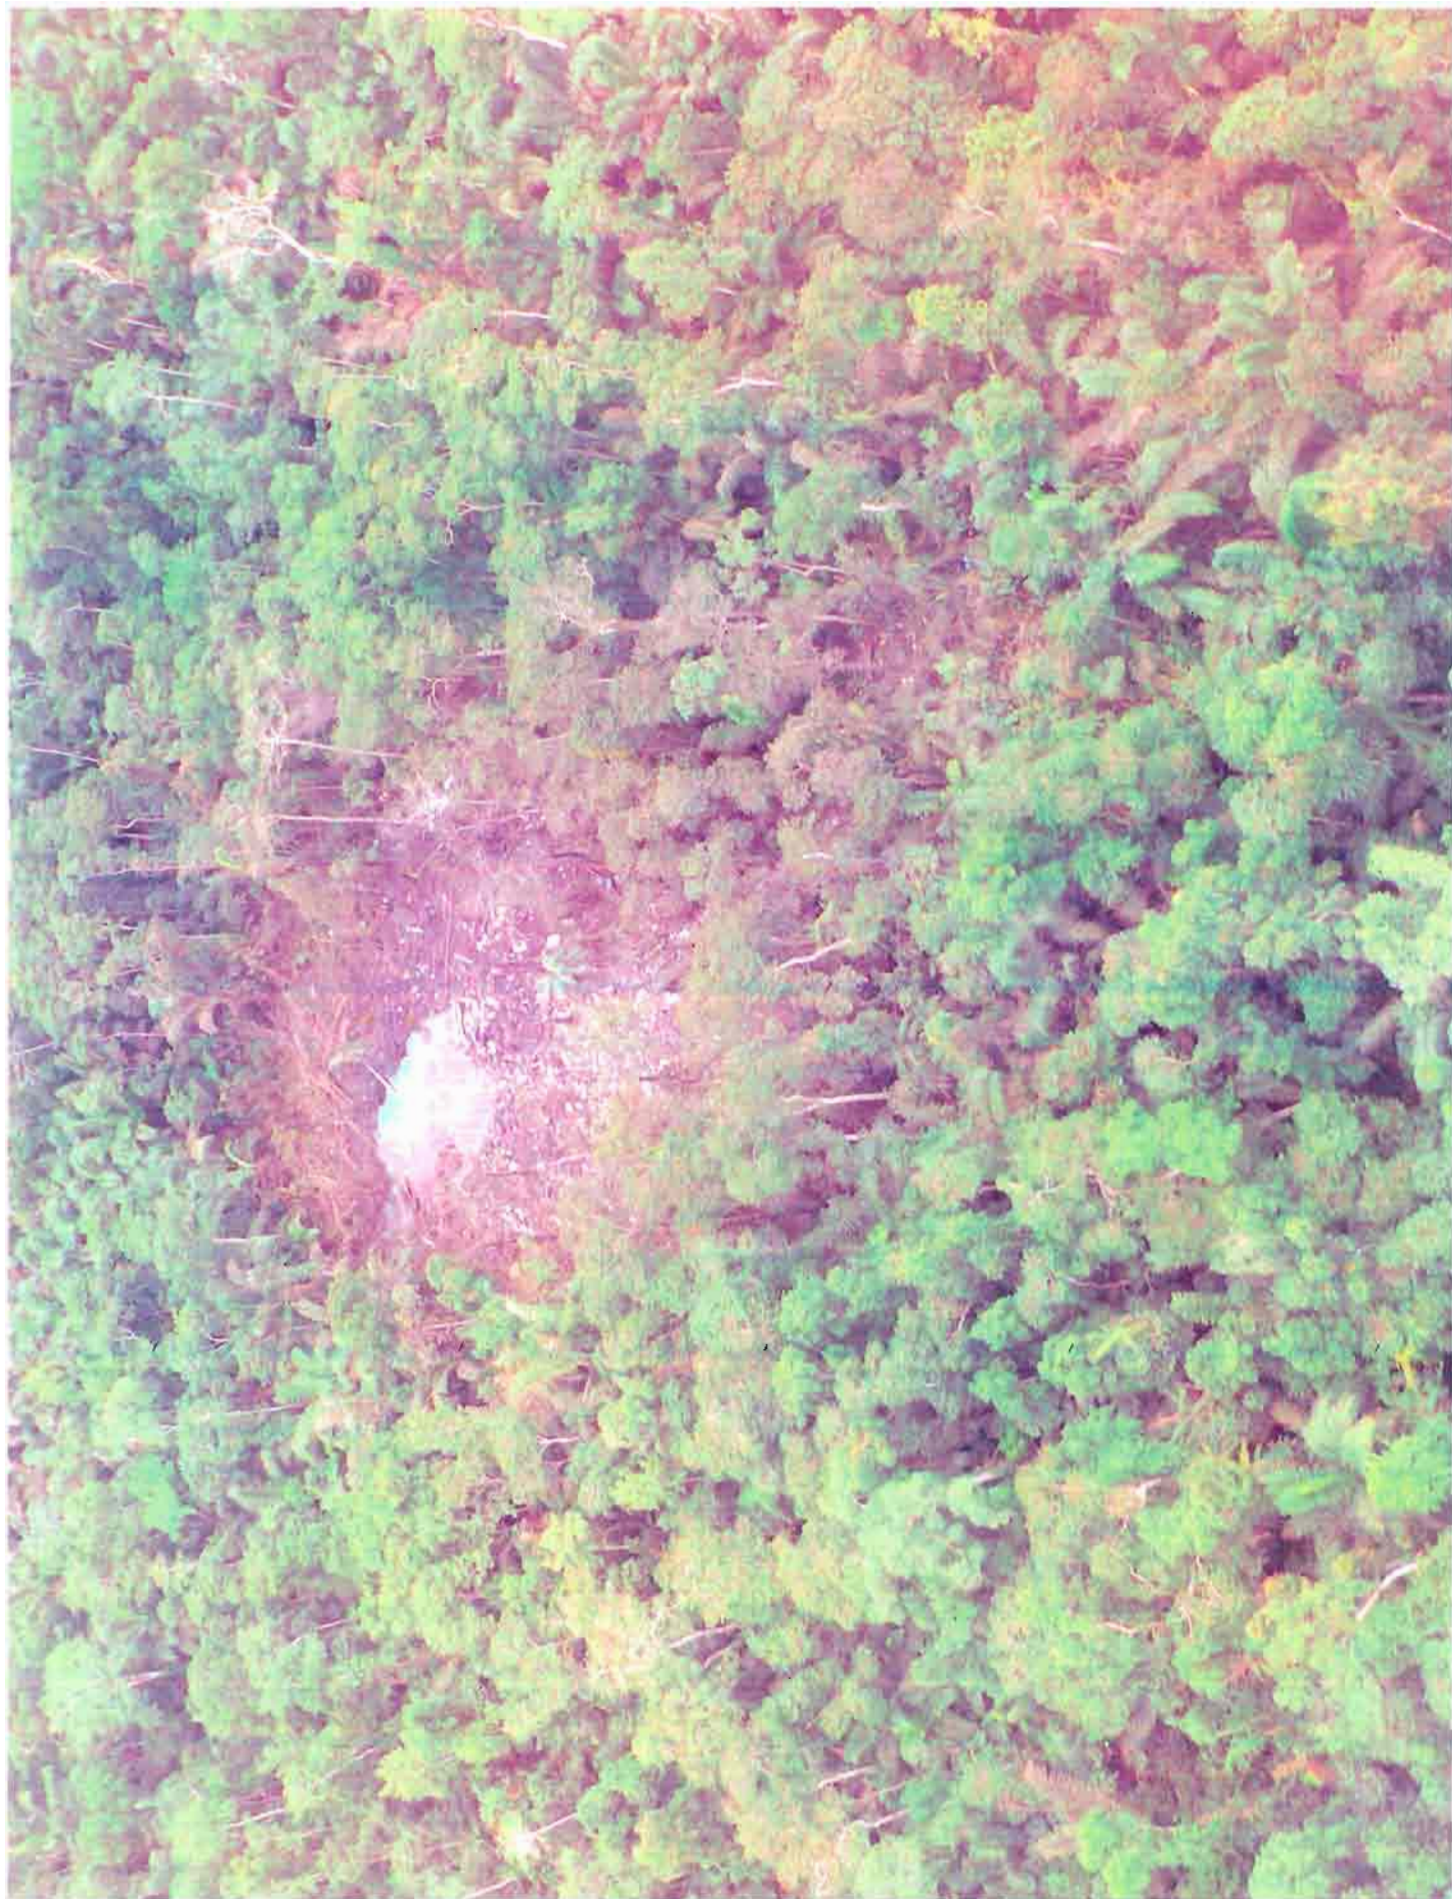
**Aerial photo of crash site**

A significant mass of overturned mud is found on the North West and South West borders of the crater. The vegetation all around is covered with mud up to 30 m away. The trees in the immediate vicinity of the crater are lying down because they were either uprooted or broken. The damage done to the vegetation extends over a surface area of about 2000 m<sup>2</sup>. The North West side of the crater is the most affected.

The content of the airplane (flight deck, cabin and cargo compartment) is found concentrated in the 70° direction as follows: nearest to the crater-economic class (blue seats); next first class (red seats); and finally the front part of the plane.

The detailed plan of the distribution of the significant elements found, as well as aerial photographs of the site and its description are attached to this report as Appendixes 2 and 3.

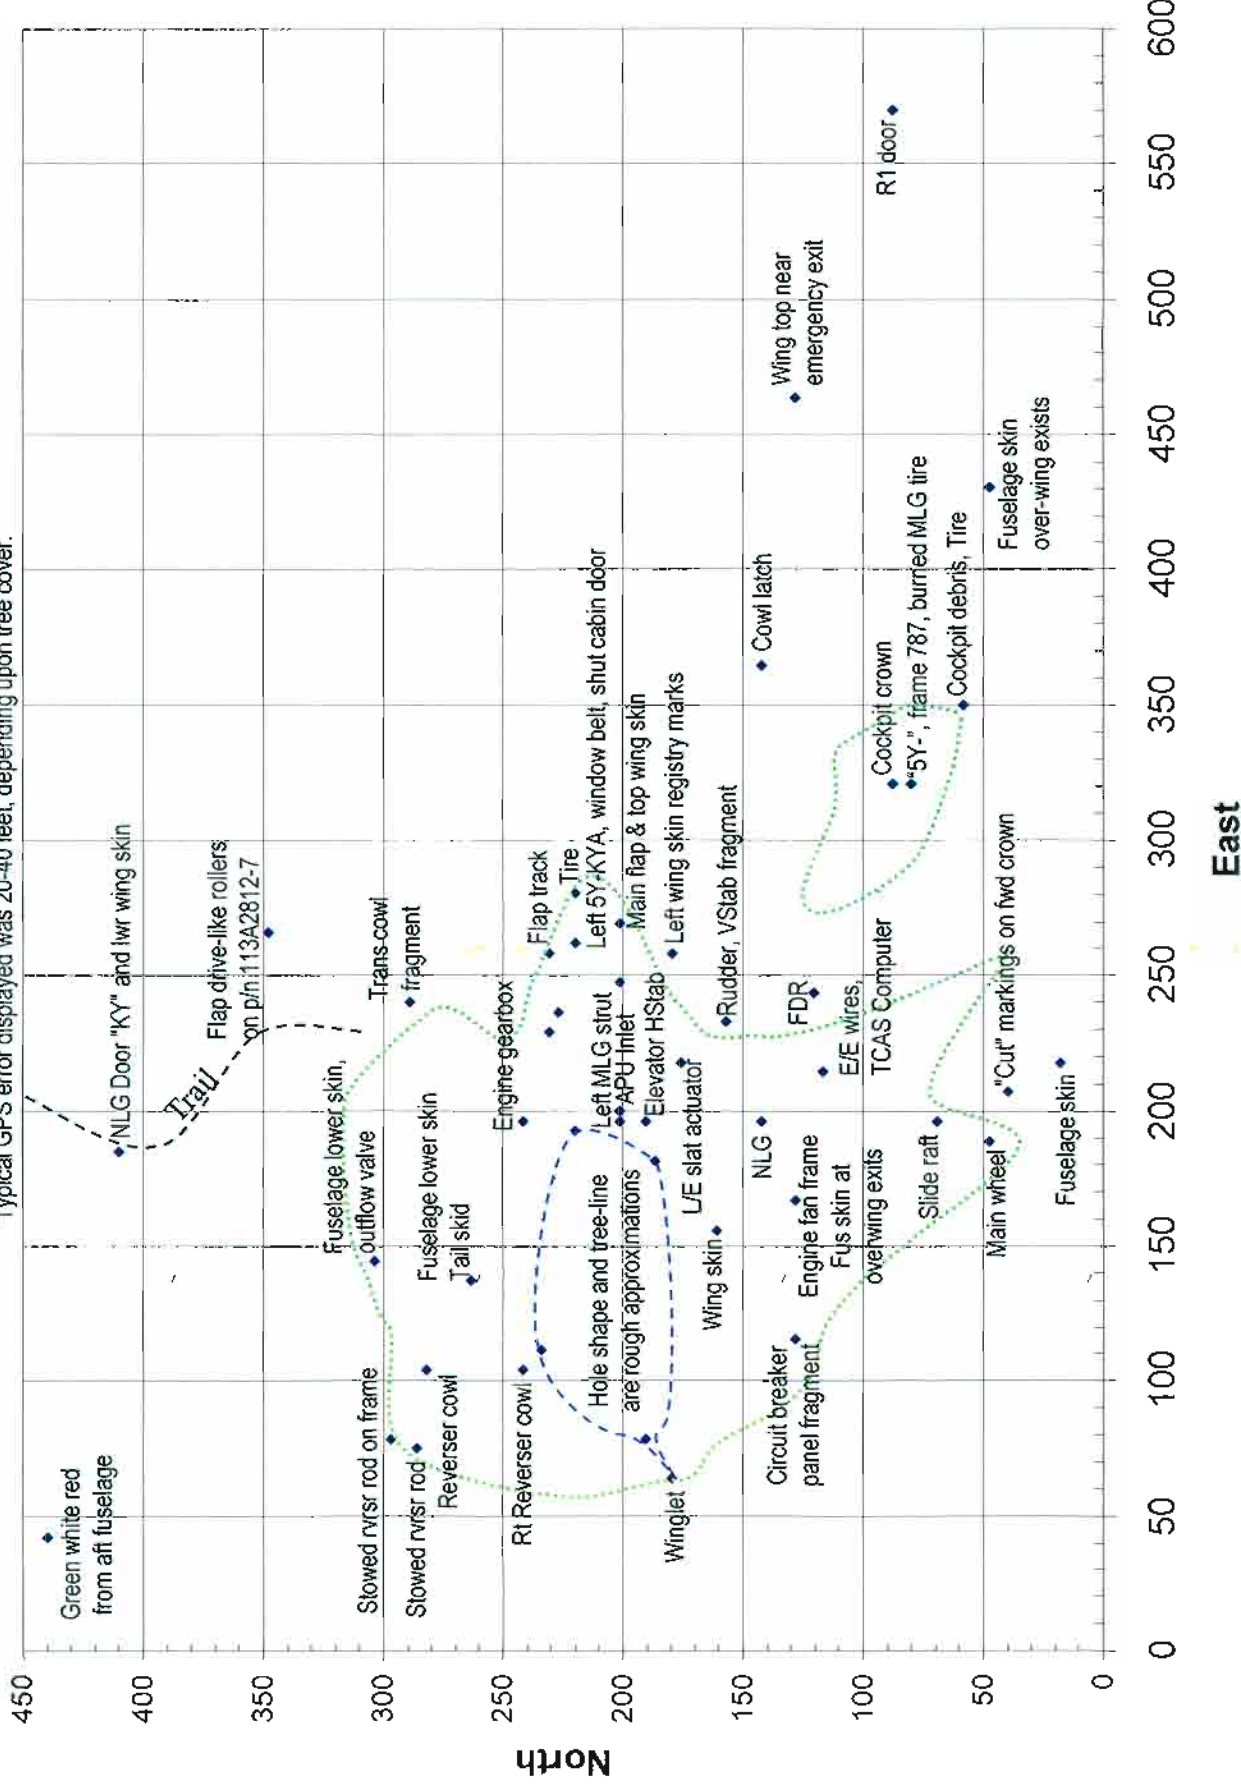
**KA507 Debris Coordinates**

Typical GPS error displayed was 20-40 feet, depending upon tree cover.
