**AVIATION INVESTIGATION REPORT
AIB-2013-0002**

**Onur Air
Airbus 300-605R, Registration TC-OAG
King Abdulaziz International Airport – Jeddah
Kingdom of Saudi Arabia**

**Abnormal Runway Contact (ARC) –
Nose Gear Retracted (SCF-NP)**

10th Jumada-II 1433 H – 01 May 2012 G

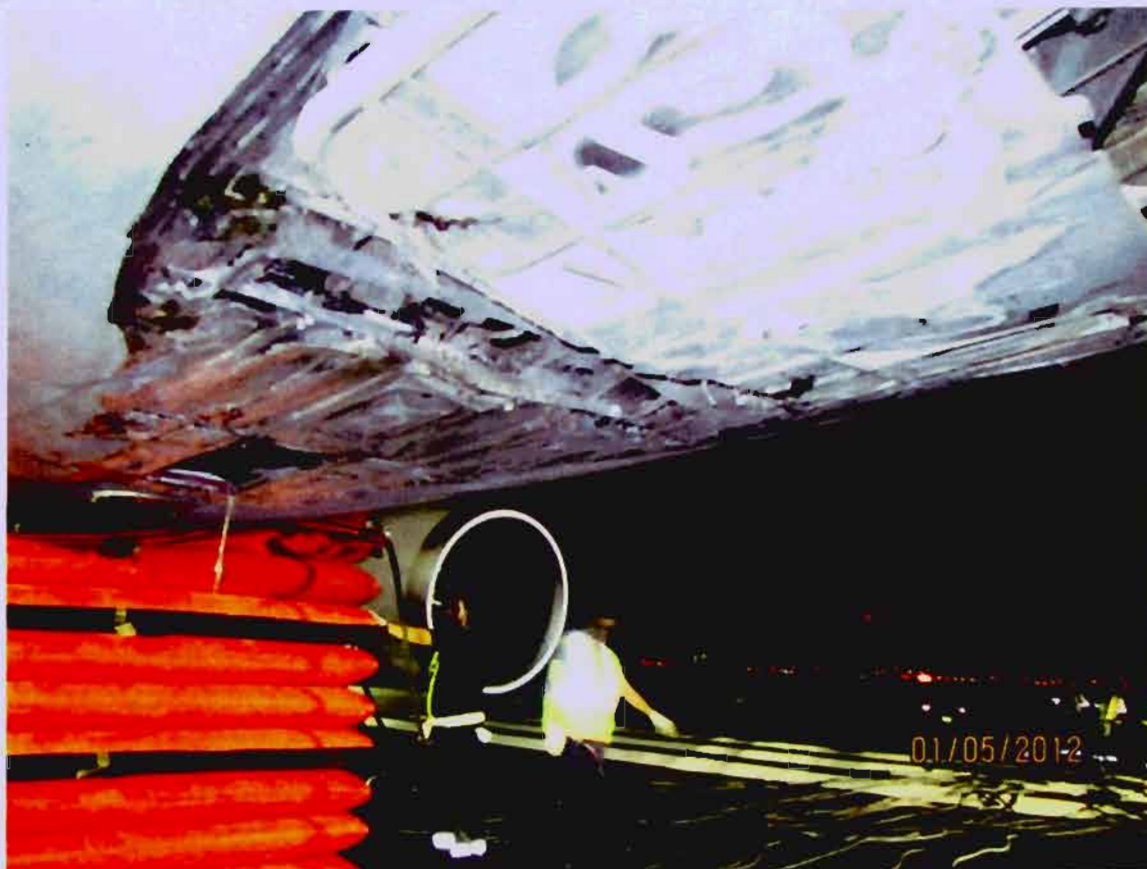
The aircraft sustained substantial damage (Figure 3).

Figure 3: Damage to forward lower fuselage area.

- Parts of the nose gear doors and nose gear door linkages were found on the runway at the 8623 feet mark;
- A small amount of airframe debris was deposited as the aircraft skidded down the runway;
- The majority of the aircraft damage was confined to the lower forward fuselage area aft of the nose landing gear wheel well as depicted at Figure 3.

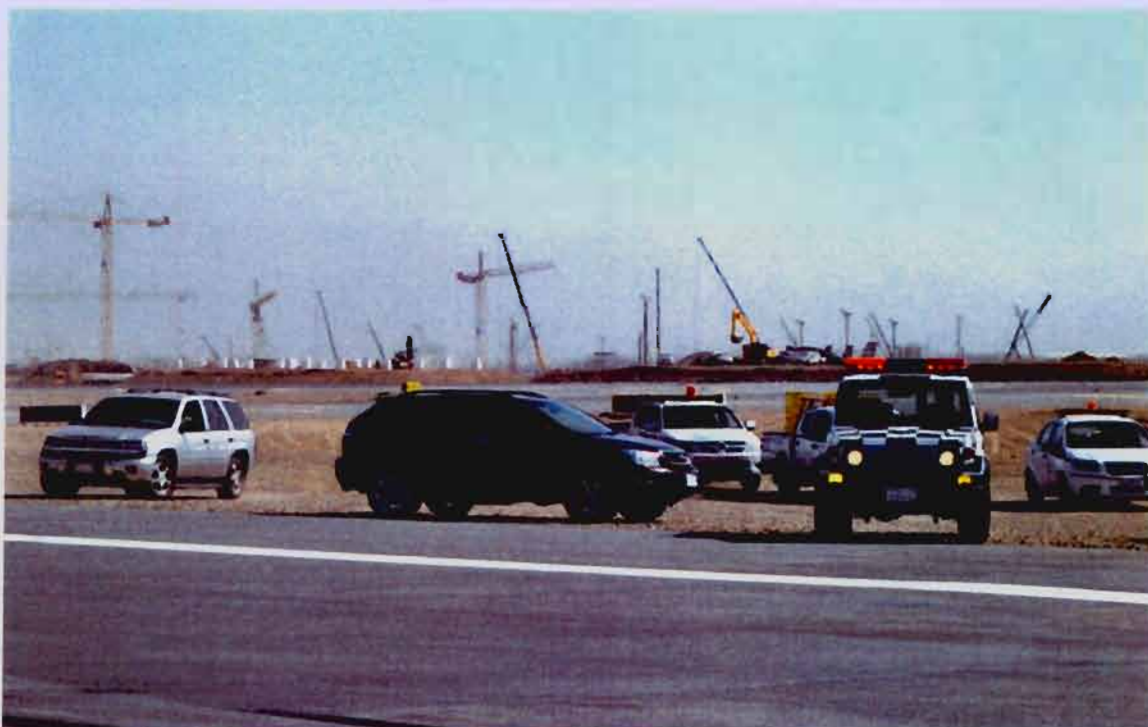
Some vehicles that accessed the area around the aircraft (Figure 11) were not equipped with rotary beacons as required by airport regulations.

Figure 11: Two (2) vehicles without rotary beacons.

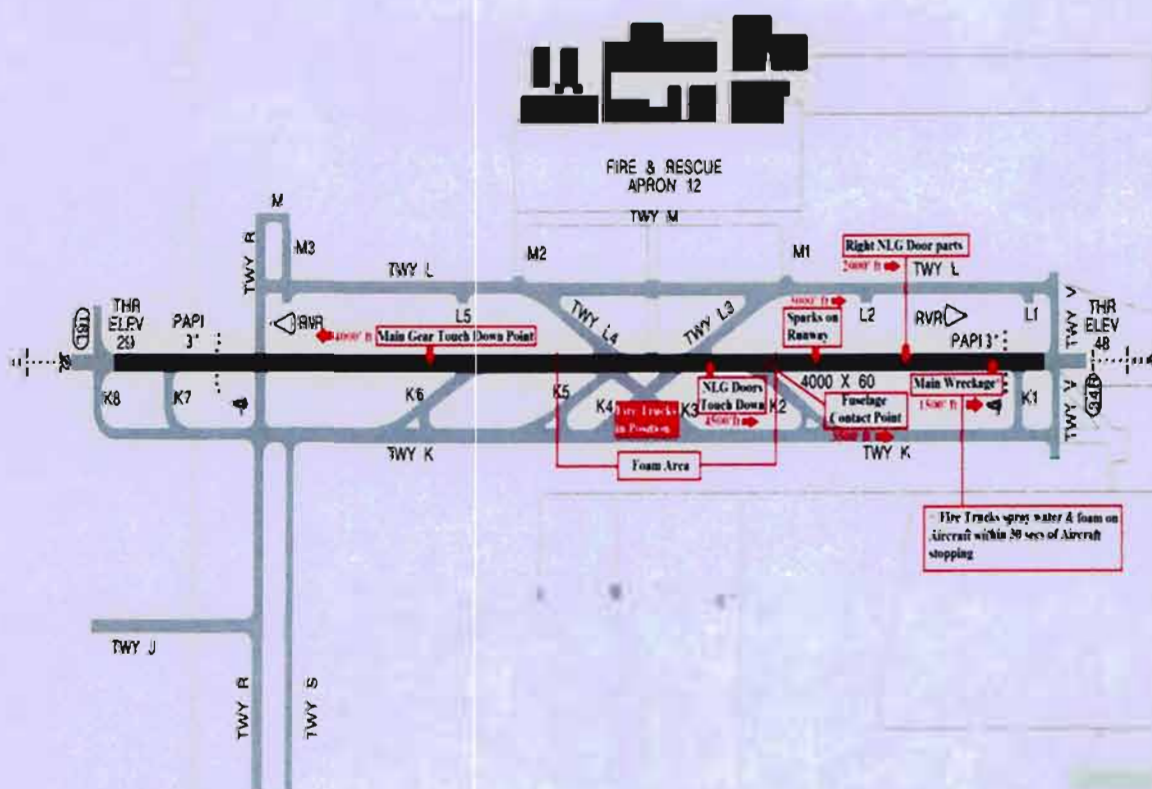
The main landing gear touched down smoothly on Runway 16L at the 4000 foot mark. The aircraft nose doors contacted the runway at the 8623 foot mark of the runway in the end portion of the foamed area.

Figure 12: Runway 16L/34R with details of aircraft contact areas.

Figure 12 shows the details of the aircraft landing points, location of the aircraft contact points for landing gear and the aircraft wreckage site on the runway. The location of FRS vehicles and areas that were foamed are also identified. The runway had been foamed from Taxiway K2 to K5.

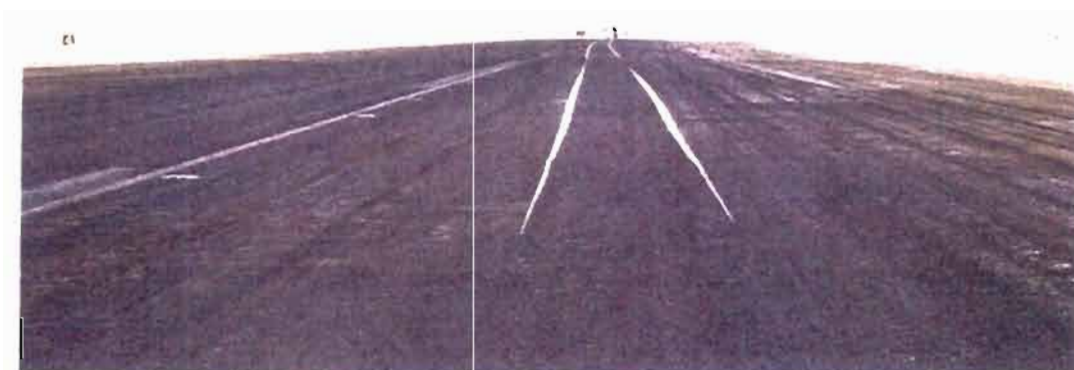
A small amount of debris from the nose gear doors and linkages was deposited on the runway along the landing path. The aircraft doors initially contacted the runway as identified in Figure 13.

Figure 13: The two lines in the runway indicate the contact area between the aircraft nose landing gear doors and the runway.

The markings from the aircraft structure contacting the runway were noticeable (Figure 13). The aircraft continued to roll on the main gears into the area of the runway that had been foamed. At the 10,623 foot mark, the fuselage contacted the runway beyond the foamed area (Figure 14).

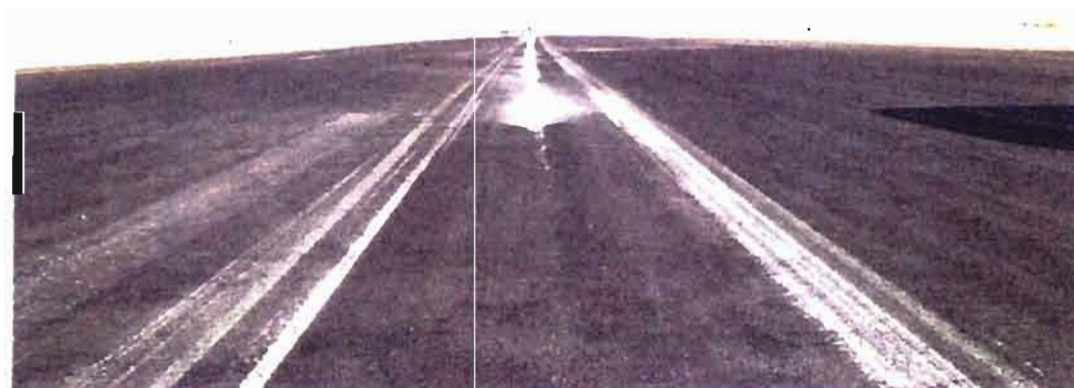
Figure 14: Contact point of fuselage on the runway.

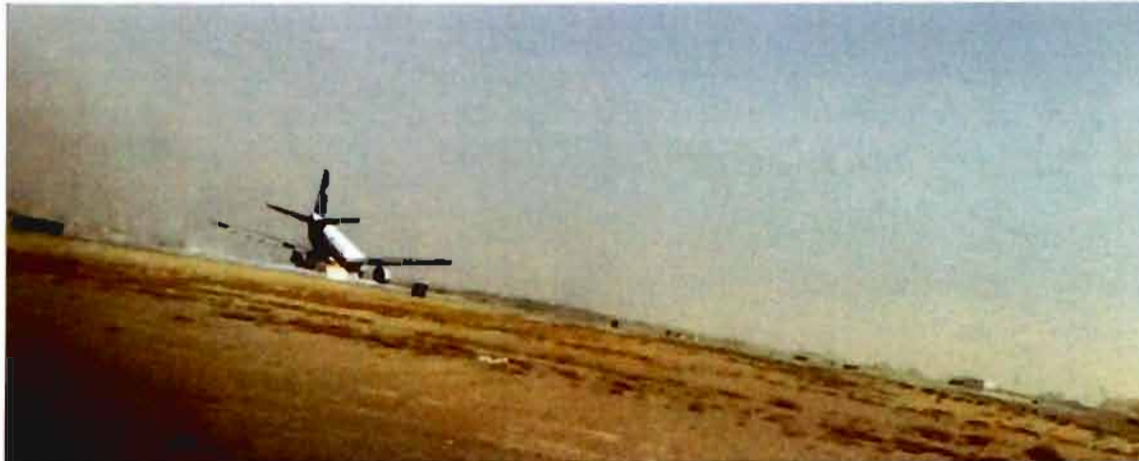
Sparks were generated due to the friction between the aircraft structure and the runway, but there was no fire (Figure 15). The aircraft continued down the runway with the nose doors being torn away from the fuselage. Small pieces of metal and fiberglass material were deposited along the aircraft landing path.

Figure 15: Sparks from friction resulting from the aircraft contact with the runway.

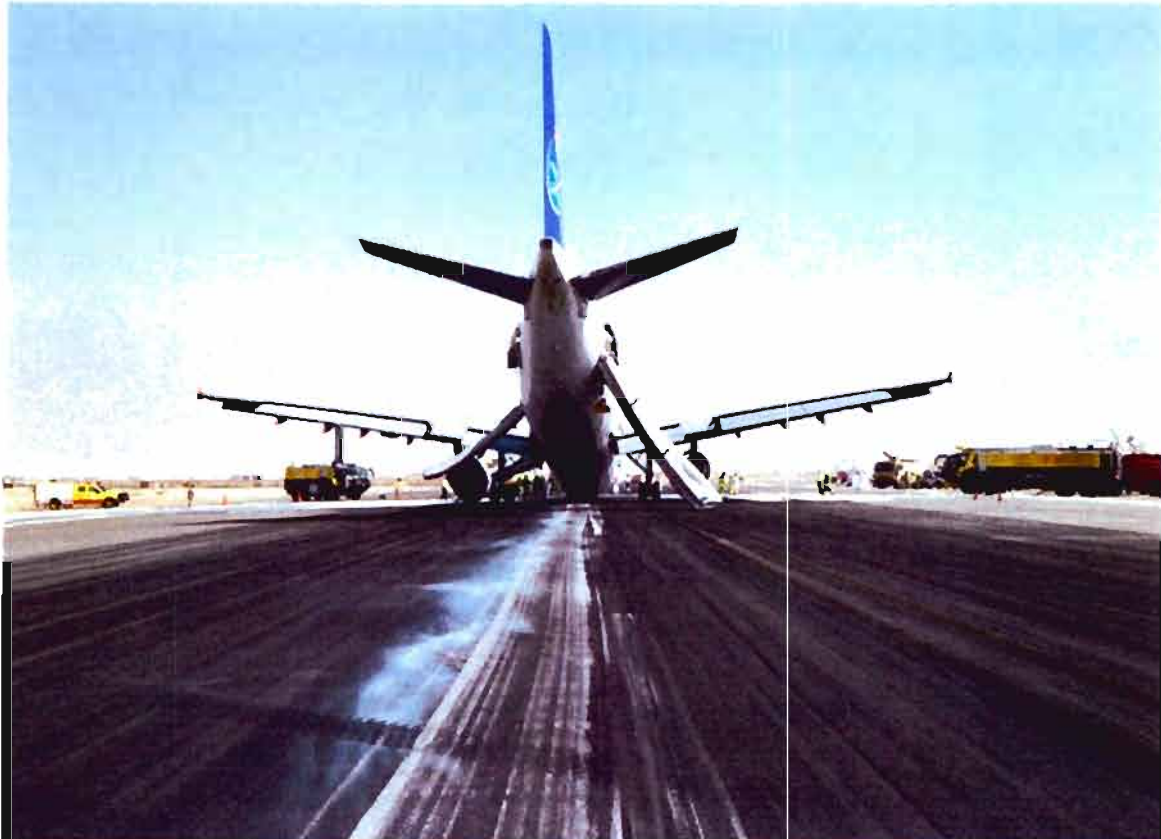
In order to evacuate the smoke from the cabin, FRS personnel opened the L2, L3 and R4 doors. Since those doors were still in the "Armed" position, their related slides inflated (Figure 16). A crew member then disarmed the other doors prior to their opening.

Figure 16: Wreckage site: Rear slides inflated and not usable. Fuselage markings on runway.

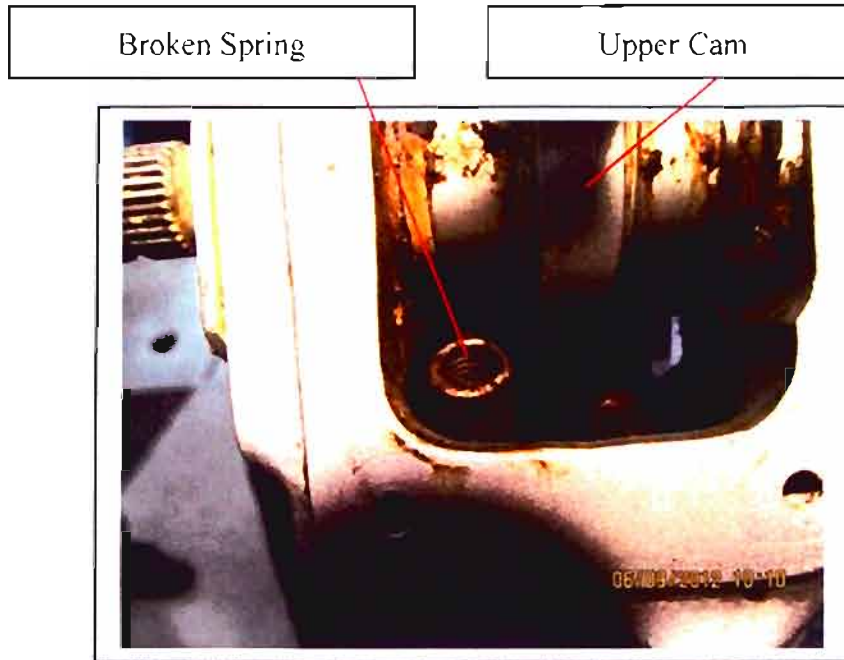
- During the application of Subtask 32-31-20-700-007-A01 load test, the slide valve load test force of 191N was applied. The limit for the test was not to exceed 170N.
- During the application of subtask 32-31-20-790-004-A01 (2) (b) leakage test, the hook unlocked under a pressure of 206 bar as a minor leak from a plug had been observed.

Figure 18: Spring broken in NLG uplock assembly.

The unit was sent to be disassembled for internal examination. During the stripping process, the investigation team found one spring, P/N GA71102, was broken (Figure 18). A detailed view of the broken spring coil is shown in Figure 19.

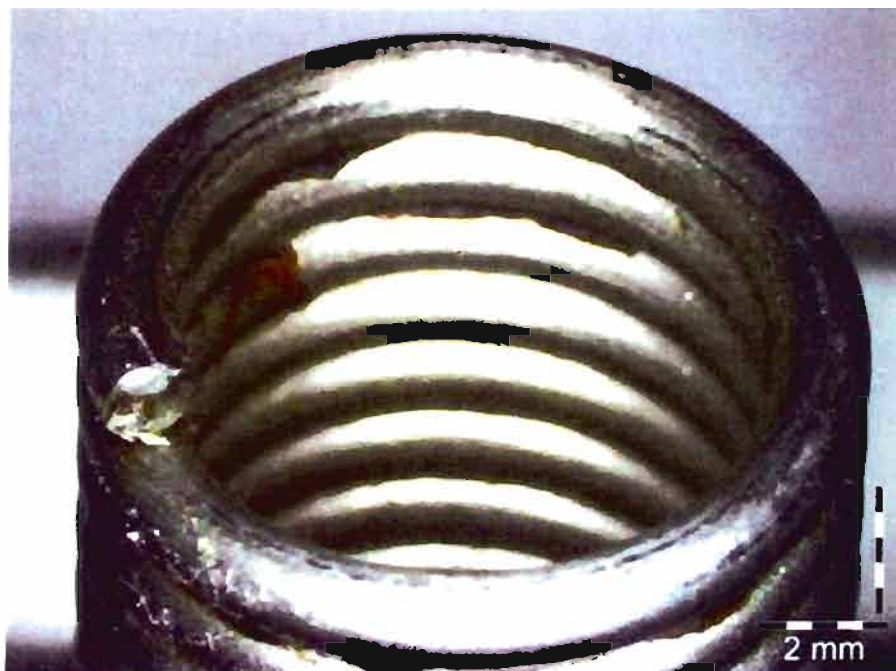
Photo 7.2: Long 1/2 spring
(No cleaning)

Figure 19: Detailed view of fractured area of broken spring.

These spring sections were identified as the “long spring” and the “short spring.” According to the component maintenance manual, the broken spring was one of the two springs, which actuate the mechanical unlocking lever during the emergency lowering of the nose landing gear. During testing, the broken long spring made contact with the cam which could have prevented the free fall unlocking mechanism to function properly.

Further examination of the spring by microscope indicated that the breakage of the spring started with fatigue and continued for some time with the spring static breakage eventually occurring.

The spring, Part Number GA71102, was found fractured as a result of the fatigue process initiated at the third coil of the spring. The cam of the NLG up-lock was also inspected, revealing damage on the cam resulting from verifiable hard contact points made by the long spring during NLG operation. Some of these marks indicated the long broken spring had been in a position perpendicular to the cam body during the NLG operations and could have prevented normal operation of the NLG up-lock in both normal and free fall operations.

Two modifications had been previously made to the type of spring used inside the NLG up-lock. The initial spring installation in the NLG up-lock had evolved from PN A80013 to PN A80013-1, through a Vendor Service Bulletin (VSB) 470-32-035 to prevent uncoupling as a result of an improper resetting after the emergency unlocking of the landing gear on the aircraft. Spring PN A80013-1, evolved to the present spring installation, P/N GA71102, through VSB 470-32-463 in order to eliminate the risk of failure of the springs, which connected the unlocking lever. It was reported in 2006 that MBD had launched a comparative test program between spring GA71102 and a modified spring. However, the test results were not conclusive enough to launch a spring product improvement. No improved spring replacement scheme had been initiated since that time.

- Effective 20 July, 2012, Airbus released a Mandatory Service Bulletin Number A300-32-6111 for the inspection of up-lock springs.
- Effective 30 July 2013, the European Aviation Safety Agency (EASA) issued an Airworthiness Directive Number (No.) 2013-0150 due to the reporting of NLG and Main Landing door and up-lock spring ruptures on some models of A300, A310 or A-300-600. This document is located in Appendix A.

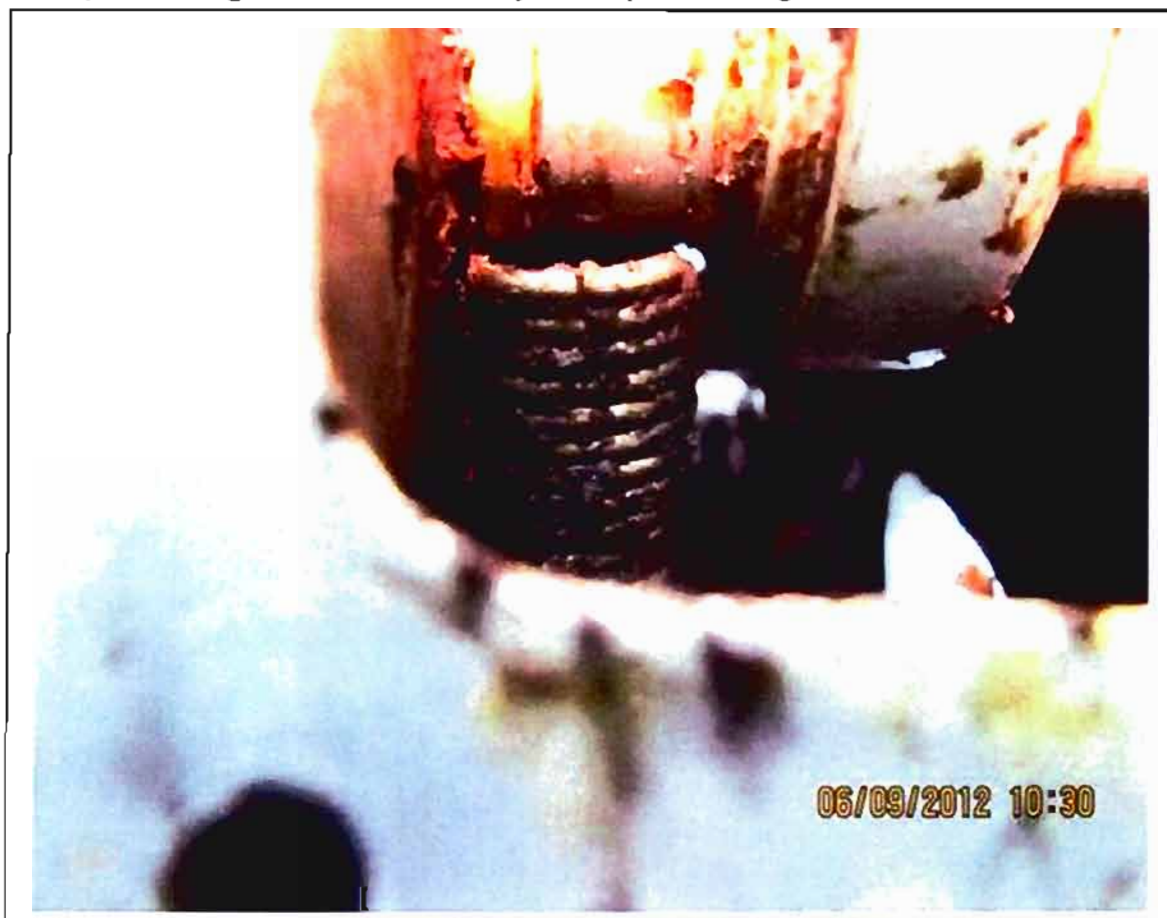
Figure 20: Spring jammed in NLG up-lock.

The long spring had the capability of rotating with an angular trajectory of nearly 180 degrees. Figure 20 shows the broken long spring making contact

However, the aircraft NLG up-lock case contained a broken spring that jammed the NLG up-lock mechanism, not allowing the nose landing gear to extend and lock into position.

- The long end of the broken spring became a mechanical stop as the long spring wedged against the cam as noted in photograph at Figure 20.

The broken spring caused a mechanical jamming of the cam and would not allow the locking lever to rotate, preventing the NLG hook to rotate and unlock the NLG.

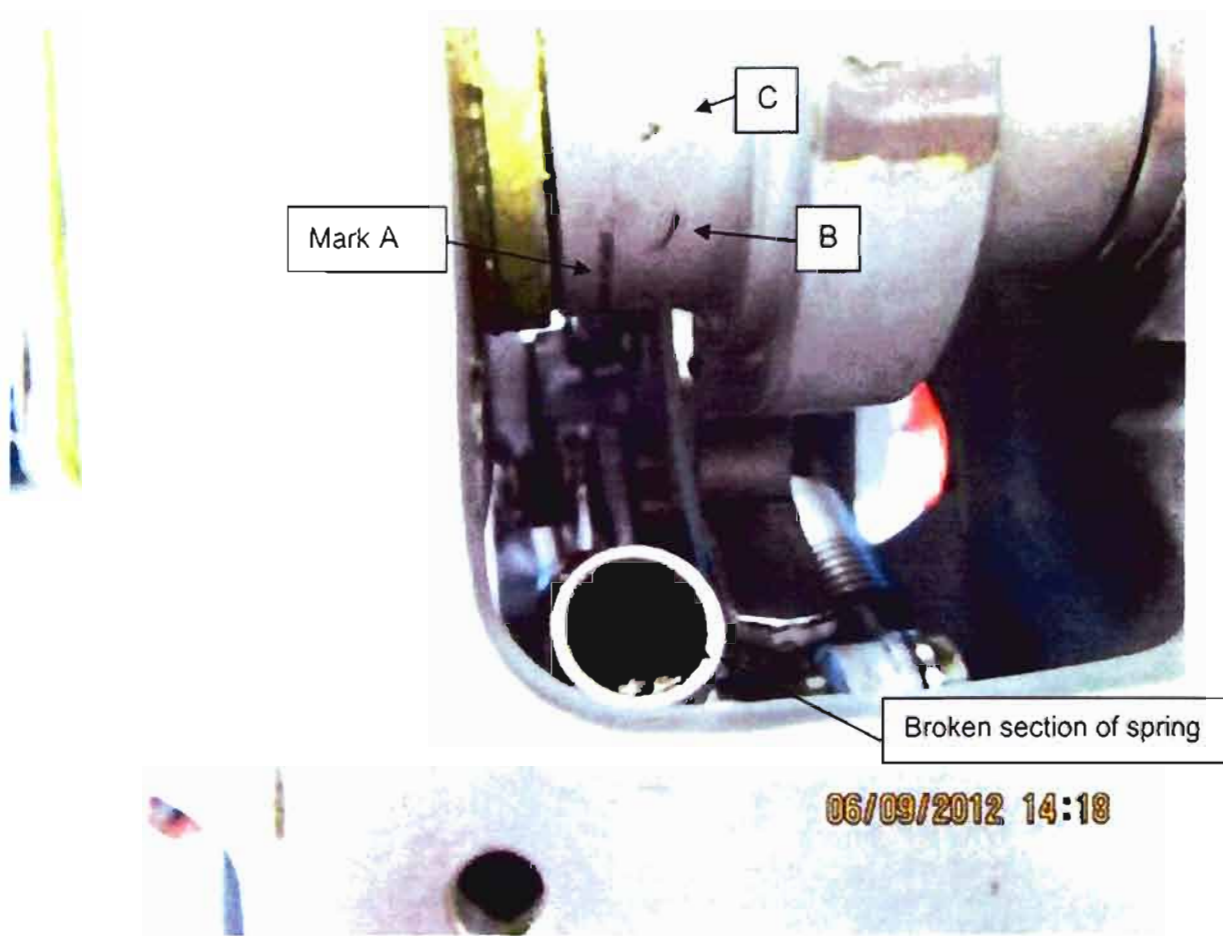
Further detailed examination of the damaged area of the cam is noted on Figure 21. The damage areas identified as areas A, B, and C are a result of contact with the broken section of the long spring.

Photo 5.6: Relation between marks B and C and broken section of spring
(Photo by GACA at Molsheim investigation after mechanism cleaning)

Figure 21: Damaged areas of NLG up-lock found during investigation.

Figure 21, photograph 5.6 detailed the marks noted on the cam and are identified showing the relationship between the broken spring movement in the NLG up-lock and the marked areas of the cam.

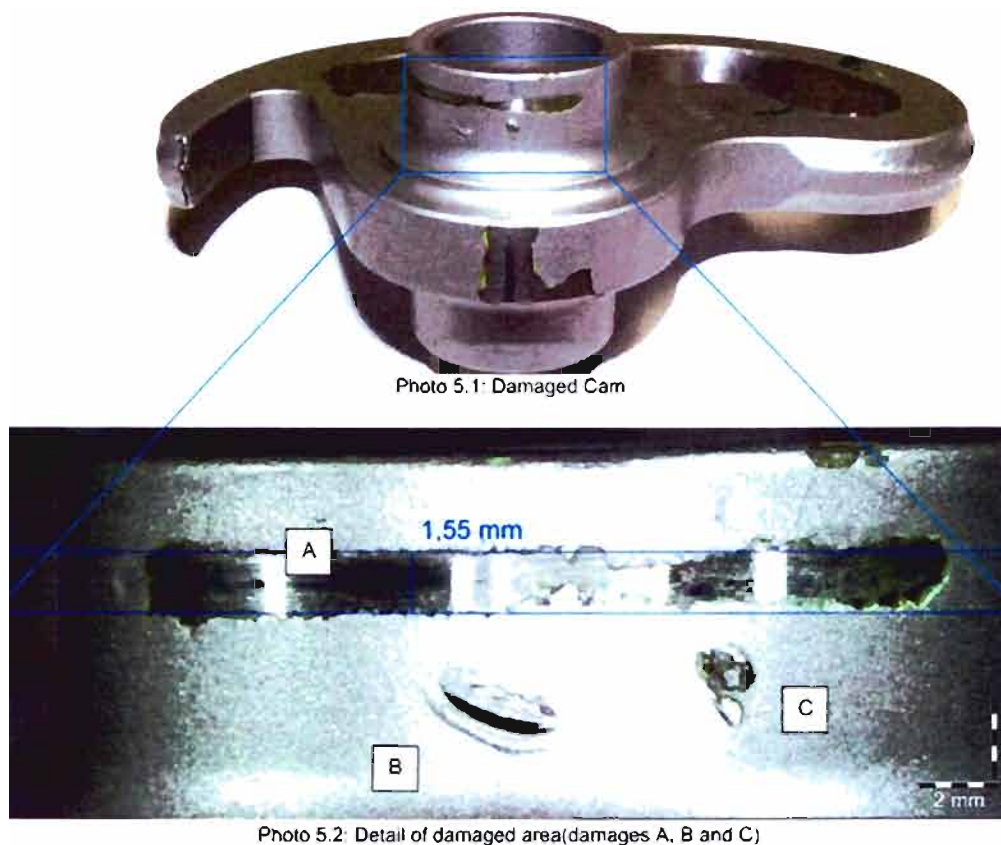
Figure 22: Photo 5.2, Damage areas of cam. Areas A, B, and C in relationship to Photo 5.1

As identified in Figure 22, Photos 5.1 and 5.2, the wear marks noted on the long spring are related to the “mark A” on the cam. An enlarged view of the spring contact surface area shows the width of the marks on the spring body (Figure 23, Photo 5.3) is equivalent to the marks width on the cam (Figure 22, Photo 5.2, Area “A”).

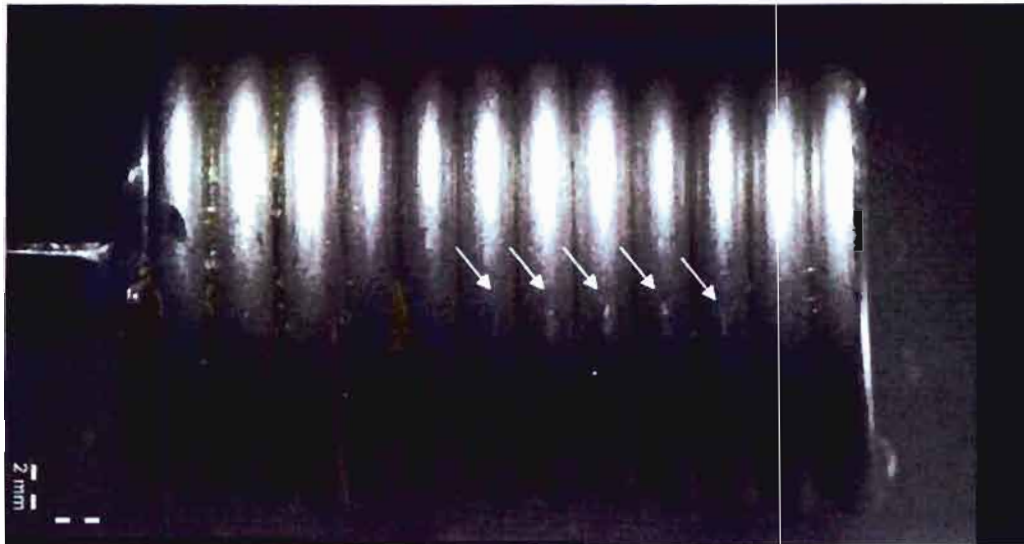
Photo 5.3: Wear marks on spring body related to mark A on Cam

Figure 23: Photo shows wear marks on long spring.

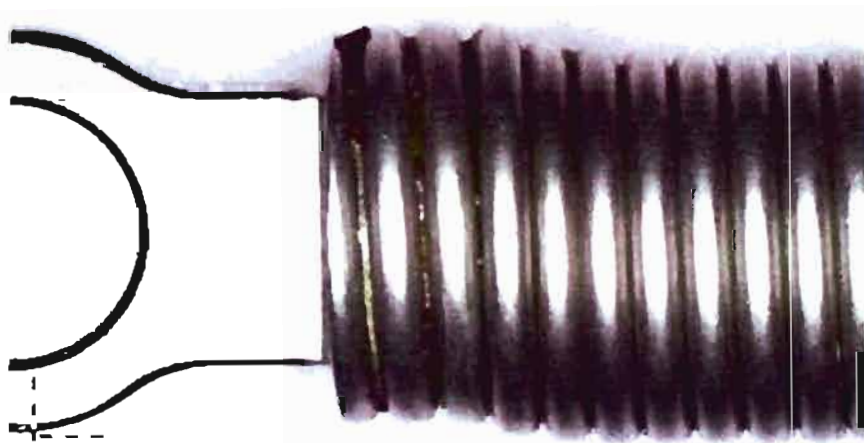
Photo 5.7: Deformation of broken spring body

Figure 24: Deformation of spring

The deformation of the broken long spring body is noted in Figure 24, Photograph 5.7. The relationship between the deformation of the broken long spring and the contact area on the cam can be viewed in Figure 25, Photograph, 5.8.

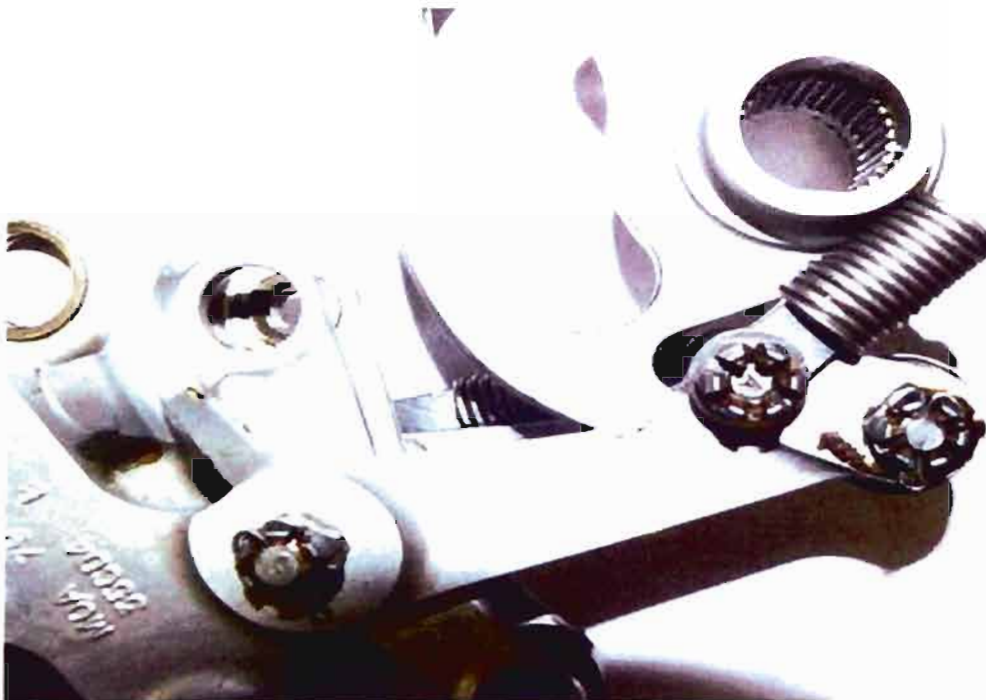
Photo 5.8: Deformation of broken spring body

Figure 25: Cam and deformation of broken long spring against cam.

The previously mentioned photographs clearly show that the broken long spring had been contacting the cam on numerous occasions.
