**Aviation Safety Council**

**GE 235 Occurrence Investigation  
Factual Data Collection  
Group Report**

**July 02, 2015**

**ASC-FRP-15-07-001**

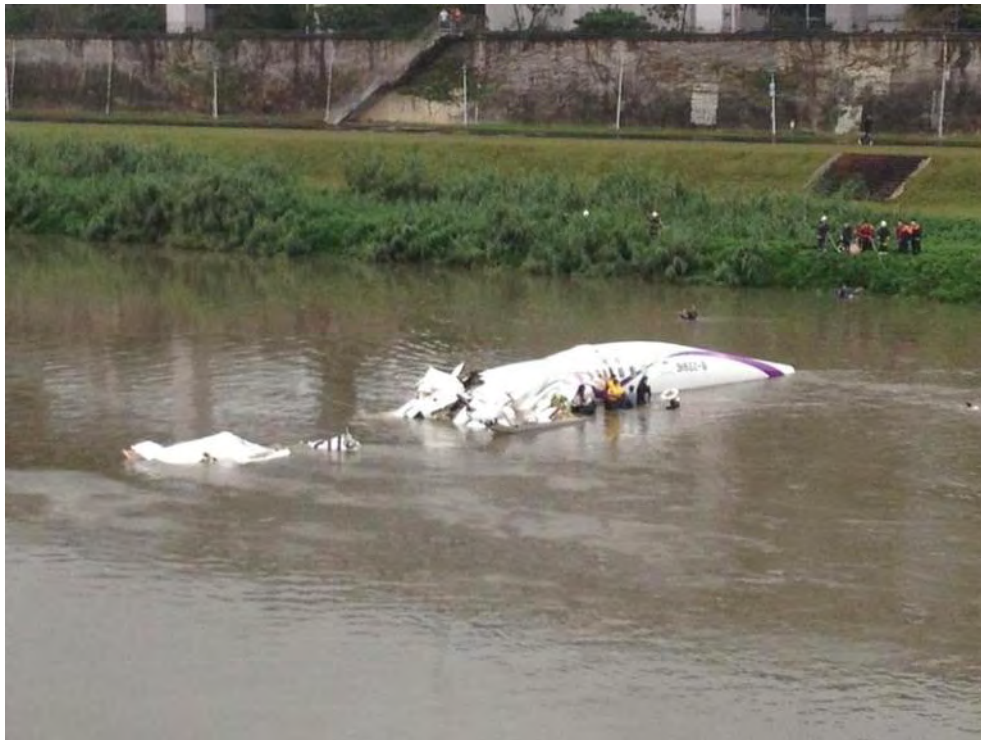
Figure 1.1-1 GE235 main wreckage

On February 4, 2015, an ATR72-212A(600 version) aircraft, registered B-22816, was operating as a TransAsia Airways (TNA) flight GE235 with 58 occupants on board, including 2 captains, 1 first officer, 2 cabin crews and 53 passengers. At 1054<sup>1</sup> Taipei Local Time, approximately 3 minutes after taking off from runway 10 of Songshan Airport (RCSS), the flight crashed into Keelung River approximately 3 nautical miles east of RCSS. The airplane was destroyed on impact and more than half of the main wreckage was immersed in the middle of the river (Figure 1.1-1). Forty-three occupants, including 3 flight crewmembers, 1 cabin crew and 39 passengers, were fatally injured. The other 13 passengers and 1 cabin crew sustained serious injuries and 1 passenger received minor injuries. When GE235 flew over an overpass before crashing into water, its left wing hit a taxi with two occupants. The taxi driver sustained serious injuries and the passenger sustained minor injuries.

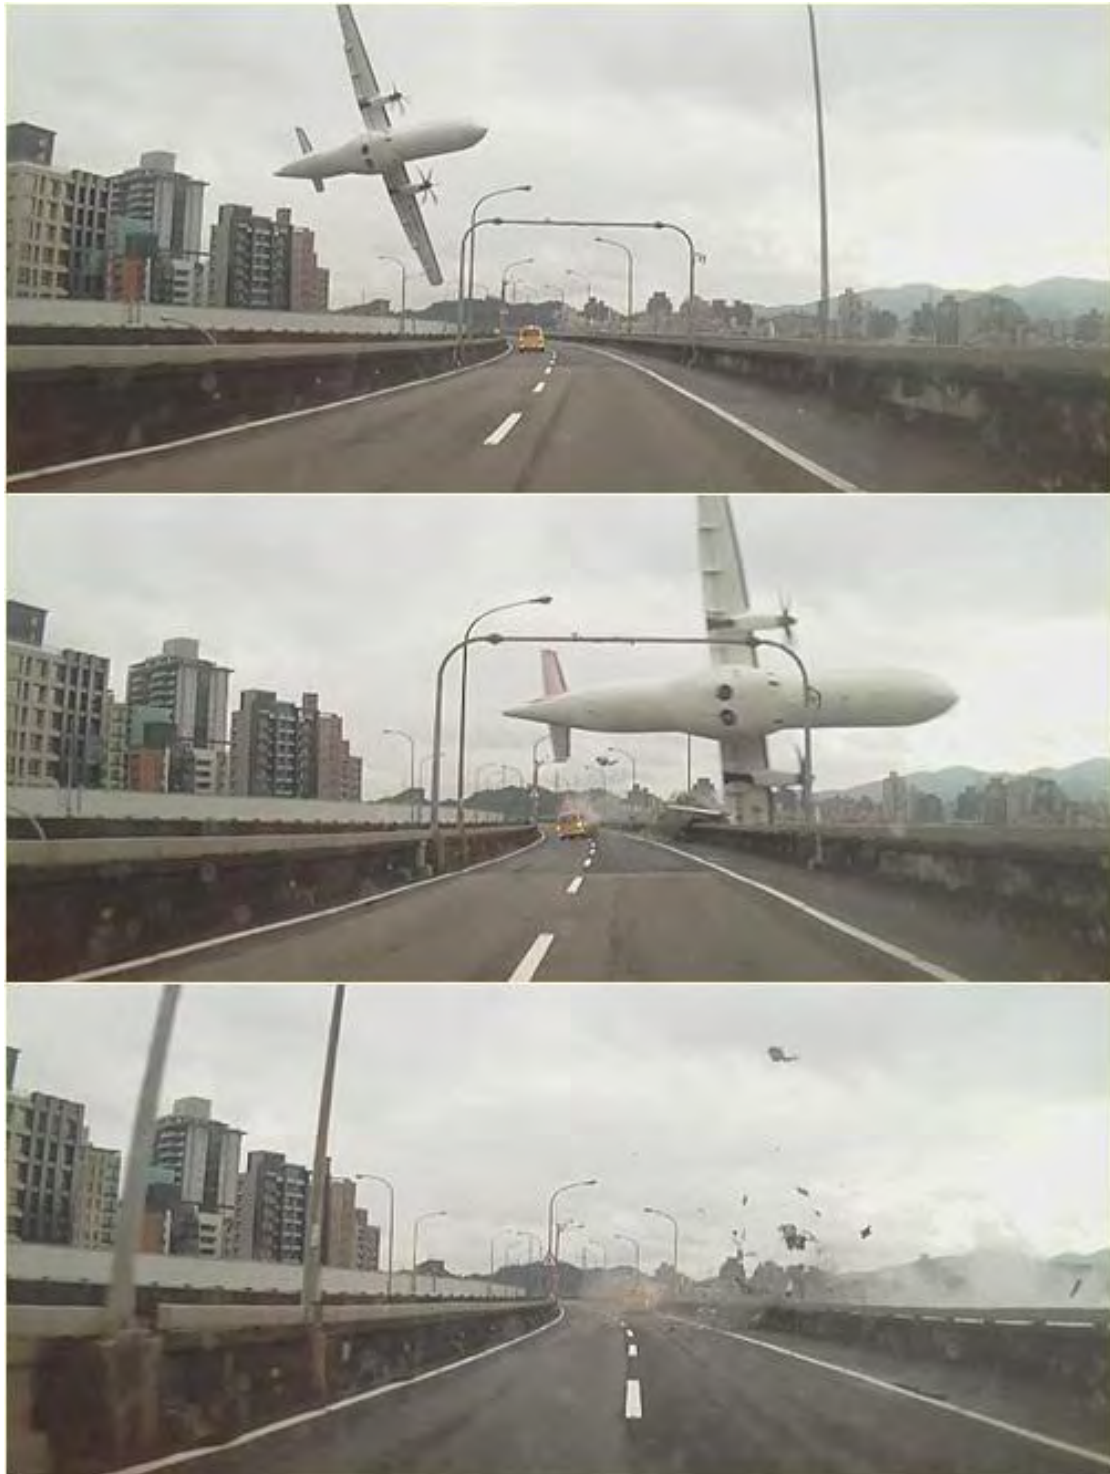
Figure 1.1-1 GE235 lost control and first impact picture

At 1054:20, the ENG1 condition lever was moved out of shut off position, at 1054:25, the ENG1 high pressure speed (NH1) rose to 30 % and the speed at that moment was 106 knots, the altitude was 400 ft, and the airplane started to bank to the left. At 1054:27, PF said “*wow pulled back the wrong side throttle*”.

At 1054:34, Enhanced Ground Proximity Warning System (EGPWS) “Pull-up” warning sounded in the cockpit. At 1054:35 the airplane increased bank from 10 to 80 degree left side, made first impact with a taxi driving on the overpass, then hit the fence and a light pole at the edge of the overpass located southwest of the crash site near Keelung river (Figure 1.1-3), and continued to bank left after impact, then crashed into the river with an upside down attitude.

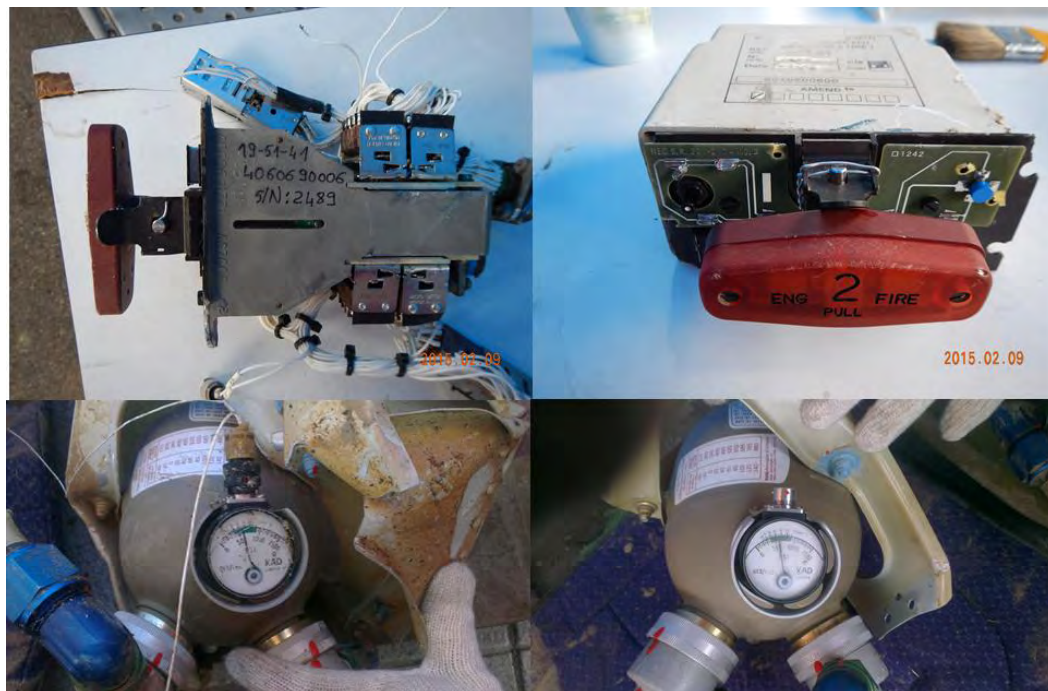
<sup>3</sup> The speed described in this report is computed air speed.

When the fire handle is pulled, feathering is performed identical to that of the automatic feathering system. Upper two photos of Figure 1.6-3 show that both safety wires of No. 1 and No. 2 fire handles are secured in place. Lower two photos of Figure 1.6-3 show the pointers of two fire bottle pressure gages are in the green ranges.

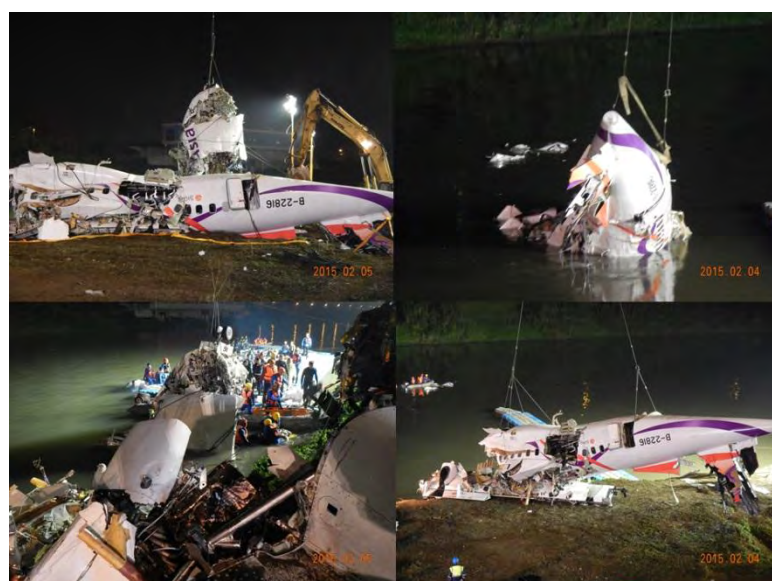
Figure 1.12-1 Wreckage recovery operations

The aircraft wreckage was broken into the cockpit and middle/aft fuselage two major portions with its nose immersed in the mud of riverbed. A floating bridge and three heavy lift vehicles were deployed by the Army Engineering Corps to facilitate the rescue of the victims and recovery of the aircraft wreckage. While the search and rescue operations were continuously going, the salvage operation of aircraft wreckage was commenced in the late afternoon of the occurrence day. The FDR and CVR of the aircraft were found at 1605 local time and had been delivered to ASC. Figure 1.12-1 showed that those two major portions of the wreckage were lifting up and moved to offshore ground of the river. By the late afternoon of day two salvage operation, the aforementioned two major portions and both engines were all successfully recovered.

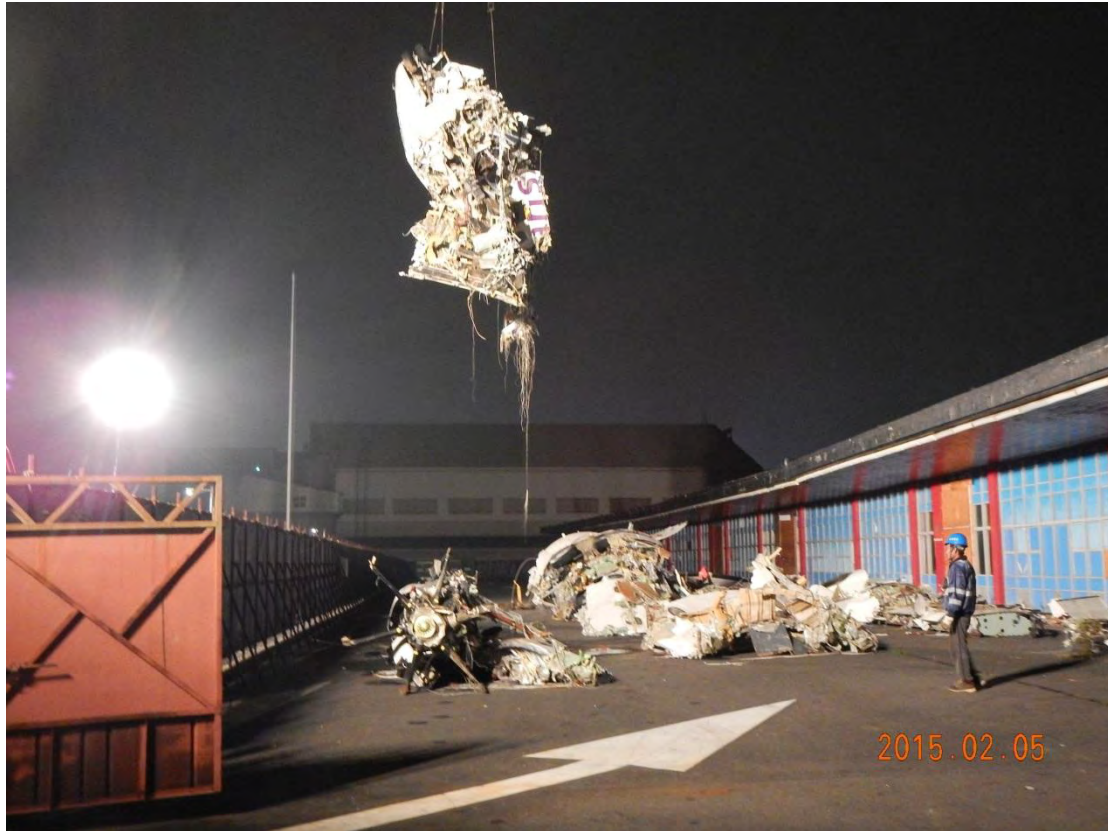
Figure 1.12-5 Temporary wreckage storage site

Figure 1.12-5 shows the aircraft cockpit portion was lifted and moved to the wreckage storage site. The locations of wreckage were arranged as two dimensions reconstruction of whole fuselage. The aircraft emergency locator transmitter (ELT) was deactivated on February 06 after being notified by Songshan airport.

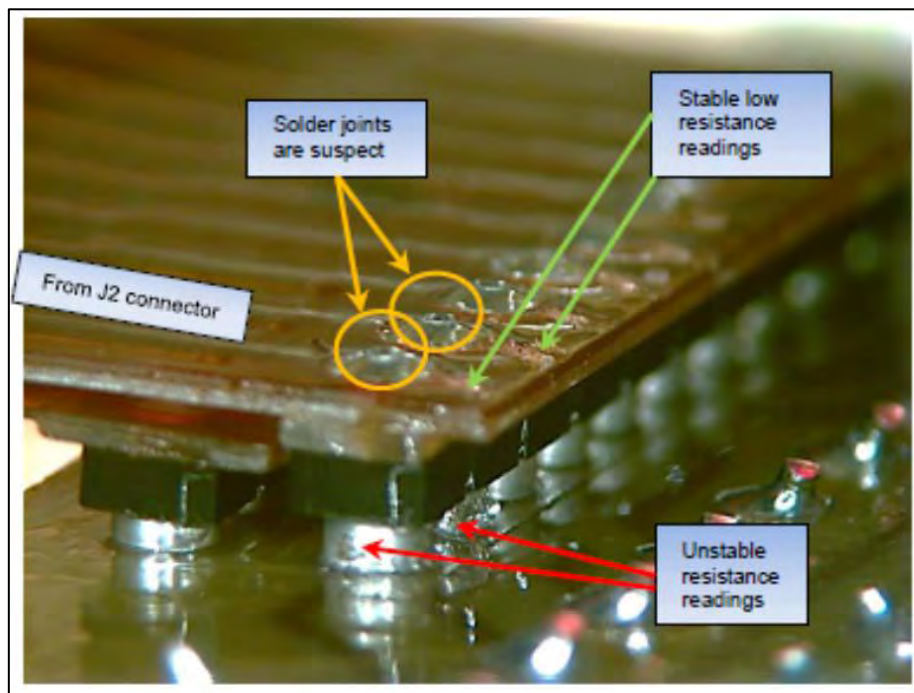
Figure 1.16-2 Continuity check of pin J and A2 board

- The resistance ( $R_{X1}$ ) measured between pin J and point X1 provided a value consistent with the maximum resistance value provided by the CMM. Moving the ribbon did not affect this value.
- The resistance ( $R_{X2}$ ) measured between pin J and point X2 provided a value greater than  $R_{X1}$ , which was unstable and changed while the ribbon was moved.
- The resistance ( $R_{X3}$ ) measured between pin J and point X3 provided a value greater than  $R_{X1}$ , which was unstable and changed while the ribbon was moved.

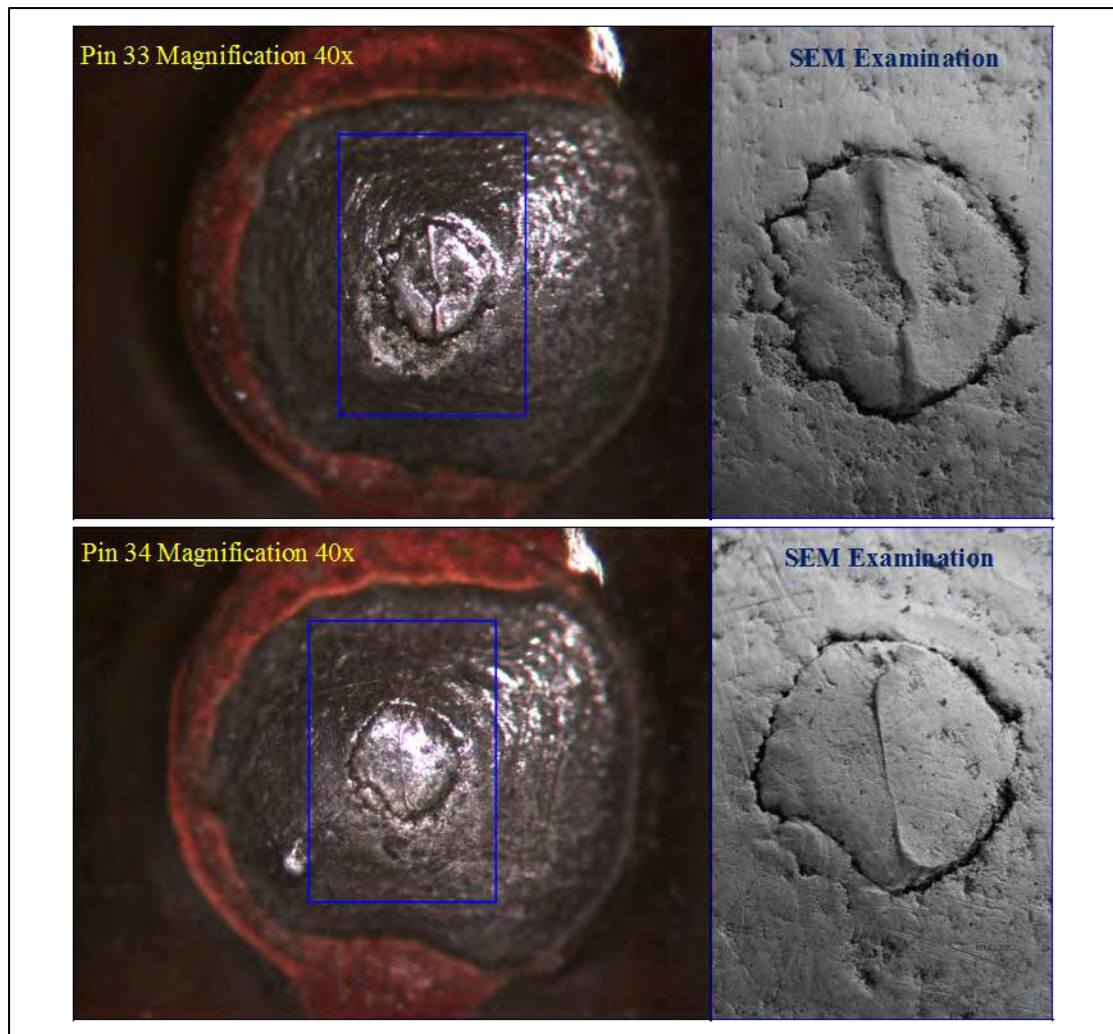
Figure 1.16-3 Pins 33 and 34 with 40X magnifications and with SEM

A CT-Scan (Computed Tomography) of J2 solder joints was performed and potential solder cracking was identified. A destructive test was performed to find the possible root cause of continuity failures inside the 90°connector of J2 flex circuit. The J2 flex circuit was cut out of the CCA (Circuit Card Assembly) and housing. Pins 33-42 of J2 flex circuit was examined using optical microscope and with the SEM (Scanning Electron Microscope). Figure 1.16-3 shows the photos of Pins 33 and 34 with 40X magnifications and with SEM examination. The Pins 33-42 of J2 flex circuit was cross sectioned to the component centerline and examined. Figure 1.16-4 and 1.16-5 show the photos of cross sectioned pin to flex solder joints of Pins 33 and 34. The Pin-Flex solder joints displayed a coursing of the solder micro structure near the pin on each of the 10 pins in the strip. The condition was most advanced on pins near the end of the strip. In the optical cross-section images the Lead-rich phase are the grey particles dispersed within the white Tin-rich phase. In the SEM images the Lead phase is white and Tin is grey. The solder microstructure is enlarging, coarsening and cracking in a stress zone adjacent to the Pin / Solder interface. Away from this “crack zone” the solder microstructure is very fine.

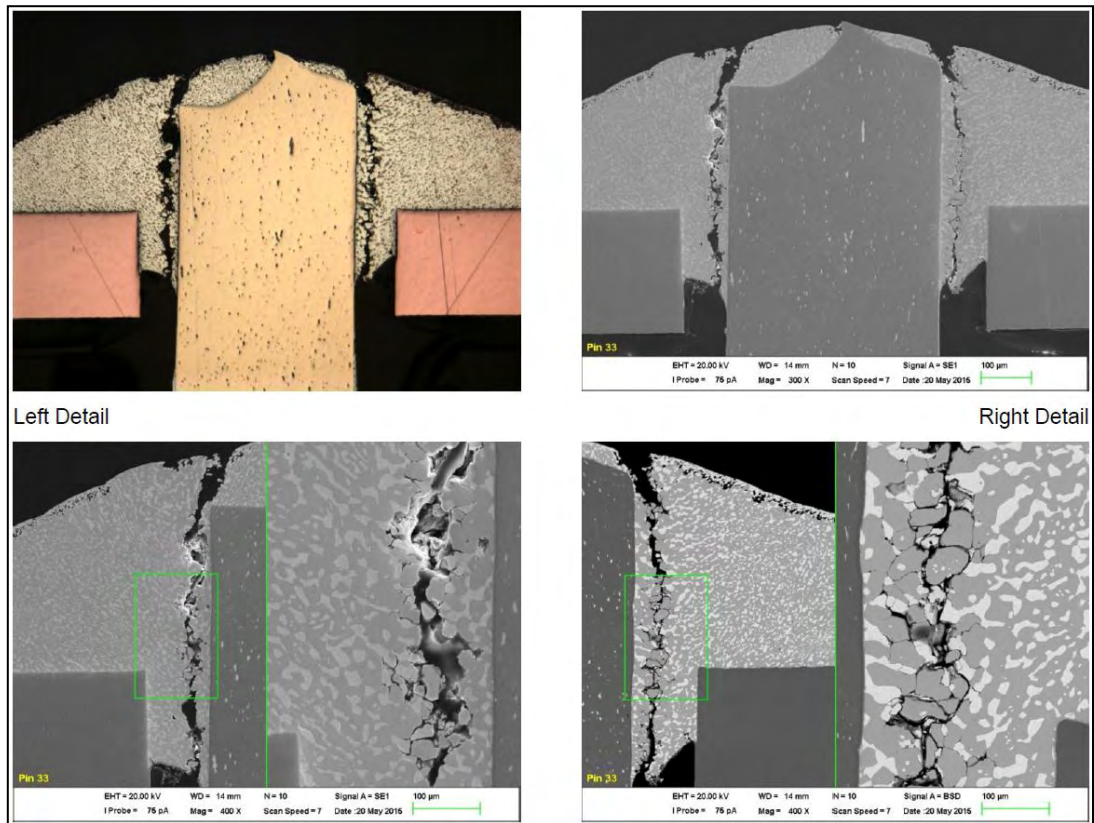
Figure 1.16-4 Cross sectioned pin to flex solder joints of Pins 33

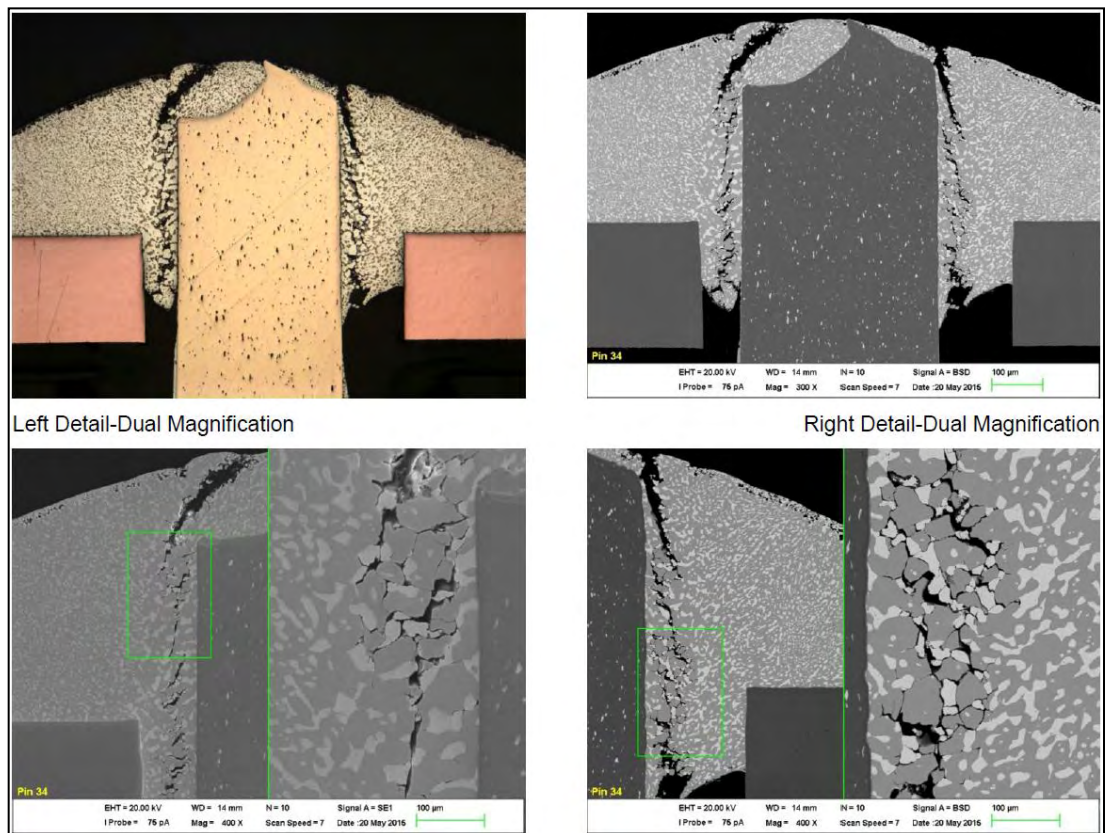
Figure 1.16-5 Cross sectioned pin to flex solder joints of Pins 34

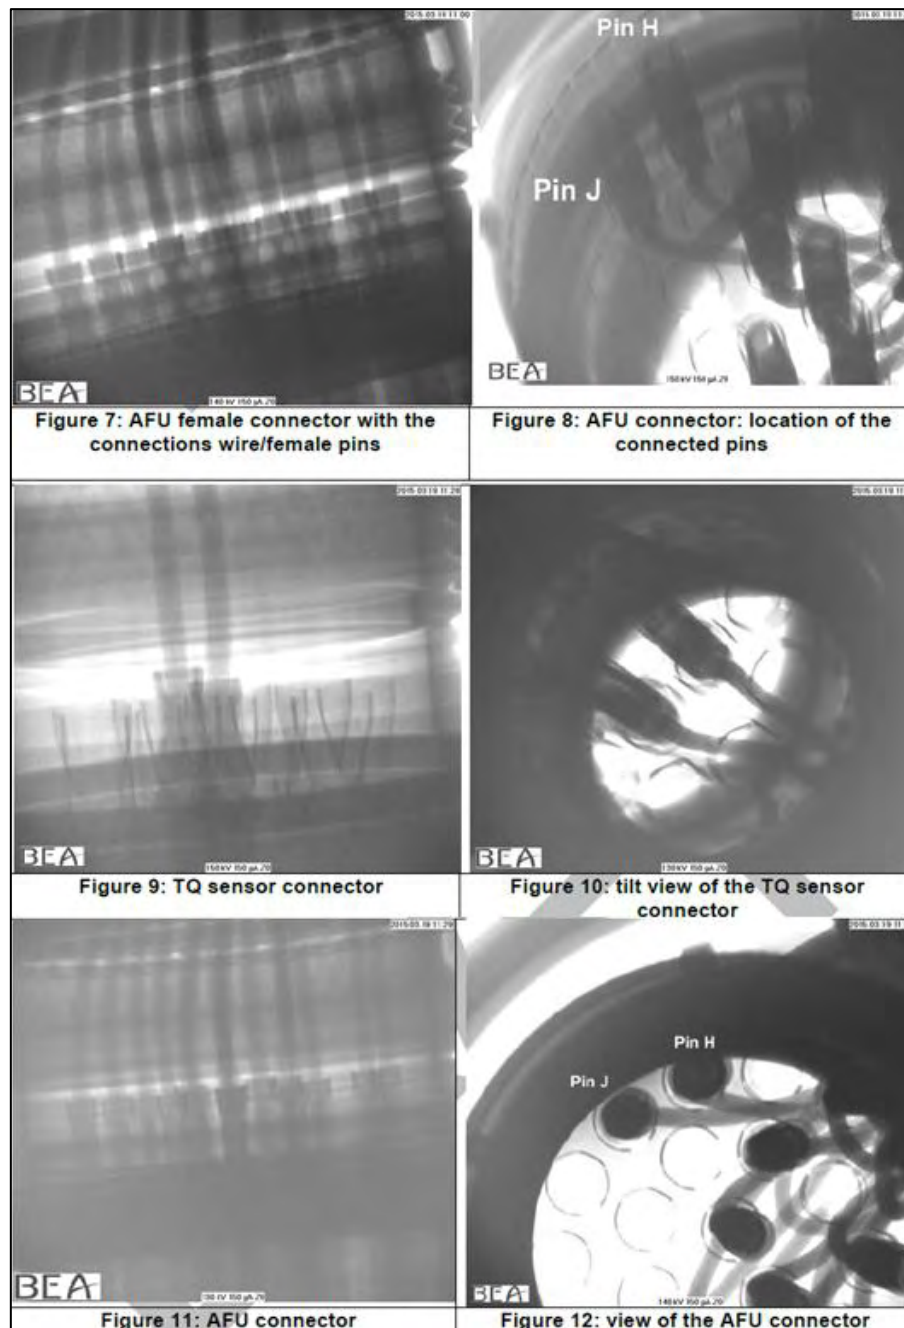
Figure 1.16-7 X-ray examination of AFU and torque sensor connectors

The X-ray examination of both harnesses showed no anomaly. The X-ray pictures of the connectors which connect AFU and the torque sensor of No. 2 engine are shown in Figure 1.16-7.

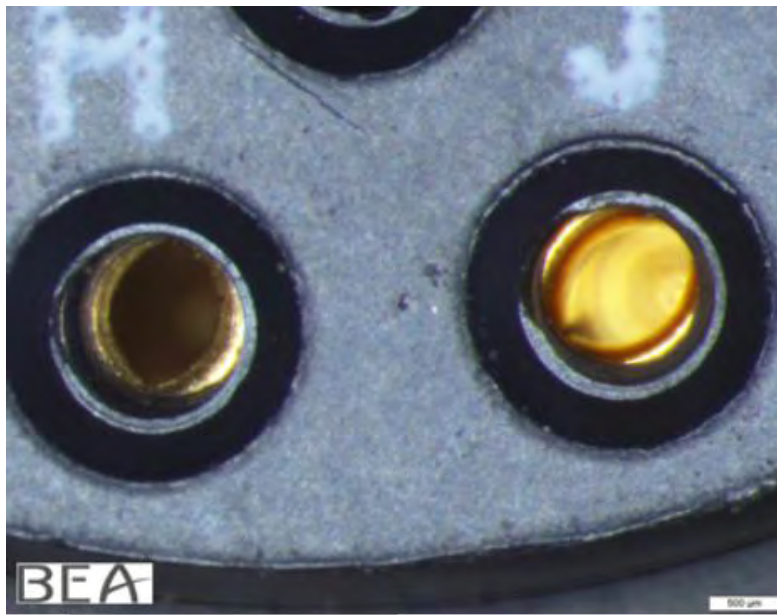
Figure 1.16-8 Pins H and J of No. 2 AFU connector

The macroscopic examination showed a difference between the pin H of AFU connector of No.2 engine and the other pins on this connector. A picture of pins H, J of No. 2 AFU connector is shown in Figure 1.16-8.

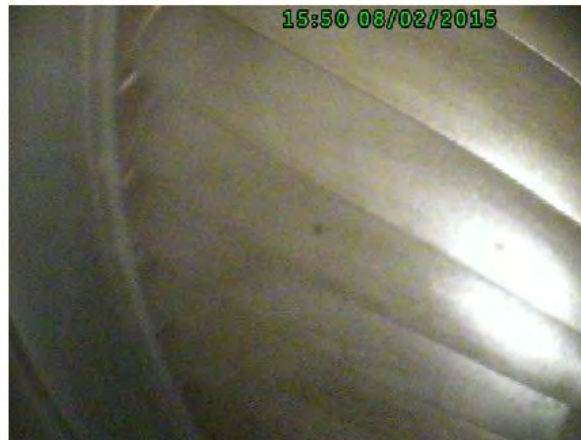
The turbine section components displayed no indications of any anomalies affecting normal operation, and all components observed showed normal running wear. All components showed water immersion damage. Please refer to photos No. 6 through 11.

Photo No. 6  
Second stage power turbine.

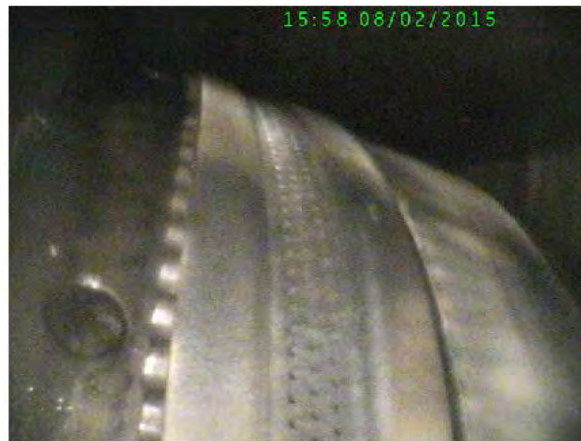
The combustion section components displayed no indications of any anomalies affecting normal operation, and all components observed showed normal running wear. All components showed water immersion damage. Please refer to photo No. 12.

Photo No. 12  
Combustion chamber liner.

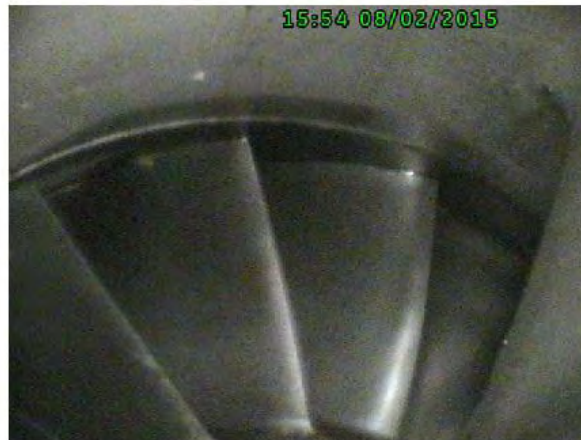
The compressor section components displayed no indications of any anomalies affecting normal operation, and all components observed showed normal running wear. All components showed water immersion damage. Please refer to photos No. 13 and 14.

Photo No. 13  
Low pressure impeller and shroud

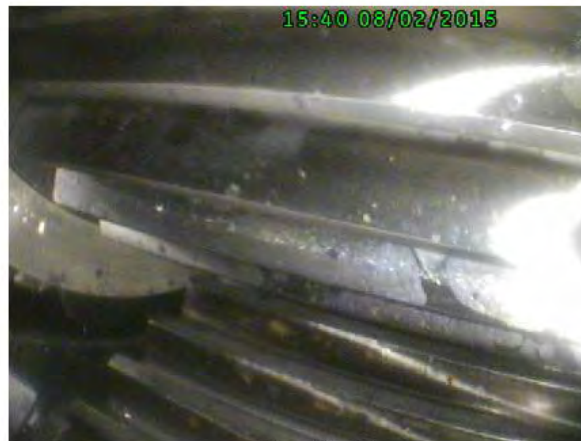
The reduction gearbox components displayed no indications of any anomalies affecting normal operation, and all components observed showed normal running wear. All components showed water immersion damage. Please refer to photos No. 15 through 17.

Photo No. 15  
Reduction gearbox second stage spur gears, detail.

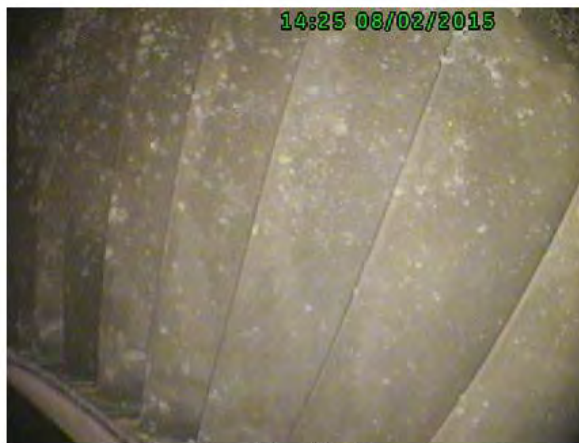
The turbine section components displayed no indications of any anomalies affecting normal operation, and all components observed showed normal running wear. All components showed water immersion damage. Please refer to photos No. 38 through 43.

Photo No. 38  
Second stage power turbine.

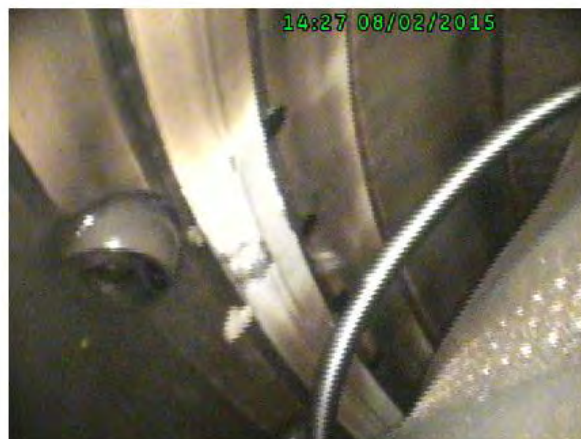
The combustion section components displayed no indications of any anomalies affecting normal operation, and all components observed showed normal running wear. All components showed water immersion damage. Please refer to photo No. 44.

Photo No. 44  
Combustion chamber liner.

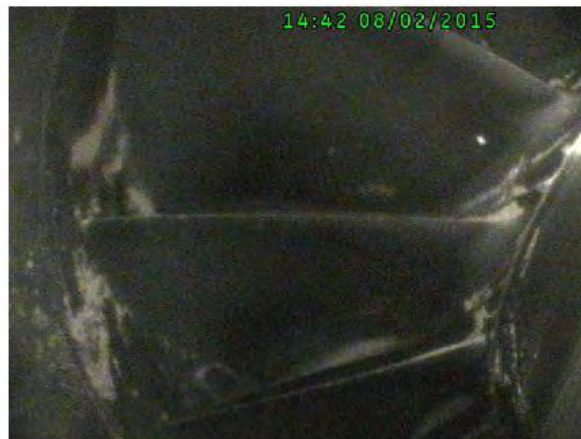
The compressor section components displayed no indications of any anomalies affecting normal operation, and all components observed showed normal running wear. All components showed water immersion damage. Please refer to photos No. 45 and 46.

Photo No. 45  
Low pressure impeller and shroud.

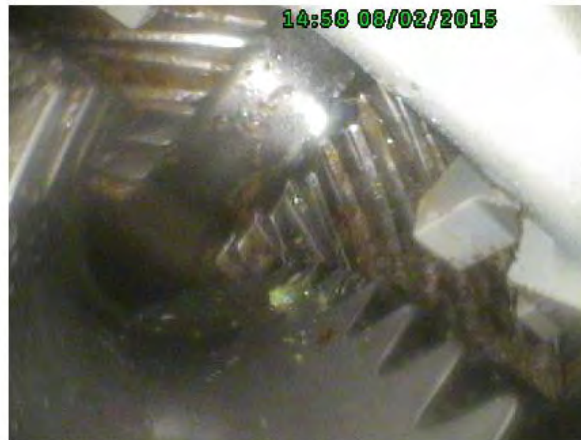
The reduction gearbox components displayed no indications of any anomalies affecting normal operation, and all components observed showed normal running wear. All components showed water immersion damage. Impact damage to the front inlet case prevented examination of the second stage spur gears. Please refer to photos No. 47 and 48.

Photo No. 47  
Reduction gearbox helical input gearshaft and helical gear.

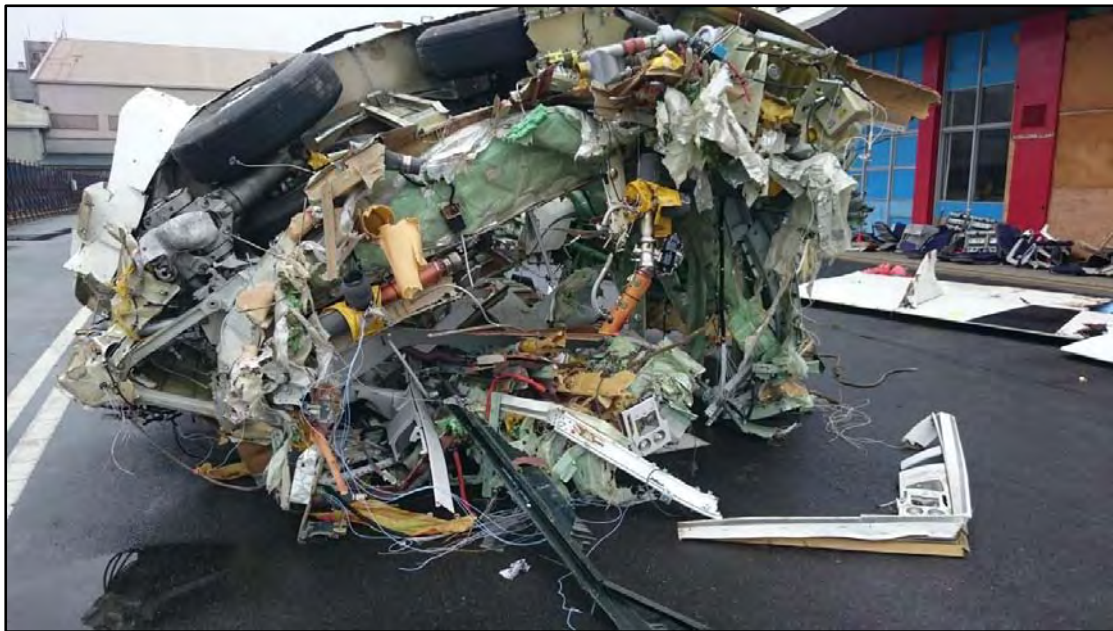
Figure 1.3-2 The FWD and Mid-Aft fuselage separation from frame 24-25

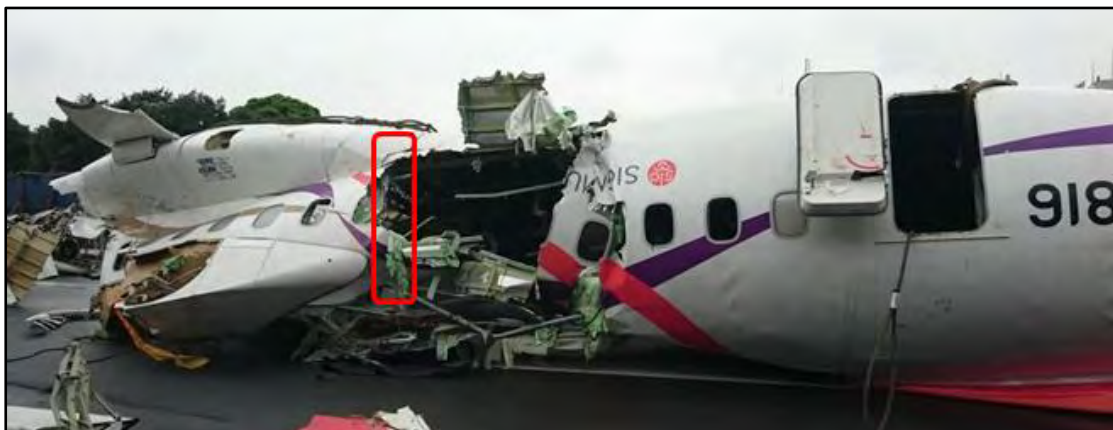
Figure 1.3-3 A broken area on the right hand side fuselage located at frame 28-28A area
