KNKT.14.12.29.04

# KOMITE NASIONAL KESELAMATAN TRANSPORTASI

Aircraft Accident Investigation Report

**PT. Indonesia Air Asia  
Airbus A320-216; PK-AXC  
Karimata Strait  
Coordinate 3°37'19"S - 109°42'41"E  
Republic of Indonesia  
28 December 2014**

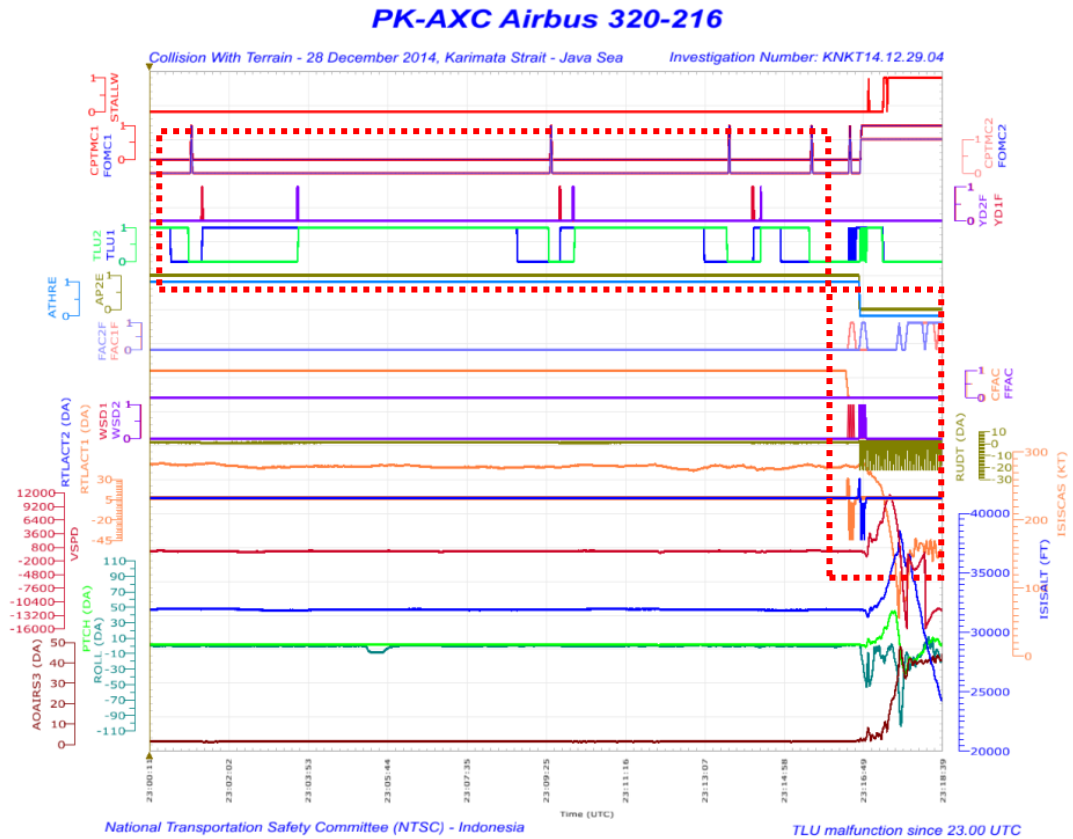
**Figure 20: RTLUT problems and pilot actions**

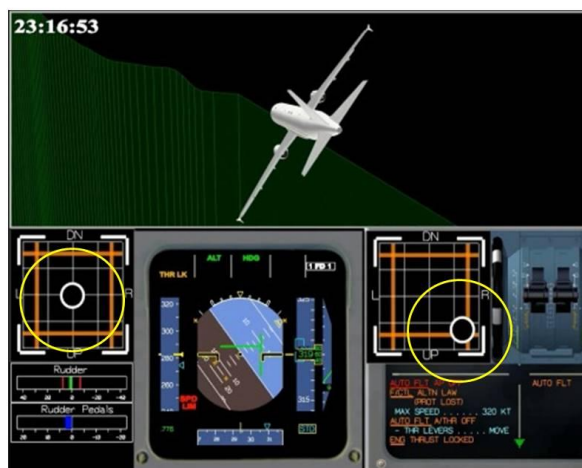
**Figure 25: Aircraft rolled 54° to the left**

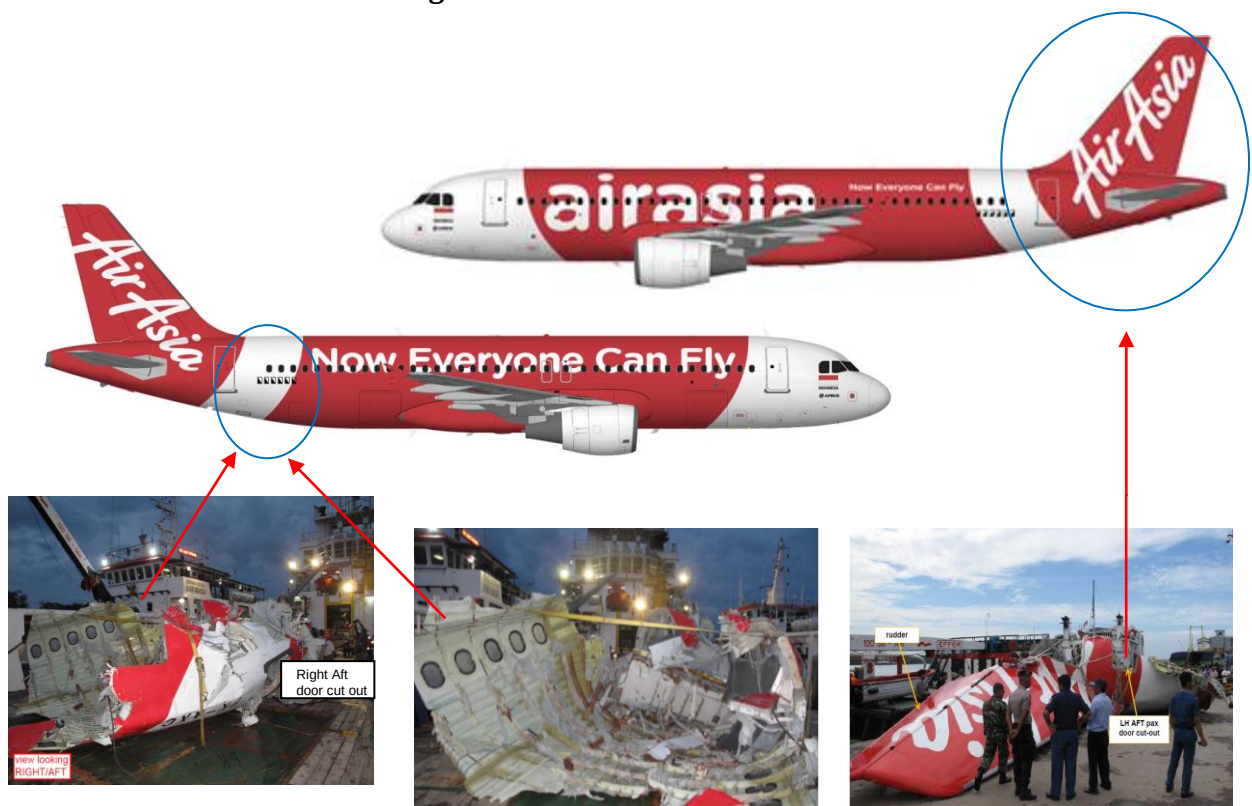
**Figure 32: Pictures of identified parts and its original position**

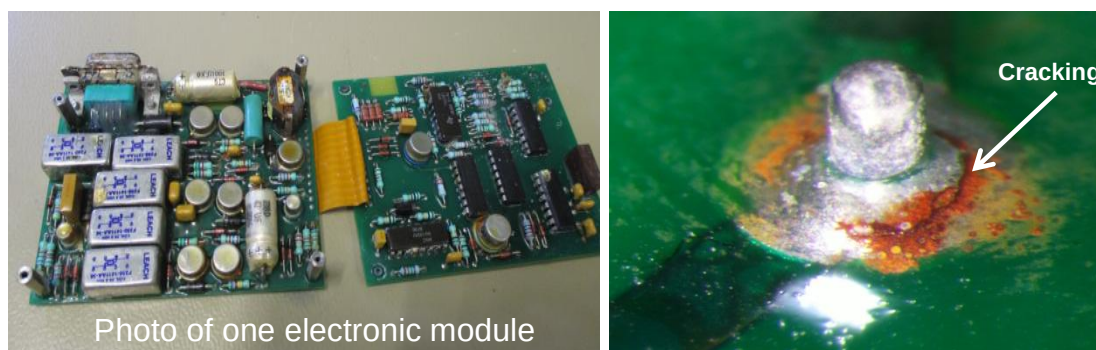
- The cracking of a solder joint of both channel A and B resulted in loss of electrical continuity and led to RTLU failure.
- The existing maintenance data analysis led to unresolved repetitive faults occurring with shorter intervals. The same fault occurred 4 times during the flight.

**Figure 35: Electronic Module of RTLUs**
