Steep Climb and Uncontrolled Descent During Takeoff  
National Air Cargo, Inc., dba National Airlines  
Boeing 747 400 BCF, N949CA  
Bagram, Afghanistan  
April 29, 2013

**Accident Report**

NTSB/AAR-15/01  
PB2015-104951

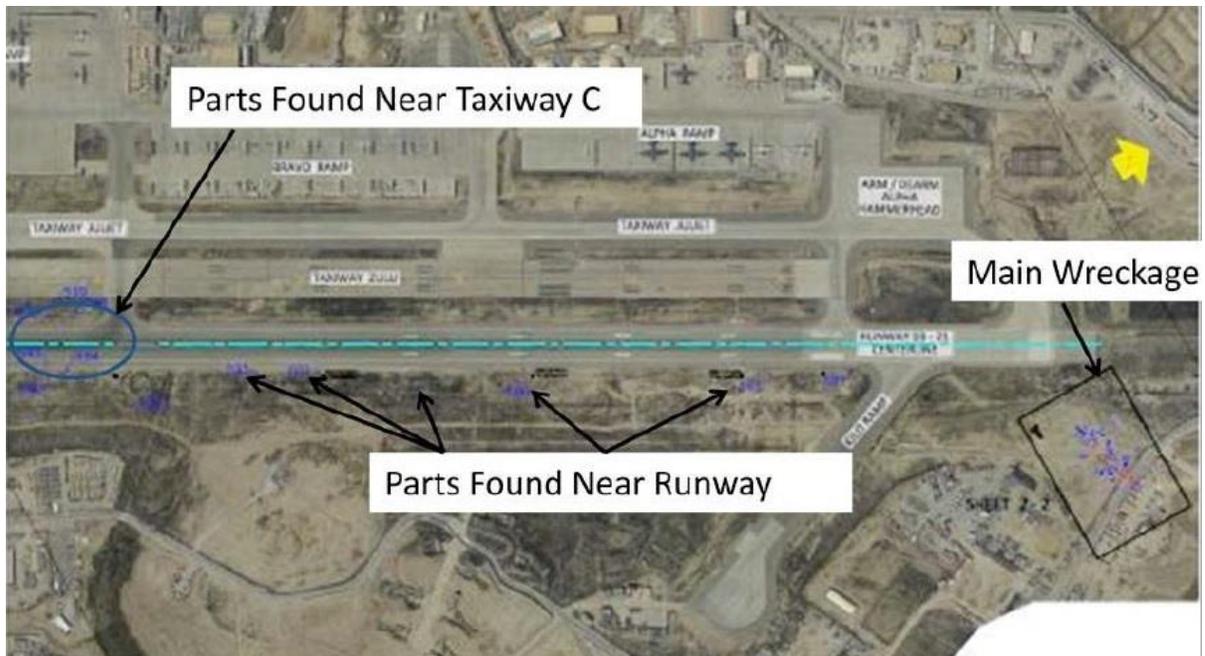
The airplane struck the ground about 590 ft northeast of the departure end of runway 3. A sweep of the runway after the accident found pieces of debris on runway 3 in the area of taxiway C that included small pieces of airplane fuselage skin, a segment of hydraulic return tubing, a piece of the E8 rack (which provides a shelf for the airplane's CVR and flight data recorder [FDR] inside the back of the airplane), and part of a M-ATV antenna assembly. These debris pieces are discussed further in section 1.7. Other pieces of debris were found along the length of the runway (see figure 5).

**Figure 5.** Overview image of runway 3 with locations of parts debris and the main wreckage noted.

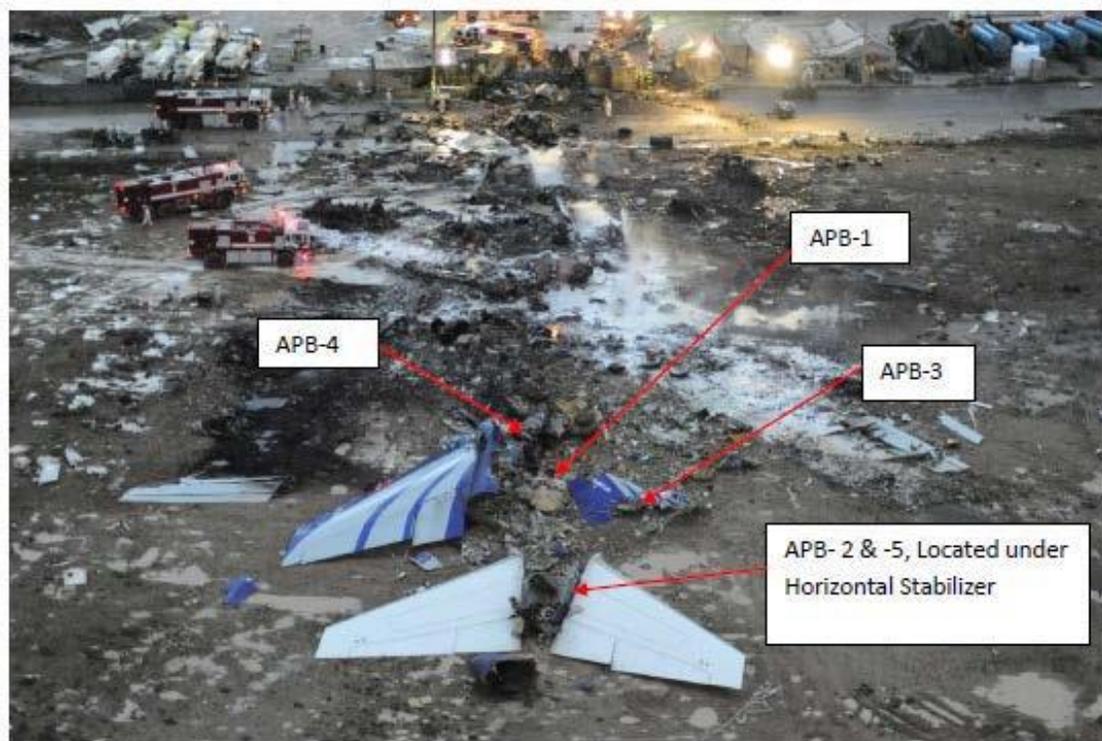
The APB, the installed location for which was in the back of the airplane (aft of the cargo) at BS 2360, was found in five main sections, labeled APB-1 through -5 by investigators. Sections APB-3, -4, and -5 were found attached to corresponding fuselage structures and skin panels. Sections APB-1 and -2 were not connected to any fuselage structure. Sections APB-2 and -5 were found under the horizontal stabilizer. Figure 8 shows where each APB section was found at the accident site.

**Figure 8.** Photograph showing where five sections of the APB were found at the accident site.

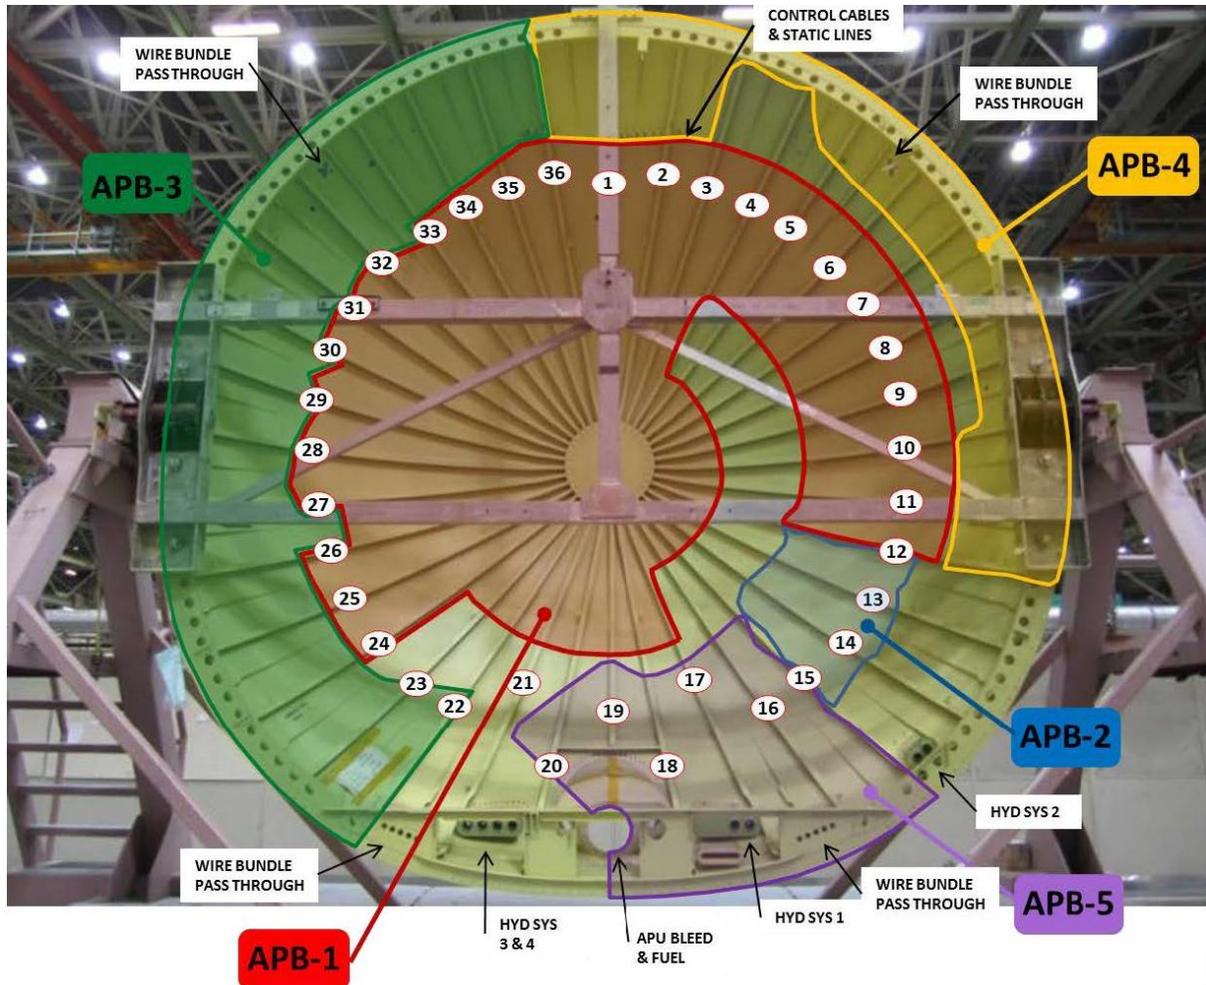
Figure 9 shows the relative installed location of each APB section using a photograph of an intact APB (without the liner), looking aft, as well as the locations where hydraulic system tubing, wire bundles, control cables, and static lines pass through the APB. (The installed location of the liner is on the forward face of the APB.)

**Figure 9.** Photograph of an intact APB, looking aft, superimposed with color-shaded and labeled areas showing the installed location of each of the APB sections.

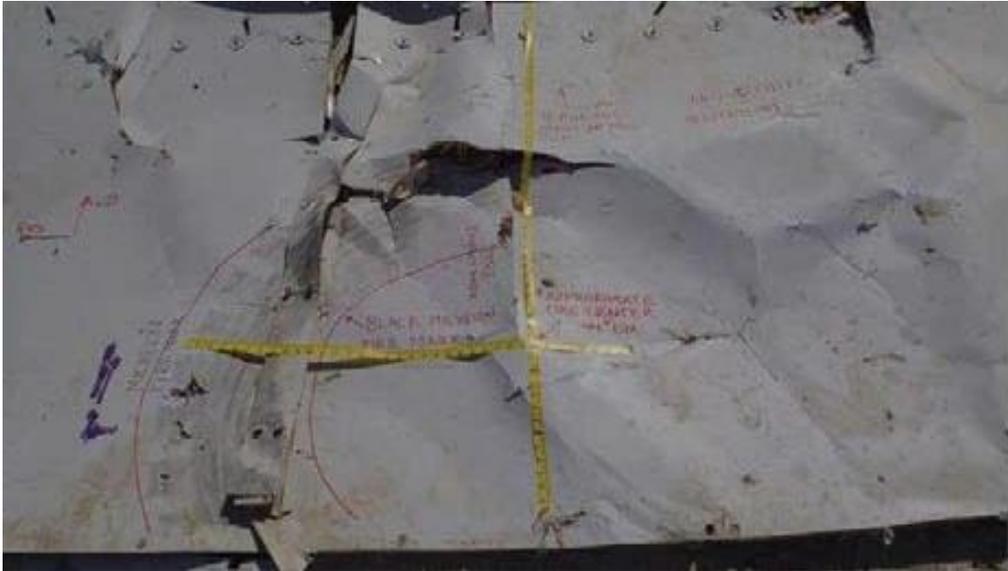
The upper left quarter panel of the APB liner showed a black mark from a 44-inch-diameter tire from a M-ATV. The installed location of this APB liner upper left quarter panel is immediately aft of and adjacent to the E8 rack. The tire imprint was consistent with a tire being parallel to the APB and the tire center located 81.5 inches above the main deck cargo floor (see figure 10).

**Figure 10.** Photograph of M-ATV tire mark on the upper left quarter panel of the APB liner.

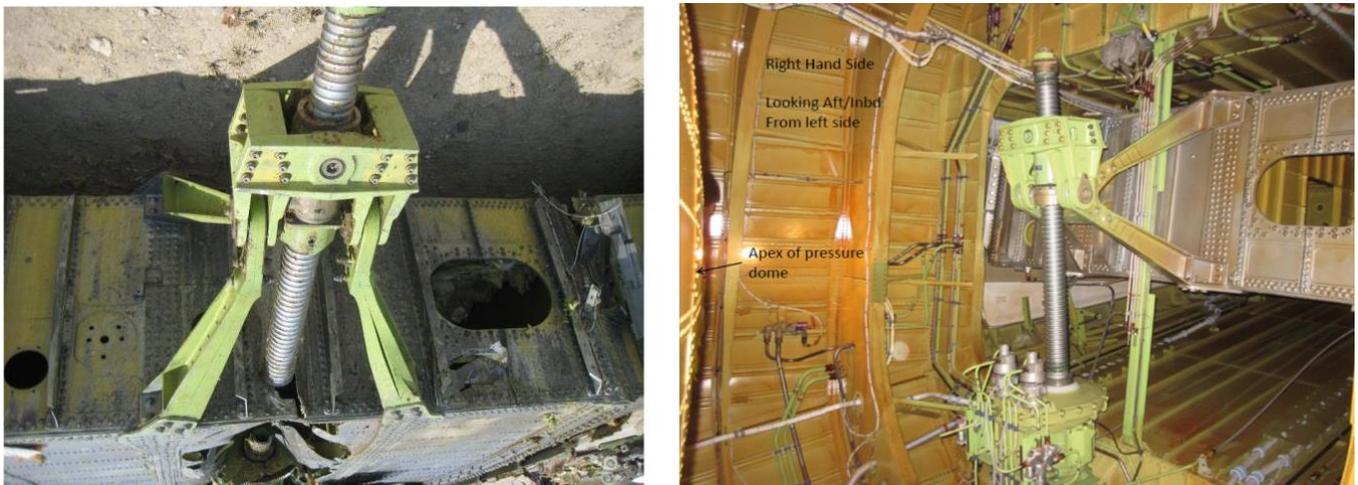
the APB was found at the stabilizer actuator. (The APB and insulation were installed forward of the stabilizer actuator.) The horizontal stabilizer jackscrew (also known as the ballscrew) was severed on its lower end about 1.5 inches above the drive assembly. A crack about 4 inches long extended longitudinally from the jackscrew's fractured end toward the upper gimbal support structure. The jackscrew drive assembly was aft of its installed location and was embedded in the lower horizontal stabilizer structure (see figure 11). The hydraulic drive motors were broken away from their housing and dislodged but were connected to brackets and tubing. The length of exposed jackscrew threads from the upper stop to the end of the threads was about 9.56 inches.

One of the legs of the upper gimbal support structure that attaches the horizontal stabilizer jackscrew to the forward side of the stabilizer structure was distorted and fractured. The yoke of upper gimbal support structure was gouged and showed material smearing on the forward surface. The installed location of yoke upper gimbal support structure is about 8 ft above the main cargo deck floor.

**Figure 11.** Photographs (left) showing the accident airplane's jackscrew and horizontal stabilizer in the wreckage and (right) showing an exemplar jackscrew in its installed position aft of the APB and forward of the horizontal stabilizer.

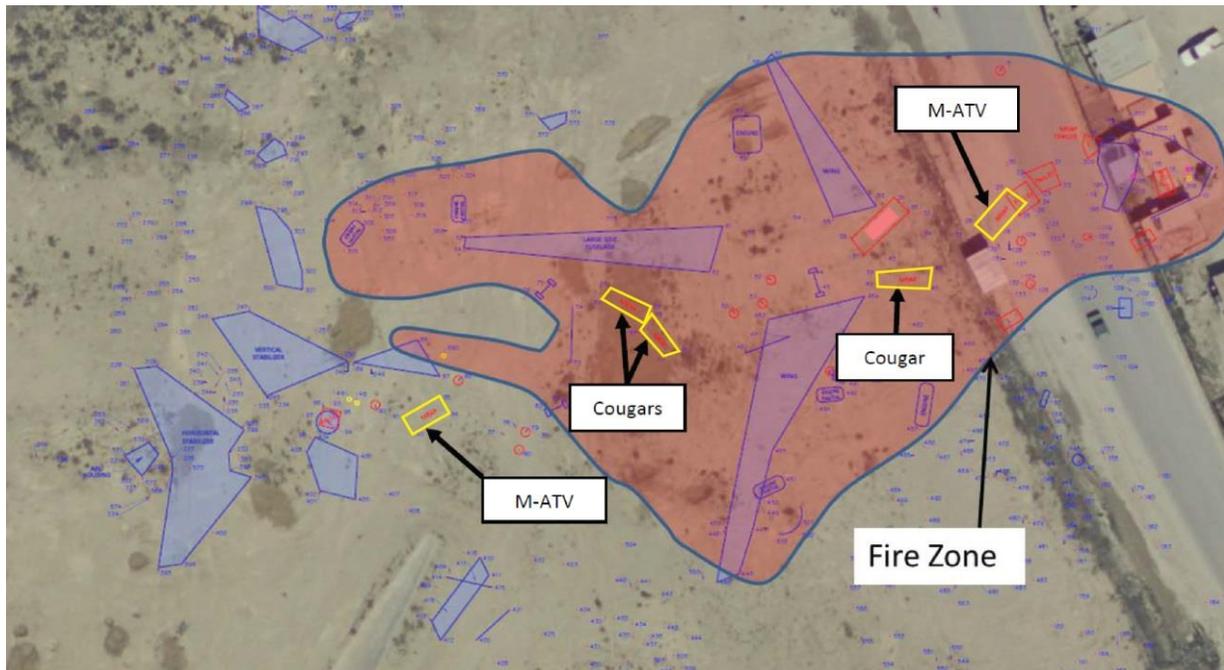
The M-ATV that was loaded in the back of the airplane was found in the wreckage in the area not consumed by fire; this area included other structure from the empennage, including the horizontal stabilizer and the vertical stabilizer (see figure 12).

**Figure 12.** Overview of the accident debris field showing the respective locations of the MRAP vehicles and fire zone.

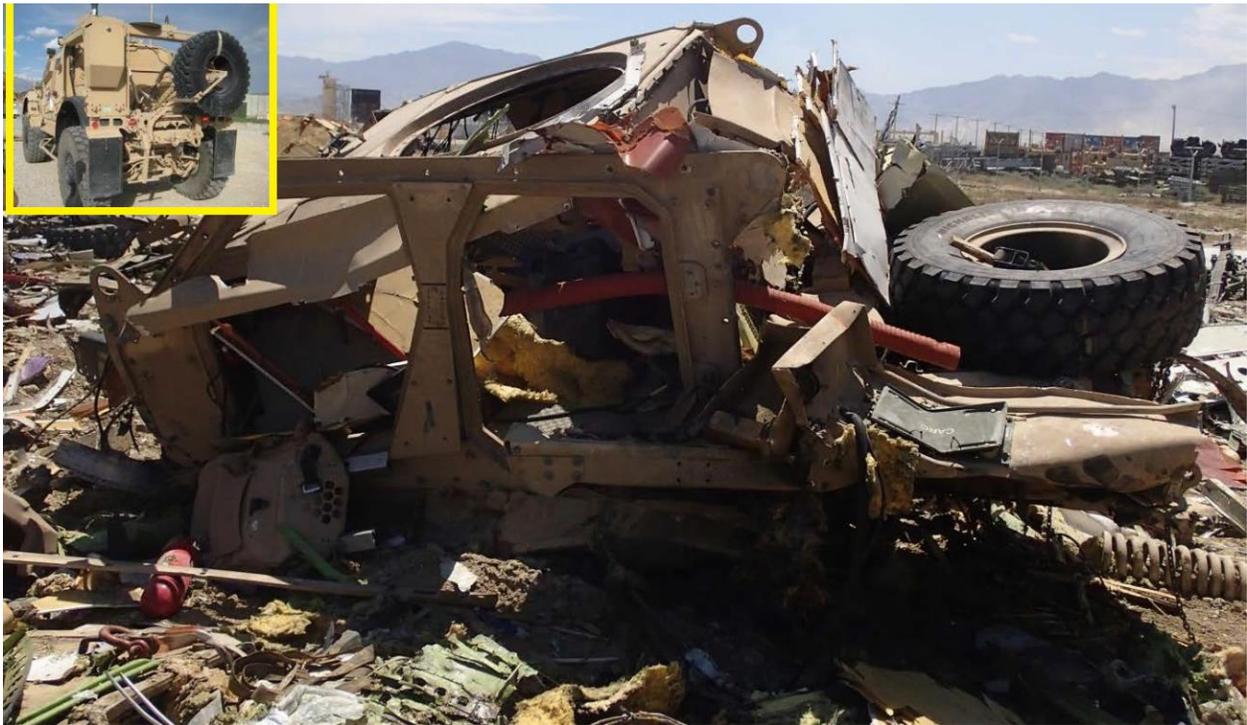
The M-ATV's spare tire, as installed, is mounted on the back of the vehicle on the upper right side, parallel to the rear bumper. For a M-ATV shored and secured on a pallet, the bottom of the spare tire is about 59.5 inches above the floor (making its center about 81.5 inches above the floor). The rear M-ATV's spare tire was found positioned forward of and at a 90° angle to its installed position (see figure 13), which shows the spare tire as found in the wreckage and an inset diagram depicting the spare tire's installed position.

**Figure 13.** Photograph of the left side of the rear M-ATV as found in the wreckage and an inset diagram showing the installed position.

An orange transfer mark was noted on the back of the M-ATV on the antenna mounting structure on the upper left side (the location of the orange transfer mark was about 104 inches from the ground on an intact M-ATV). A comparative analysis of the orange transfer mark, which was performed using an infrared microspectrophotometer, determined that the spectrum of the transfer mark on the M-ATV was similar to other spectra of paints, indicating that the transfer was likely paint. A comparison of the transfer mark with a paint sample from the FDR chassis found that the spectra shared three similar peak patterns; however, the origin of the orange paint transfer could not be determined by spectral analysis.

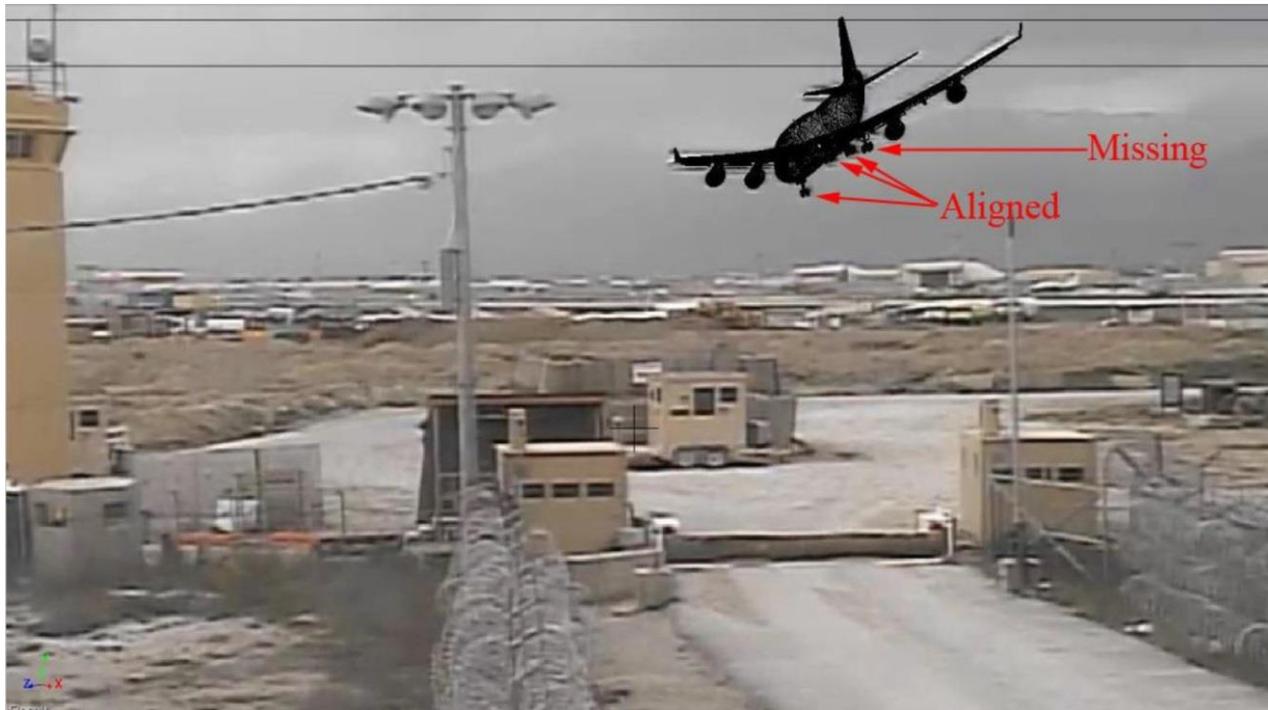
The image study used Autodesk Softimage 2013 to compare the image data to a three-dimensional model of the airplane. The study found that, during the portions of the flight captured by one or more cameras, the airplane's left wing landing gear was not visible, consistent with it being in the retracted position. The right body landing gear, left body landing gear, and nose landing gear were visible (captured by one or more cameras), consistent with them being in the extended position. The study also found that the nose landing gear door was visibly protruding, consistent with the fully open position (see figure 15).

**Figure 15.** Still image from a security video of the accident airplane with a superimposed three-dimensional model airplane. (The model has all landing gear extended.)

**Note:** Red arrows indicate which of the accident airplane's landing gear appear to be missing when compared to the model (consistent with the retracted position) and which appear to be aligned (consistent with the extended position).

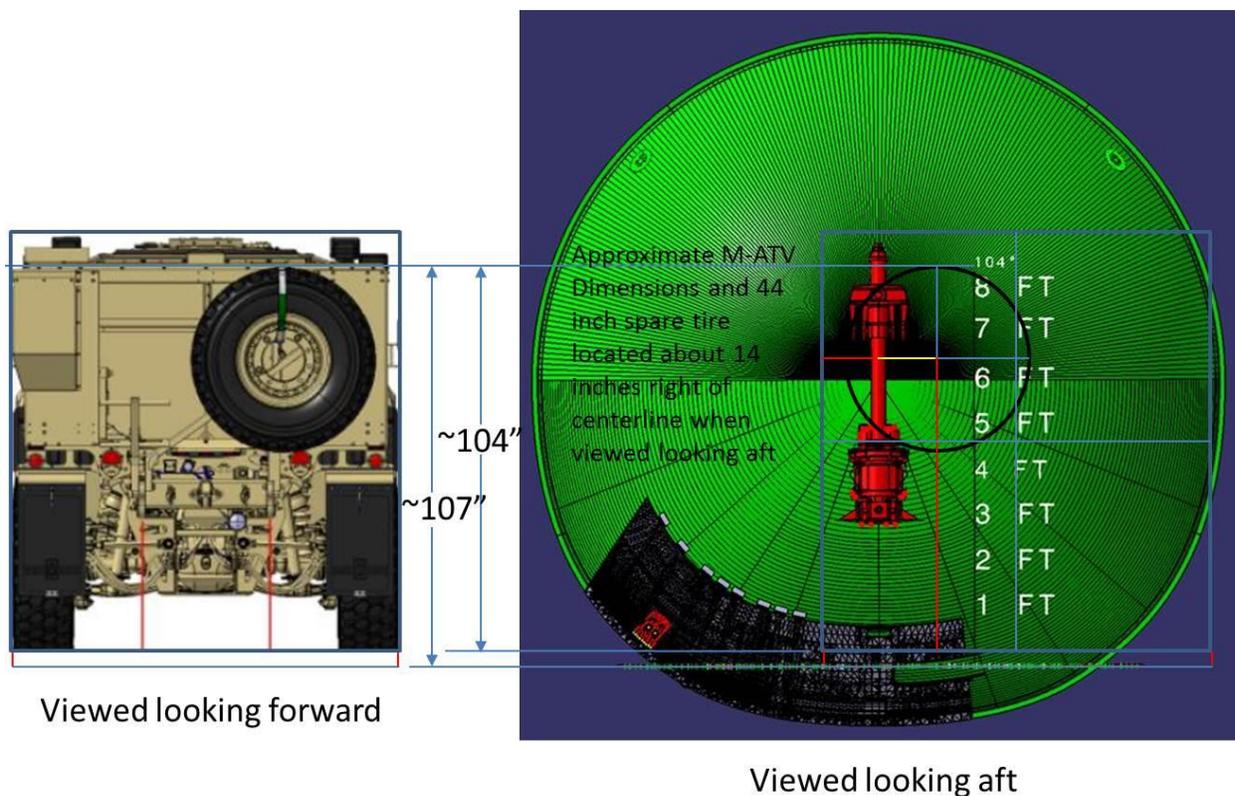
was consistent with the M-ATV structure becoming crushed around the liner material during the ground impact sequence. All of this evidence suggests that the rear M-ATV moved aft through the APB before the airplane struck the ground. In addition, damage on the underside of the M-ATV's pallet, damage to the aft floor locks, and the premature cessation of the CVR and FDR (which are powered by separate alternating current buses and stopped recording almost simultaneously) further support the scenario that the rear M-ATV moved aft shortly after the airplane's rotation.

Damage observed on the horizontal stabilizer jackscrew assembly and support structure and the presence of tire marks on structure aft of the APB provide further evidence that the rear M-ATV moved aft until it struck these components (see figure 17). Also, the displacement of the M-ATV's tire 90° from its original position and the presence of tire marks on the green dorsal fairing support structure for the vertical stabilizer are consistent with the M-ATV having been located aft of its original loaded location when the airplane struck the ground; that is, the tire displacement and the tire mark evidence is consistent with the M-ATV having been positioned beneath the vertical stabilizer at the time of the airplane's ground impact, and the vertical stabilizer collapsed down onto the rear portion of the M-ATV at ground impact.

**Figure 17.** Illustration showing how the dimensions of the M-ATV align with the APB and jackscrew structures. On the image at right, the jackscrew components are shown in red, and the location of the tire imprint found on the APB is depicted with a black circle.
