## Loss of grip by tractor during pushback, collision with aircraft

<b>Aircraft</b>	Airbus A330-200 registered OD-MEA
<b>Date and time</b>	17 December 2010 at 10 h 17 <sup>(1)</sup>
<b>Operator</b>	Middle East Airlines
<b>Place</b>	Paris Charles de Gaulle Airport (France)
<b>Type of flight</b>	Scheduled international public transport of passengers
<b>Persons on board</b>	Captain, co-pilot
<b>Consequences and damage:</b>	Lower fuselage badly damaged

*This is a courtesy translation by the BEA of the Final report on the Safety Investigation. As accurate as the translation may be, the original text in French is the work of reference.*

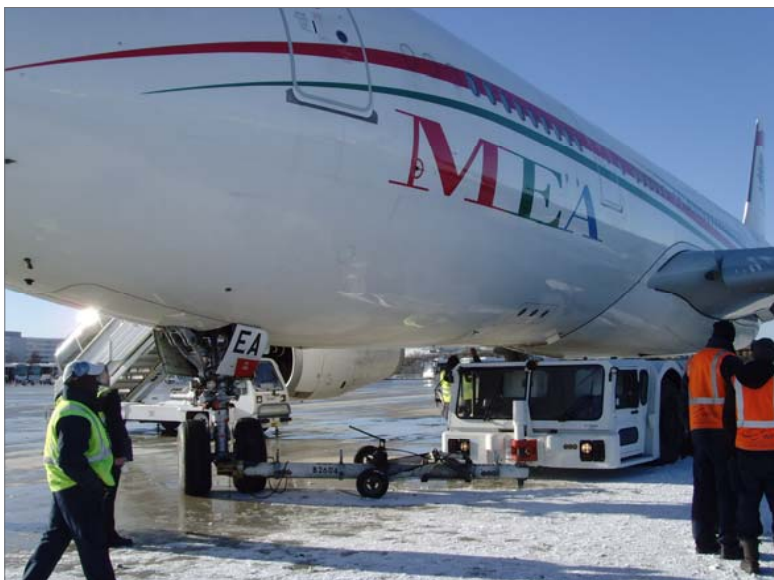
As the tractor driver pulled the aircraft forward, the tractor lost grip when driving over ice. The aircraft continued to move forward, pushing the tractor.

Via his wired connection to the crew, the ground agent requested that they put on the parking brake. The aircraft continued to move forward. The tractor skidded to the left. The pins on the tow bar broke and the tractor hit the side of the fuselage. The crew braked and the aircraft slowed to a stop.

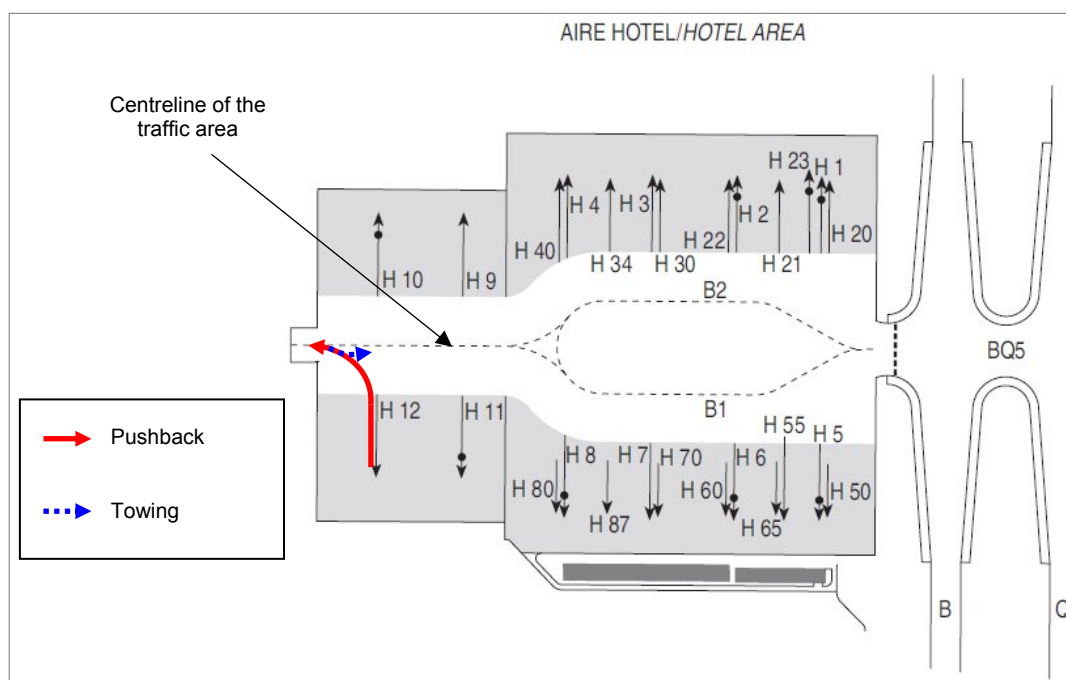
The parking area where the aircraft was located is a cul-de-sac. During a pushback from stand H12, the tractor driver has little room in which to align the aircraft on the centreline on the traffic area.
