**AIRCRAFT ACCIDENT REPORT 3/91**

**Air Accidents Investigation Branch**

**Report on the accident to  
Lockheed L1011-500, C-GAGI  
1 nm south east of Manchester,  
Cheshire on 11 December 1990**

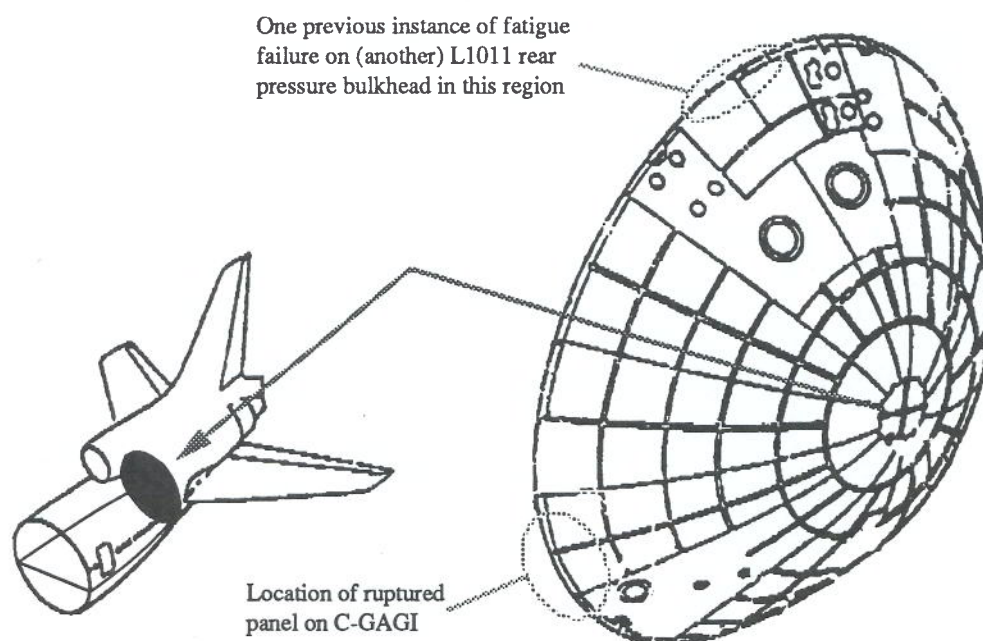
**Figure 1**  
**Rear pressure bulkhead**  
Location of failure on C-GAGI, and prior instance of failure on another L1011 aircraft

Only one prior instance of rear pressure bulkhead rupture on an L1011 aircraft has occurred. In that case a slightly smaller 'D' shaped rupture (14 inches by 11 ½ inches) was produced adjacent to the 6 inch wide edge doubler at the top of the bulkhead, within the area indicated in Appendix 1, fig 1.

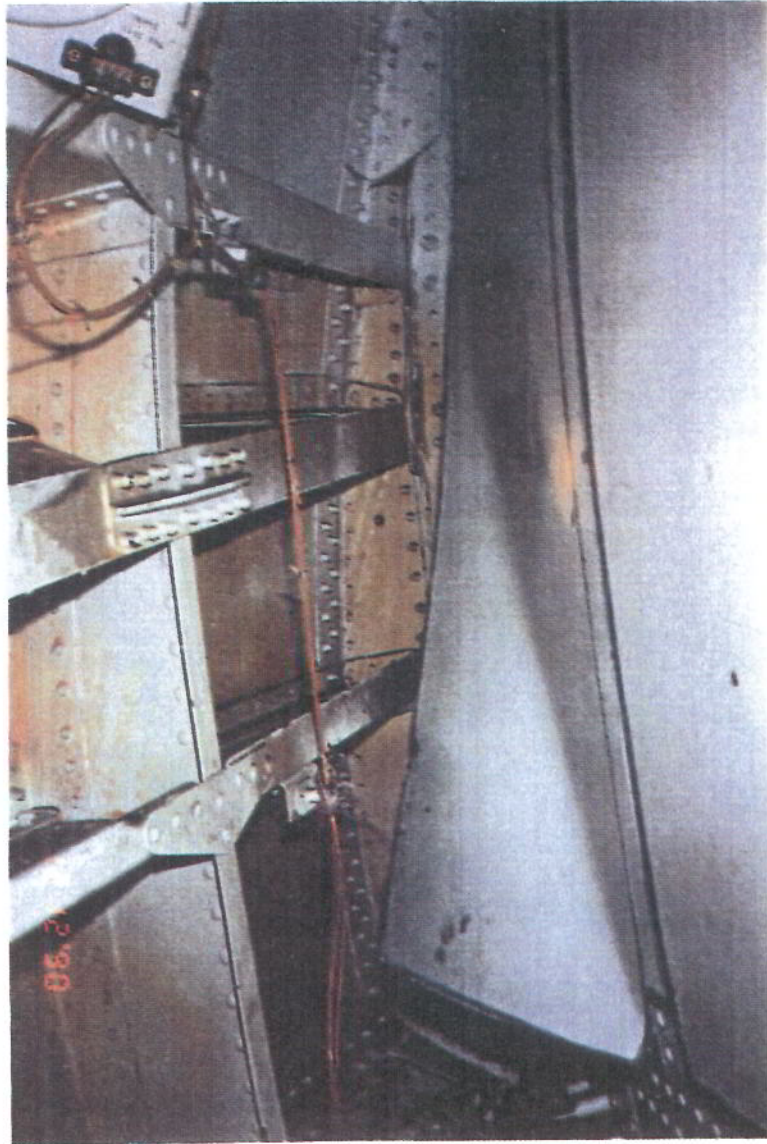
**Figure 3**

A detailed examination was made of the structure in the area immediately aft of the rear pressure bulkhead. Access was severely restricted, but it was established that the rear pressure bulkhead membrane had ruptured near the outer edge of the 8-9 o'clock gore panel (viewed from the rear), allowing a rectangular element approximately 2 feet high by 1 foot wide to flap outwards, as shown in Appendix 1, fig 3.

Photograph of rupture on C-GAGI, taken from inside unpressurised section of aft fuselage, looking forward onto bulkhead left side at cabin floor level

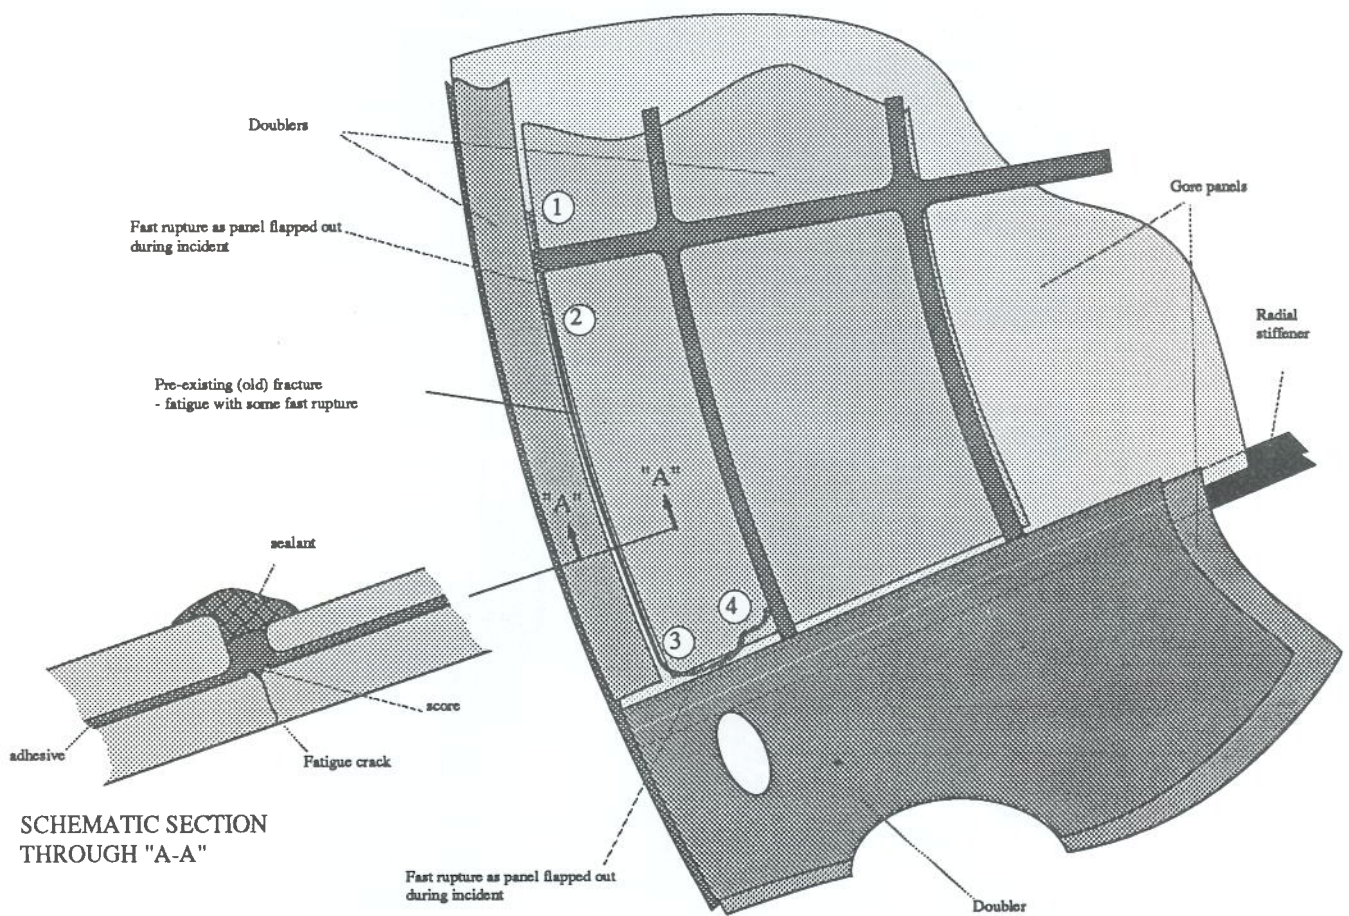
**Figure 4**  
**Rear pressure bulkhead fracture details**  
 View looking on aft side of bulkhead (region identified in figure 3)

The bulkhead had failed on the left side, close to the outer periphery of the 8-9 o'clock gore panel. Appendix 1, fig 4 shows an expanded view of this area, and the general shape of the fracture path.

The gore panel fracture extended circumferentially downwards from position '1', along the joint line between the 6 inch wide 0.040 inch thick doubler and the adjacent 0.020 in. thick bonded doubler panel, to the bottom of the panel at position '3'. It then turned inboard and ran along the radial stiffener frame as far as the next circumferential anti-tear strap at position '4', before turning upwards for a short distance.

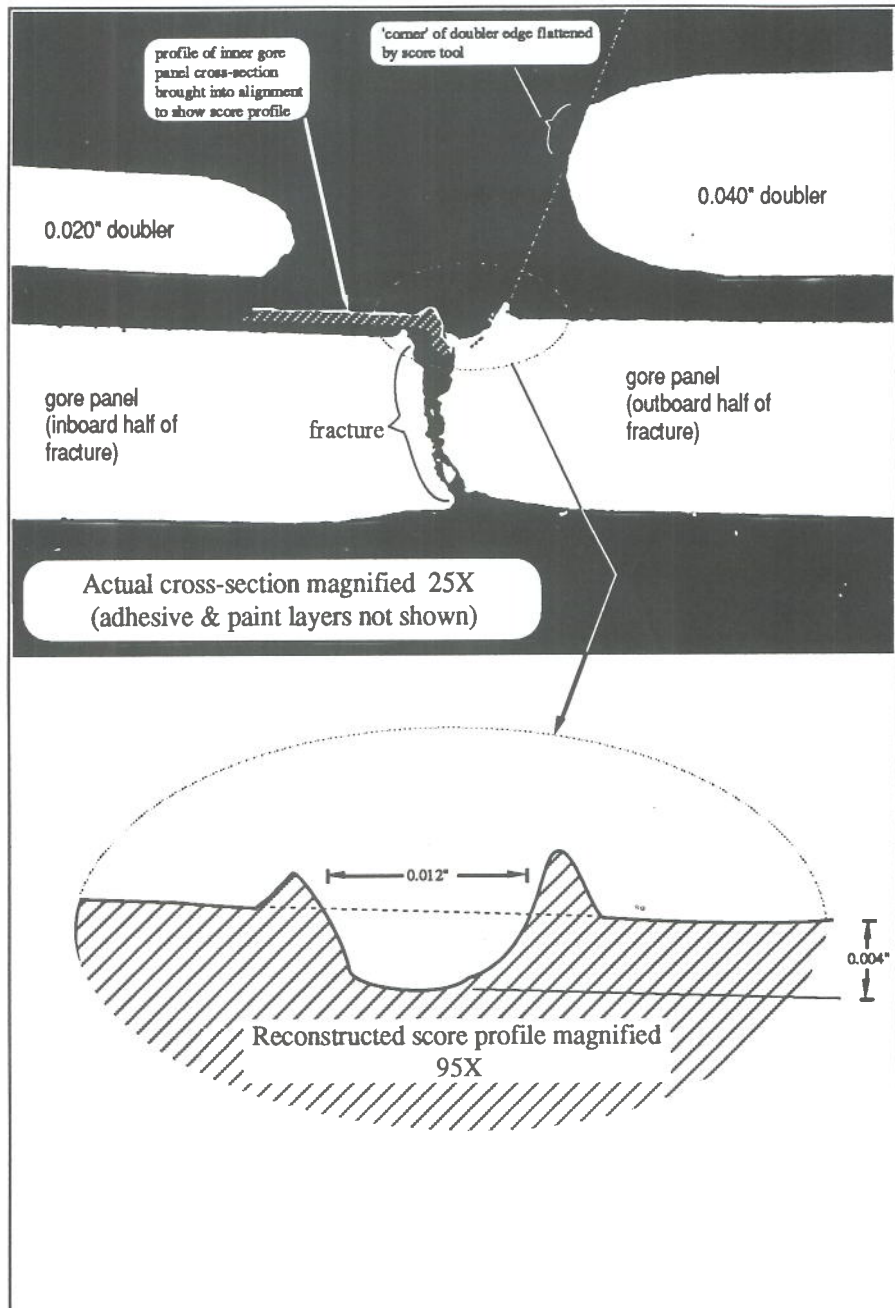
**Figure 5**  
**Score details**

Microsections taken through the fracture/score-line area indicated that the score had been produced by some form of tool which had been drawn along the edge of the 6 inch doubler, producing the score channel itself and also displacing material along the sides of the score channel. The score cross-section is clearly evident in the micrograph reproduced in fig 5, one of three sections taken through the fatigue fracture region. The outer edge 'corner' of the 0.040 inch doubler was cut back at a slight angle which matched the position of the score channel, as shown by the dotted line in fig 5, consistent with the passage of the score tool along the edge of the 0.040 inch doubler.

The fatigue failure initiated from the base of a score on the outer face of the gore panel. This score (0.004 inch to 0.014 inch deep; 0.012 inch to 0.016 inch wide) would have critically reduced the fatigue strength of the bulkhead and there is no doubt that it provided a linear initiation region of high stress intensity along which the many fatigue thumbnails started to grow. The thumbnail fractures grew inwards through the thickness of the gore section from the bottom of the score channel, and were clearly driven by the tensile stresses in the gore - caused by a combination of membrane tension in the gore and, probably, by bending stresses near the outer surface of the gore panel caused by slight flexing of the bulkhead as it picked up fuselage differential pressurization loads. These fatigue thumbnails increased in size

Actual profile of bulkhead gore panel and doublers in fatigue fracture region showing relationship between score and 0.040" doubler, and reconstructed score profile.
