# **AVIATION INVESTIGATION REPORT**

## **A06Q0188**

### **LOW FUEL EMERGENCY**

**AIR CANADA JAZZ**  
**BOMBARDIER CL-600-2B19 C-GJZF**  
**FORT ST. JOHN, BRITISH COLUMBIA**  
**21 NOVEMBER 2006**

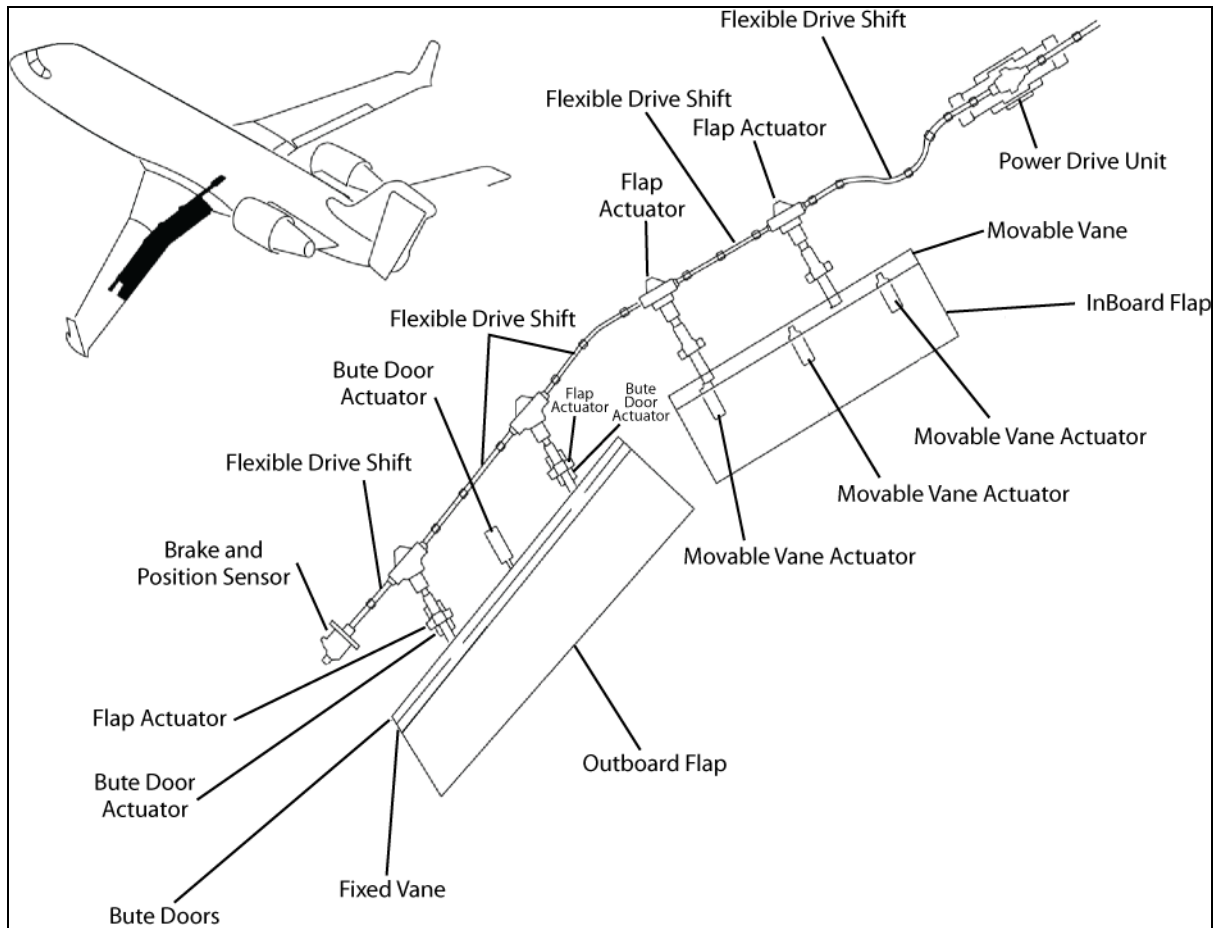
## Appendix A – Flap Drive System

The flap control surface system consists of one inboard and one outboard double-slotted flap (see Appendix A) installed on the trailing edge of each wing. The two inboard flap panels move through a range of 0° to 45°, and the two outboard flap panels move through a range of 0° to 40°. Each inboard flap contains one movable leading edge vane and three movable vane actuators. Each outboard flap contains one bent-up trailing edge (BUTE) door and three BUTE door actuators.
