Aviation Occurrence Report Volume I

ASC-AOR-05-02-001

IN-FLIGHT BREAKUP OVER THE TAIWAN STRAIT

CHINA AIRLINES FLIGHT CI611

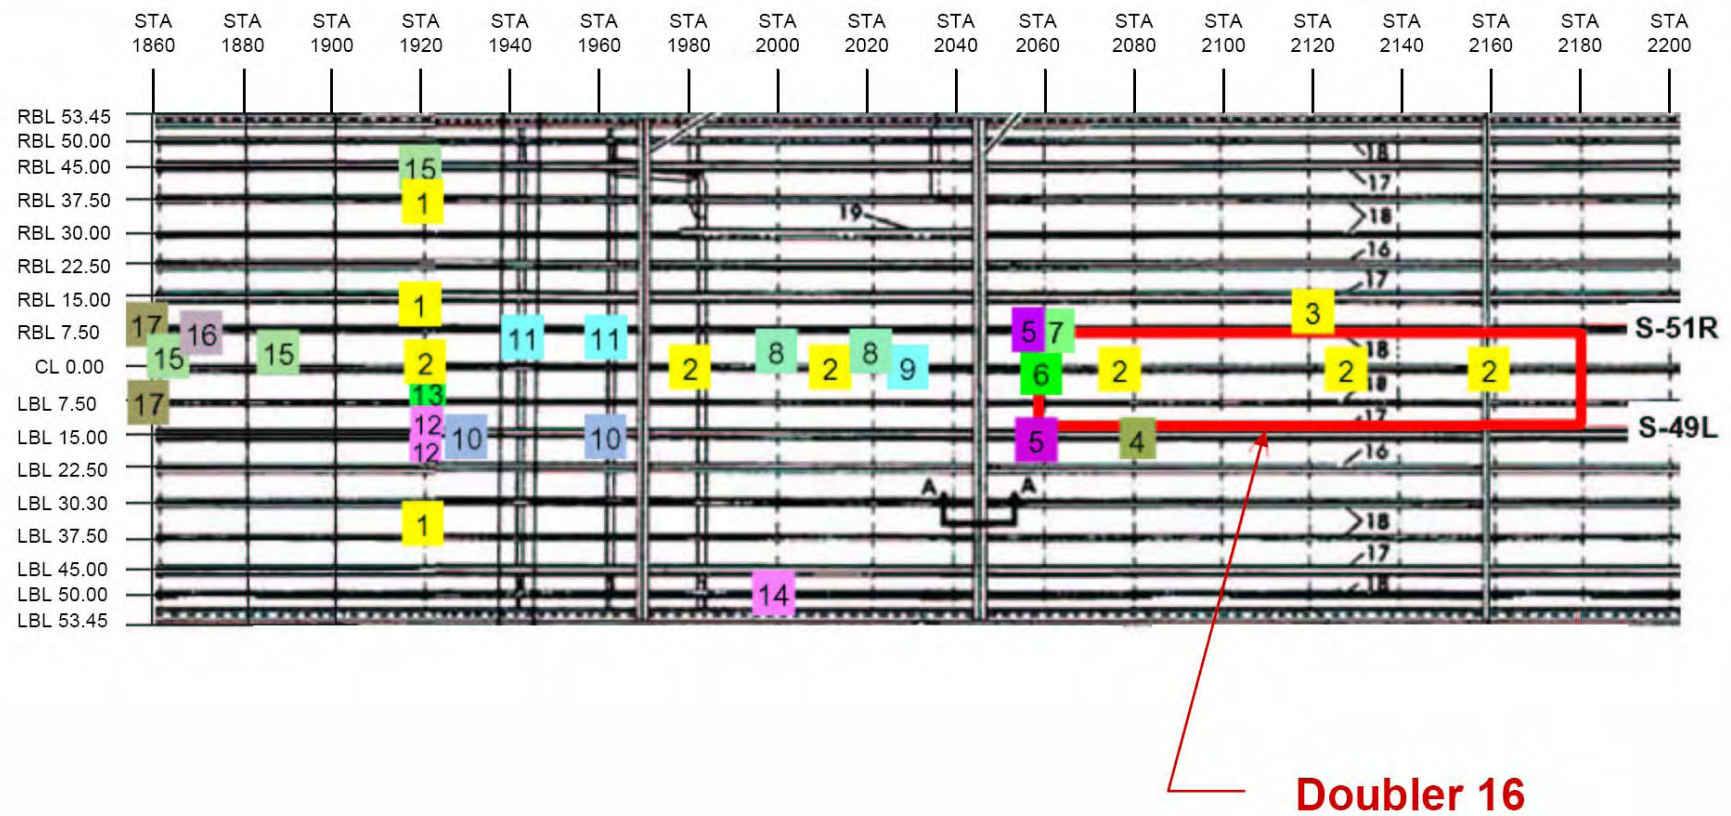
Figure 1.6-5 Locations of discrepancies adjacent to the STA 2060 doubler

The above defects were corrected by the approved methods.

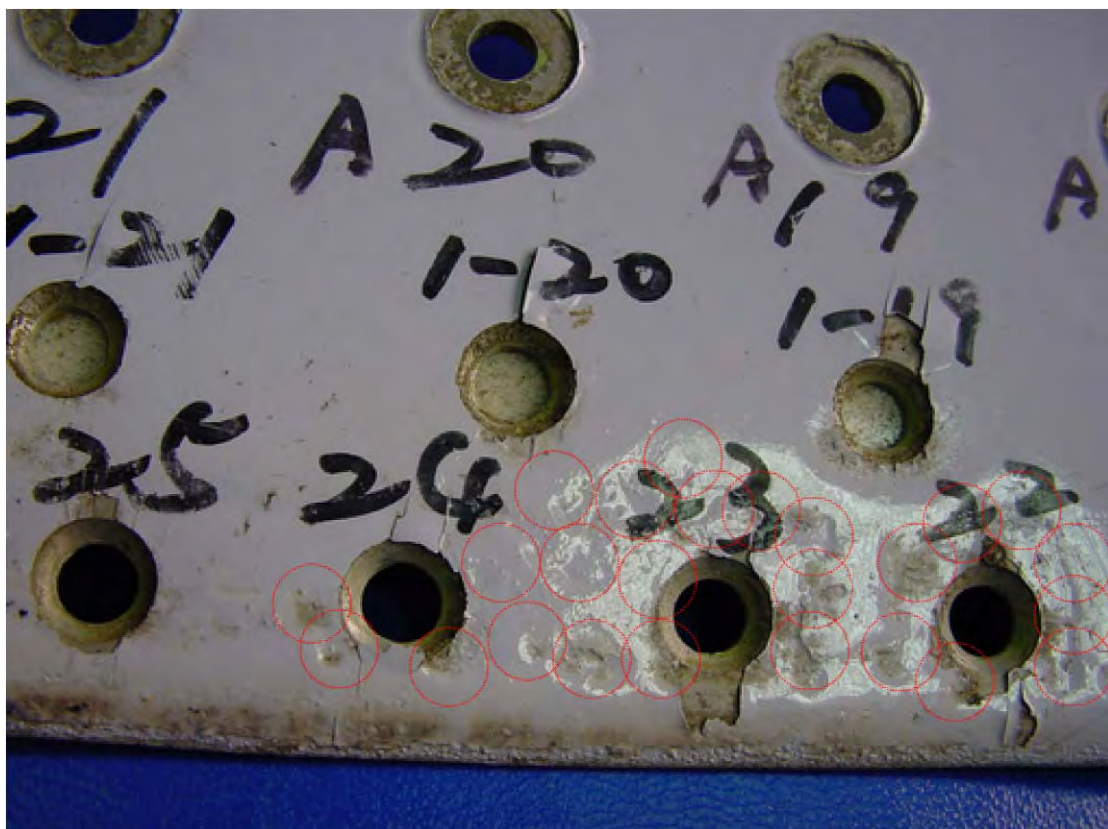
The exterior skin of number-16 doubler with various types of cavities around the rivets and along the edge of doubler can be observed as shown in Figure 1.6-10. Paint (topcoat) was present up to the edge of the doubler without sealant. In the same doubler paint (topcoat) was removed from the edge of the doubler during the doubler disassembly process, the sealant was still present, as shown in Figure 1.6-11.

Figure 1.6-10 Various types of cavities along the doubler edge

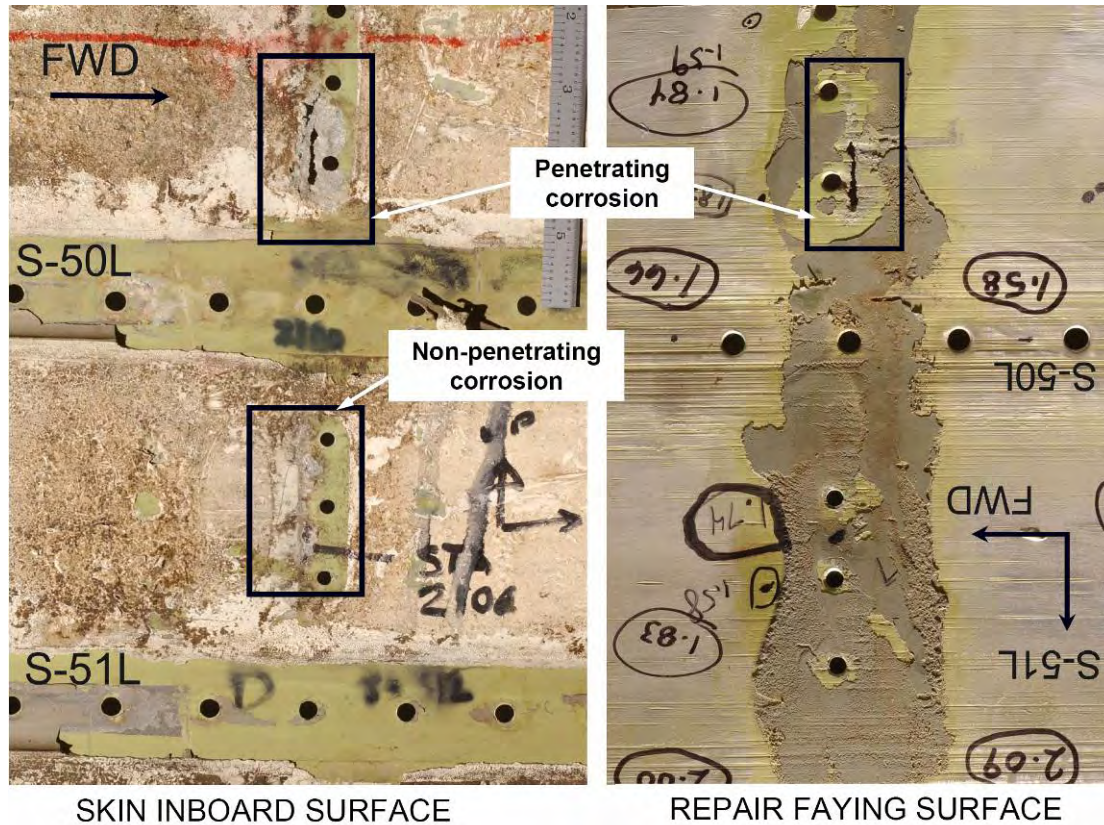
Corrosion was noted at several shear tie locations on the skin inboard surface sometimes penetrating completely through the skin thickness. Figure 1.16-5 shows the corrosion features near STA 2100. General features of this damage and condition of the skin indicate that the corrosion was not the result of salt-water immersion after the event. Table 1.16-2 displays all the corrosion features found on item 640C1.

Figure 1.16-5 Skin corrosion features at STA 2100

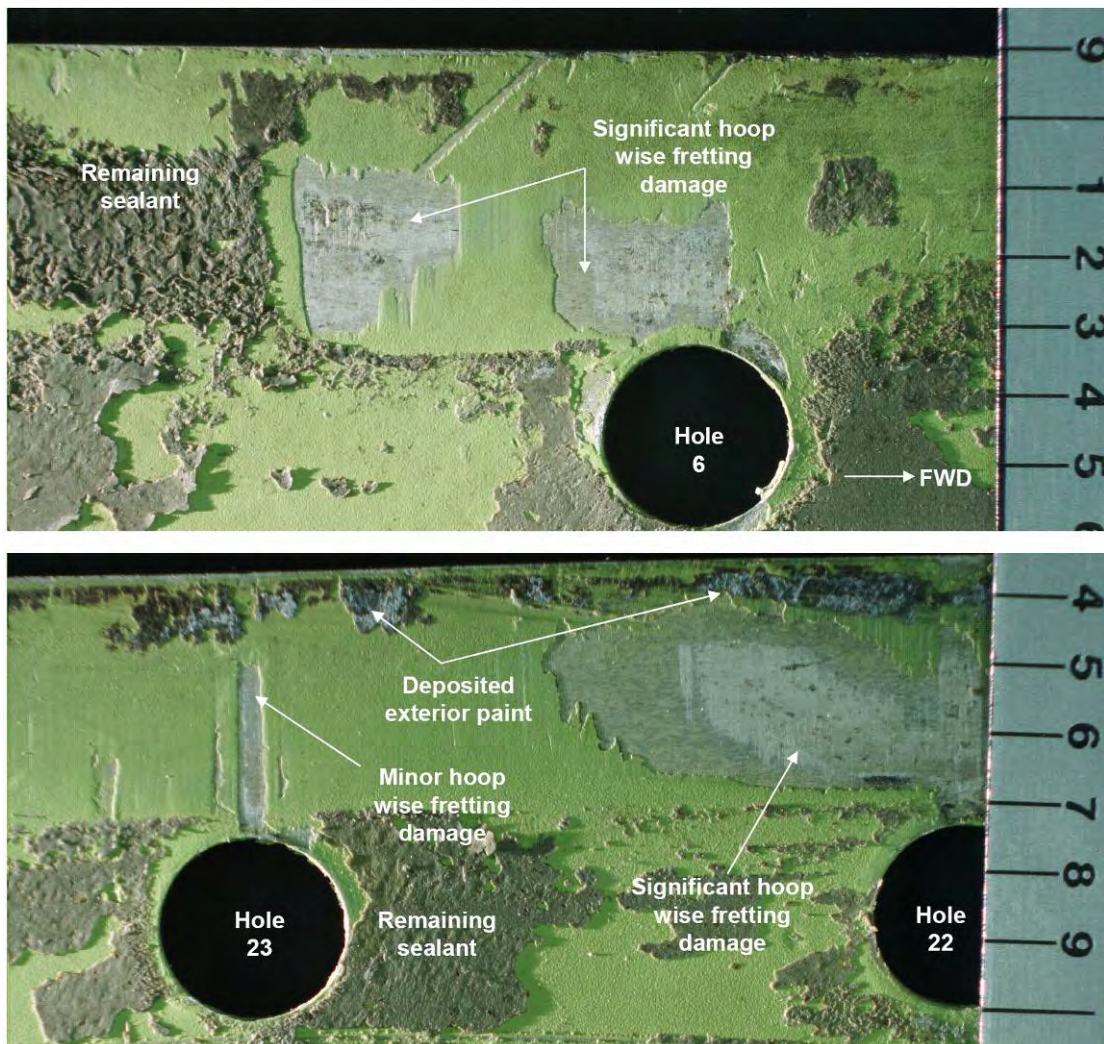
- The fretting marks observed from STA 2061 (hole +16) to STA 2132 (hole 49) are associated with most of the rivet locations. The most significant fretting damage was present between holes 8 and 43.
- The fretting marks near hole 32 and an optically magnified photograph of the area of contact is shown in Figure 1.16-9. It shows that the area of contact exhibits many colors and some hoop-wise scratches (marked by arrows).
- Two cross-section locations were chosen to characterize the area of contact. Figures 1.16-10 and Figure 1.16-11 show the metallographic photographs through the area marked by data sampling cut #1 and data sampling cut #2 respectively. It is observed that there was some material superimposed over the grooves of the scratches.

Figure 1.16-8 Fretting damage observed on faying surface of the repair doubler

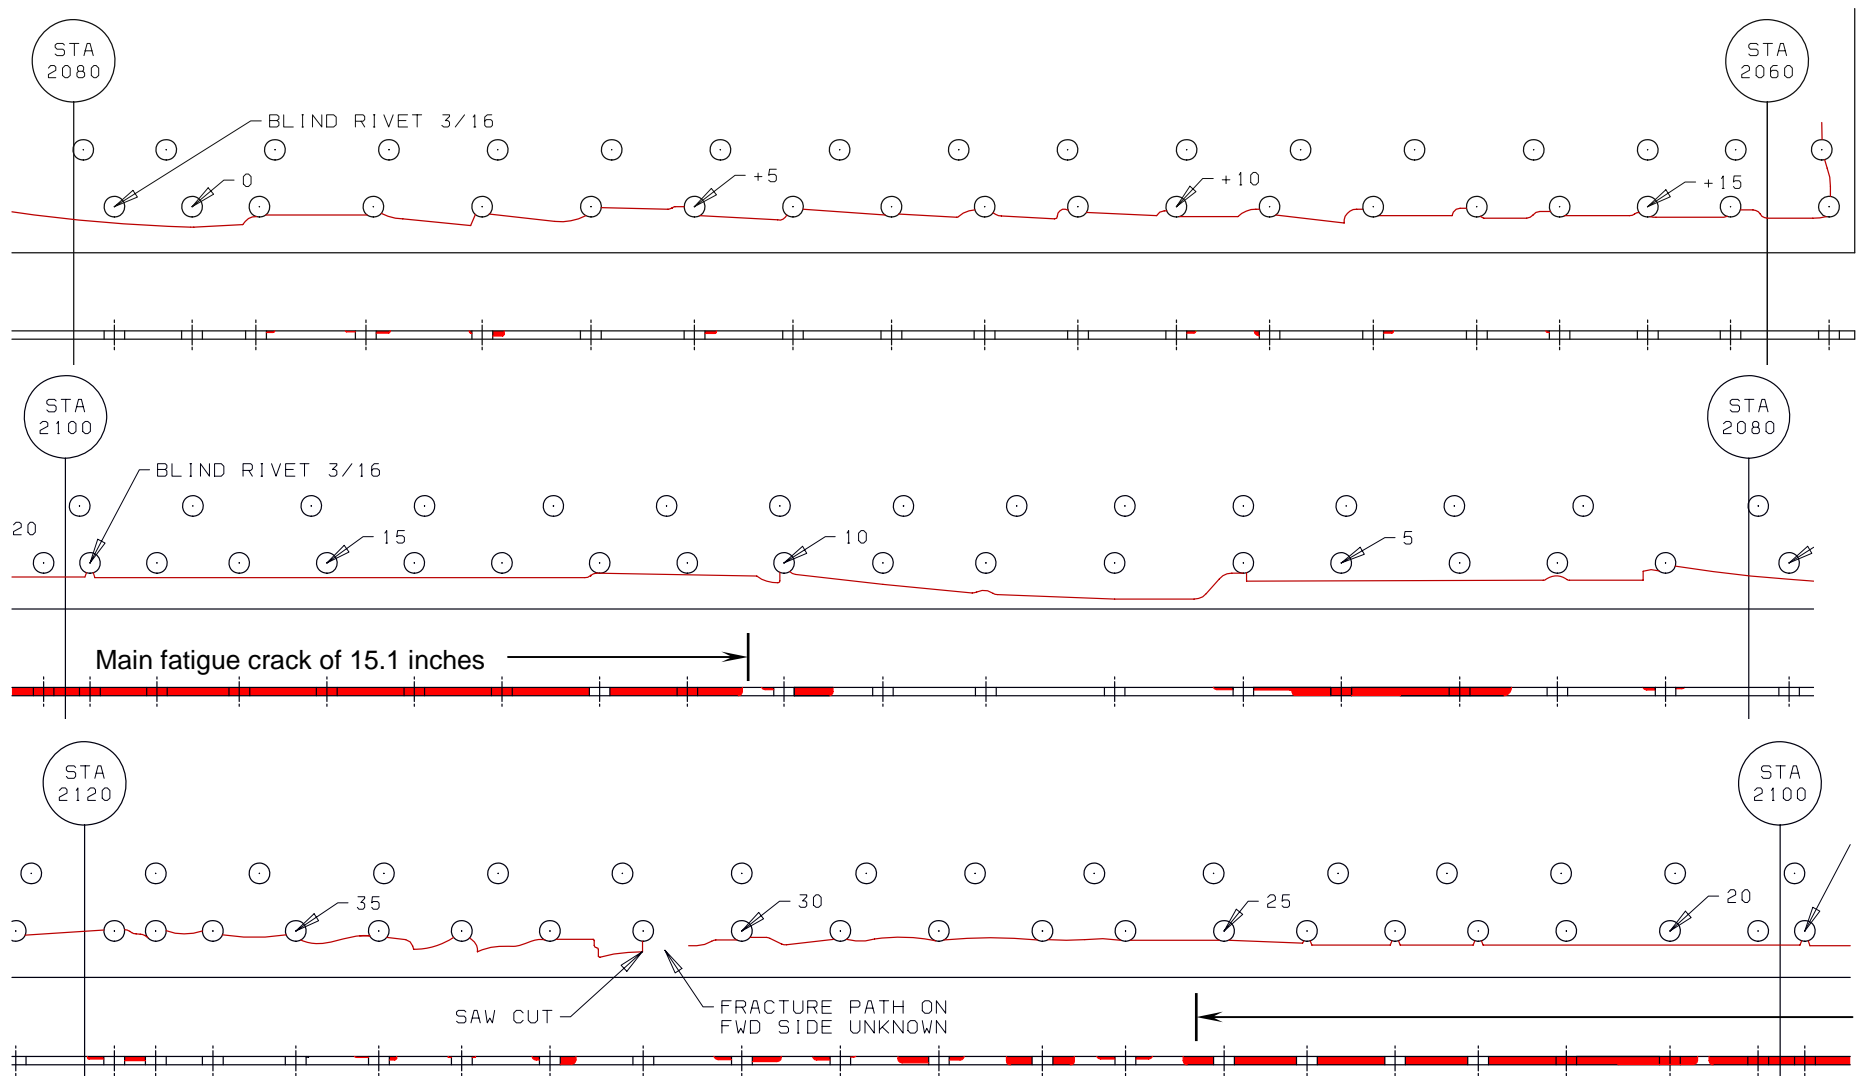
Figure 1.16-12 Distribution of the fatigue cracks (from STA 2060 to STA 2120)

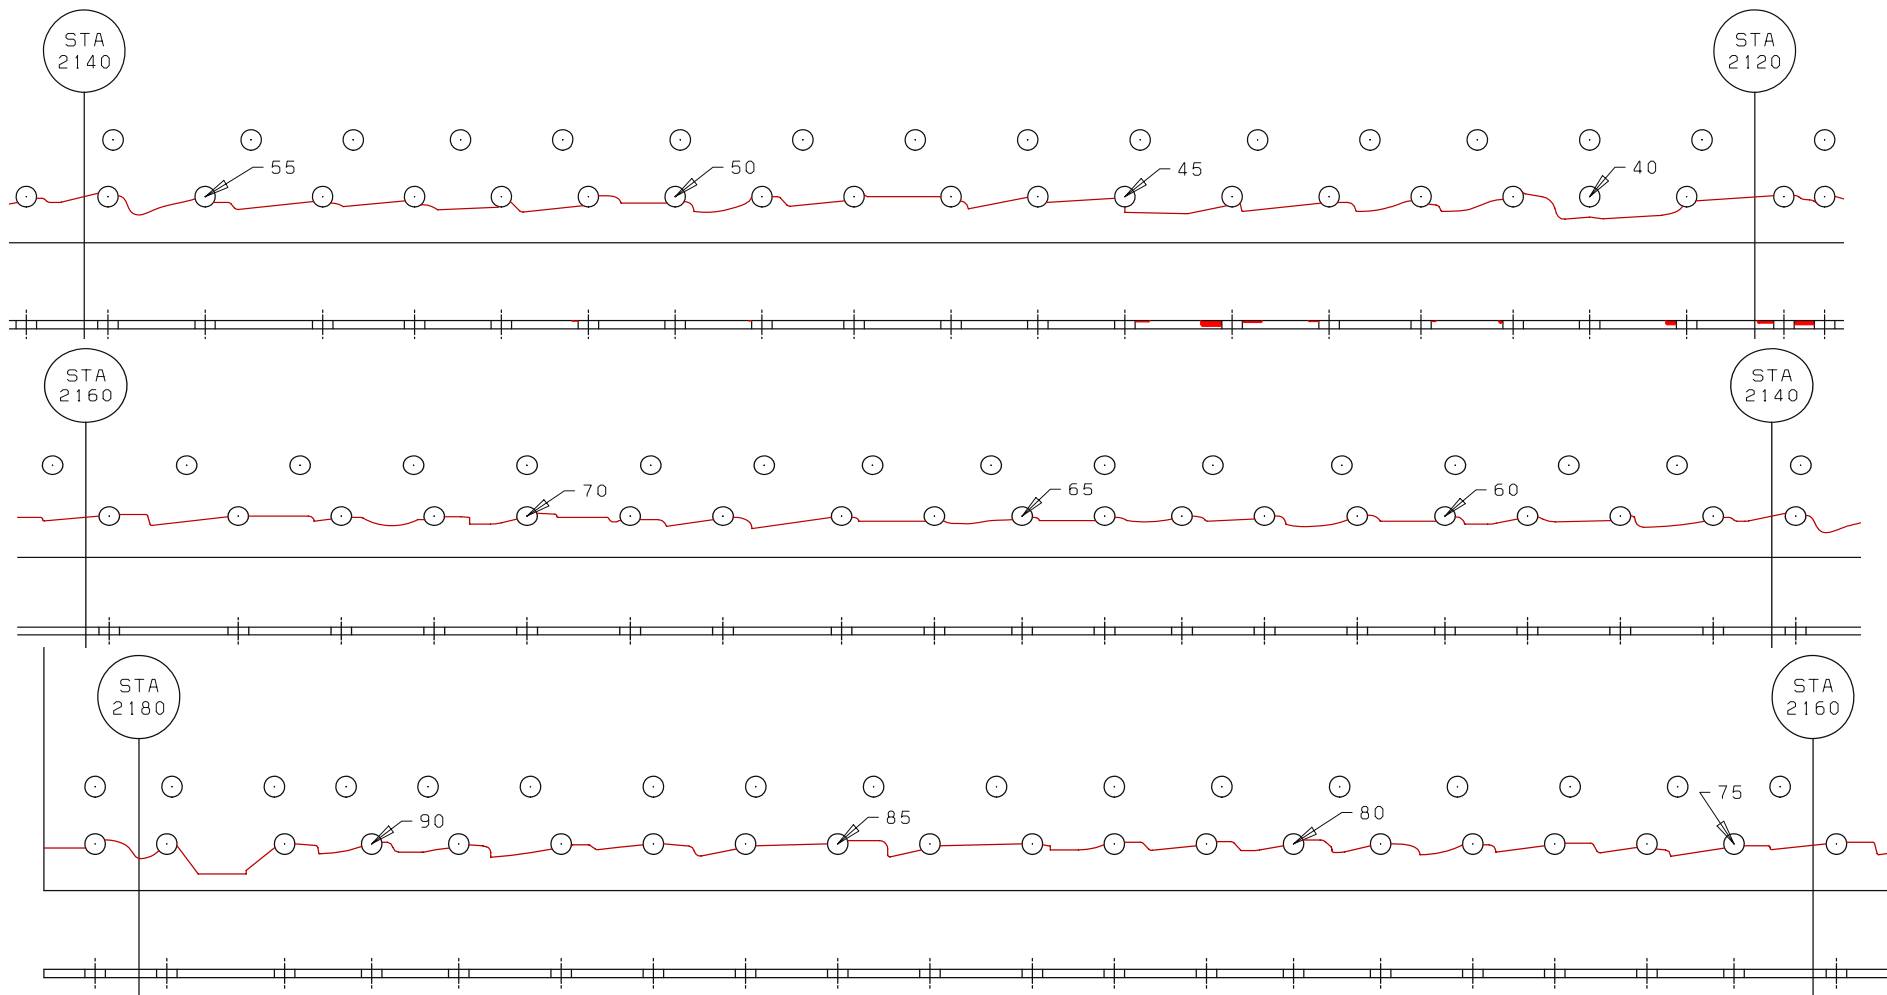
Figure 1.16-13 Distribution of the fatigue cracks (from STA 2120 to STA 2180)

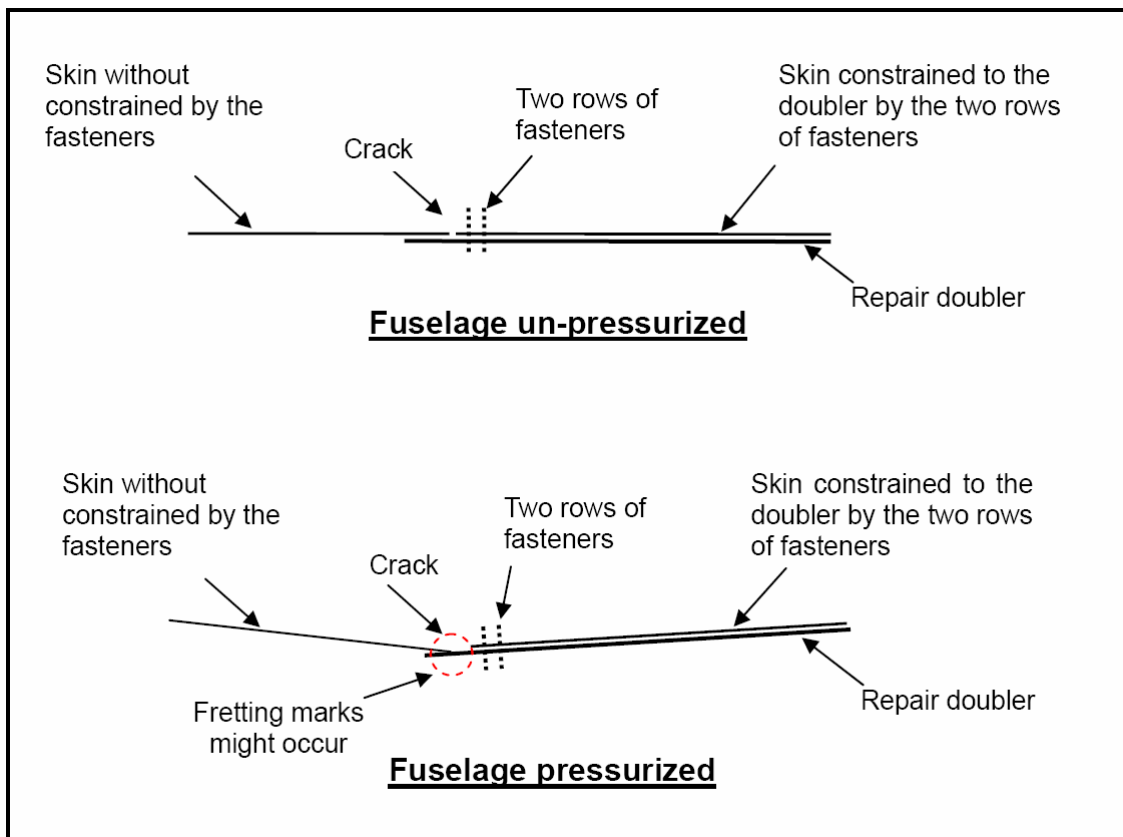
portion of the repair doubler was consistent with this phenomenon (Figure 1.16-8).

Figure 2.2-8 The fretting marks caused by the pressurization cycles

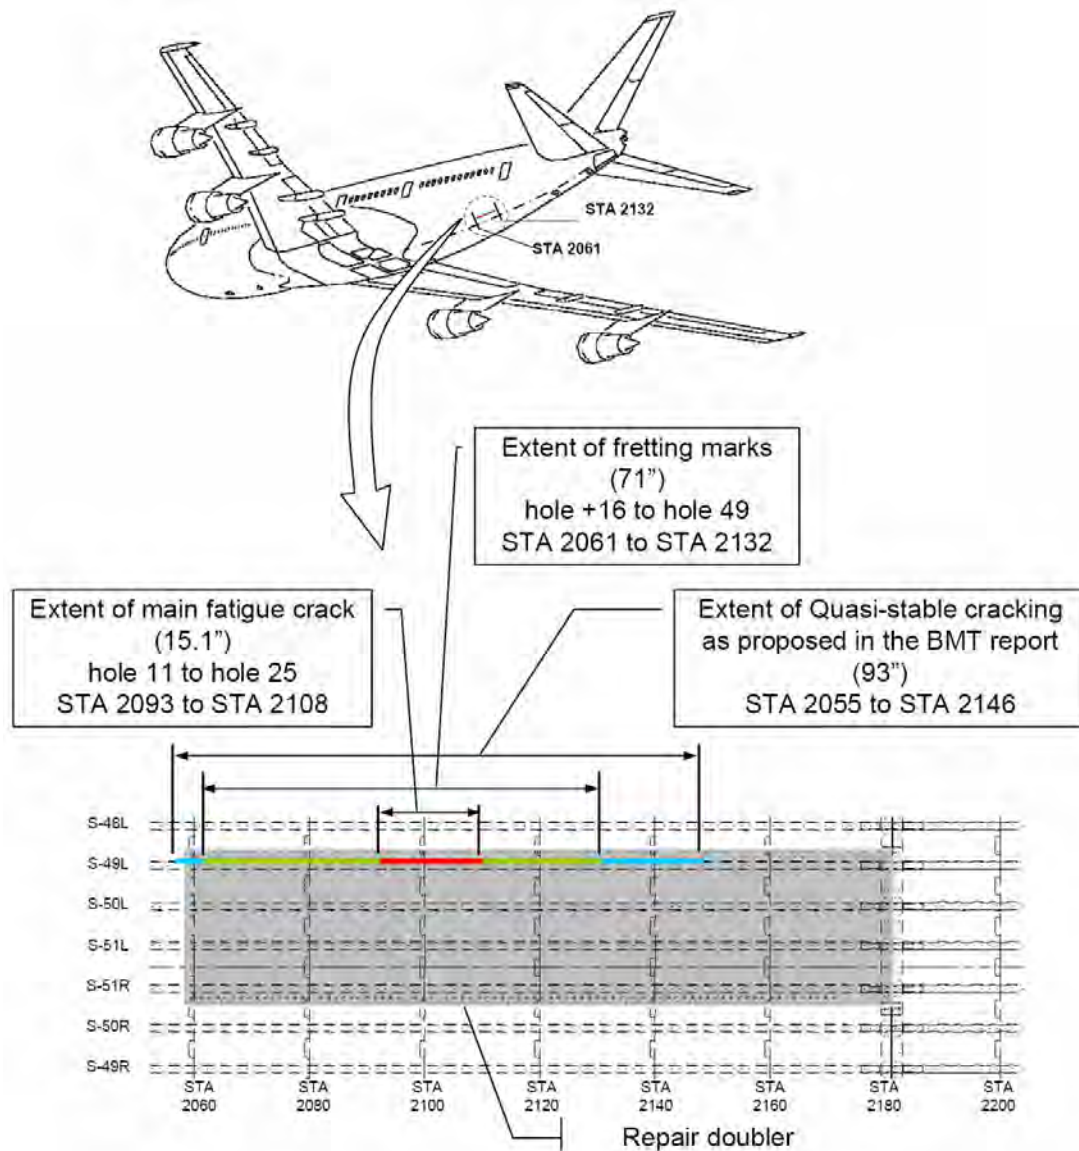
According to these observations, the BMT report suggested a pre-existing crack in the skin continuously from STA 2055 to 2146, or approximately 93 inches in length prior to the in-flight breakup. The diagram of different length of crack was shown in Figure 2.2-12.

Figure 2.2-12 Different signs of cracks

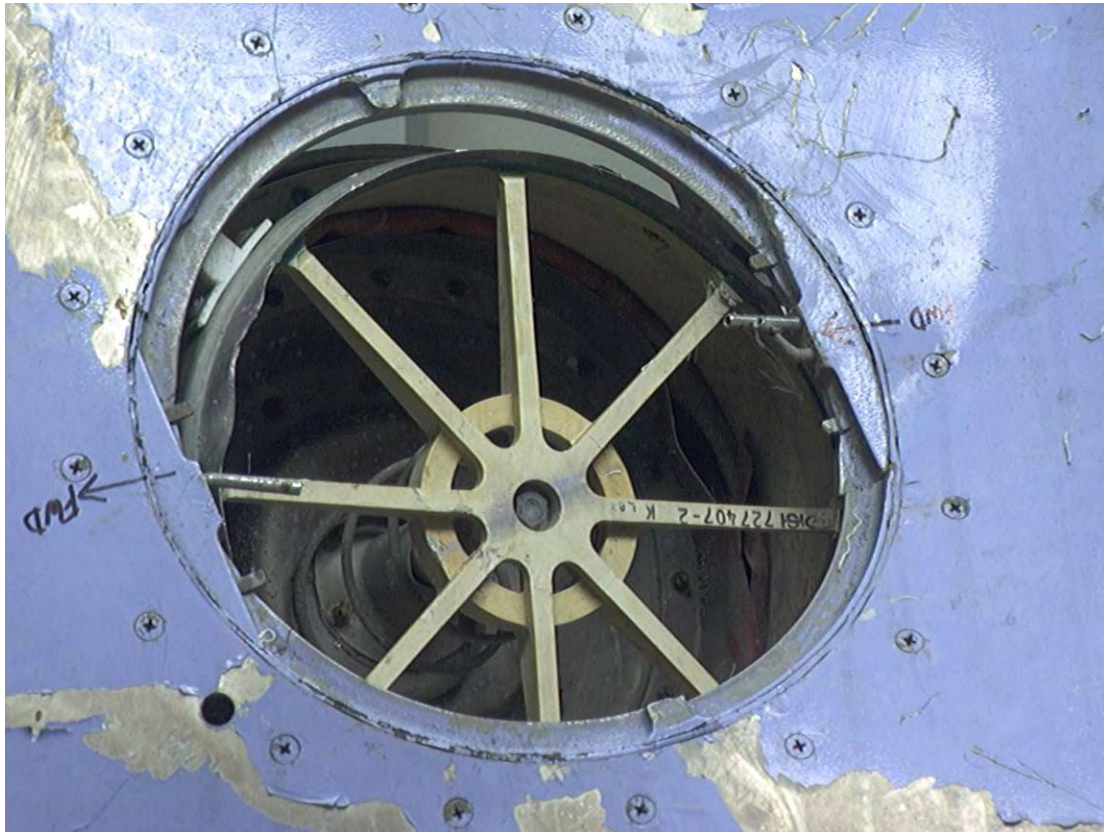
The visual inspection result shows the Upper Pressure Relief valve (Figure 2.7-5) has been deformed inward, the blowout doors are missing, the gate web fractured, FWD upper hinge pin is bent, lower hinge pin missing, AFT lower hinge pin is bent and all hinge pins are moveable.

Figure 2.7-5 Upper pressure relief valve

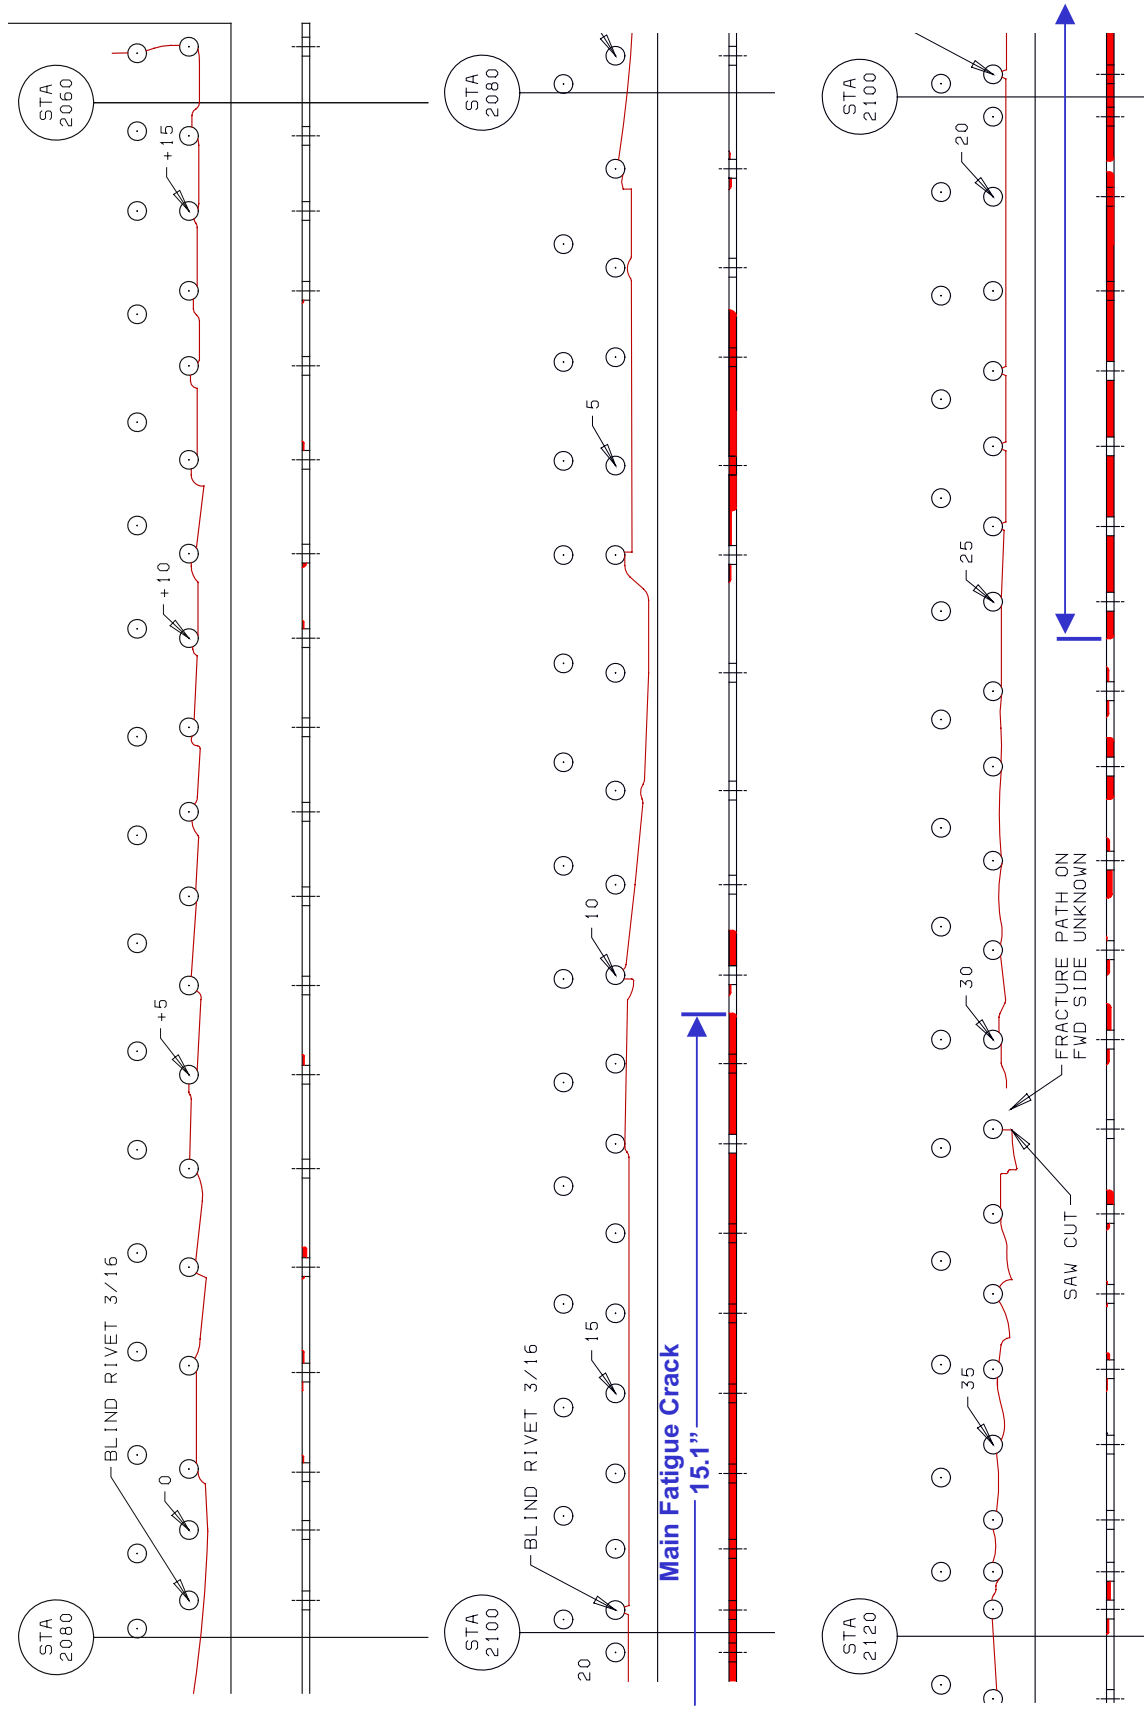
Figure 5.
Map of fatigue cracking (red areas) observed on fracture above S-49L from STA 2060 to STA 2120. The length of the main fatigue crack centered about STA 2100 is shown. Refer to Table JVI for a complete list of fatigue crack lengths and depths.

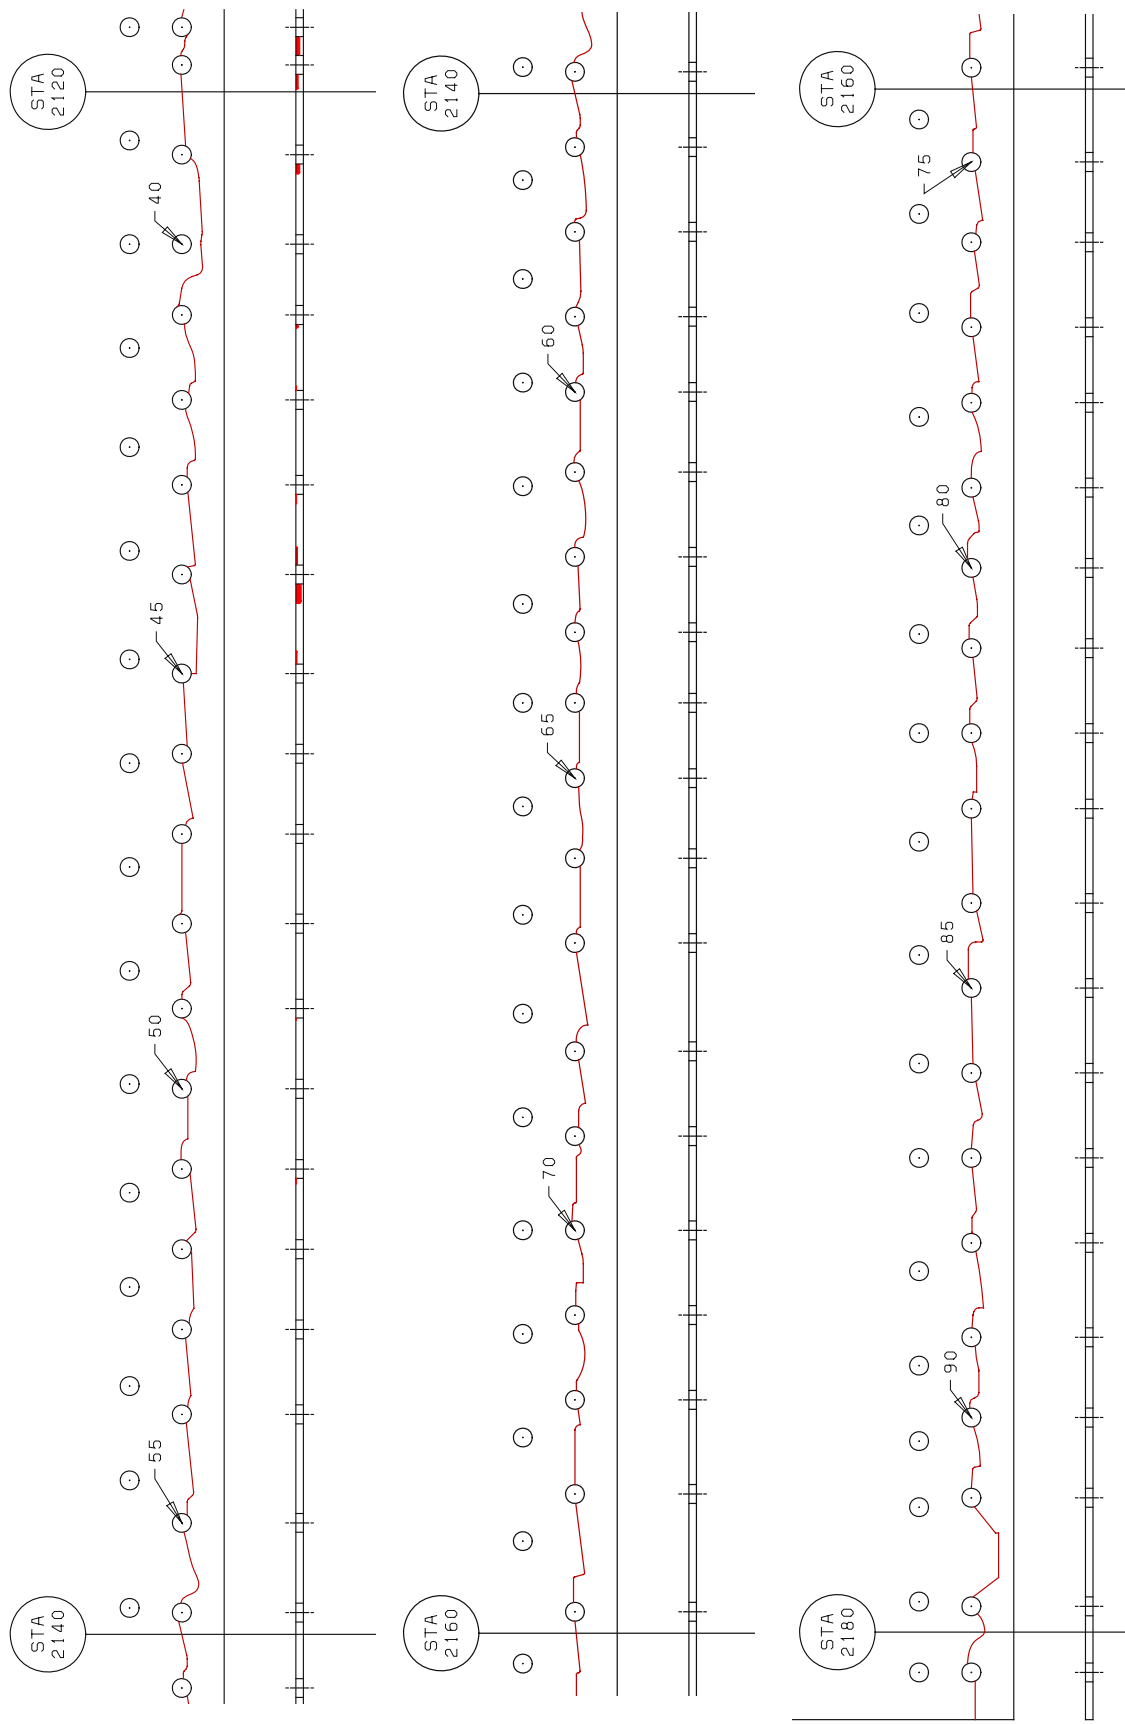
Figure 6.
Map of fatigue cracking (red areas) observed on fracture above S-49L from STA 2120 to STA 2180. Refer to Table JVI for lengths and depths of the fatigue cracks provided in this figure.

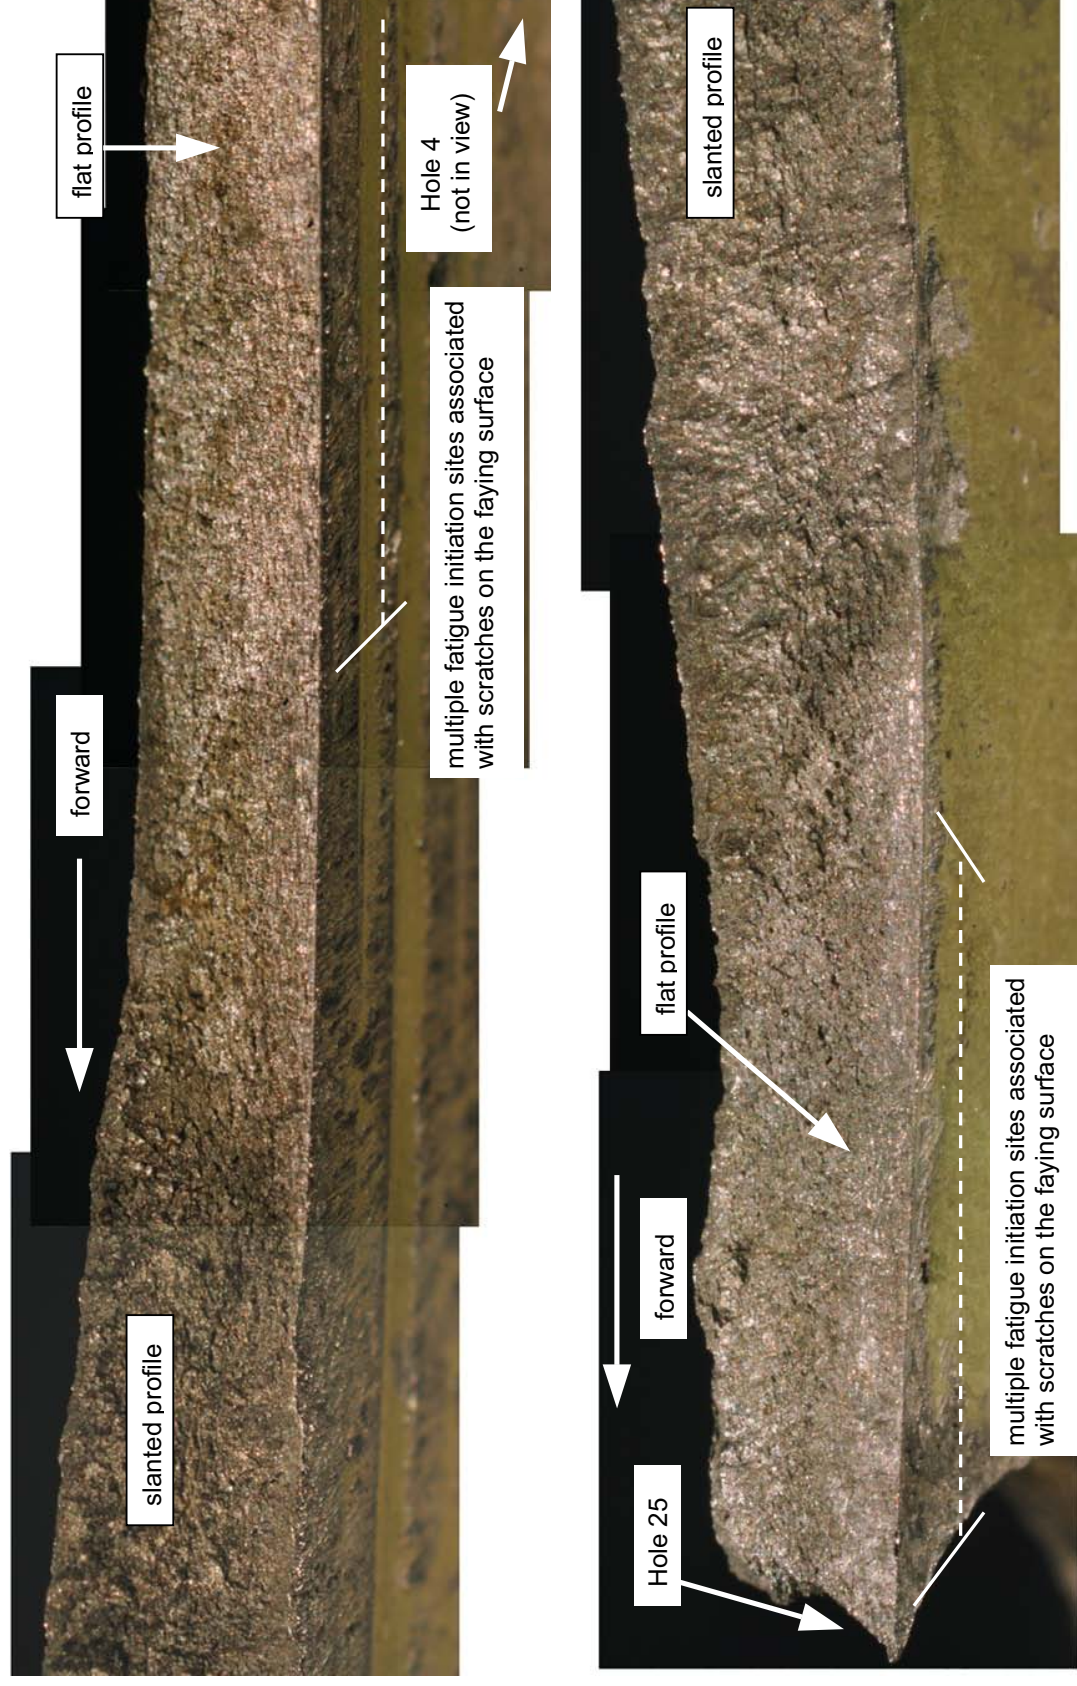
Figure 9, Photographs showing the transition regions from flat fracture profiles to slanted profiles just forward of fastener Hole 4 (top) and Hole 25 (bottom).

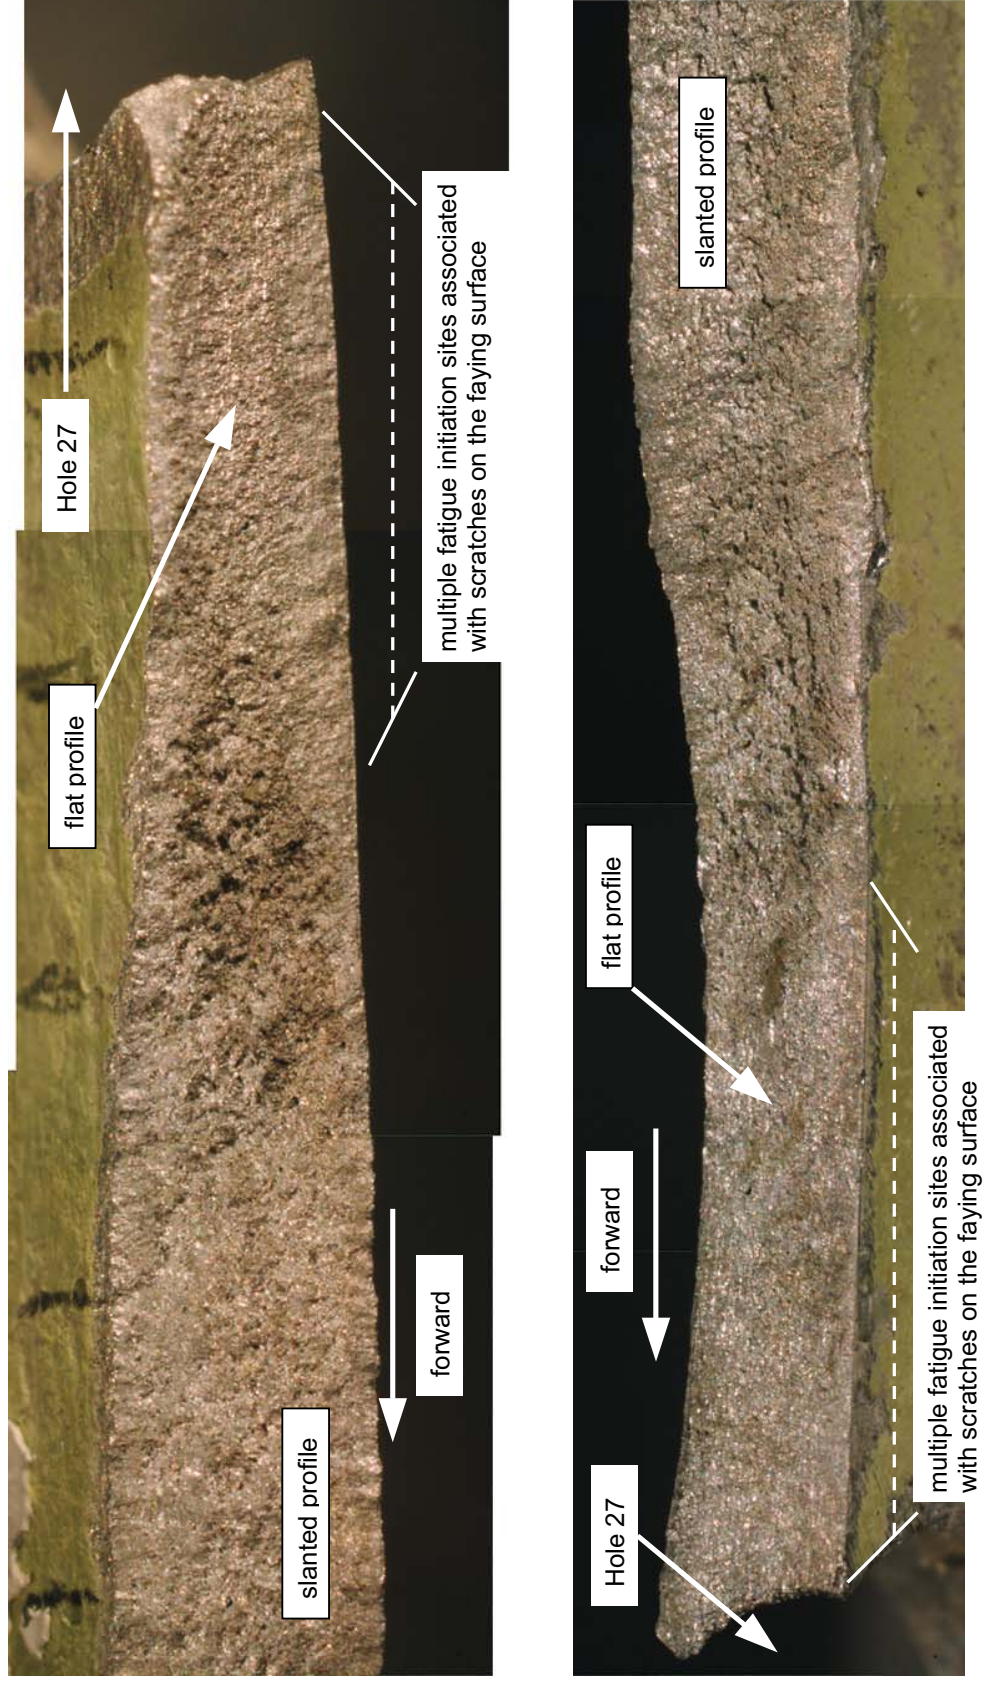
Figure 10. Photographs showing the transition regions from flat fracture profiles to slanted profiles at fastener Hole 27 in the forward direction (top) and the aft direction (bottom).

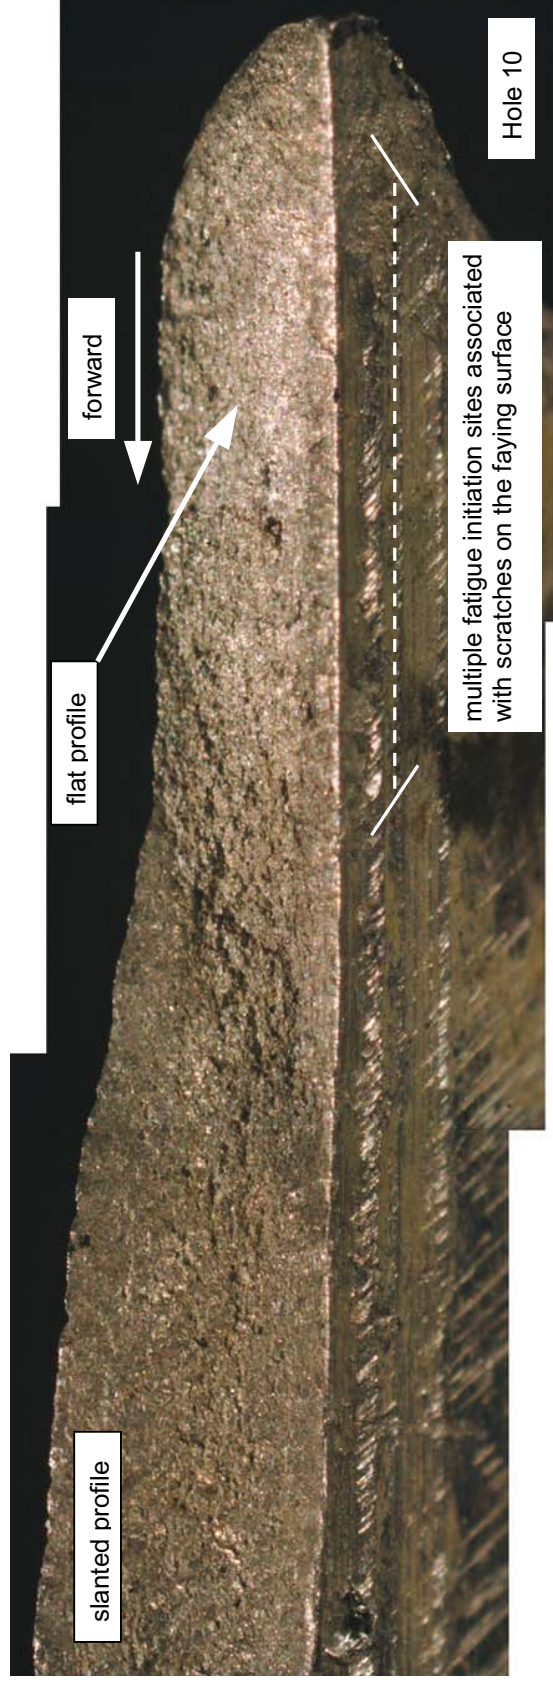
Figure 11, Photograph showing the transition region from a flat fracture profile to a slanted profile at fastener Hole 10 in the forward direction.

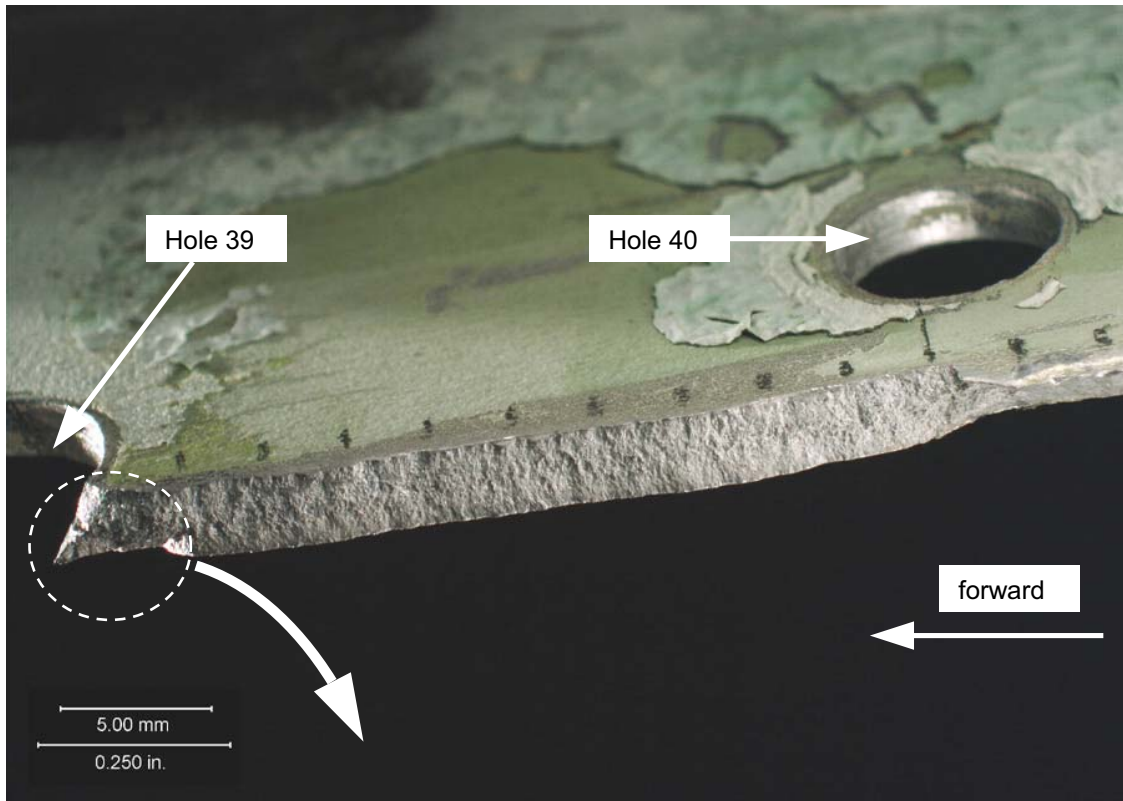
Figure 13, Photographs of the fracture segment extending from Hole 39 to 40 (top), and closer view of the flat profile fatigue region and short transition zone on the aft side of Hole 39 (bottom). SEM photographs showing a dramatic increase in striation spacing near the extent of the flat fracture thumbnail (indicated area) are shown below in Figure 14.

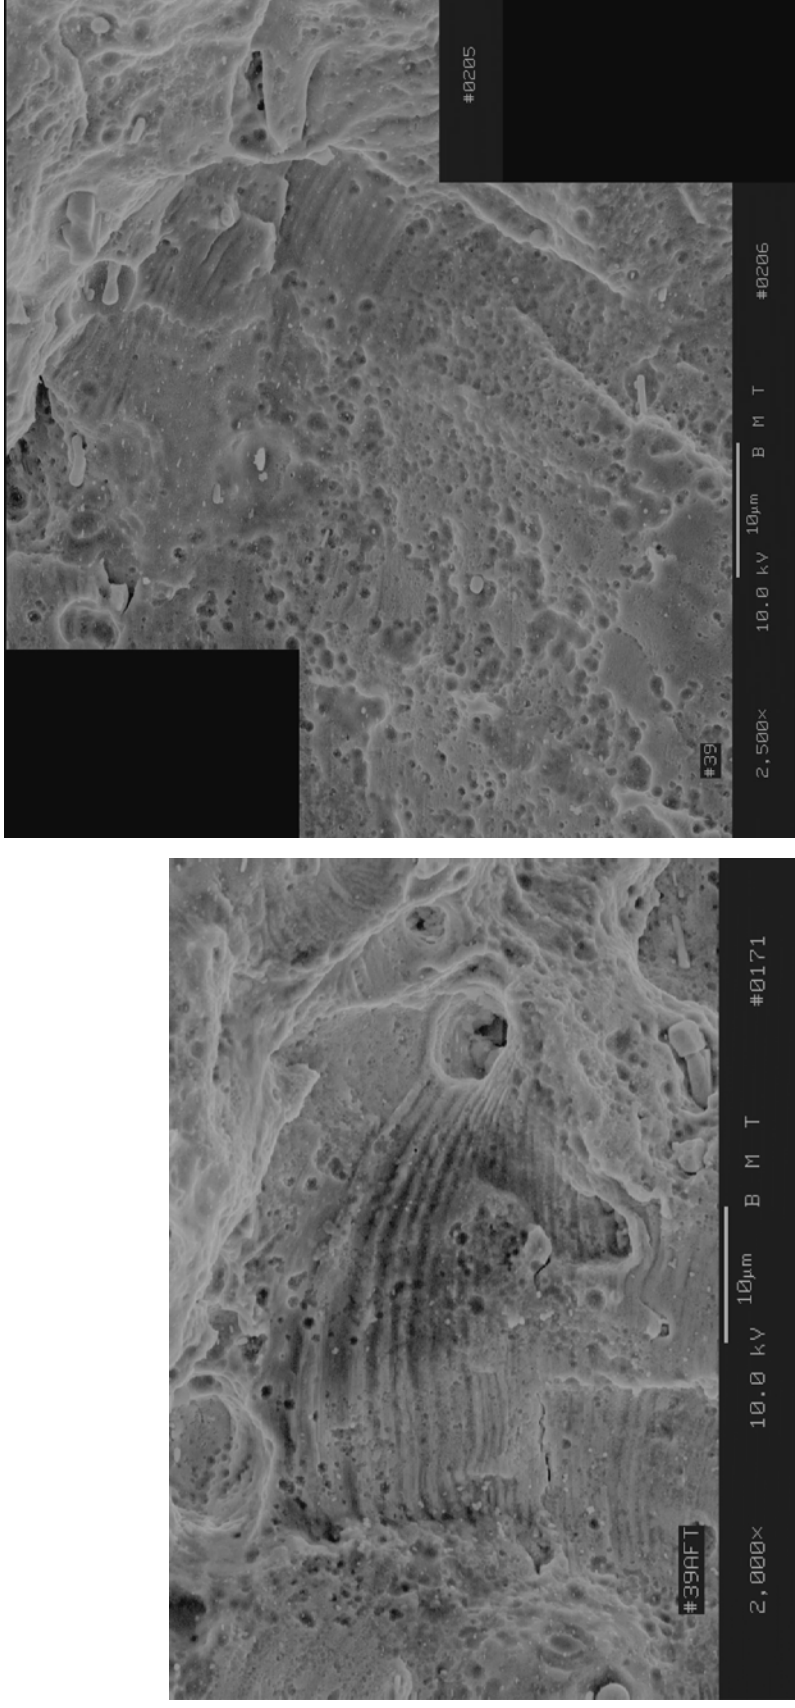
Figure 14, scanning electron microscope photographs showing fatigue striations near the end of the flat profile fracture surface aft of Hole 39. Just beyond these regions, the fracture surface was dominated by a dimpled morphology, indicative of the fracture mechanism of micro-void coalescence, or ductile separation. Severe pitting due to corrosion can also be seen.
