Aviation Occurrence Report Volume I

ASC-AOR-05-02-001

IN-FLIGHT BREAKUP OVER THE TAIWAN STRAIT

CHINA AIRLINES FLIGHT CI611

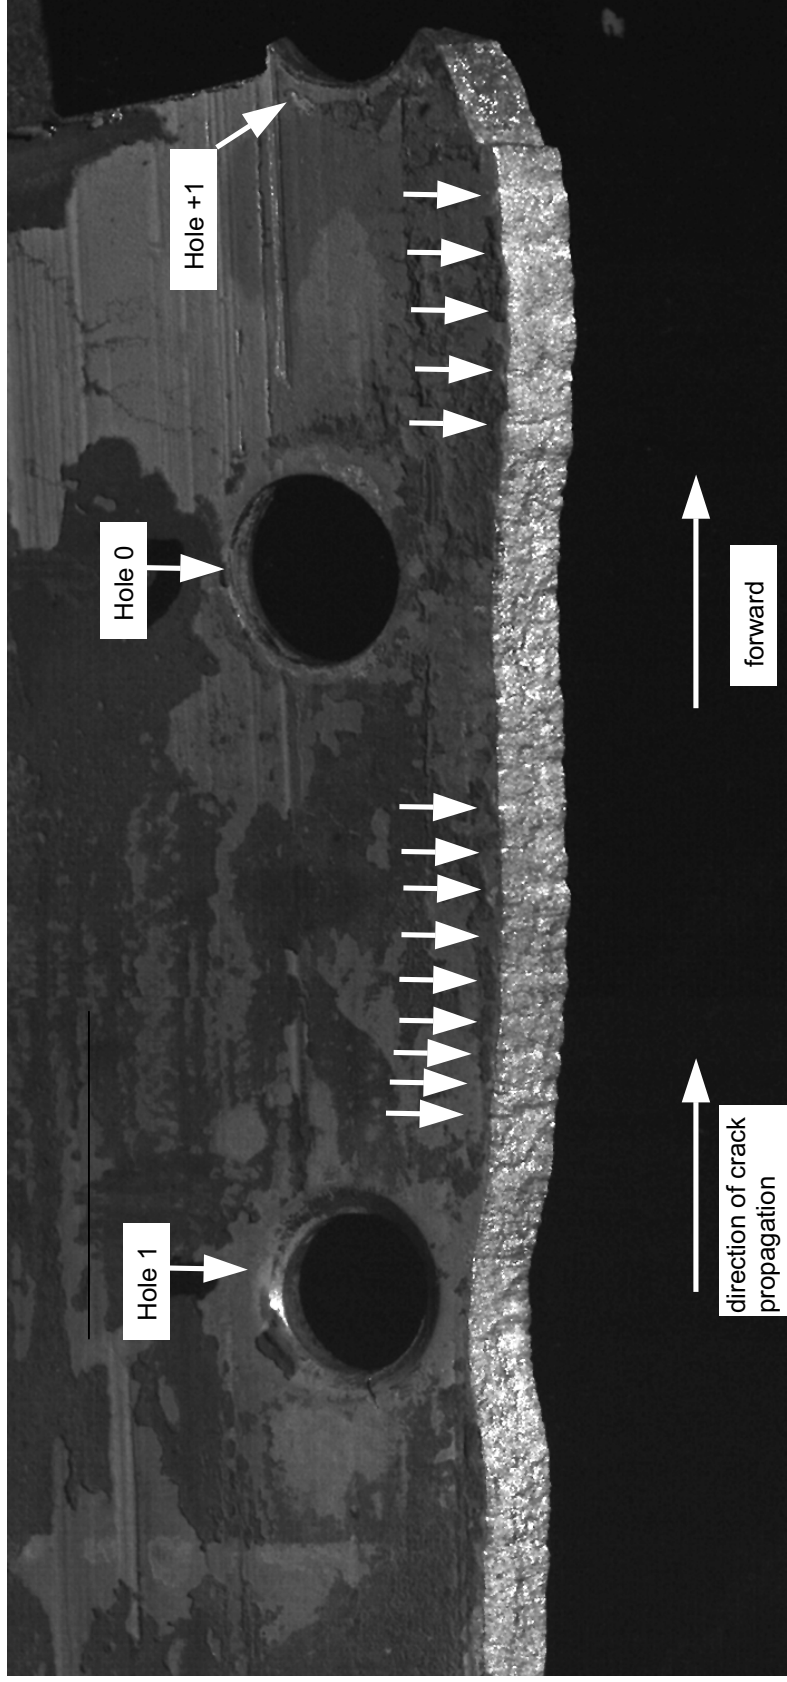
Figure 15, Photograph showing the incremental crack growth indications on the fracture segment from Hole 1 to Hole +1 with two groups of them identified with arrows. This area is just a few inches forward of the flat profile fatigue and transition areas of Hole 4 shown in Figure 9. Note that the regular spacing generally increases as the distance increases from the main cracking system at Holes 4 through 26. These features indicate that the dominant crack was growing at macroscopic rates in a forward direction here when these features were formed, rather than in a through-thickness direction as was the earlier fatigue initiation and propagation mechanism. This point is further exemplified in the following Figure 16.

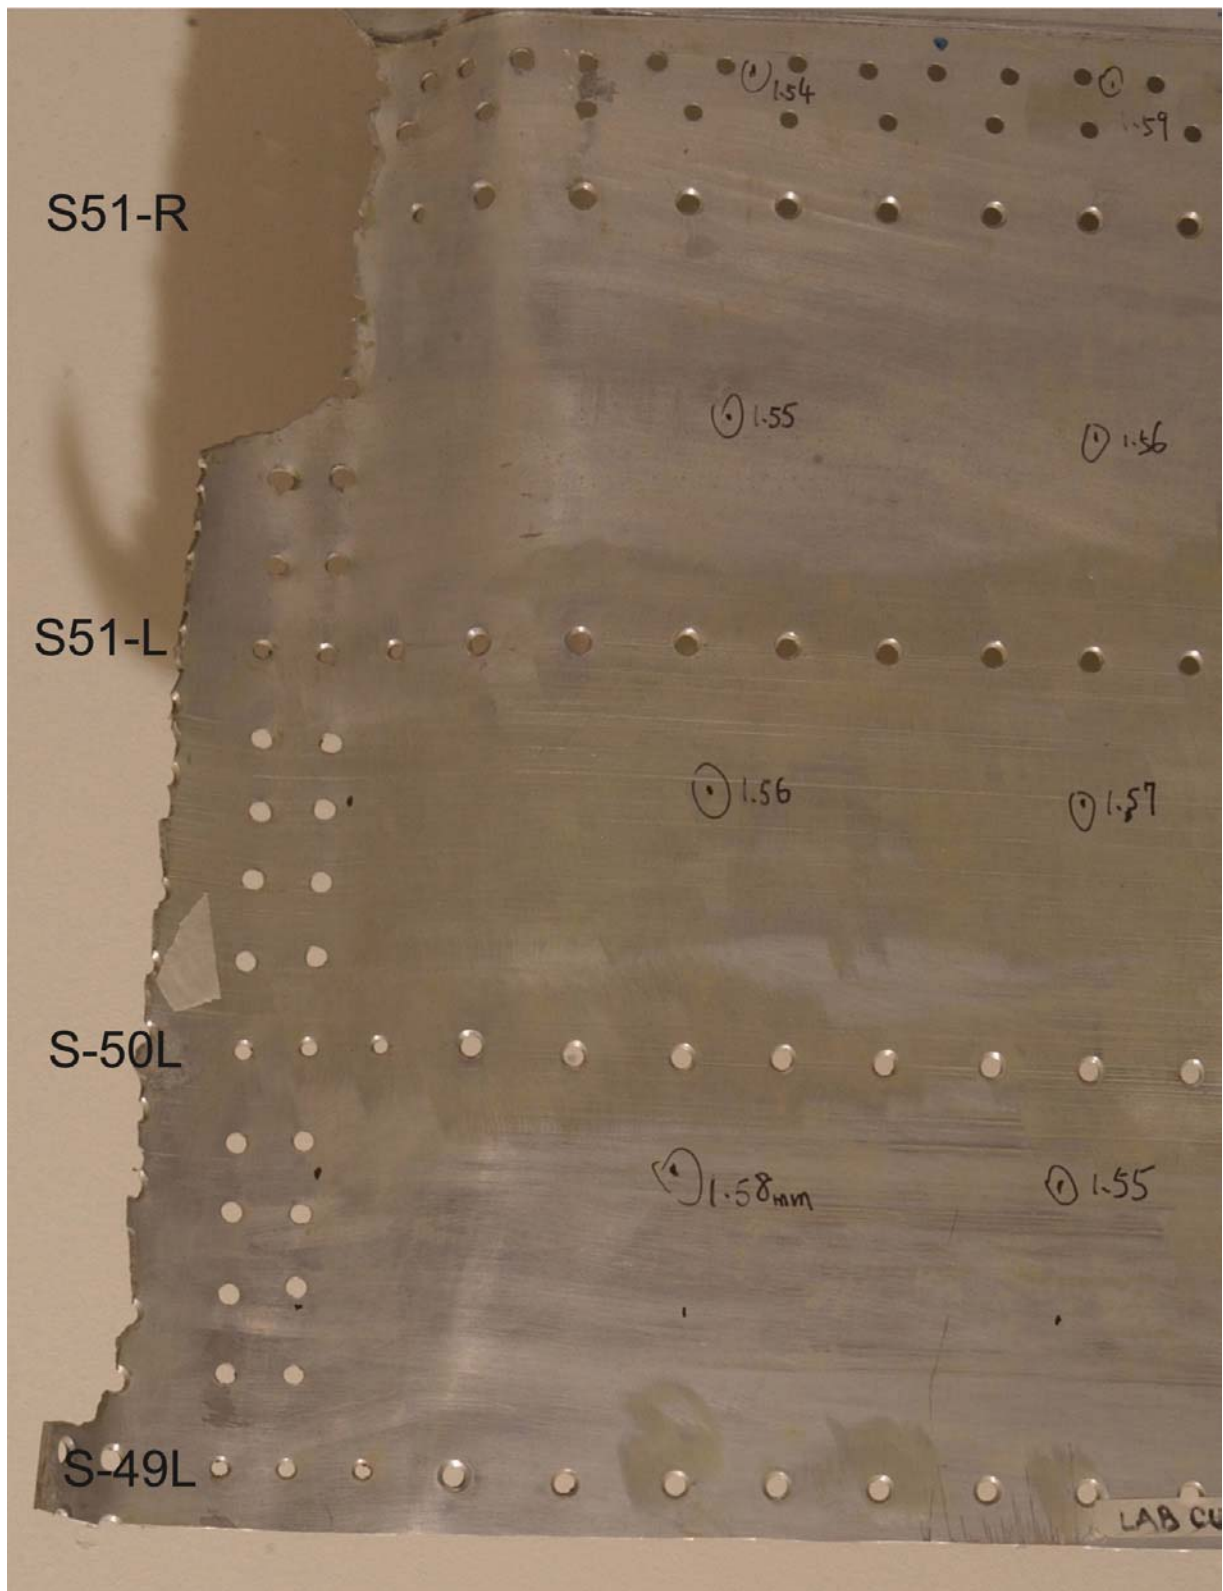
FIGURE 28 – EXTENT OF DAMAGE CONSISTENT WITH A TAIL STRIKE – Scratches may be noted at S-50L and S-51L. Numerical information on skin are results of thickness measurements at the CSIST. Scratch severity increases as you move forward on the panel as shown in the following photographs.

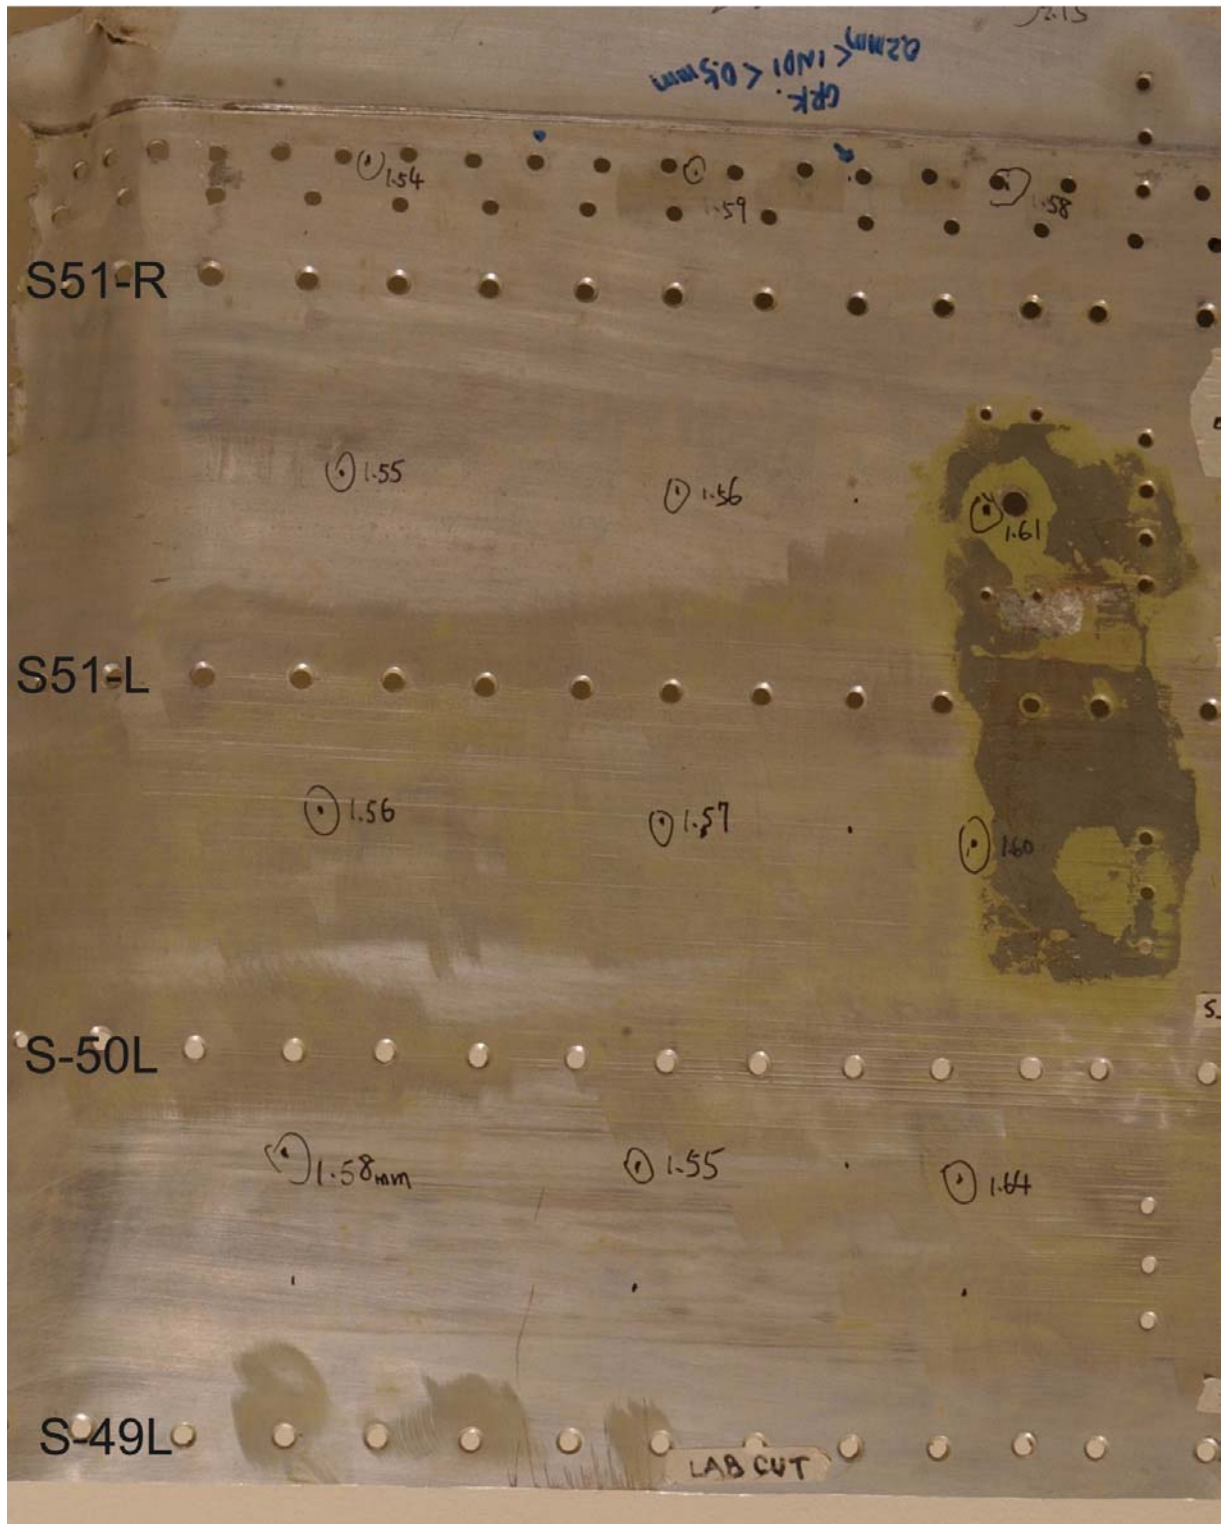
FIGURE 29. EXTENT OF DAMAGE CONSISTENT WITH A TAIL STRIKE – Scratches may be noted at S-50L and S-51L. Scratches may also be noted at the shear tie between S-49L and S-50L.

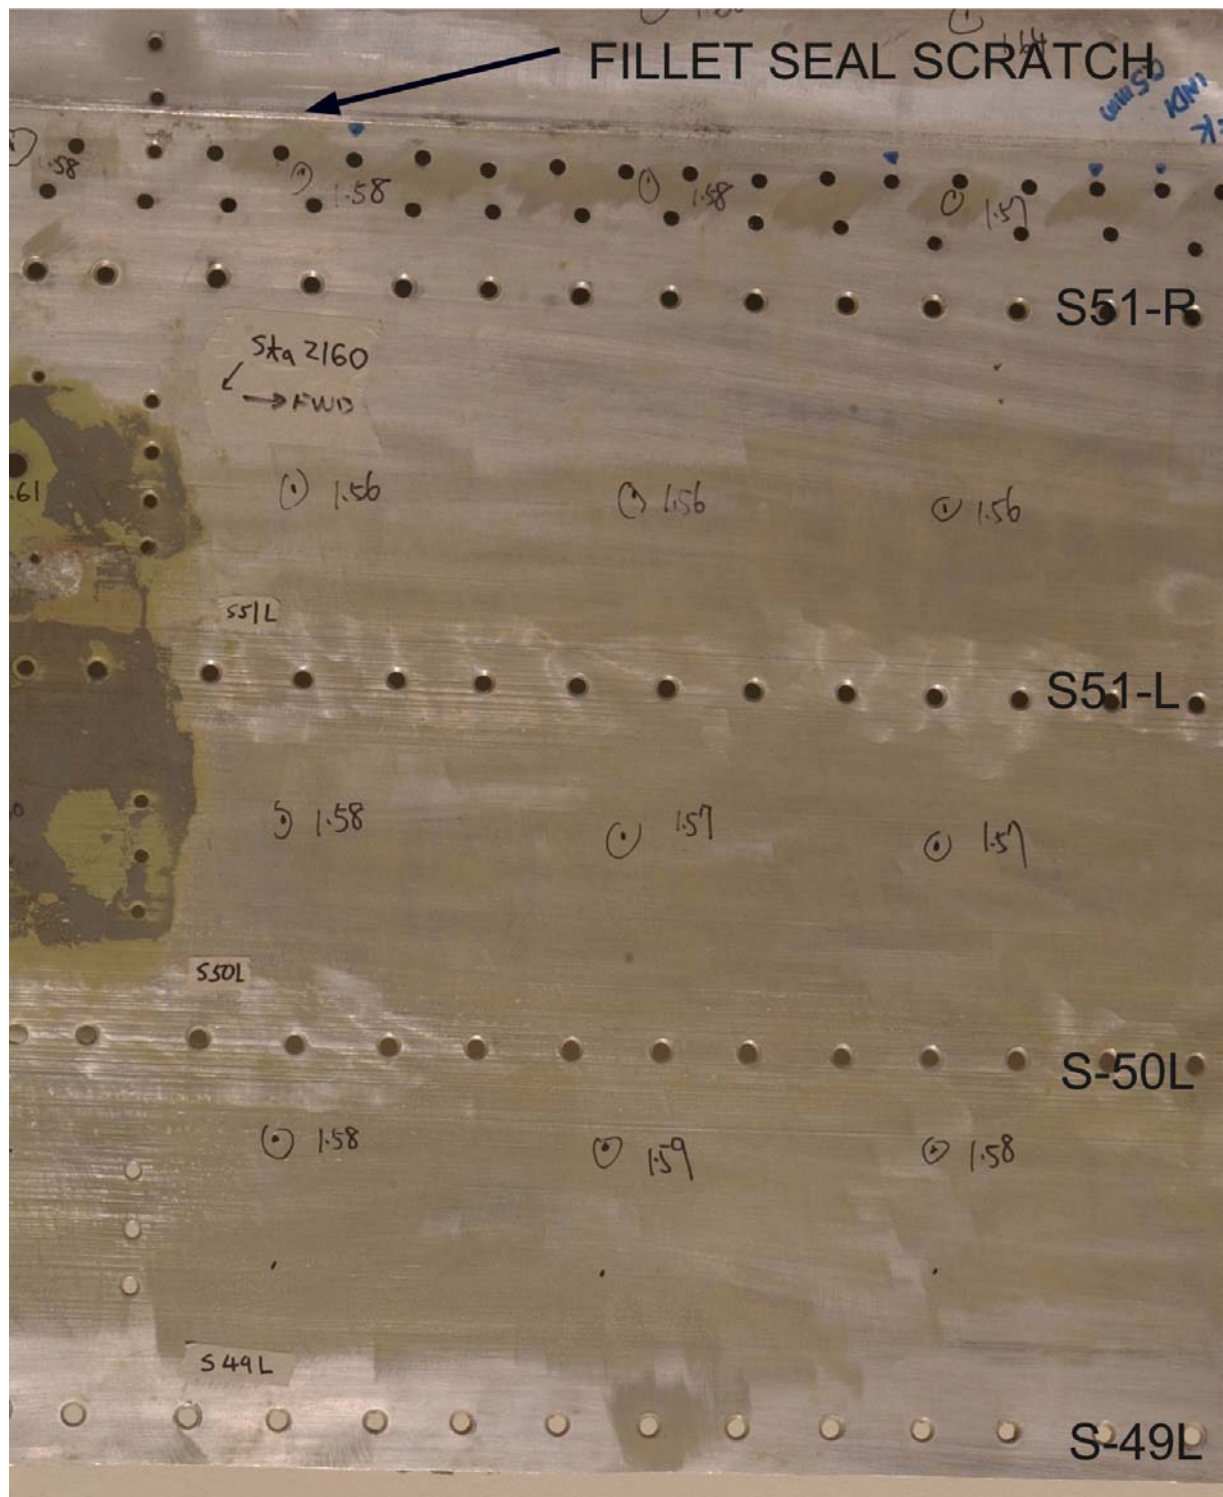
FIGURE 30. EXTENT OF DAMAGE CONSISTENT WITH A TAIL STRIKE - Note that minimal damage occurs on the right hand side of the repair area. Scratching in the doubler fillet seal area may also be seen in this photo.

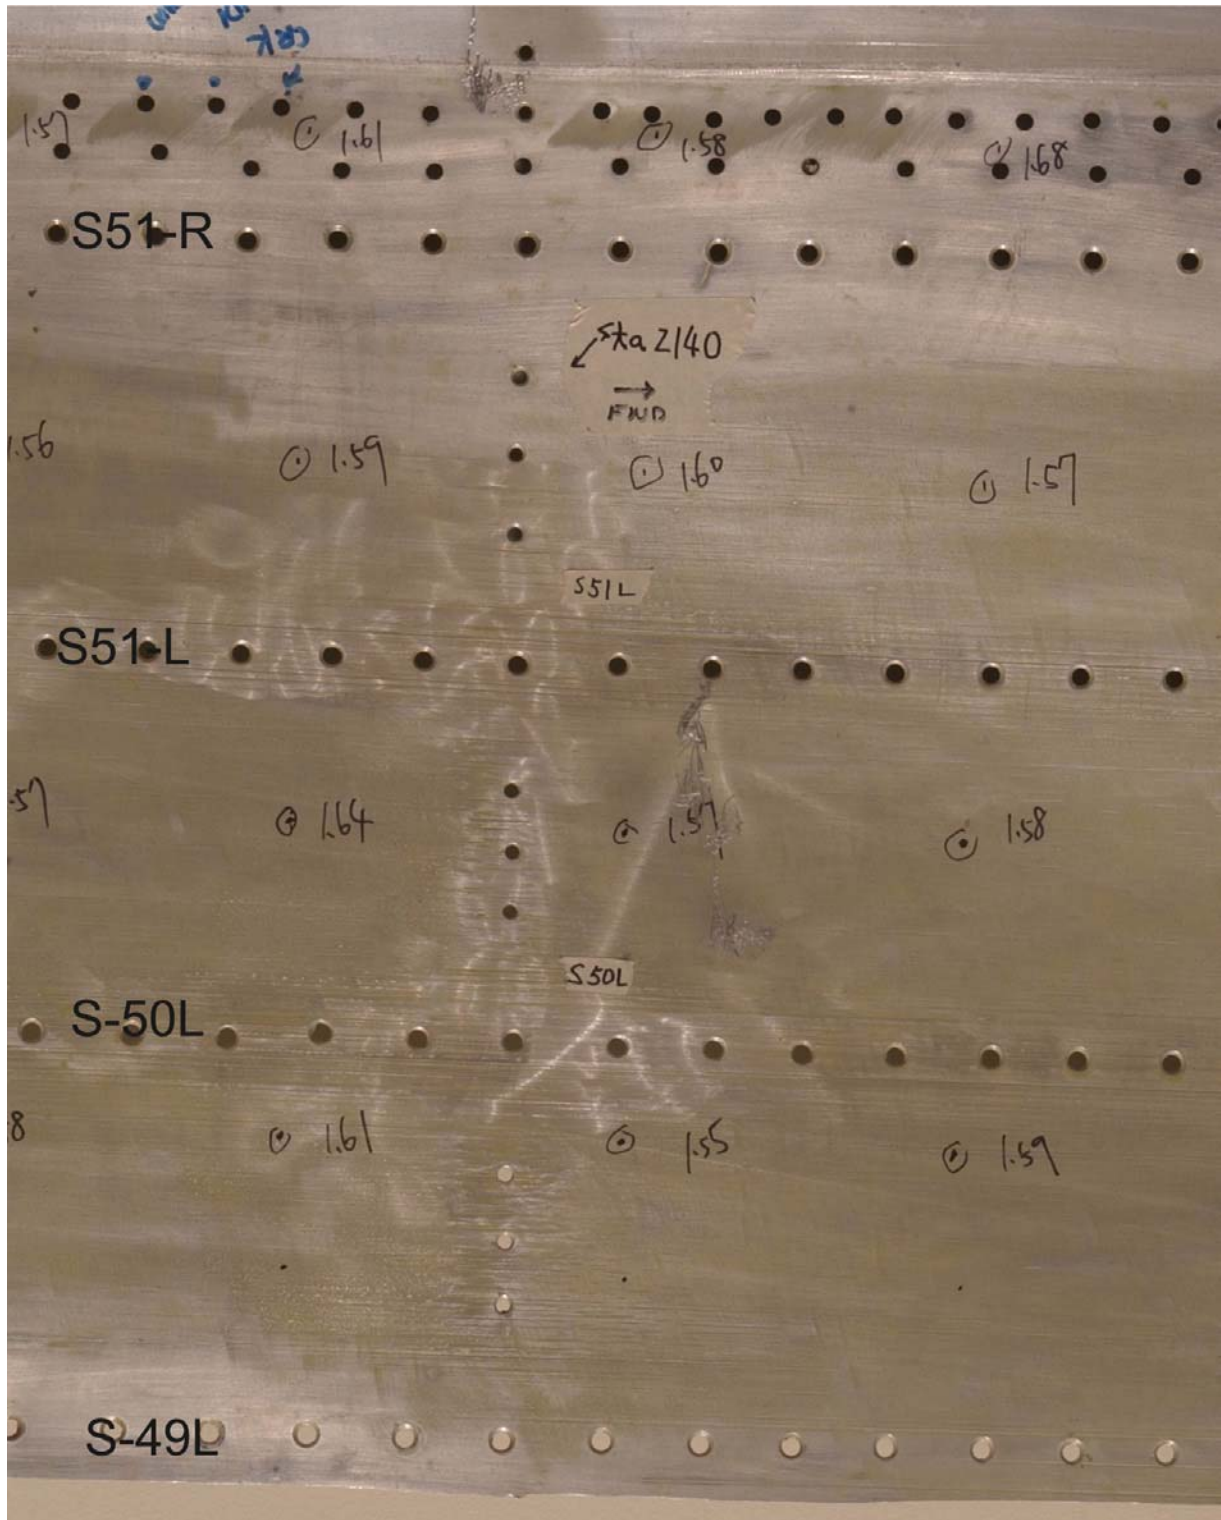
FIGURE 31. EXTENT OF DAMAGE CONSISTENT WITH A TAIL STRIKE

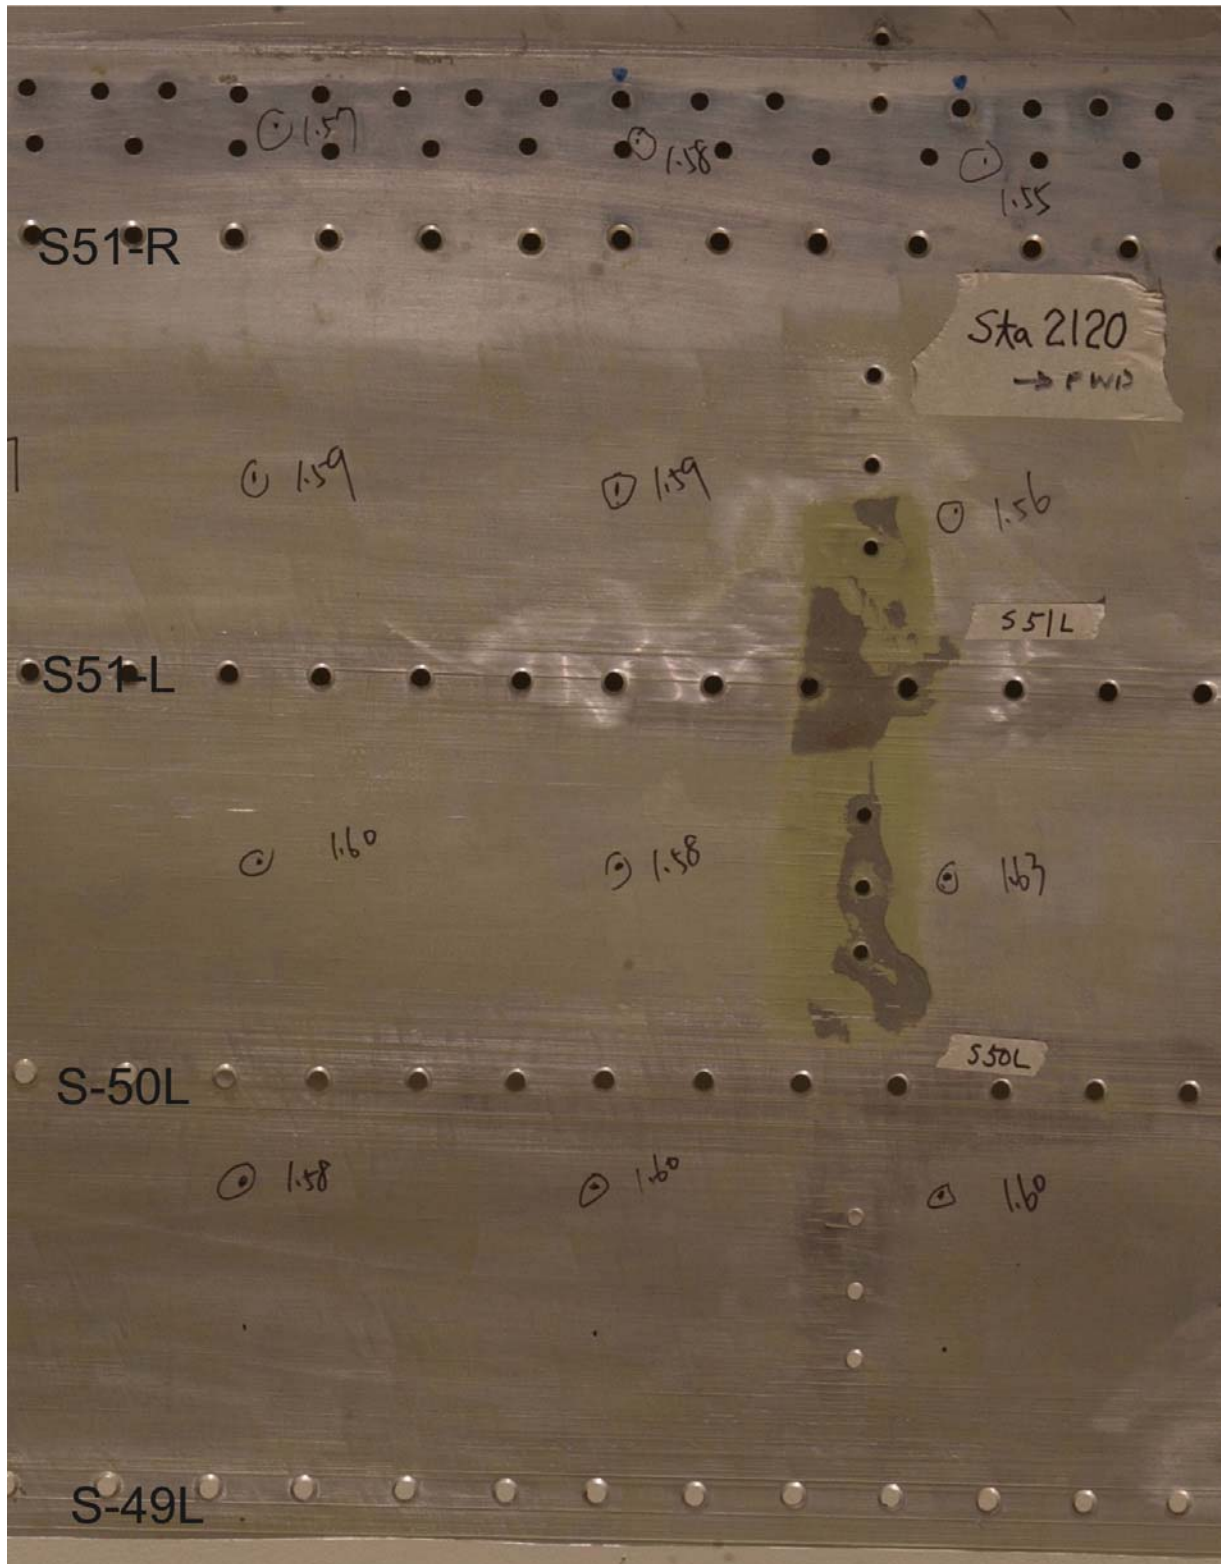
FIGURE 32. EXTENT OF DAMAGE CONSISTENT WITH A TAIL STRIKE – Deep scratches can be noted at S-49L, S-50L, AND S-51L.

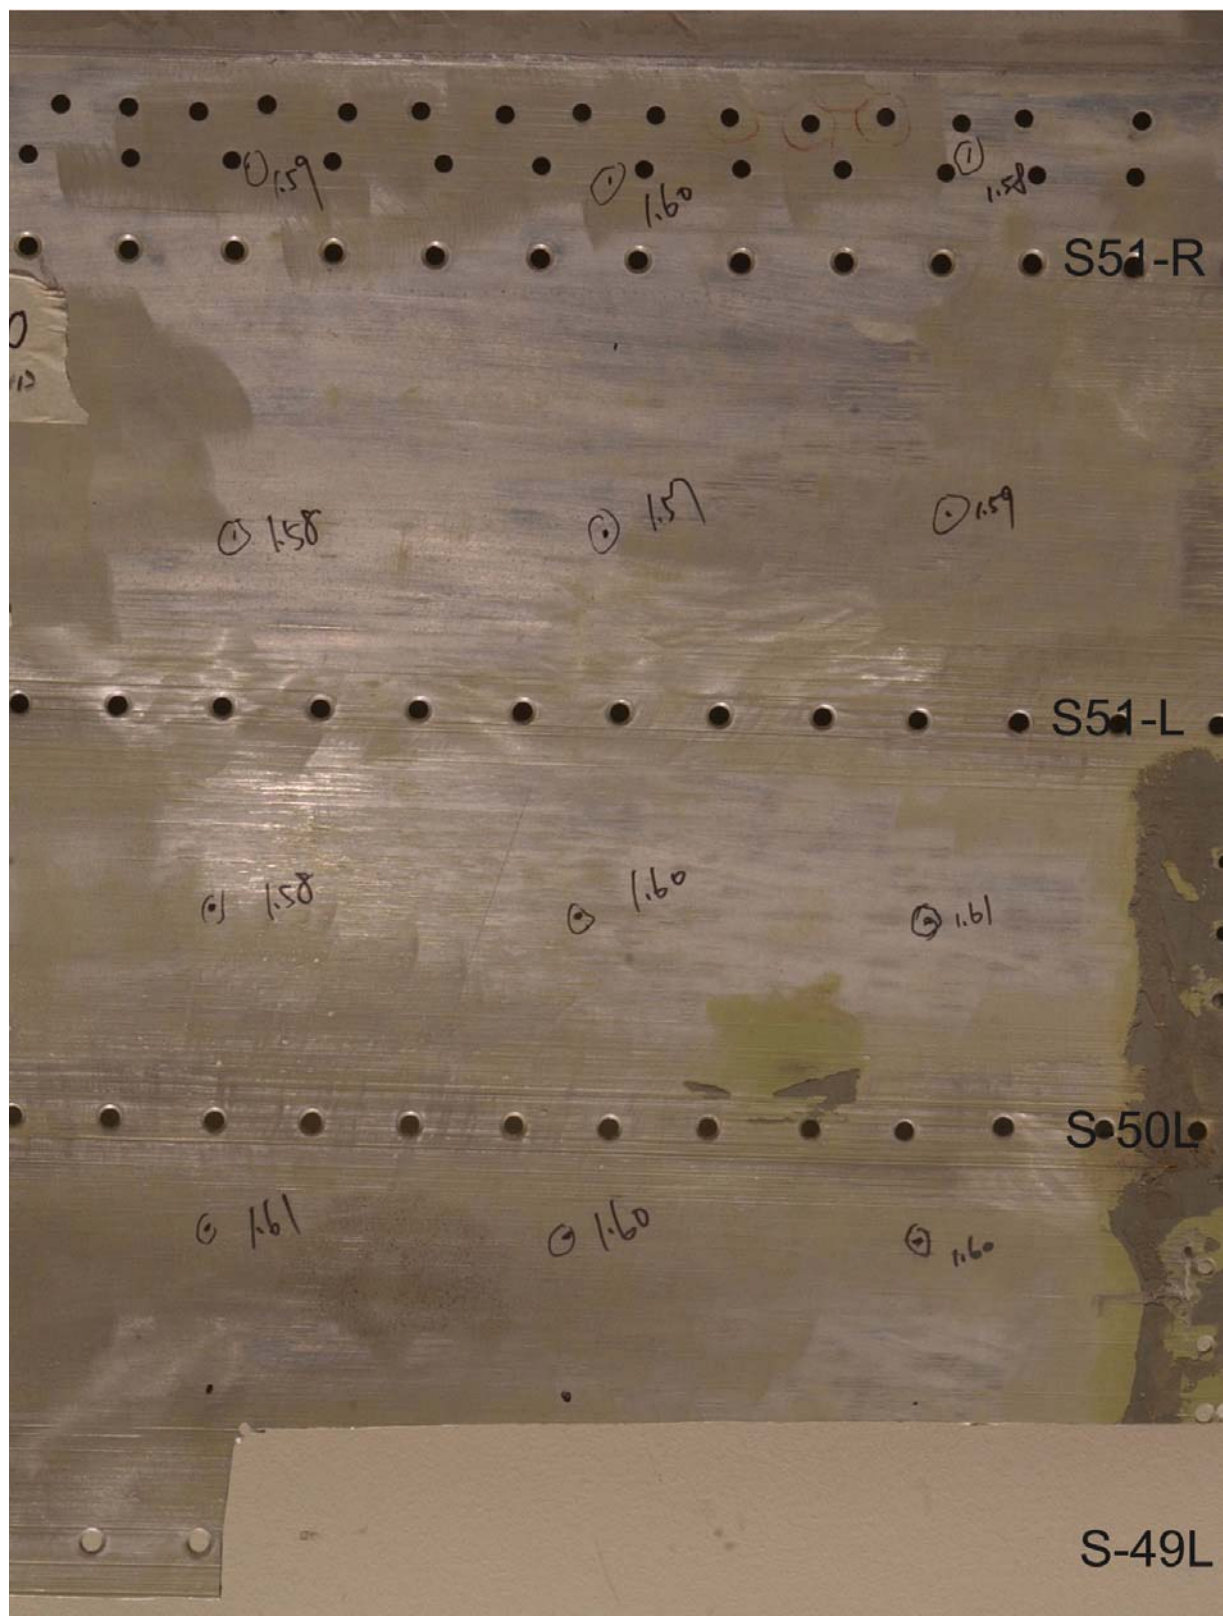
FIGURE 33. EXTENT OF DAMAGE CONSISTENT WITH A TAIL STRIKE

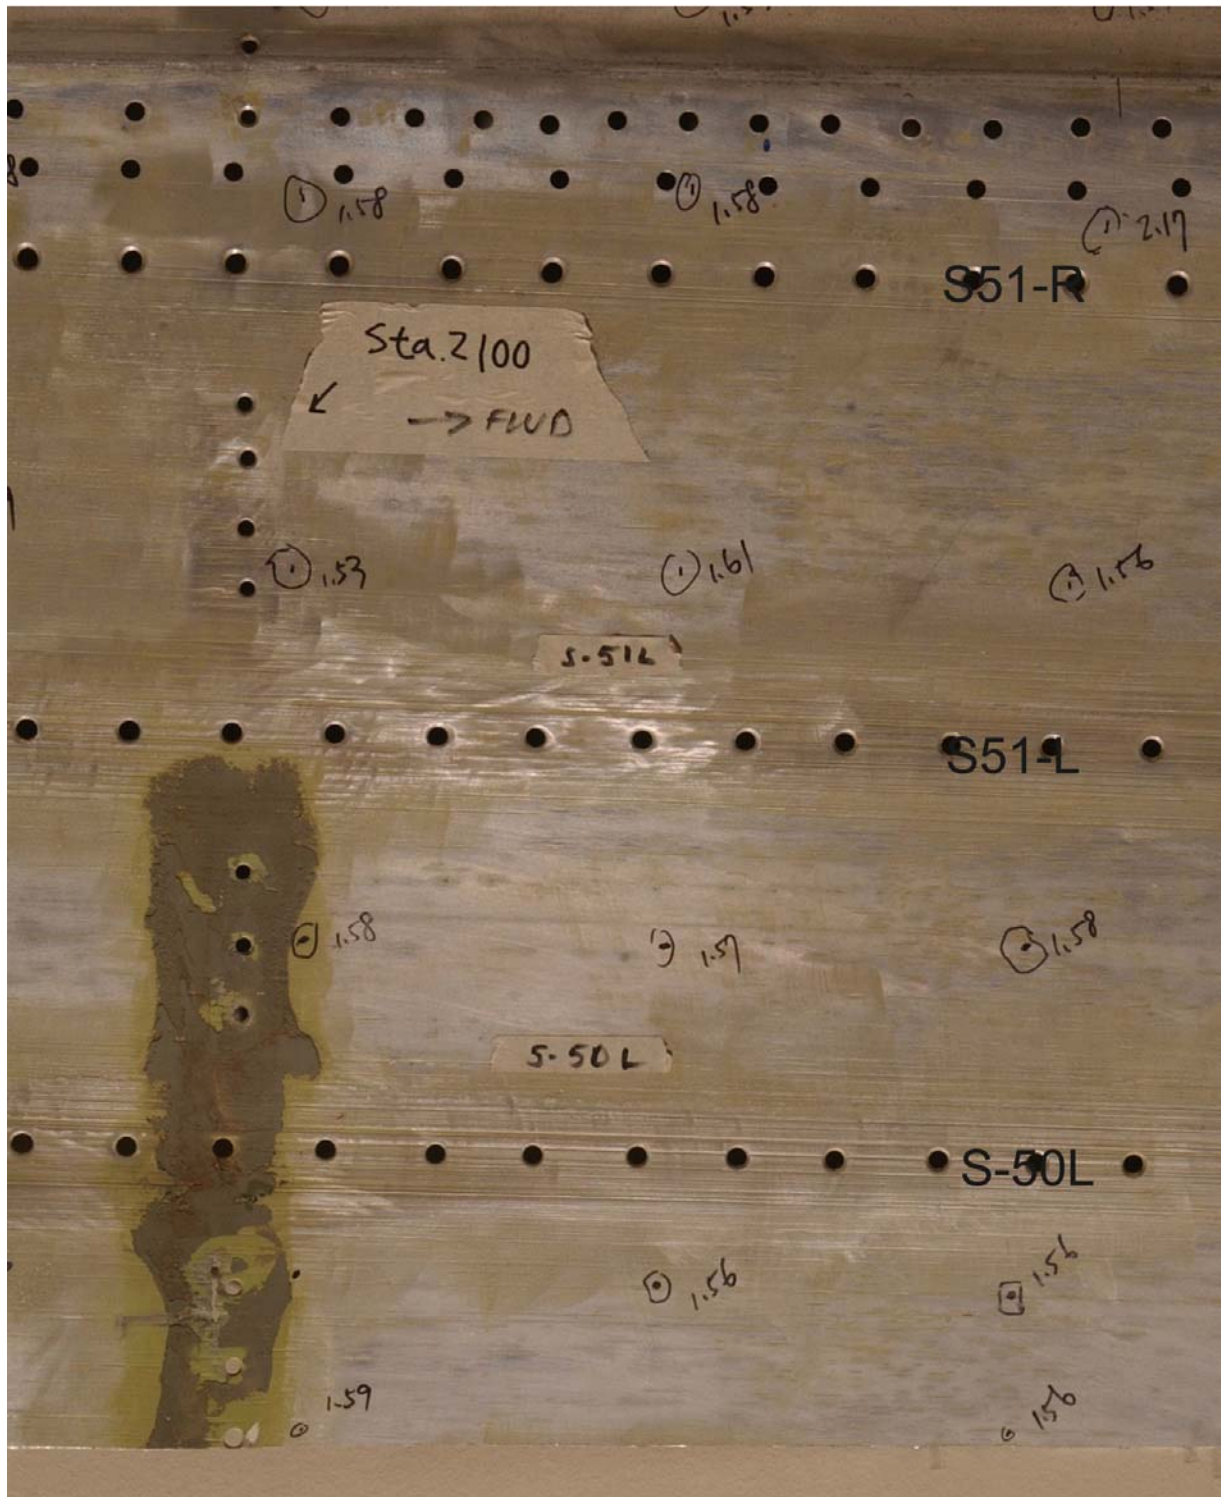
FIGURE 34. EXTENT OF DAMAGE CONSISTENT WITH A TAIL STRIKE

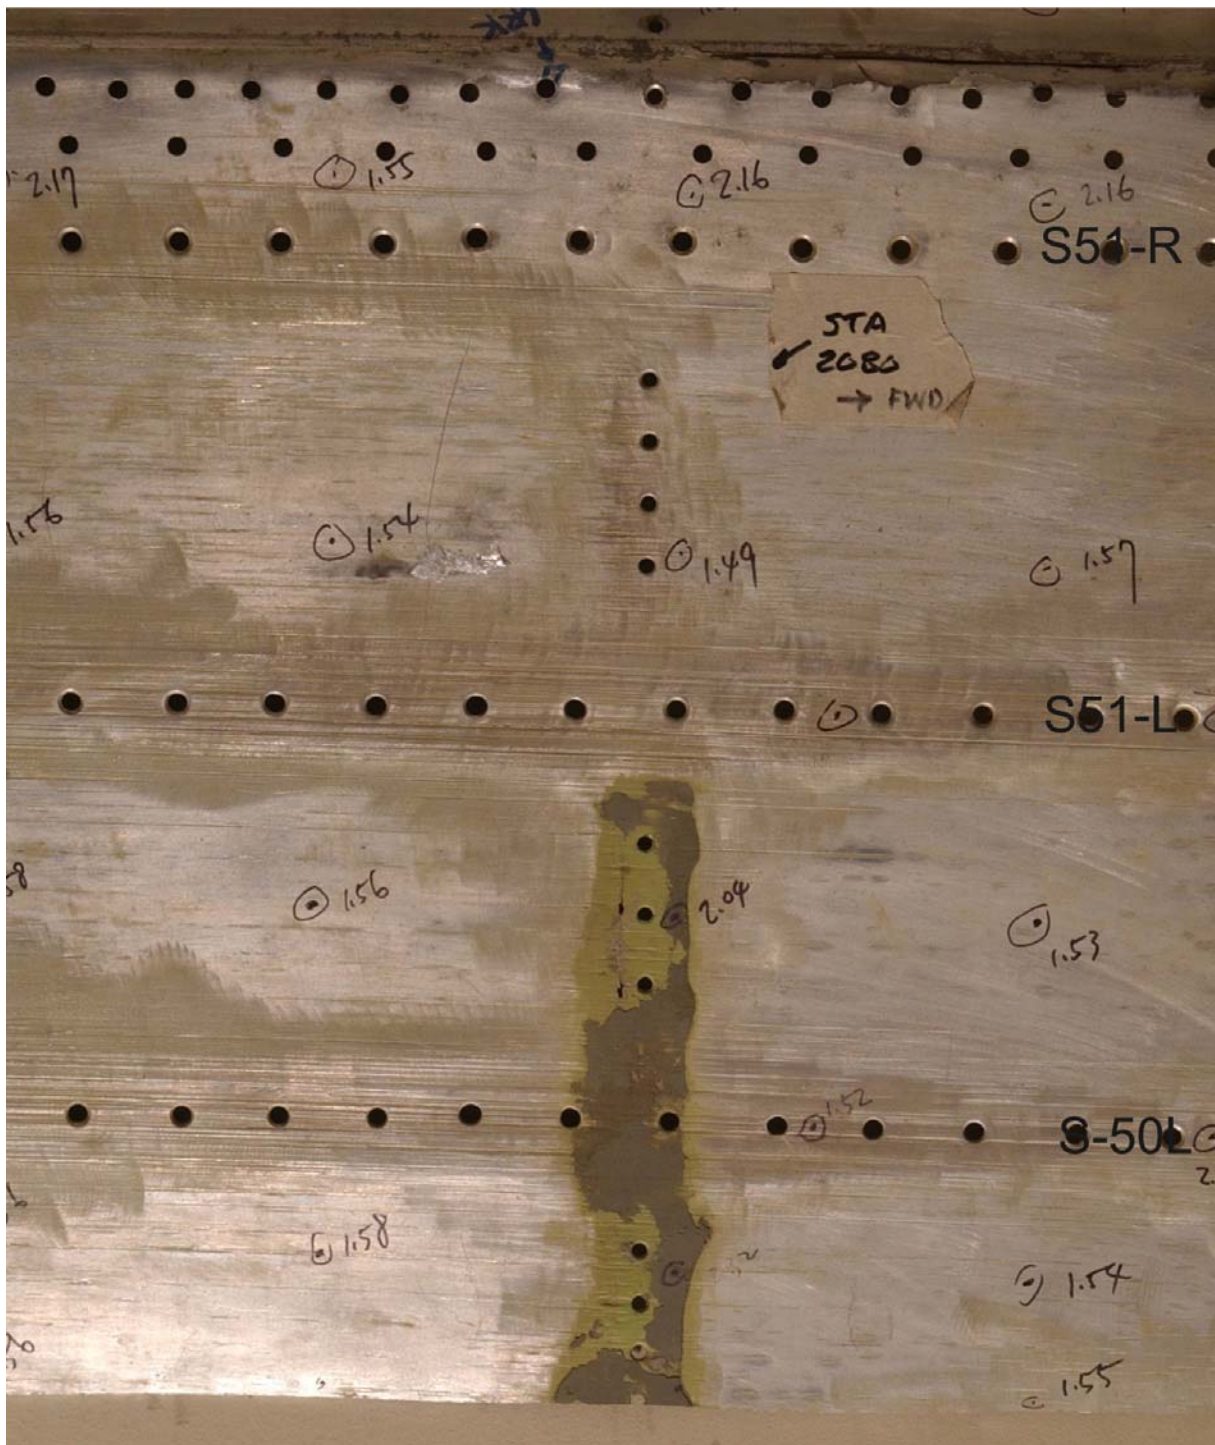
FIGURE 35. EXTENT OF DAMAGE CONSISTENT WITH A TAIL STRIKE – Note the severity of damage in this photo.

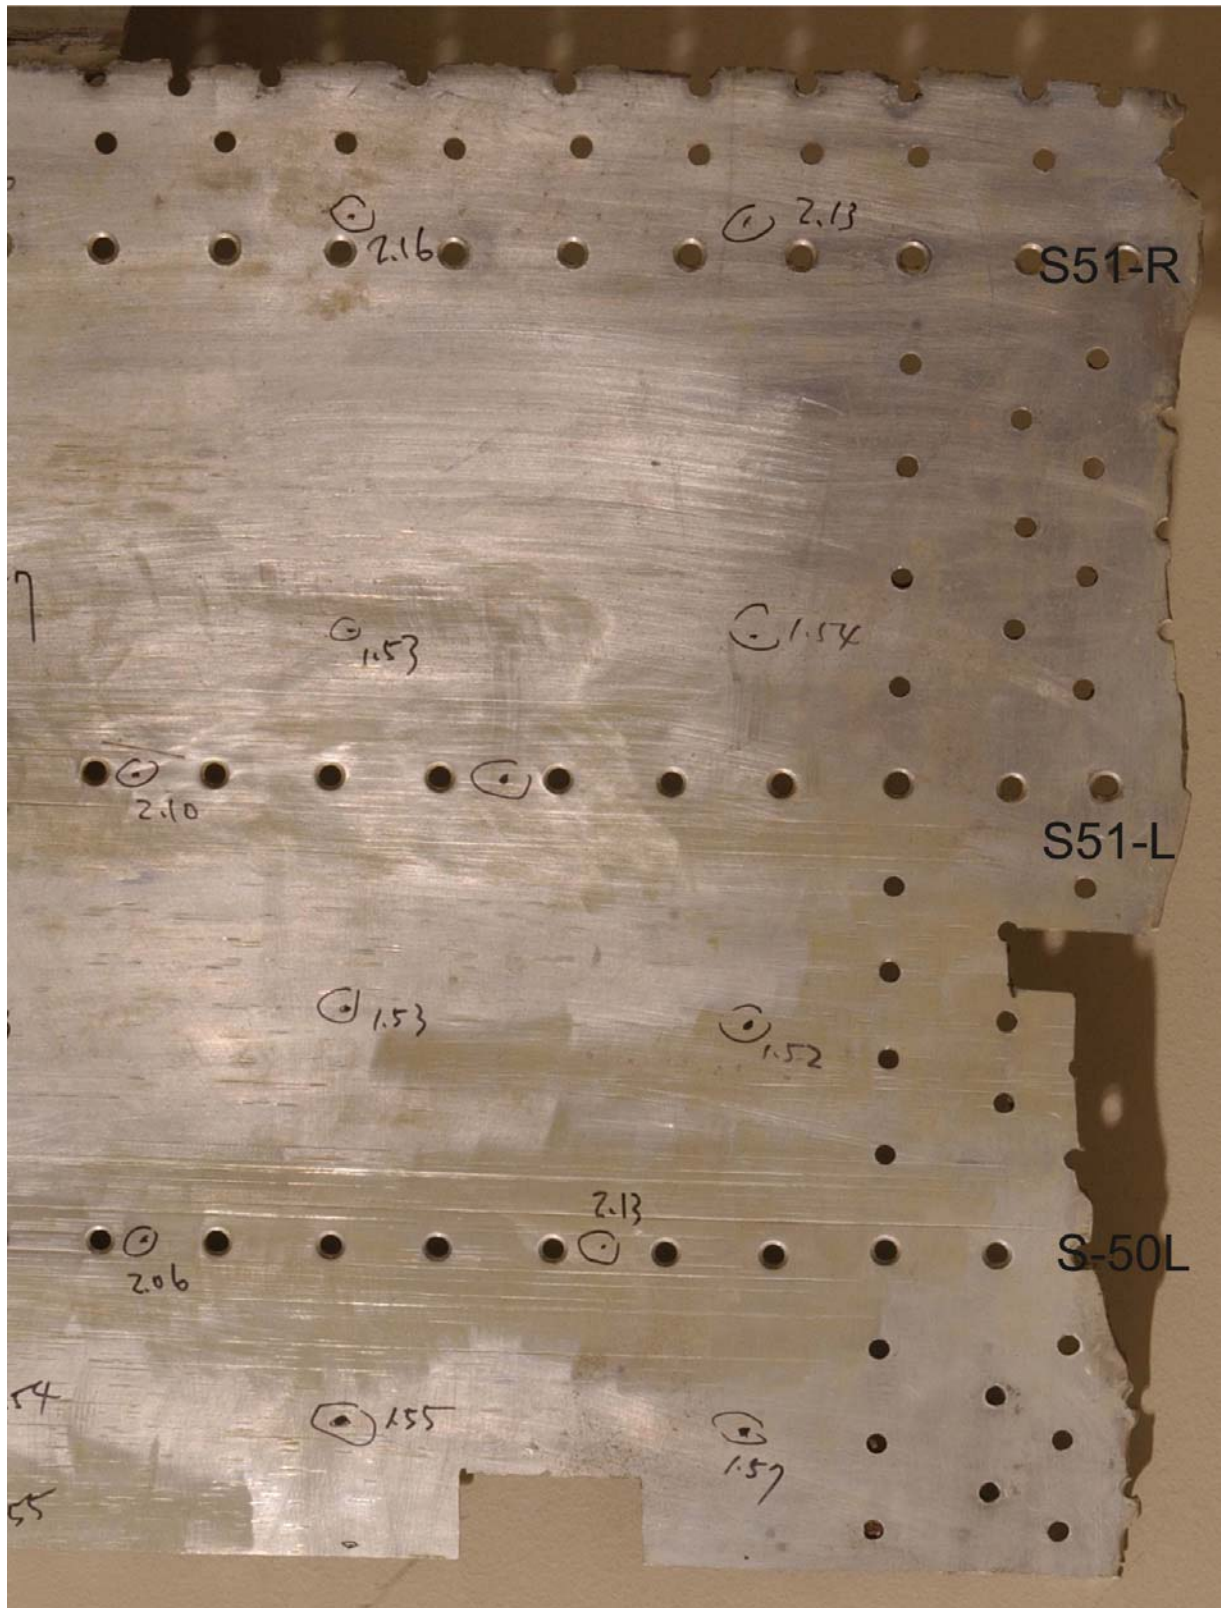
FIGURE 36. EXTENT OF DAMAGE CONSISTENT WITH A TAIL STRIKE

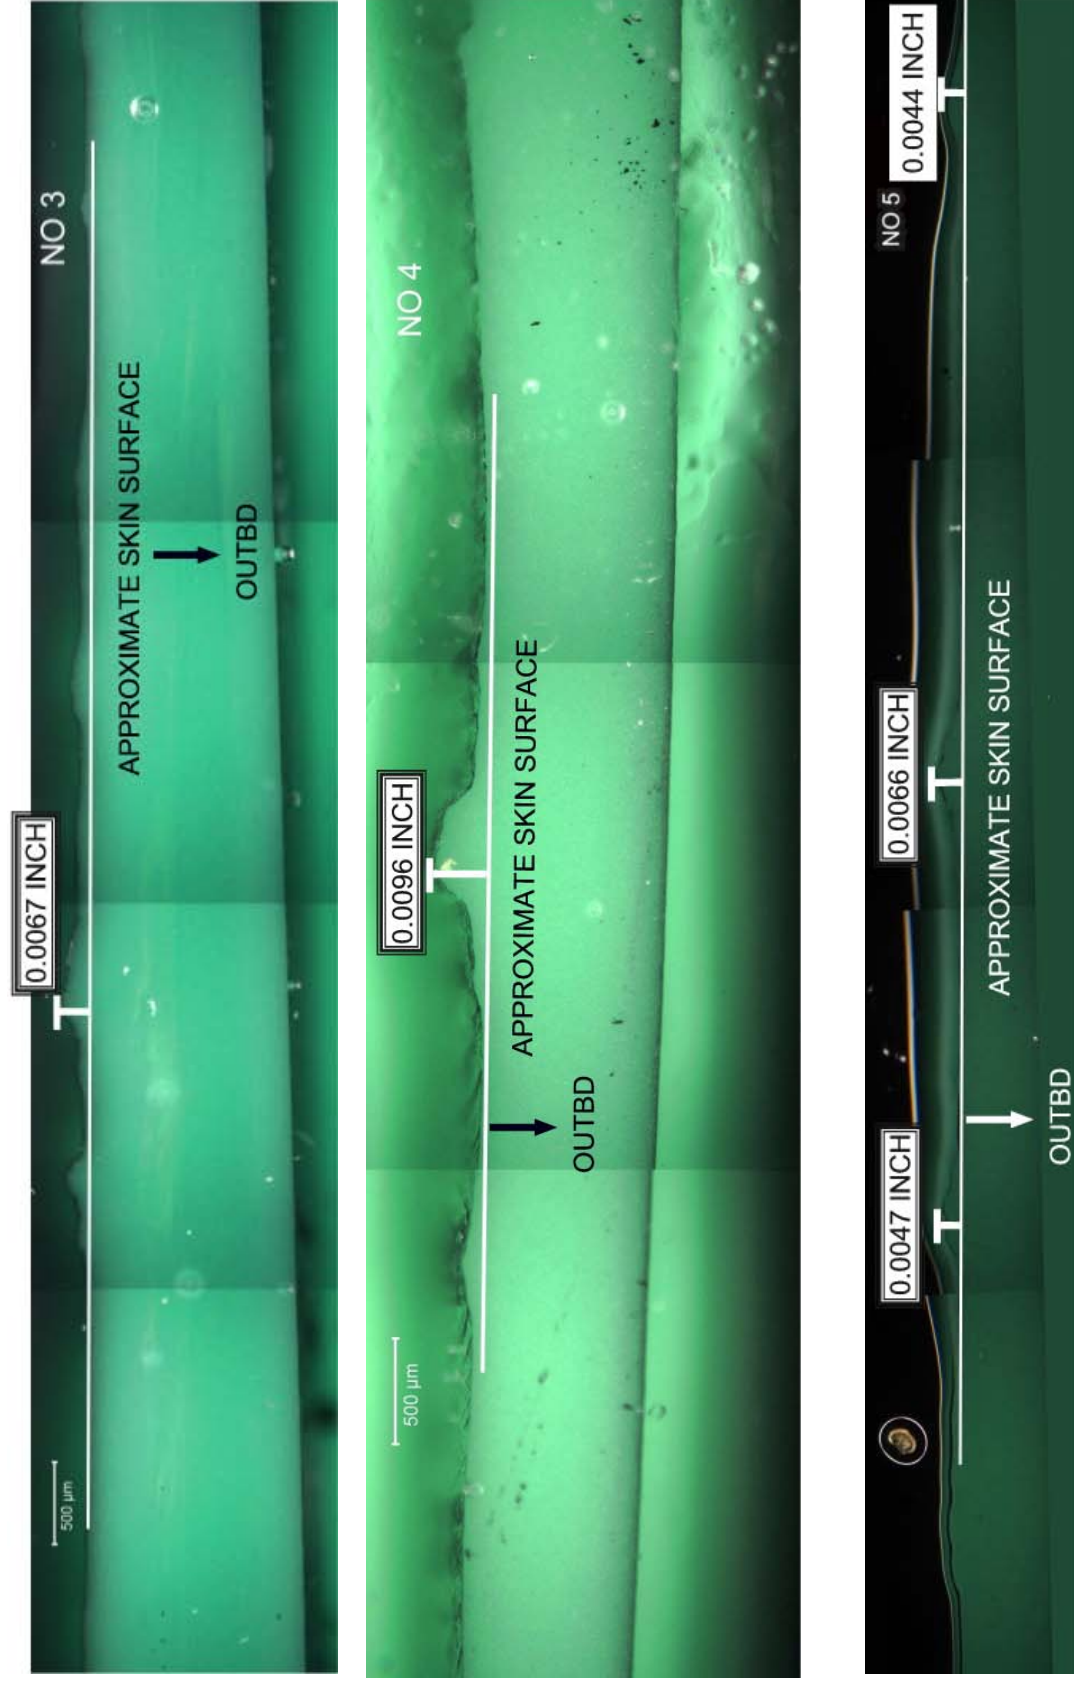
FIGURE 40. SCRATCH PROFILE COMPOSITE PHOTOGRAPHS – Shown above are replicas from locations 3,4, and 5. Location 4 presented the deepest scratch found using this technique.

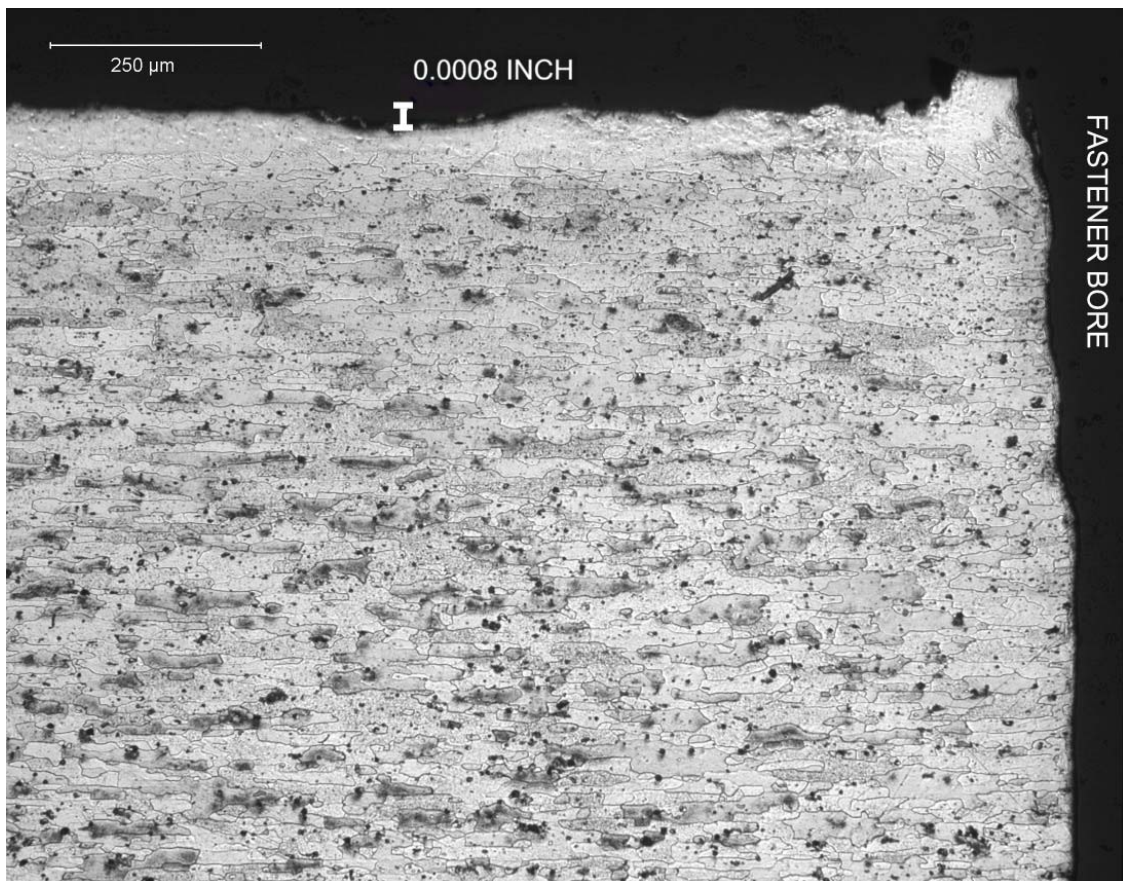
Figure 59. OUTER FASTENER ROW SCRATCH FEATURES AT PLANE A-A – Skin damage at this location was much less severe than on the left hand side of repair doubler. Skin cladding was not compromised by surface damage in this view.

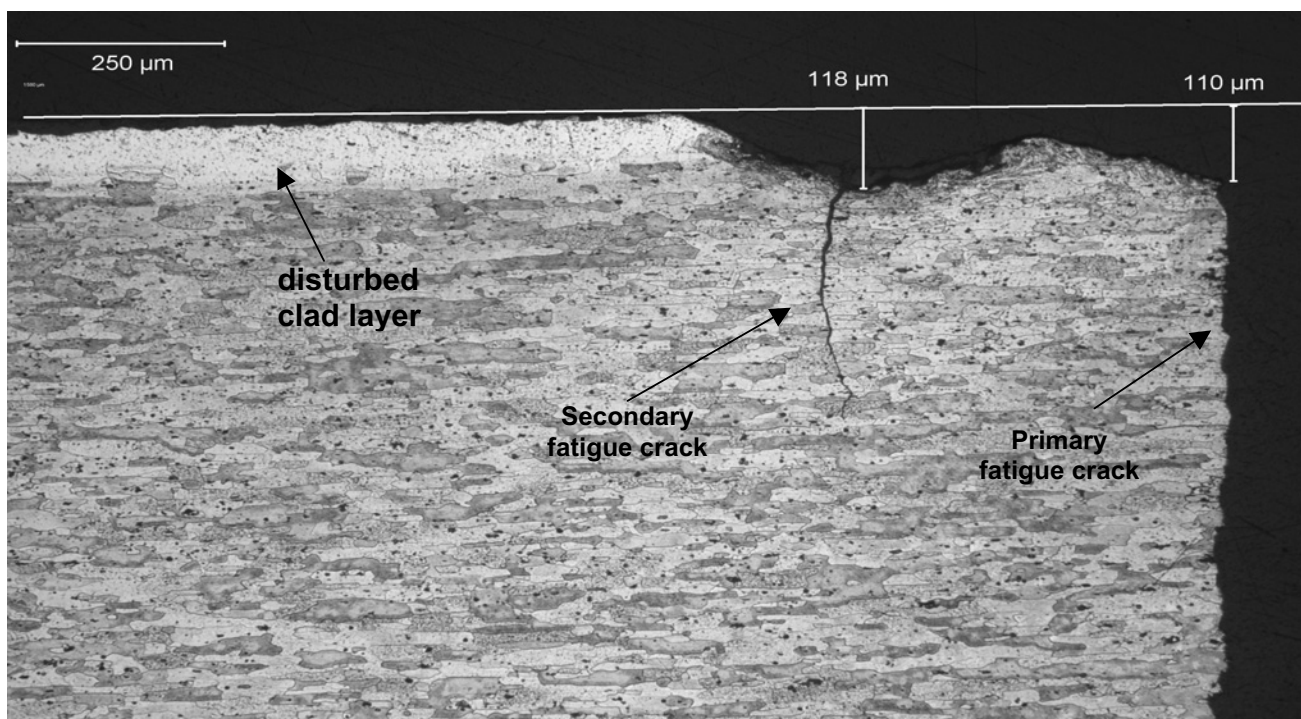
Figure 62. Metallographic specimen through the area indicated in Figure 61 above. The line shown was projected back to an area of undisturbed clad material to determine the depth of the scratches at the primary and secondary fatigue cracks present in this area.
