Aviation Occurrence Report Volume I

ASC-AOR-05-02-001

IN-FLIGHT BREAKUP OVER THE TAIWAN STRAIT

CHINA AIRLINES FLIGHT CI611

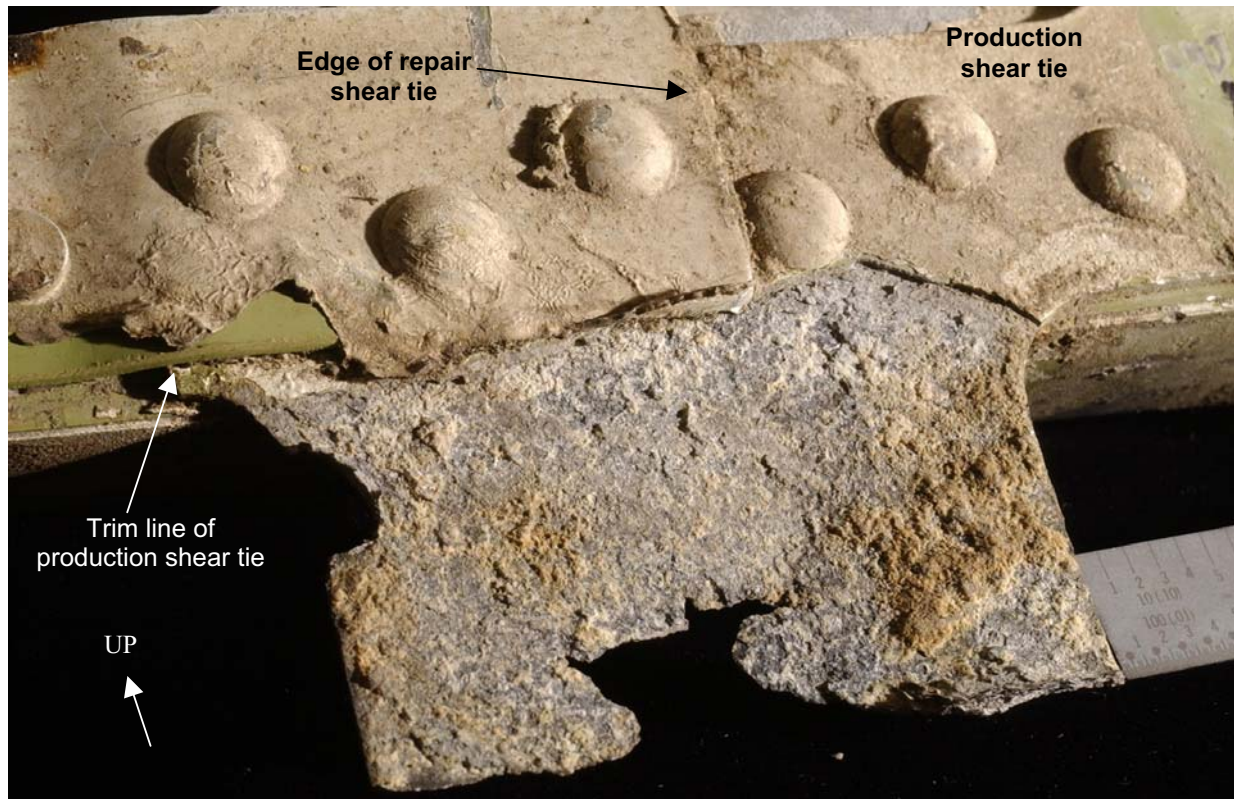
Figure 73.
Exfoliation corrosion present at shear tie between S-50L and S-49L of STA 2160 frame segment.

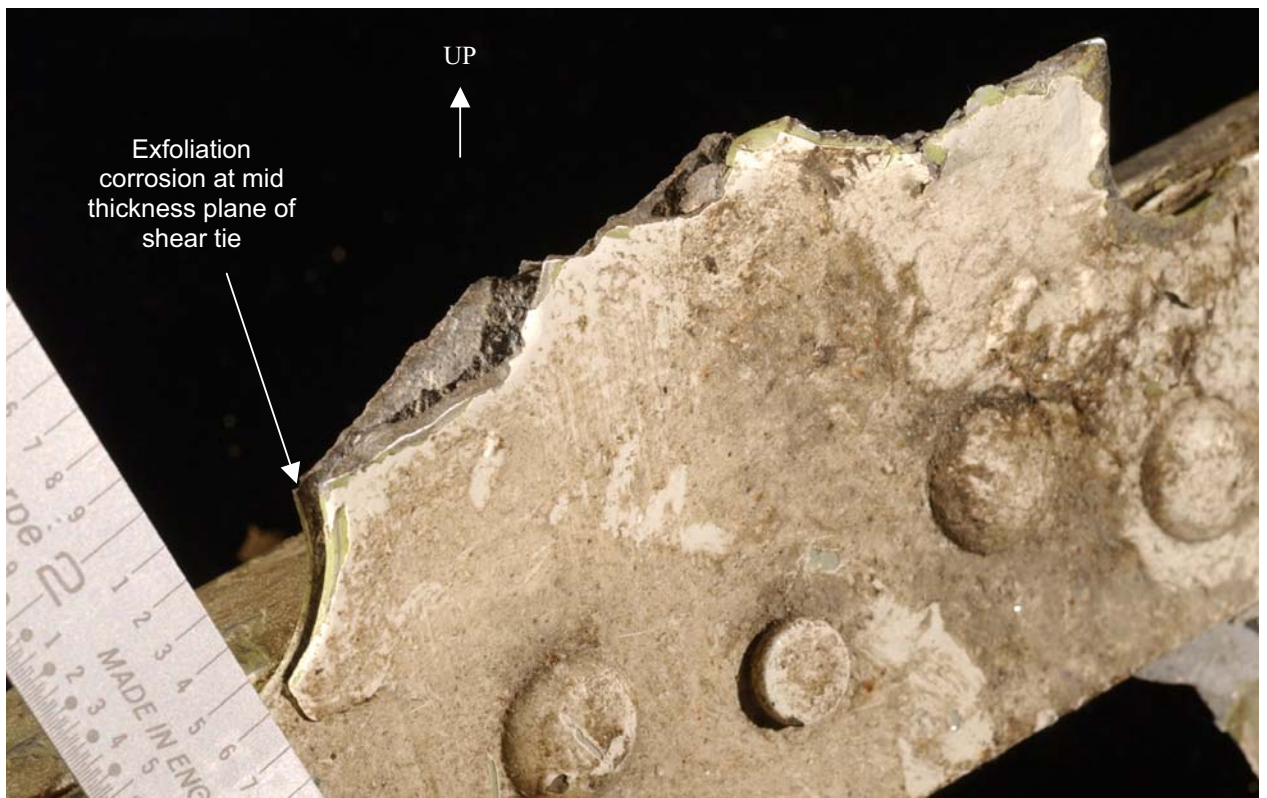
Figure 74.
Exfoliation corrosion present at shear tie between S-49L and S-48L of STA 2160 frame segment.

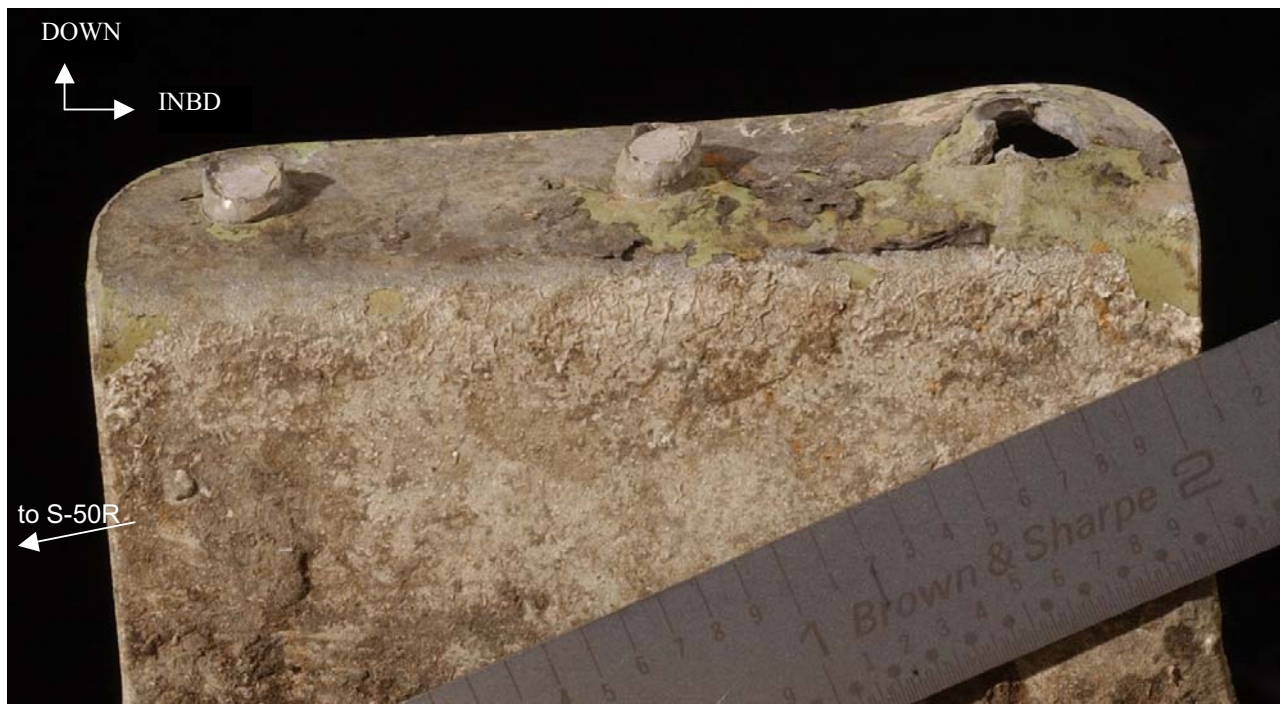
Figure 78.
Shear tie between S-51R and S-50R of the STA 2100 frame segment showing downward deformation in skin flange and pull through of the fastener hole at the inboard most fastener hole.

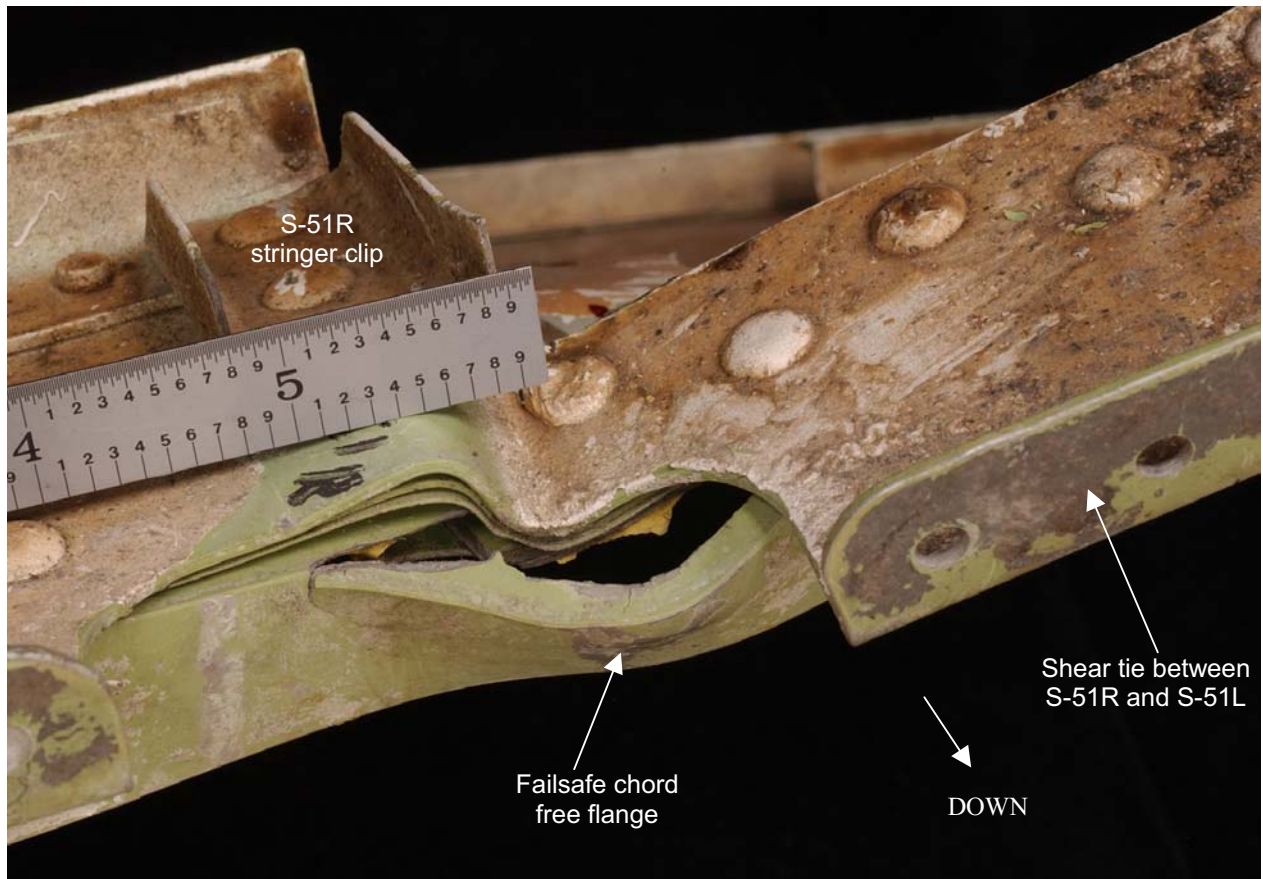
Figure 86. Fracture in failsafe chord free flange radius at S-51R of the STA 2040 frame segment.

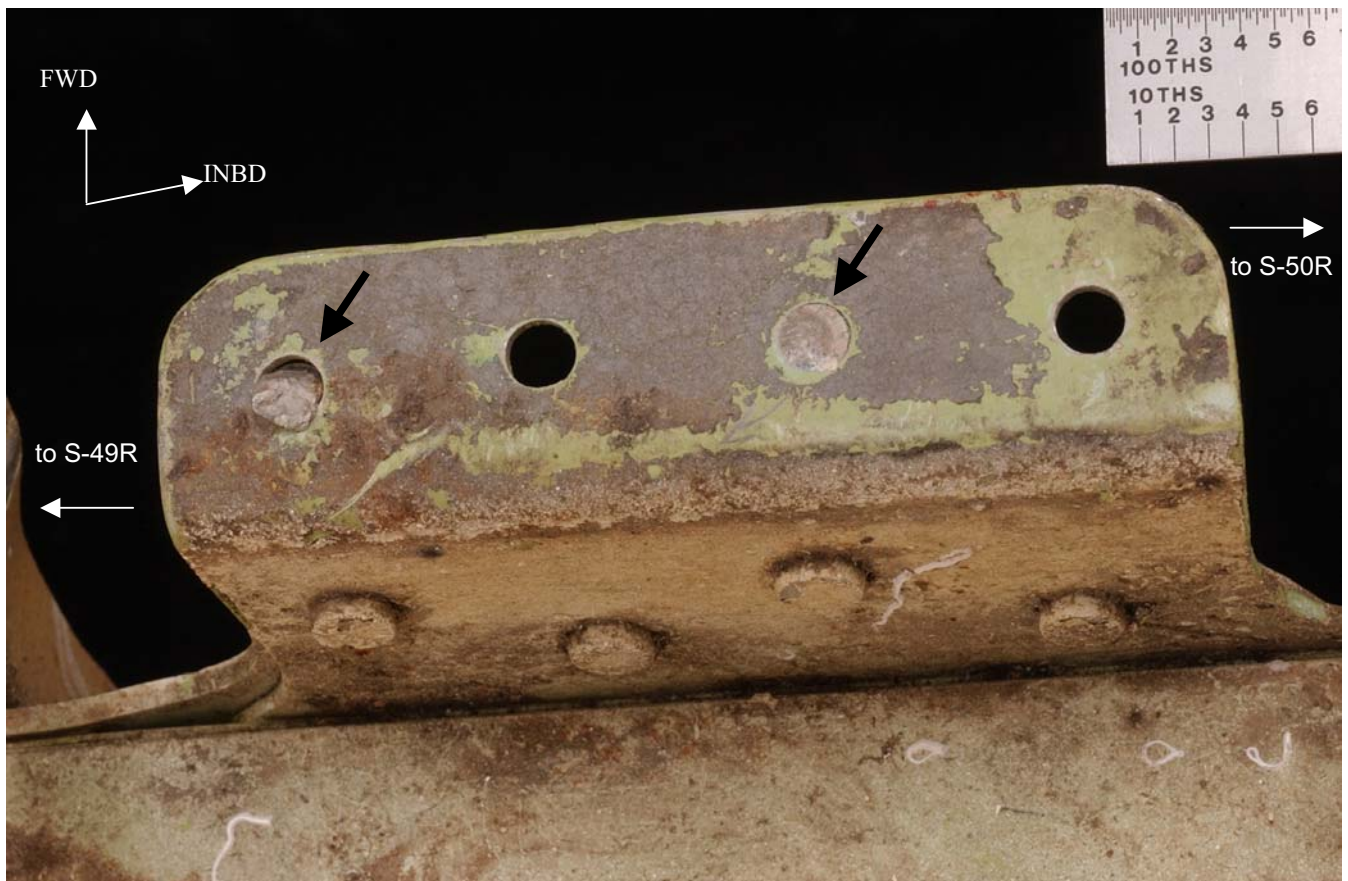
Figure 88. Skin flange rivet fractures at shear tie between S-49R and S-50R of the STA 2040 frame segment. Black arrows indicate the direction of loading.

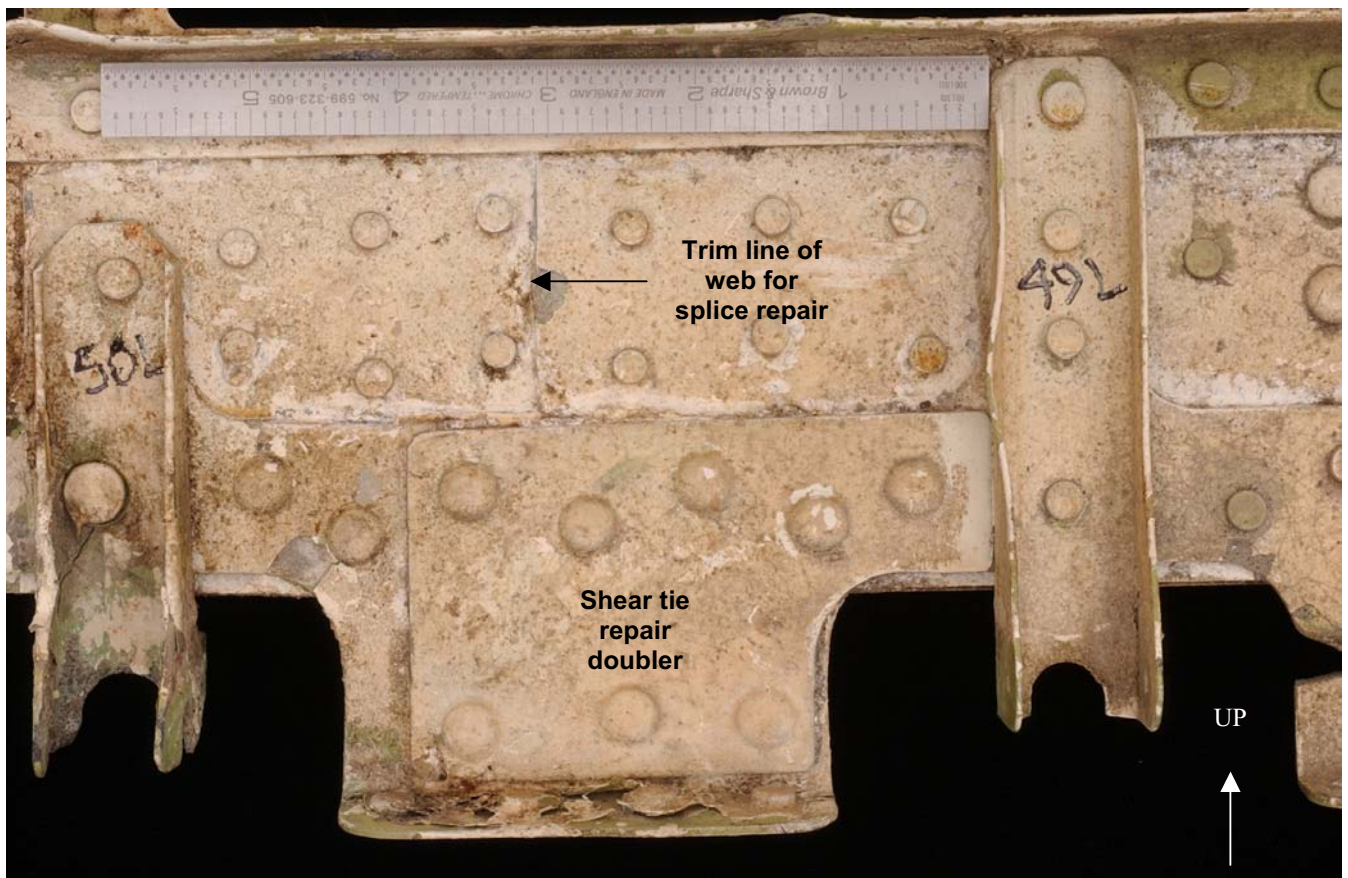
Figure 91.
STA 1940 frame segment showing the shear tie repair doubler and web splice repair
at the location between S-50L and S-49L.

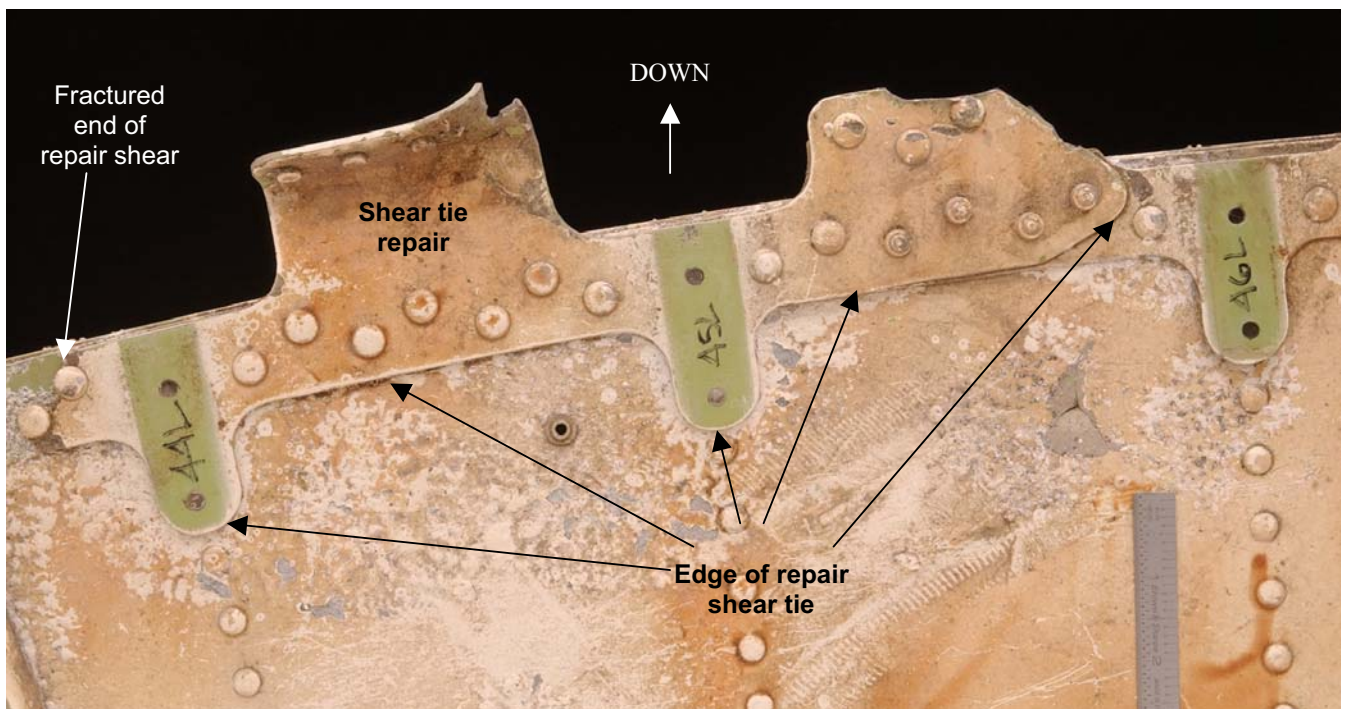
Figure 92.
STA 1940 frame segment showing the shear tie repair between S-46L and S-44L.

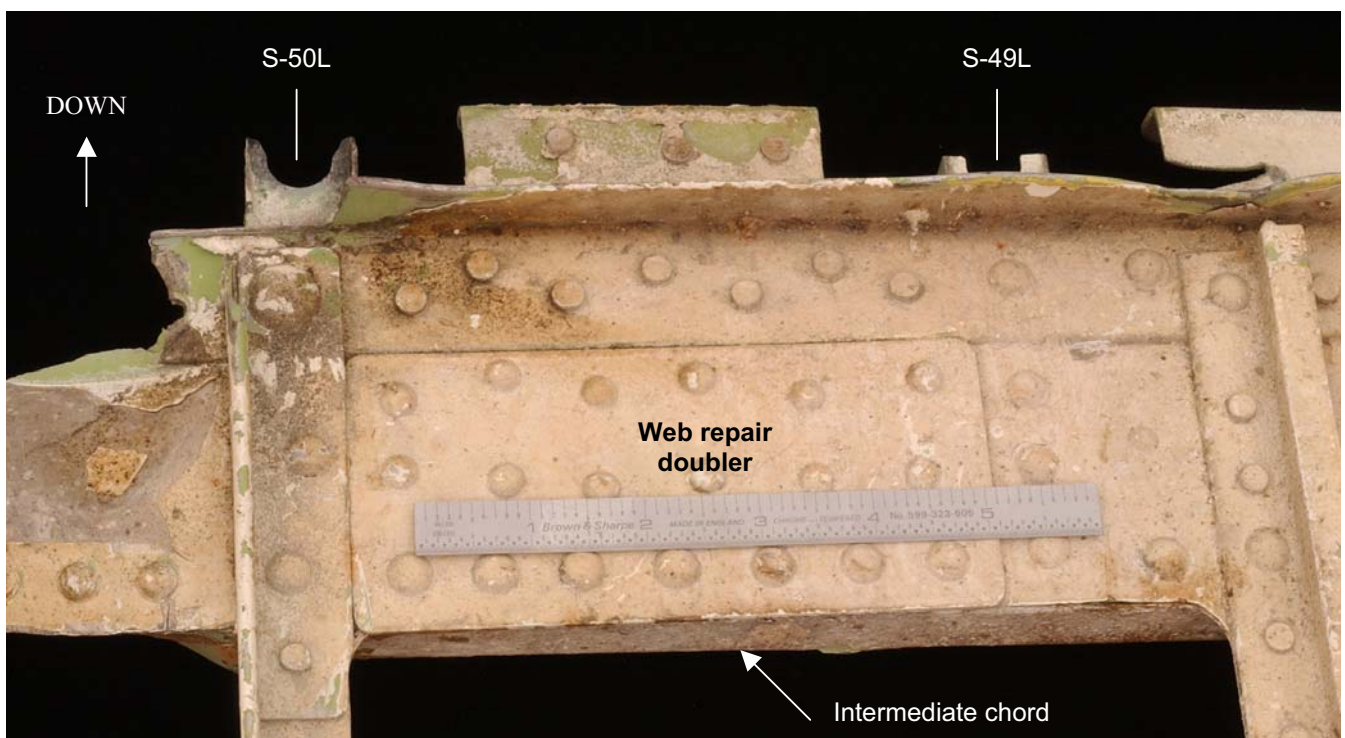
Figure 93.
STA 1940 frame segment showing the web repair doubler on the aft side between S-50L and S-49L.

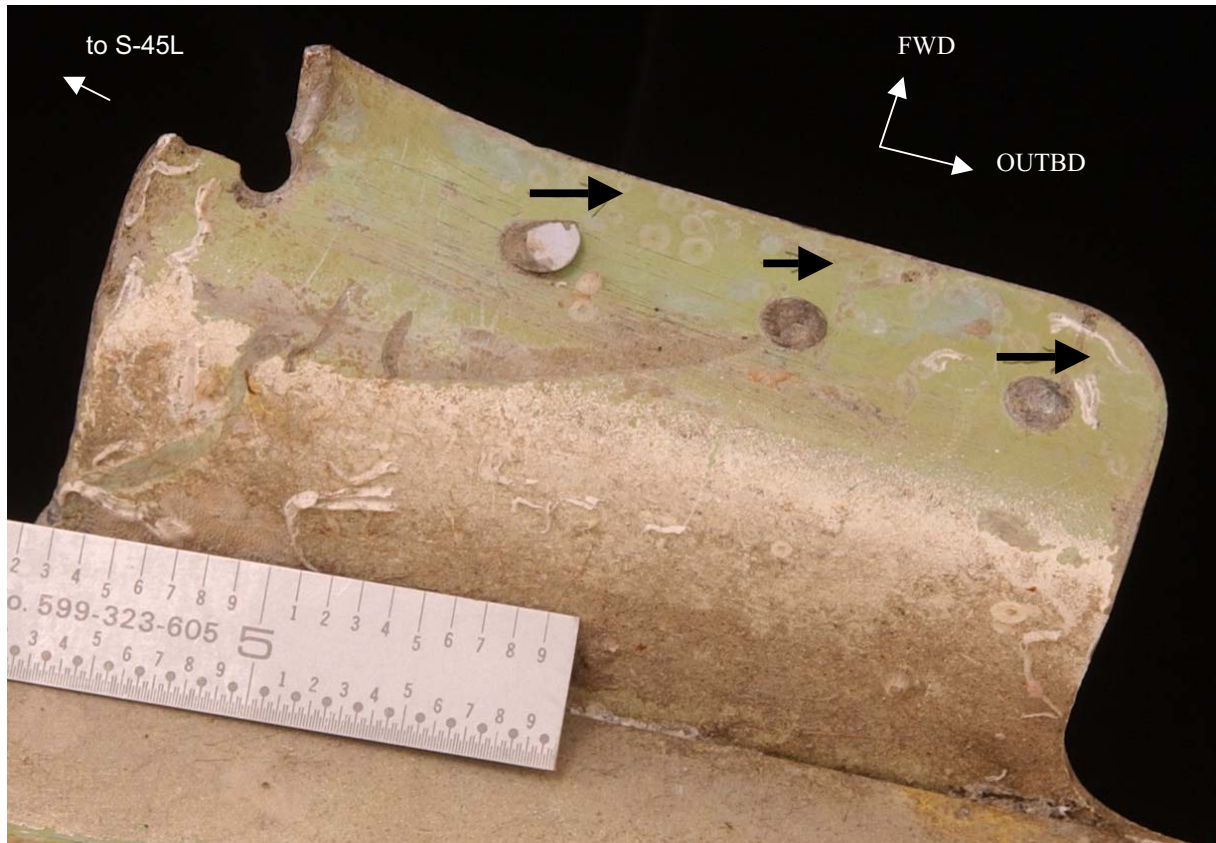
Figure 94. Shear tie between S-45L and S-44L of STA 1940 frame segment.
Black arrows indicate the direction of loading.
