**AIRCRAFT SERIOUS INCIDENT  
INVESTIGATION REPORT**

**AIR NIPPON CO., LTD.**

**J A 5 5 A N**

**AIR NIPPON CO., LTD.  
BOEING 737-800, JA55AN  
AT AN ALTITUDE OF ABOUT 6,800 FT, AT ABOUT 30 KM EAST OF  
ASAHIKAWA CITY, HOKKAIDO PREFECTURE  
AROUND 13:38 JST, OCTOBER 26, 2010**

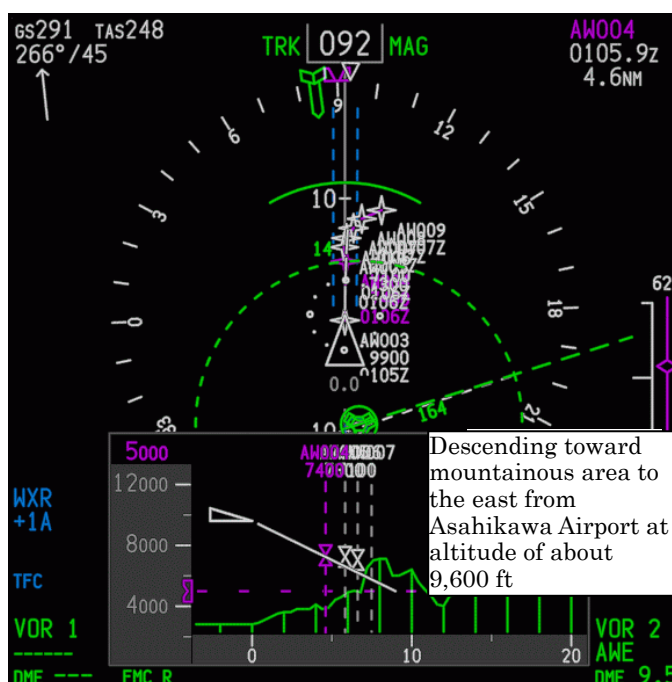
Figure A ND-1 on the FO side

- (1) While descending toward a mountainous area to the east from over Asahikawa Airport, the ND on the FO's side showed a geographical feature (a mountain ahead) on the VSD with a 20 nm range selected even at about 10,800 ft at around a point 6.3 nm from AWE. (See Figure A)

At about 8,100 ft at around a point 12.7 nm from AWE, the peak of the geographical feature shown on the VSD with a 10 nm range began to change to yellow. At this moment, the ND remained on the WXR mode.

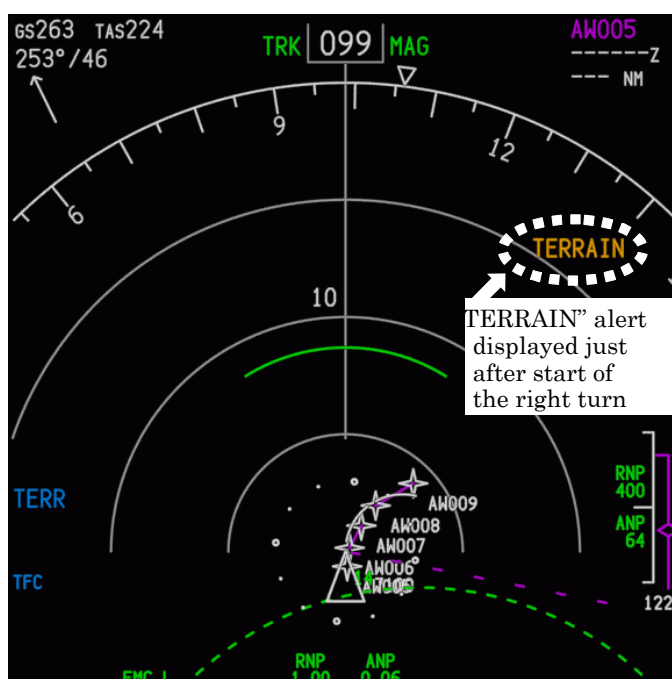
Figure B ND-1 on the PIC's side

- (2) The ND on the PIC's side showed the "Caution Terrain" heads-up message of the TERRAIN" (EGPWS) in yellow around heading 099° just after the start of a right turn from heading 090° . At the same time, the WXR mode was switched to the terrain mode. (See Figure B)

About five seconds later, a geographical feature shown in yellow began to appear on the ND from around heading 109° .

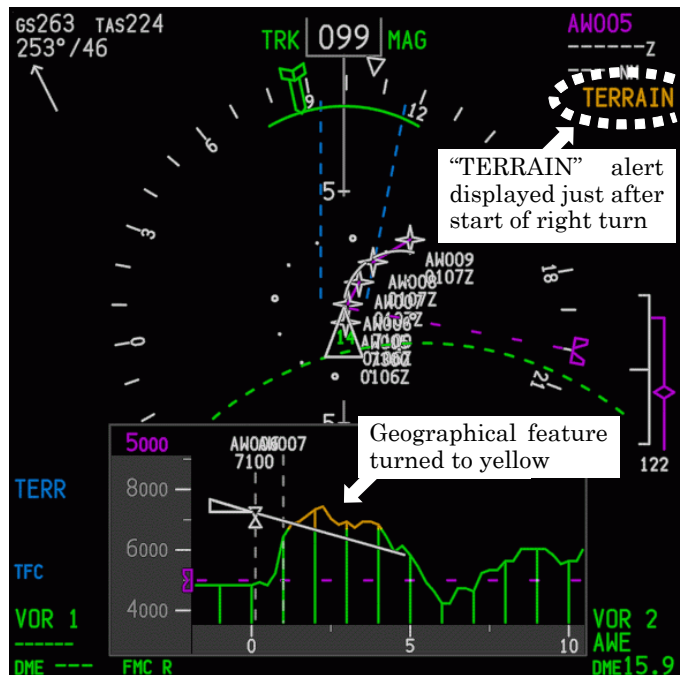
Figure C ND-2 on the FO side

- (3) Around the same time as the phenomena mentioned in (2), the ND on the FO's side showed the "TERRAIN" in yellow around heading 099°, 15.9 nm from AWE at about 7,200 ft just after the start of a right turn. Simultaneously, the WXR mode was switched to the terrain mode. The geographical feature shown in yellow on the VSD was within a range of 2 nm. (See Figure C)

The geographical feature shown in yellow began to appear on the ND from around heading 109°, 16.3 nm from AWE.

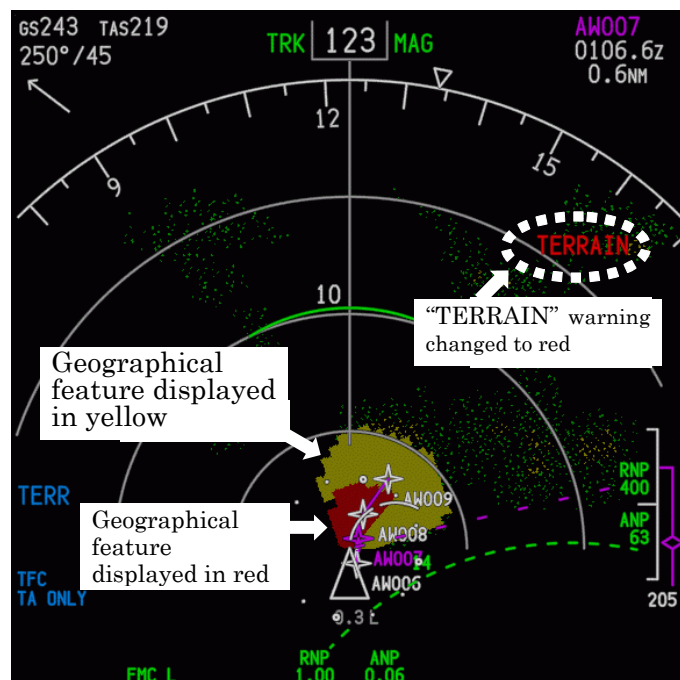
FigureD ND-2 on the PIC's side

- (4) On the PIC's ND, the color of the "TERRAIN" indication (the "Terrain" warning by EGPWS) changed to red from around heading 118°. The geographical feature began to be shown in red from around heading 121°. (See Figure D)

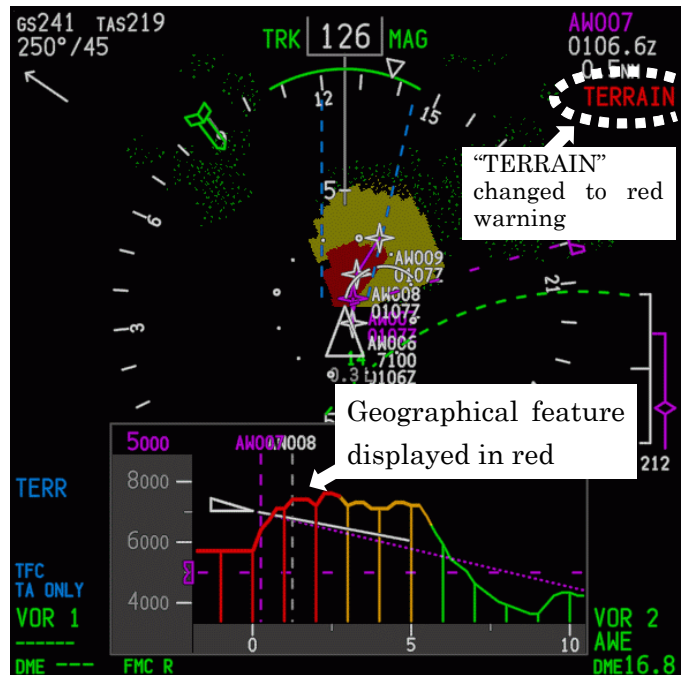
FigureE ND-3 on the FOside

- (5) Around the same time as the phenomena mentioned in (4), the color of the “TERRAIN” message on the ND on the FO’s side changed to red from around heading 119° , 16.6 nm from AWE. The geographical feature on the VSD began to be shown in red around heading 126, 16.8 nm from AWE. (See Figure E)

A collision evasive maneuver was performed and ten-odd seconds later, the “TERRAIN” indication and the red geographical features disappeared from the ND.

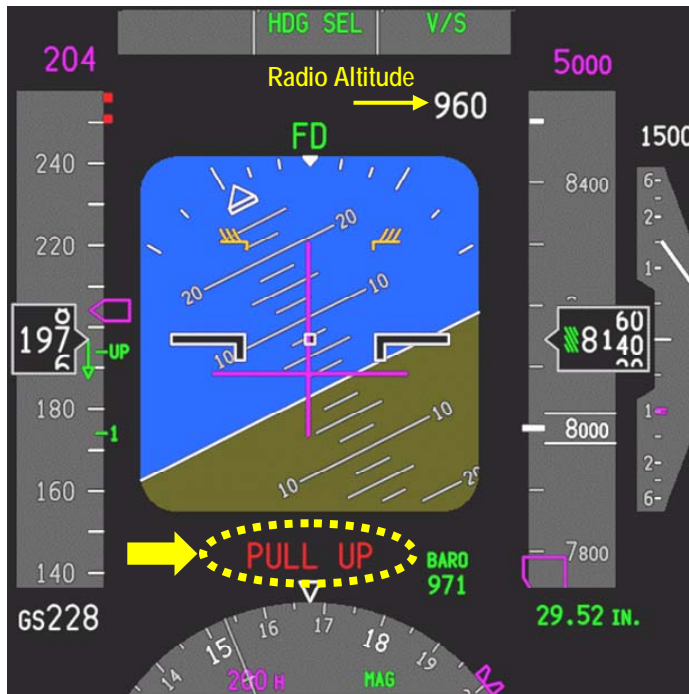
PFD (Primary Flight Display)

**PULL UP** warning during right climbing turn at 27 degrees bank angle

- Airspeed: 197kt
- Ground speed: 228kt
- Press. Alt: 8,140ft
- Radio Alt: 960ft
- Heading: 168deg
- V/S: 1,500ft/min
- QNH setting: 29.52inHg

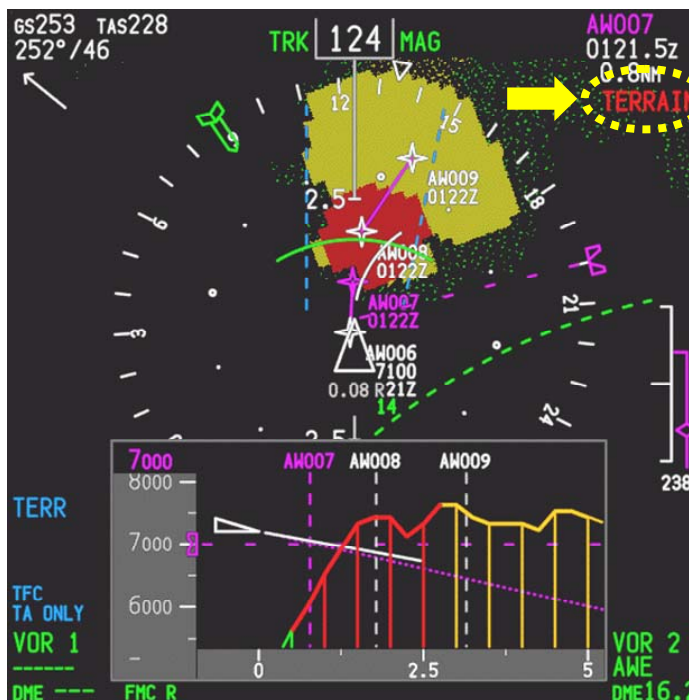
ND (Navigation Display) – selected VSD

**TERRAIN** warning during right descending turn

- Heading: 134deg (Track angle: 124deg due to wind from 4o'clock)
- 16.2nm from AWE
