**Boeing 747 G-AWNC**  
**Report on the accident near Subang**  
**International Airport, Kuala Lumpur,**  
**Malaysia on 11 May 1976**

Accidents Investigation Branch  
Aircraft Accident Report No. 10/77  
(EW/A262)

<i>Operator:</i>	British Airways (Overseas Division)
<i>Aircraft:</i>	<i>Type:</i> Boeing 747
	<i>Model:</i> Series 136
	<i>Nationality:</i> United Kingdom
	<i>Registration:</i> G-AWNC
<i>Place of Accident:</i>	Near Subang International Airport, Kuala Lumpur, Malaysia
<i>Date of Accident:</i>	11 May 1976

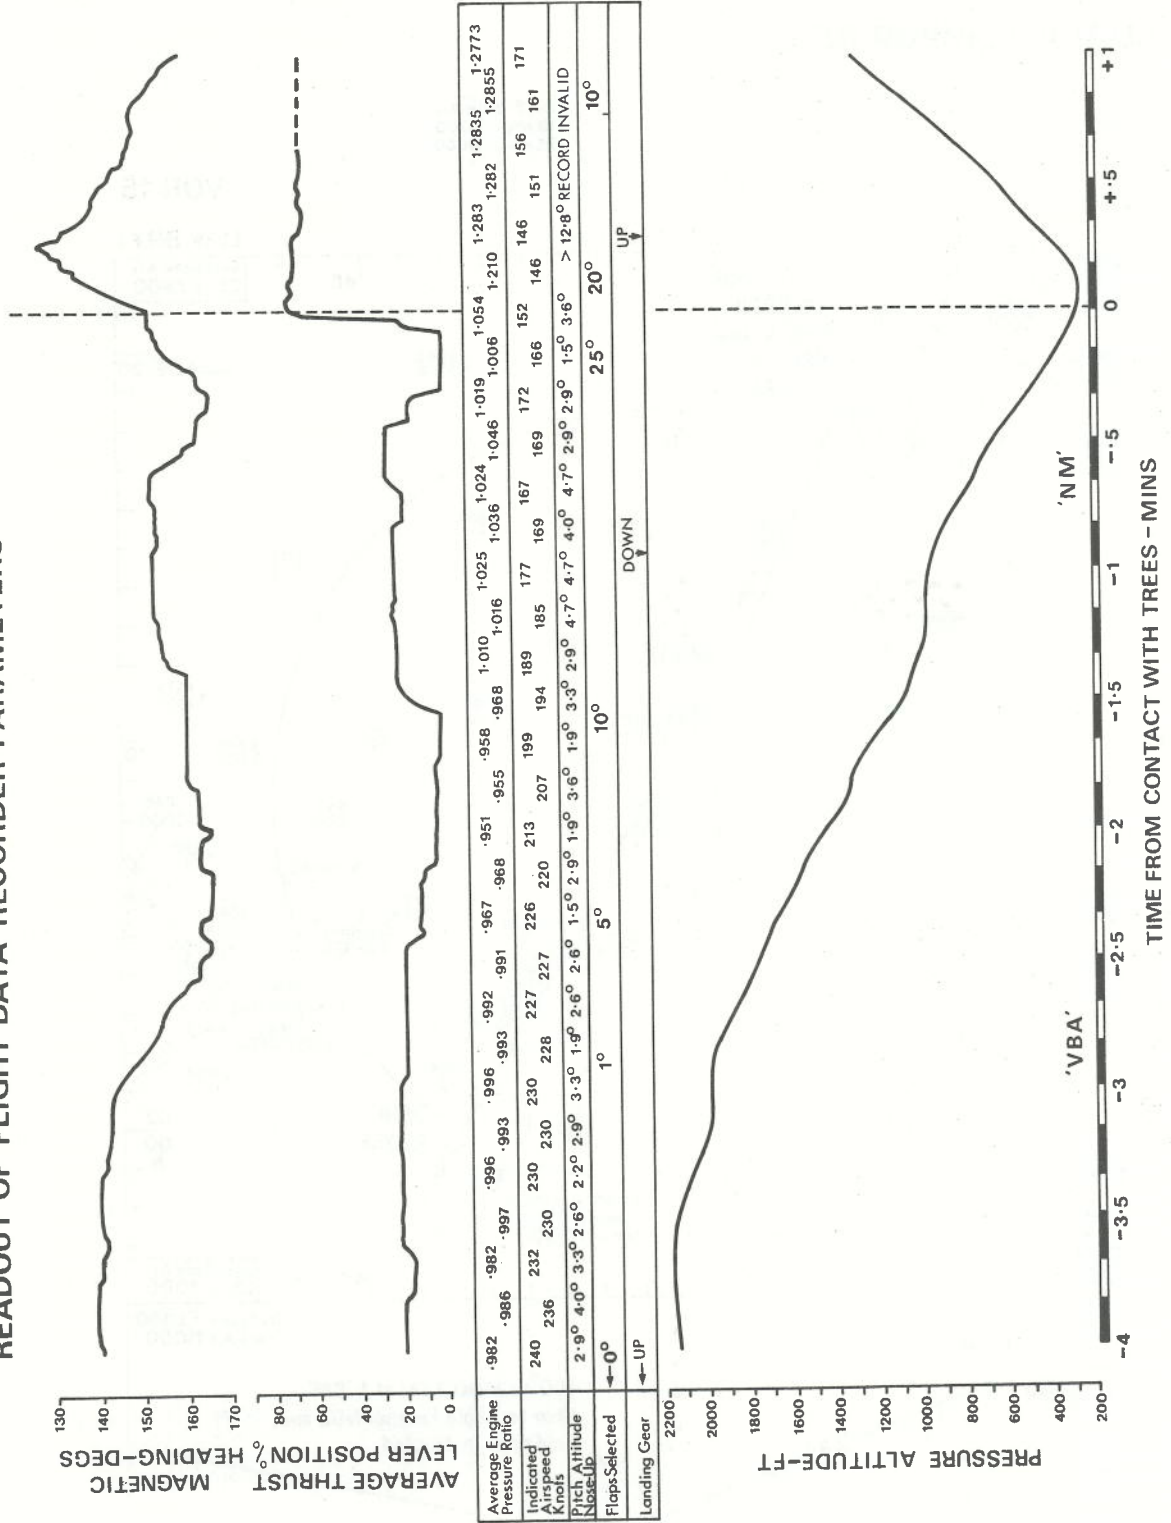
# READOUT OF FLIGHT DATA RECORDER PARAMETERS

The flight recorder data shows that as the aircraft approached the VBA VOR beacon it was descending on a heading varying between 140° (M) and 142° (M), with the thrust levers retarded and the indicated airspeed (IAS) reducing to 230 knots overhead VBA. After crossing the beacon at 2,000 feet QNH, the aircraft turned on to 165° (M), flaps were extended to 1, and a descent towards NM was started at about 500 feet per minute (fpm). Flaps were then progressively extended to 5 and then to 10 whilst the descent continued steadily on the heading of about 165° (M) and by approximately 1,100 feet QNH the IAS had reduced to 194 knots.

The descent was checked at about 1,000 feet QNH, 100 seconds after leaving VBA and approximately 2 nm before NM. The thrust levers were advanced slightly, increasing the engine pressure ratios (EPR) from about 0.955 to about 1.025. Level flight was maintained for about 20 seconds at 980 feet QNH during which time the IAS decayed to about 180 knots, and also during this 20 second period there was an alteration of heading to the left on to 153° (M).

120 seconds after leaving VBA and approximately 18 seconds before reaching NM the aircraft began to descend again, initially with about the same thrust setting used in the period of level flight. At 123 seconds the landing gear was indicating down and locked, thus it may be deduced that it had been selected 'down' about 23 seconds earlier, coincident with the aircraft being levelled out. The aircraft passed a little to the east of NM at 138 seconds and almost immediately turned right on to 166° (M). It was then at about 760 feet QNH descending at an average rate of about 500 fpm with the IAS reducing from 177 knots to 172 knots. At 162 seconds, ie about 40 seconds after renewing the descent, the thrust levers were fully retarded and a left turn towards a heading of 152° (M) simultaneously initiated. About 8 seconds later, as the aircraft was passing 380 feet QNH, flaps were selected to 25°. This selection was made at about 160 knots, and was accompanied by a nose-down change in pitch attitude from +2.9° to +1.5°; the rate of

descent then increased to about 900 fpm until the thrust levers were advanced about 4 seconds prior to impact. At a speed of 152 knots 180 seconds after leaving VBA the aircraft struck the trees; at that time the pitch attitude had increased to +3.6° and the thrust levers were moving forward.

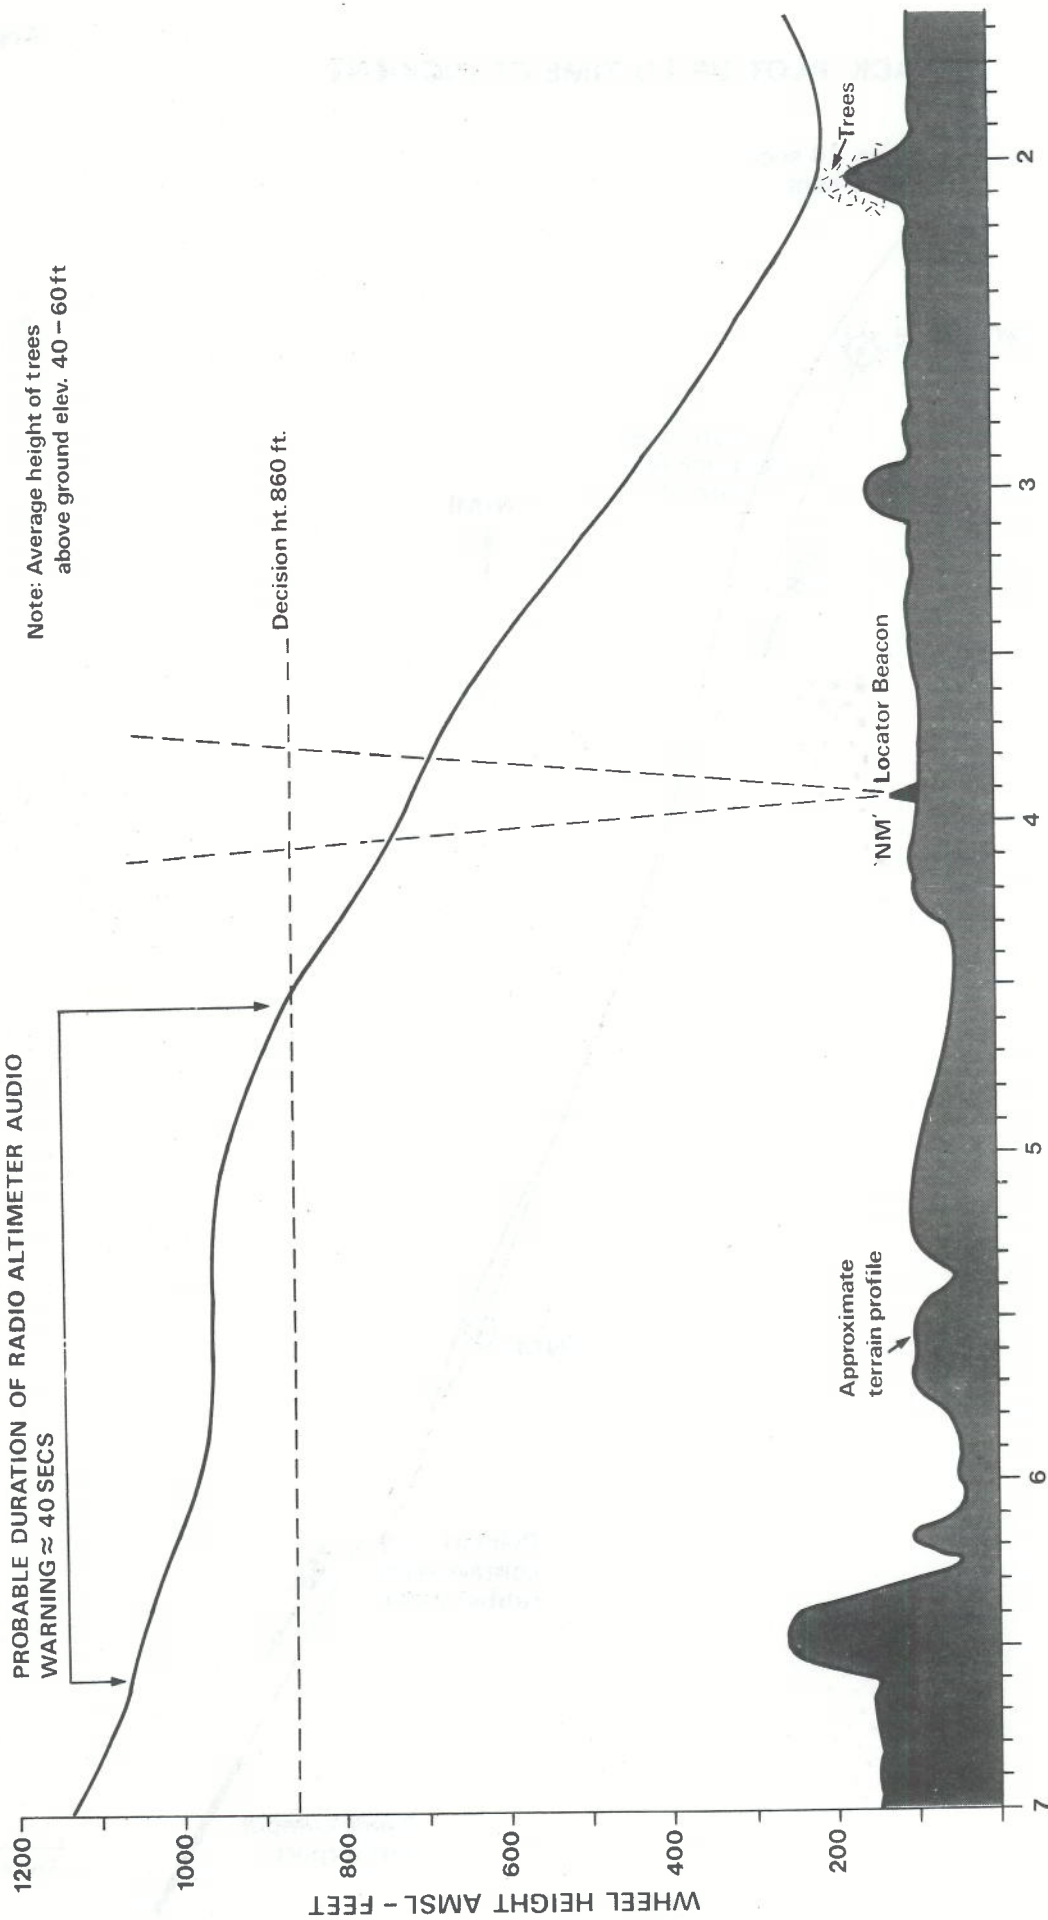
# APPROACH PROFILE

- (viii) The extension of 25 flap and the reduction of thrust at a late stage in the approach in an attempt to reduce airspeed caused a nose-down pitch which was either unnoticed by or uncompensated for by the commander.

- (ix) The flight crew failed to notice a dangerous excursion below the safe approach path to the runway.
- (x) Both pilots were concentrating on airspeed to the detriment of other flight instruments. There was a breakdown of overall monitoring of the flight instruments and of the visual flight path during the last 30 seconds before overshoot action was taken.

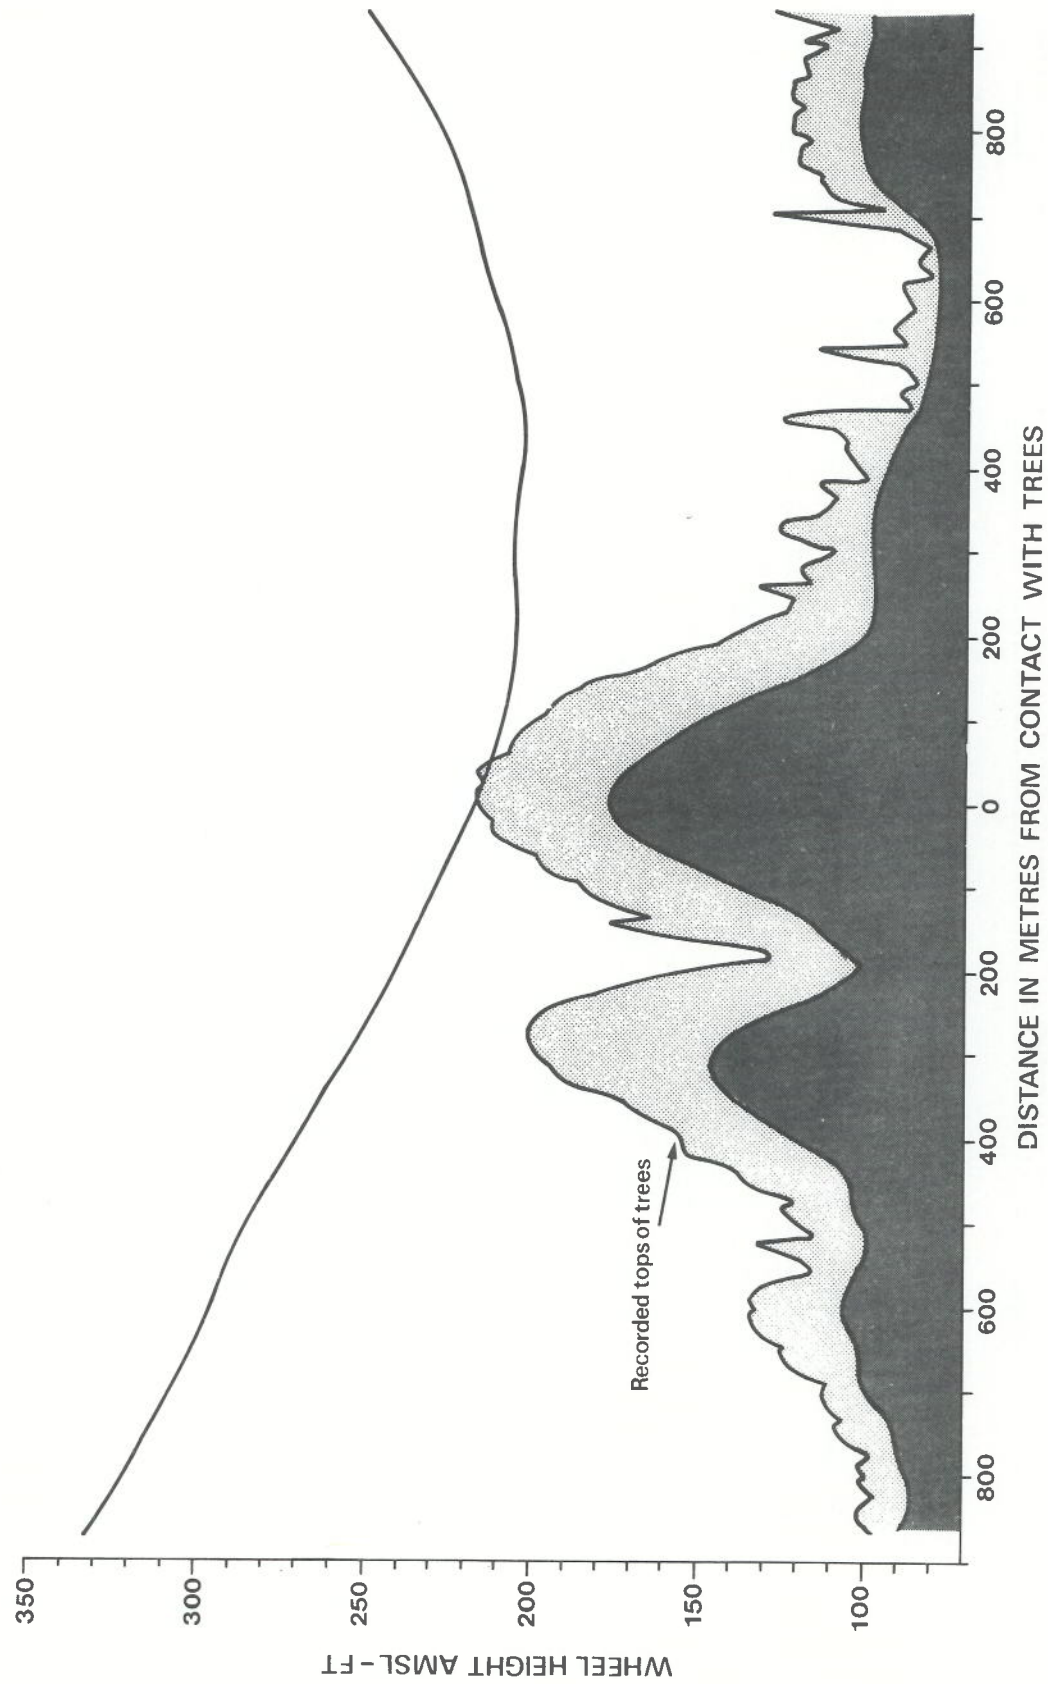
# TERRAIN AND TREE CLEARANCE DURING APPROACH TO INCIDENT AND OVERTHOOT

The position at which the aircraft had struck the trees was identified from the air by lines of discoloration in the tops of rubber trees on a low hummock about two miles short of the runway and about 400 metres to the right of the runway extended centre line. The ground elevation at this point is about 140 feet amsl and the tops of trees are about 60 feet above ground level. The main impact mark was a 200 metres long swathe of defoliated branches heading directly towards the airfield; the width of this swathe corresponded to the width of the main landing gear and to the left of this swathe were two deep straight 'trenches' in the tree tops at a spacing appropriate to the aircraft's left side engines. To the right of the swathe there was a faint trough at the correct spacing for the number 3 engine.

On the ground there were small fragments of flap structure and along the line of the main swathe two complete trees and several large boughs had been felled by the passage of the aircraft. Witness marks on the trees indicated that the aircraft had penetrated the foliage down to a depth of about 15 feet from the tree tops. The length of the trail of broken branches was measured at about 200 metres with some traces of freshly broken foliage extending a further 100 metres.
