- Final Report -

AAIS Case N°: AIFN/0016/2014

Hydraulic Fluid Mist and Protective Breathing Equipment Fire in the Passenger Cabin

Operator:	Emirates
Make and model:	Airbus A330-243
Nationality and registration:	The United Arab Emirates, A6-EAQ
Place of occurrence:	Karachi International Airport
State of Occurrence:	Pakistan
Date of occurrence:	4 October 2014

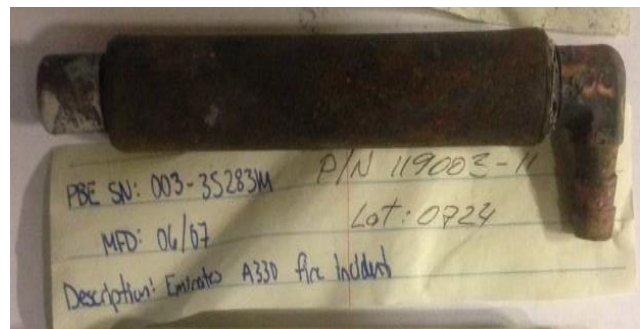
Figure 13. The candle from the PBE unit involved in the Incident [Source: B/E Aerospace CT scan report]

- The candle from the PBE unit that caught fire during activation by the cabin crew on the Incident Aircraft (S/N 003-35283M) (figure 13).
- The candle from a PBE unit (S/N 003-35282M) tested at the Operator's facility that had caught fire.
- The candle from a PBE unit (S/N 003-35280M) tested at the Operator's facility that had generated some black deposits after activation.

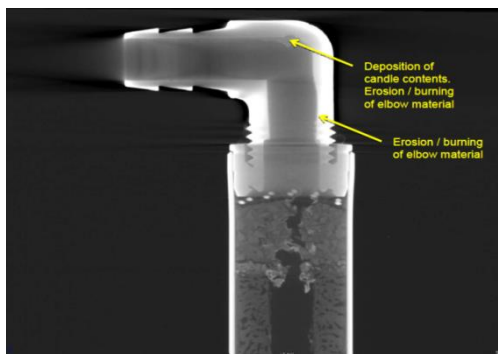
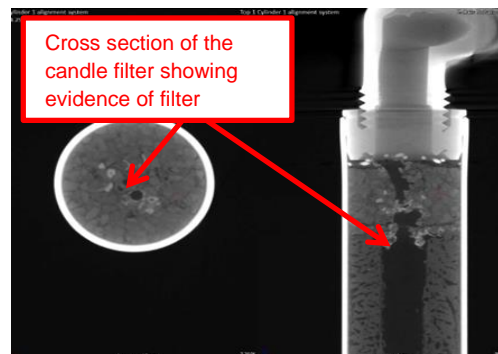
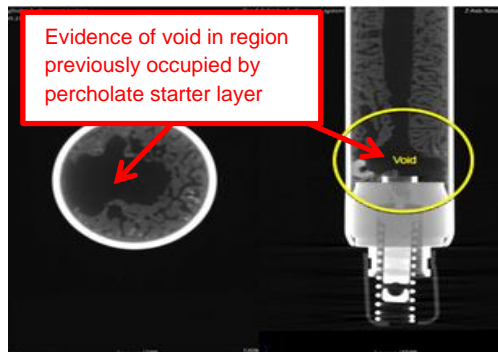
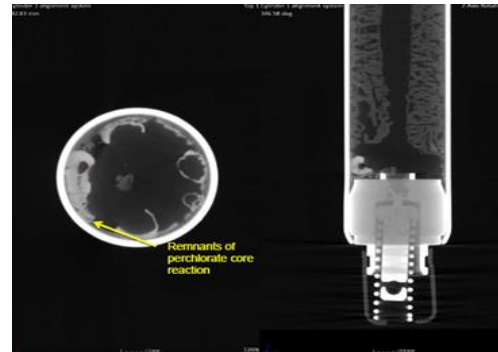
Photos related to the Incident PBE unit candle. [Source: B/E Aerospace CT Scan Report]

The two PBE units that had been exposed to fire (S/N 003-35283M and 003-35282M), exhibited residues of the core and filter in the oxygen path. The candles also showed evidence of localized outlet elbow burning and material loss in the vicinity of these compacted core/filter materials, or in the preceding flow path. In addition, residue from the perchlorate based starter layer of the candle, that is the region normally occupied by the starter layer, was essentially void and the starter layer residue assumed a displaced position in the direction of the candle outlet. (Figure 14a, 14b, 14c, 14d).
