الهيئة العامة للطيران المدني
GENERAL CIVIL AVIATION AUTHORITY

- Preliminary Report -

AAIS Case N°: AIFN/0008/2016

Runway Impact During Attempted Go-Around

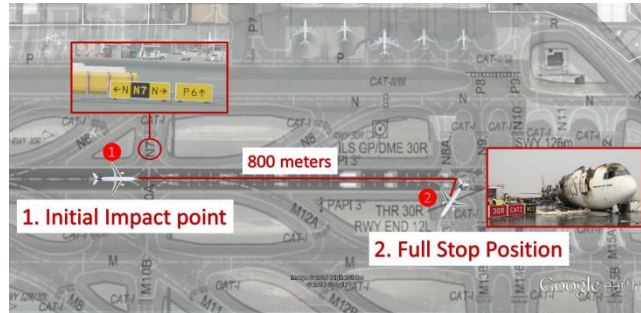
Figure 1. Aircraft Initial impact and final position

The point of impact of the Aircraft with the runway was approximately 2,530 meters from runway 12L threshold, adjacent to the November 7 taxiway. Marks on the runway indicated that the Aircraft slid for approximately 800 meters along the runway with the three landing gears not fully up. The Aircraft came to rest adjacent to the Mike 13 taxiway, having turned to the right onto a heading of approximately 240 degrees.

The Aircraft aft fuselage lower section impacted first, followed by the engines, the lower section of the aircraft belly fairing, and then the forward fuselage and nose landing gear doors. The No.2 engine separated, moved laterally on the right wing leading edge, and remained near the right wingtip until the Aircraft came to rest.

As it slid along the runway surface, various components detached from the Aircraft. These components included portions of the engine cowlings, secondary support structures and parts of the wing to body fairings, access panel doors, and systems components. (Figure 1).

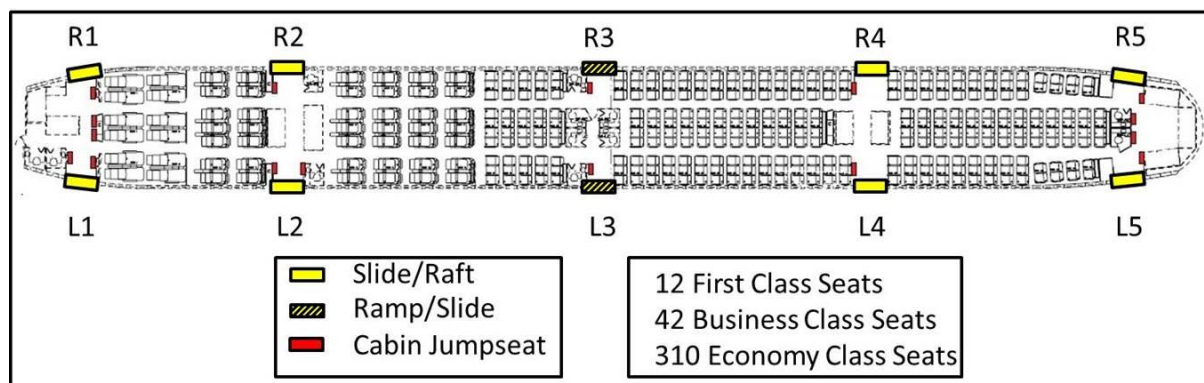
Figure 2. Cabin layout with door location
(Note: The cockpit evacuation windows are not shown)

The Aircraft was configured to seat 16 cabin crewmembers on jump seats located at each cabin door and in the forward cabin between L1 and R1 doors. Additional seats were located in the aft galley between L5 and R5 doors. The senior cabin crewmember's jump seat was located at L1 door, opposite the cabin crewmember jump seat. L2 door was equipped with an additional jump seat facing aft. All of the jump seats were occupied by cabin crewmembers (figure 2).

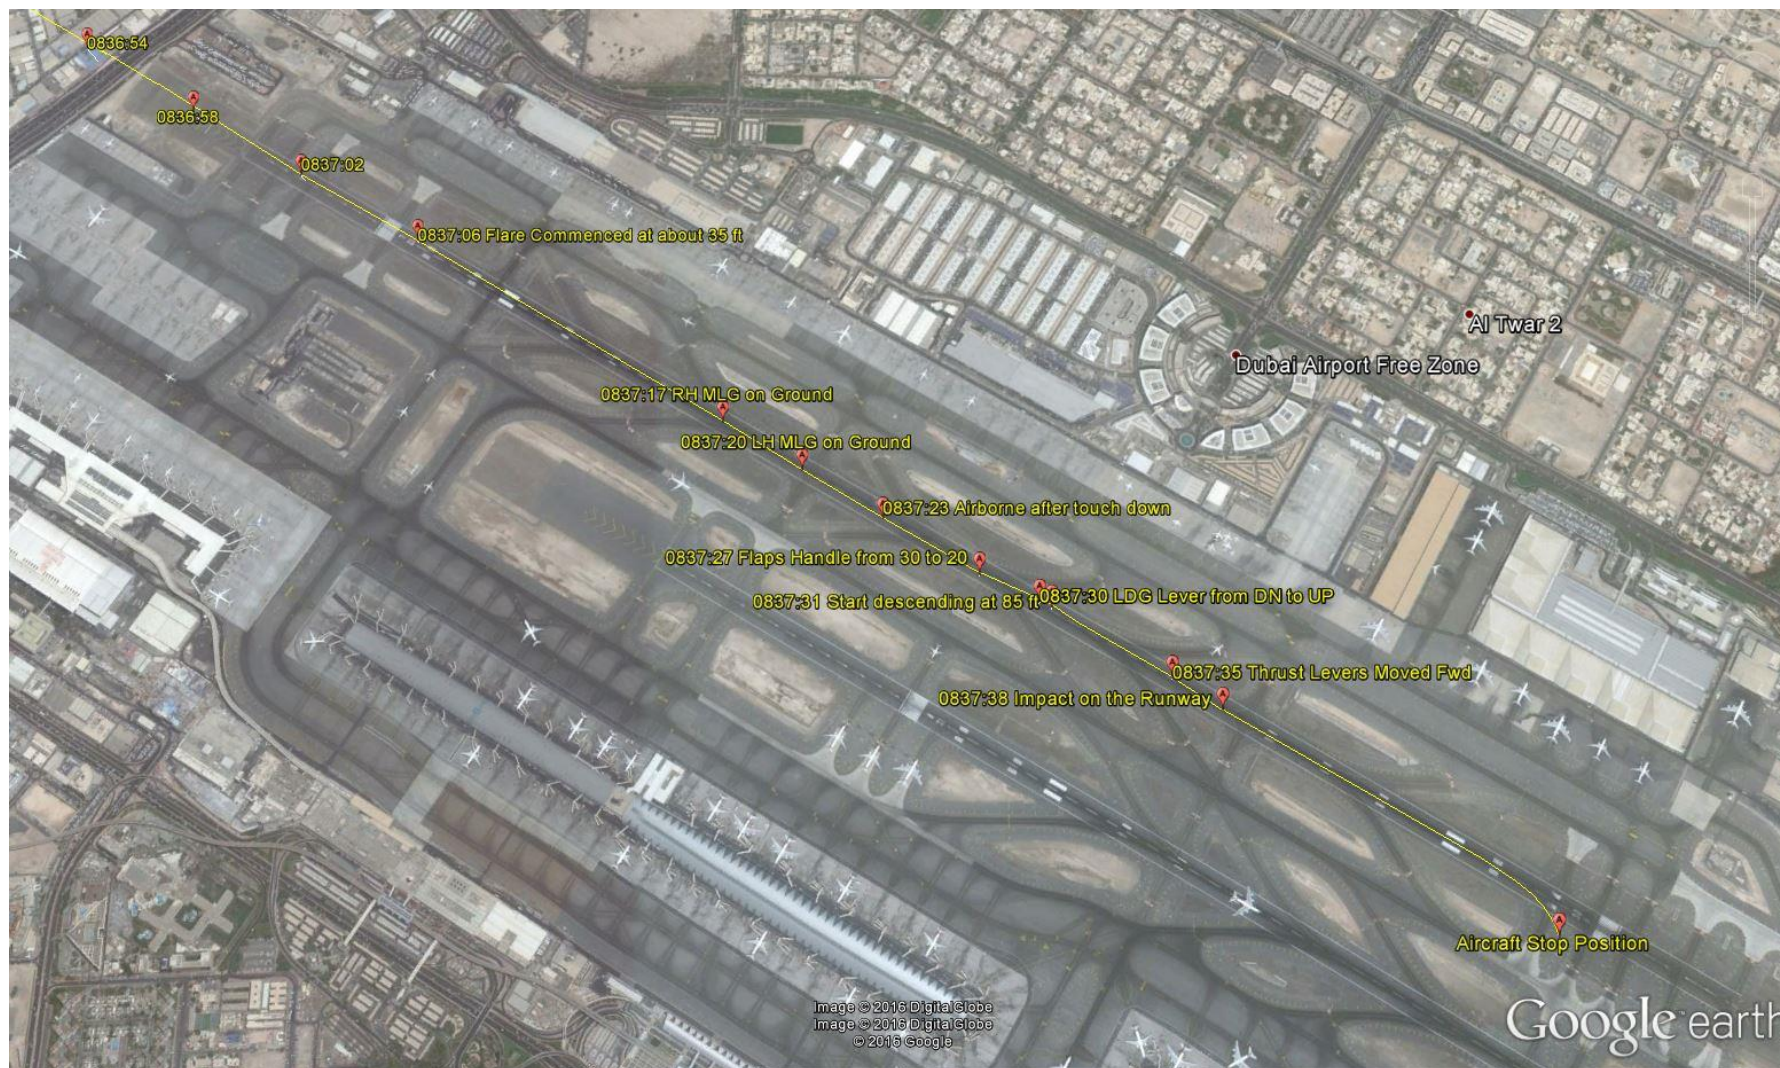
Appendix A. Final Flightpath

Appendix A to this Report illustrates the final flightpath from over the threshold until the Aircraft came to rest.
