FINAL REPORT

**Garuda Airlines
Boeing 737-300 Registration PK-GGG**

**Singapore Airlines Engineering Company
Maintenance Jeep**

AIB/AAI/CAS.001

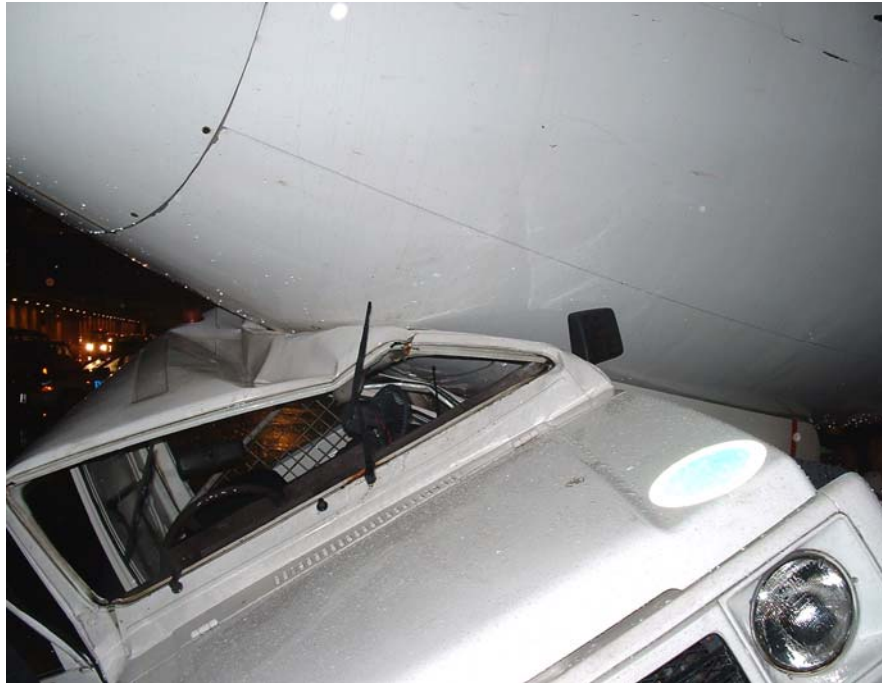
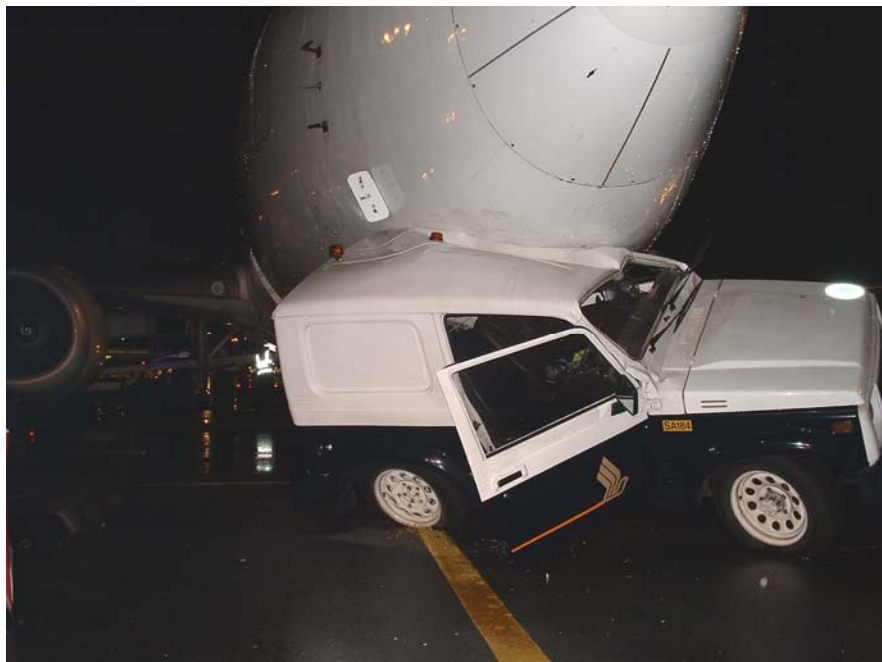
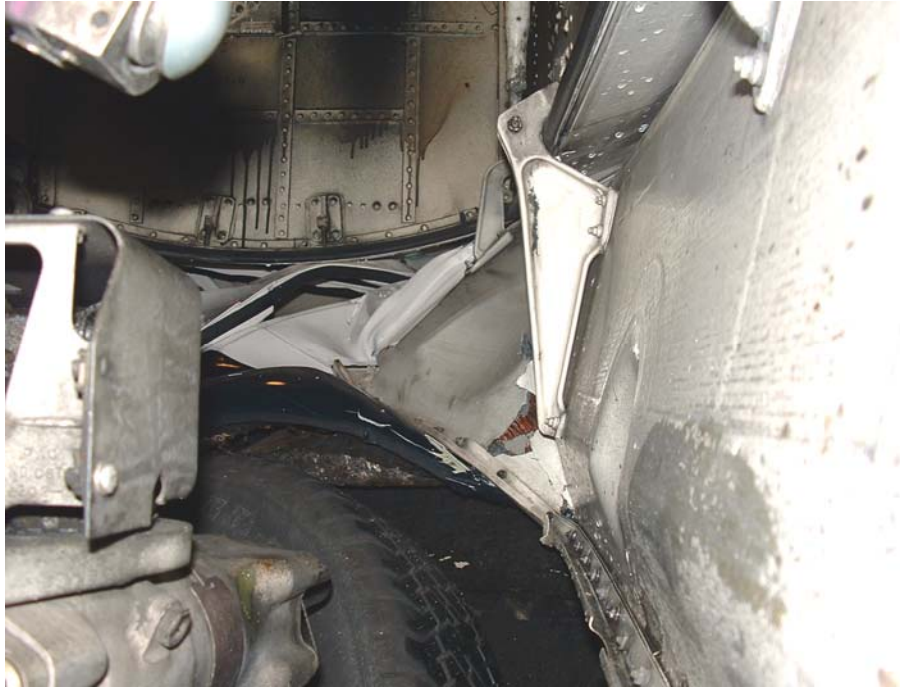
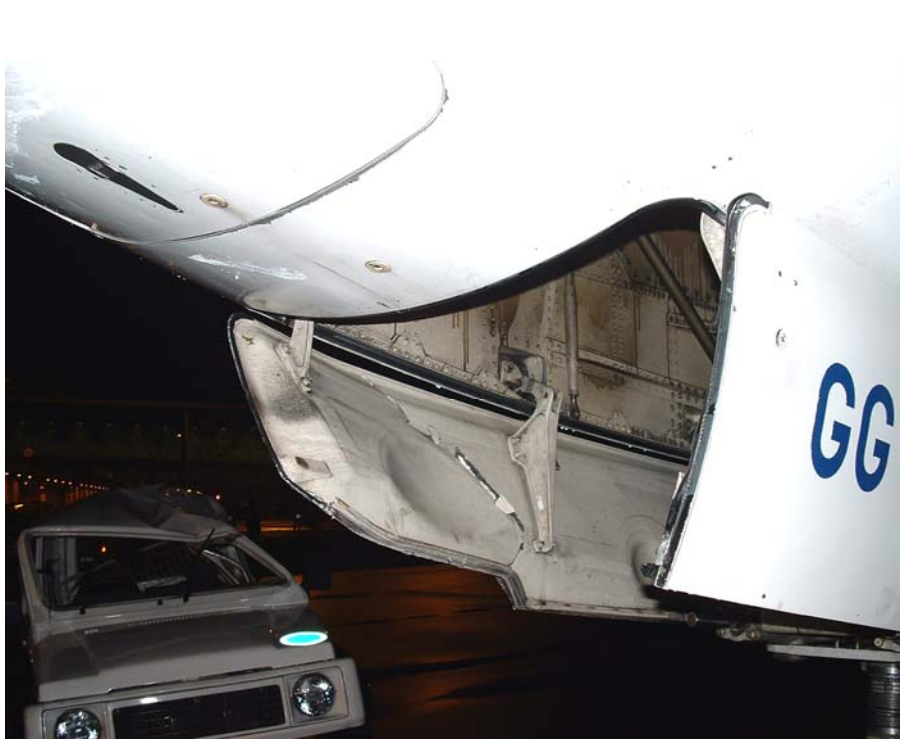
Appendix 2

1.3.1 The nose gear right hand door was buckled and broken. The nose gear left hand door was damaged through its penetration of the left hand door of the vehicle. (See **Appendix 2.**) There were three shallow dents on the right hand side of the fuselage forward of the nose gear well opening.

1.4.1 The vehicle involved in the collision with the aircraft belonged to the SIA Engineering Company Limited. The roof and the left hand door of the vehicle were crushed by the forward fuselage of the aircraft. The left hand door was also punctured by the nose gear left hand door.

1.4.2 There was a 2-metre long gouge on Taxiway NC3 caused by the rim of the right hand rear wheel of the vehicle when the vehicle was pinned under the aircraft forward fuselage.

Photographs showing damage to aircraft and vehicle

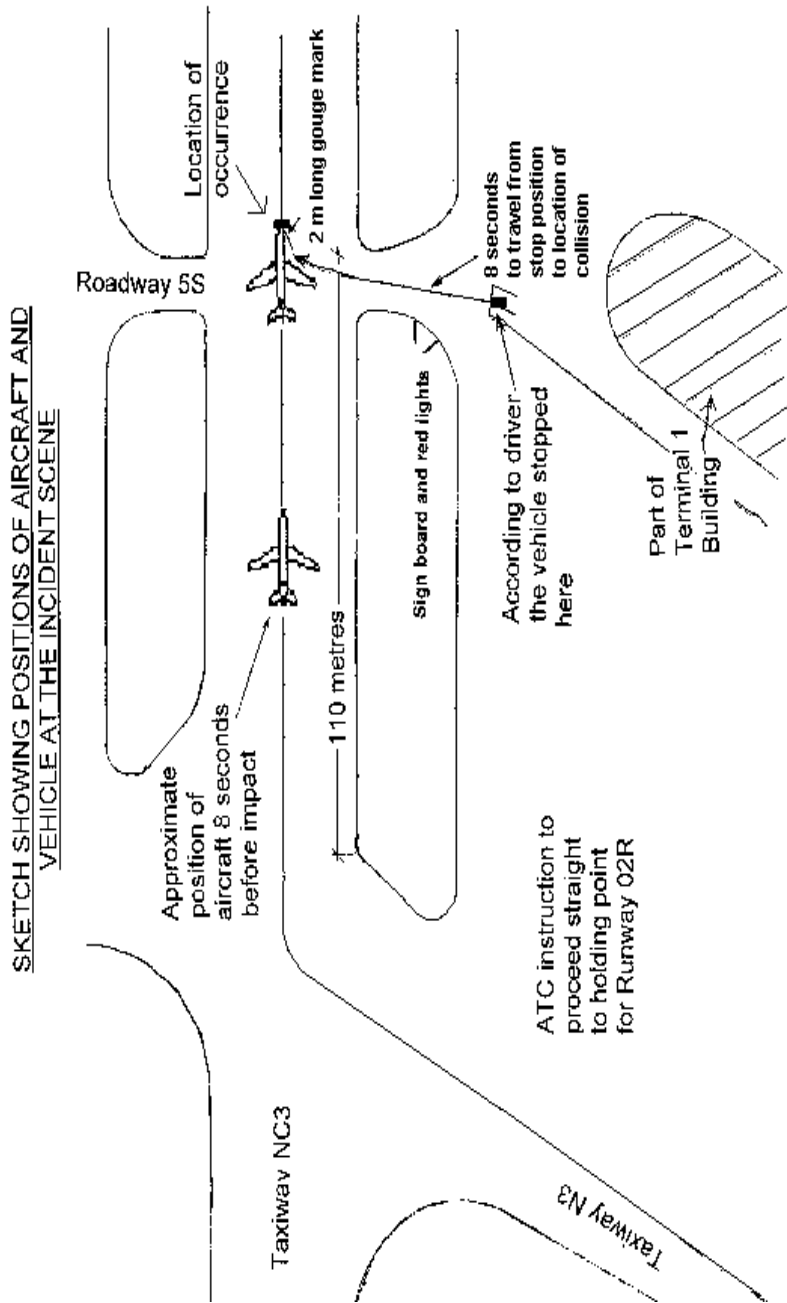
Appendix 5

1.16.1 In tests conducted following the incident, it was found that a similar vehicle took about 8 seconds to travel from stationary position at the stop point to the point of collision (see Appendix 4). The time taken for the ground vehicle travelling at 30-40 kph and without stopping at the stop sign was measured to be about 6 seconds.

Sketch showing positions of aircraft and vehicle at the incident scene
