# **AIRCRAFT ACCIDENT INVESTIGATION REPORT**

**AIR CHINA LIMITED  
B 2 9 0 6**

**Japan Transport Safety Board**

**AIR CHINA LIMITED  
BOEING 737-300, B2906 (China)  
ABOVE MATSUE CITY, SHIMANE PREFECTURE, JAPAN  
AT ABOUT 19:19 JST, FEBRUARY 10, 2008**

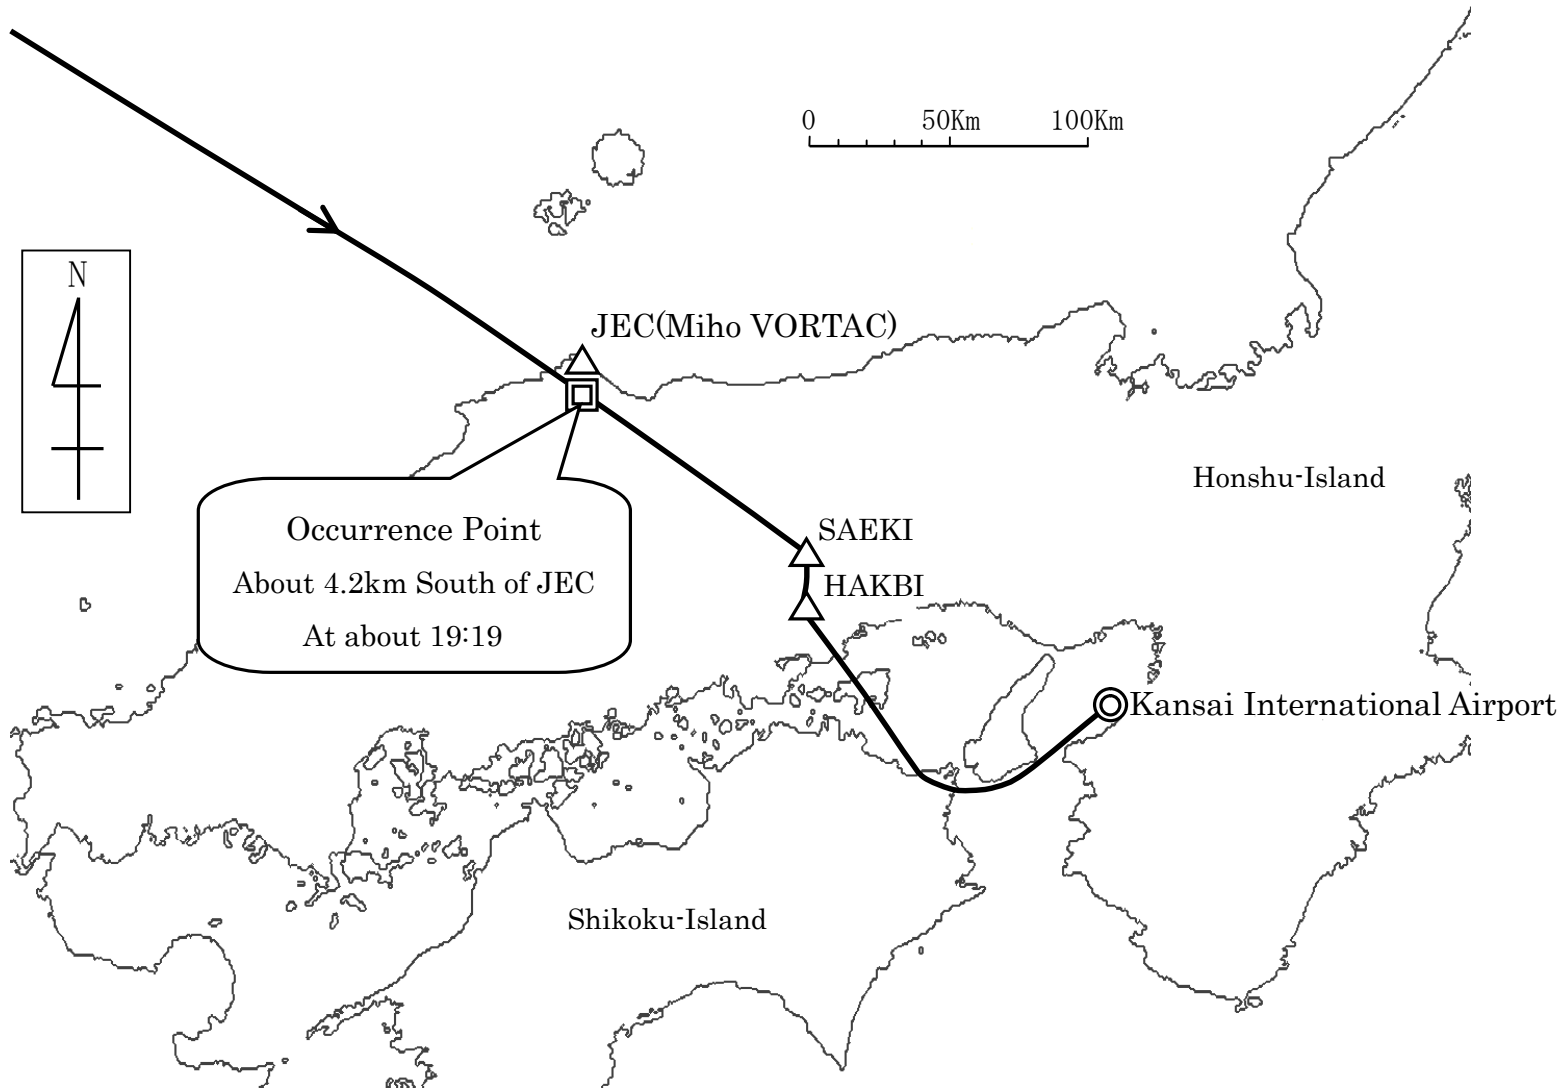
Figure 1 Estimated Flight Route

While the Aircraft was descending at a rate of about 2,000 ft/min, the wind velocity began to drop at a steeper rate, the CAS<sup>\*3</sup> increased rapidly and the control column position (CCP)<sup>\*4</sup> moved towards the pitch-up direction at about 19:19:03, when the Aircraft was at a pressure altitude of about 31,500ft, and the A/P disengaged at about 19:19:06. Subsequently, the CCP changed back and forth. During the period from 19:19:08 to 19:19:11, the vertical acceleration showed remarkable change, dropping from about 2.2G to about 0.0G and then reaching again to about 2.0G. Until about 19:19:27, the pitch angle<sup>\*5</sup> had changed upward and downward following the changes in CCP, and the changes in the vertical acceleration accompanied by the changes in the pitch angle were recorded.

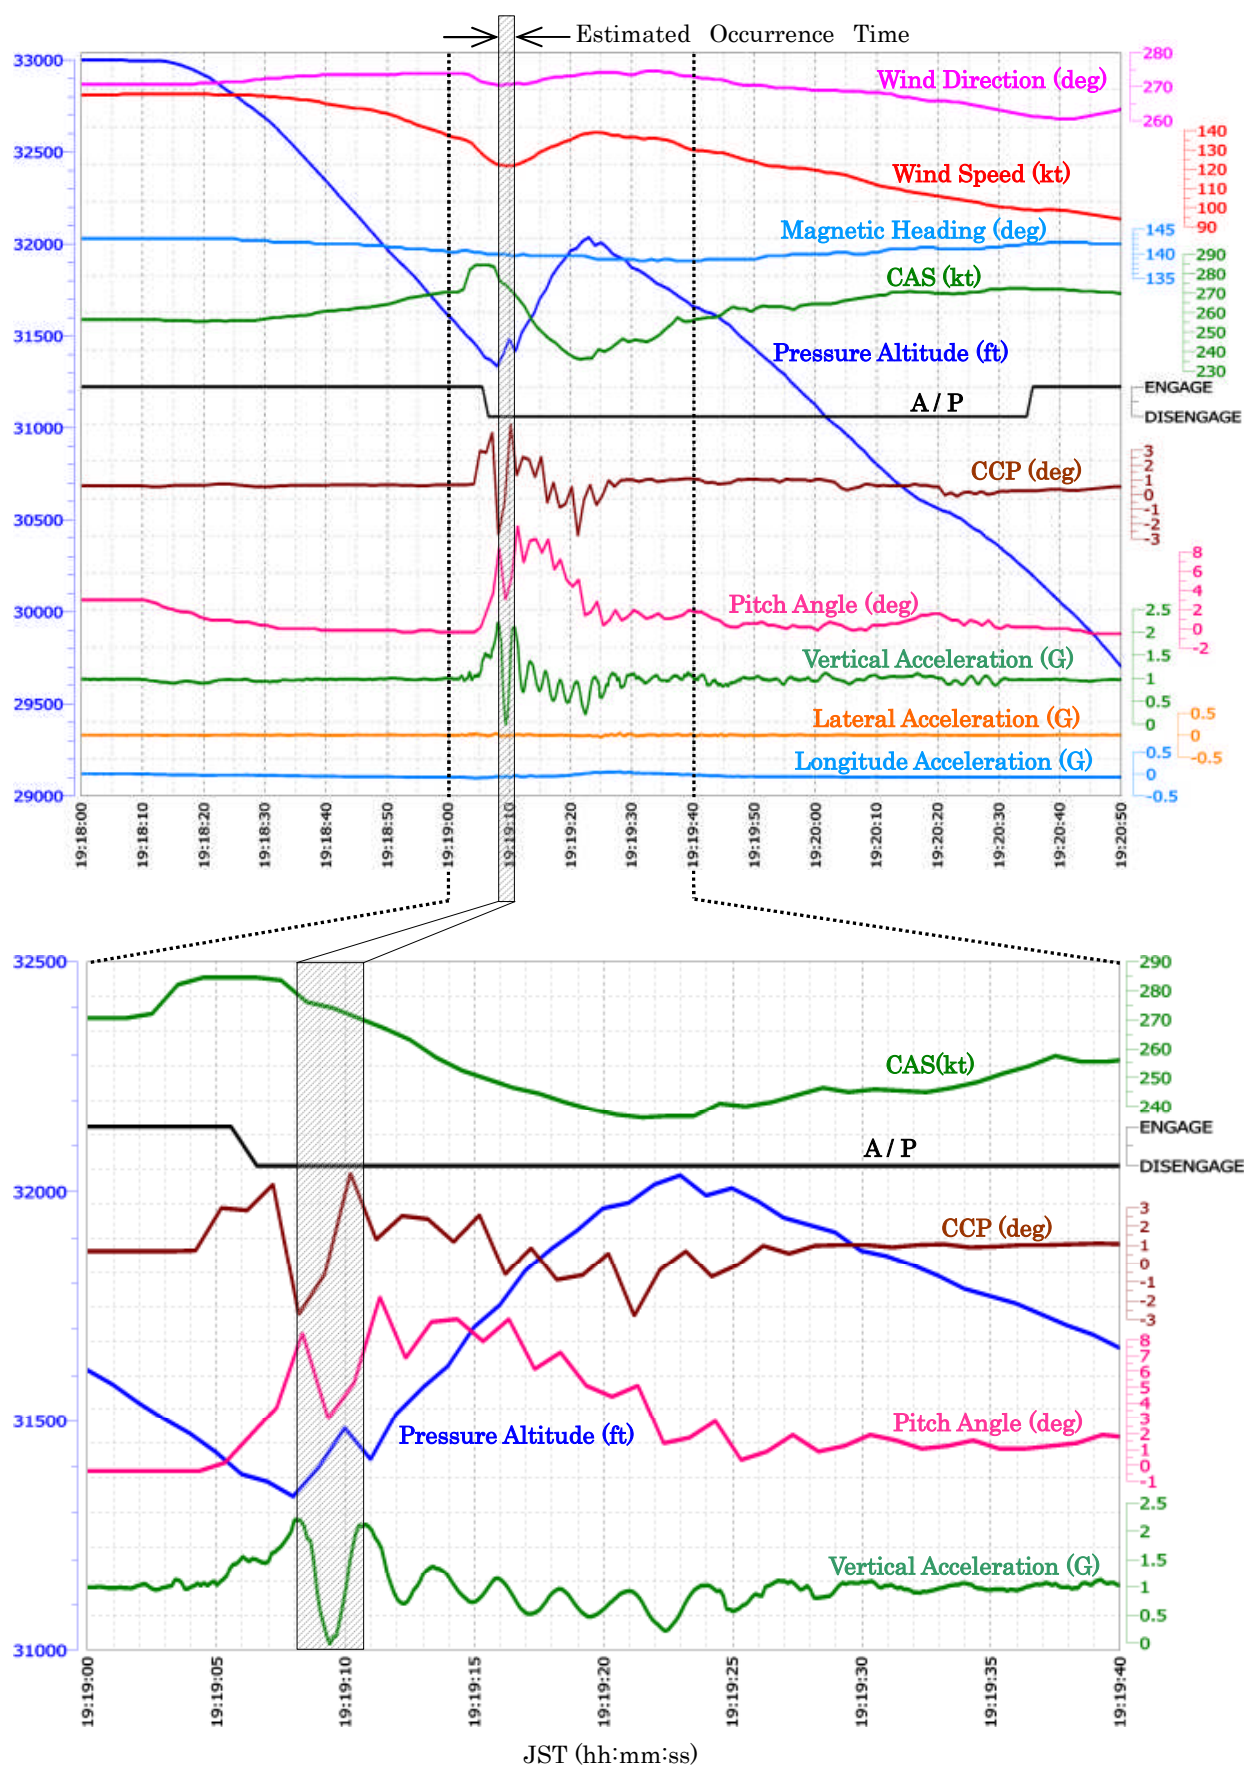
# Figure 3 DFDR Records

- (1) The Aircraft began descending from a cruising altitude of FL330 at about 19:18:13 with the A/P engaged. At about 19:19:04, when the Aircraft was at a pressure altitude of about 31,500 ft, the CAS increase rapidly from about 270 kt to 285 kt, in response to which the A/P moved the control column to pull up the nose as an automatic control action against this quick change in CAS. At about 19:19:06, i.e., when the Aircraft began to pitch upwards, the A/P disengaged. There was no factual information in the data from the Aircraft's DFDR to indicate what caused the disengagement of the A/P.

- (2) After disengagement of the A/P while the Aircraft's pitch-up attitude had begun to increase, the Second PIC executed manual control to continue bringing the nose up in order to decrease the CAS. When the CAS stopped increasing, the Second PIC moved the control column forward by a fairly large amount to bring the nose down, and

immediately after this, he moved the column aft, also by a large amount. Following these control column movements, the Aircraft's pitch angle changed upward, then significantly downward, and again upward. The vertical acceleration thus showed these large changes during the period from 19:19:08 to 19:19:11, i.e., having changed positively to about 2.2G, the maximum value during the flight, then changing negatively to about 0.0G, the minimum value during the flight, and again changing positively to about 2.0G.

This wide fluctuation in vertical acceleration took place 55 seconds after the Aircraft began descending. Since there were no significantly large fluctuations in vertical, lateral or longitudinal acceleration in the DFDR data for any other time from takeoff to landing, it is considered highly probable that the injured passenger lost one's balance due to this distinctively large fluctuation in vertical acceleration.

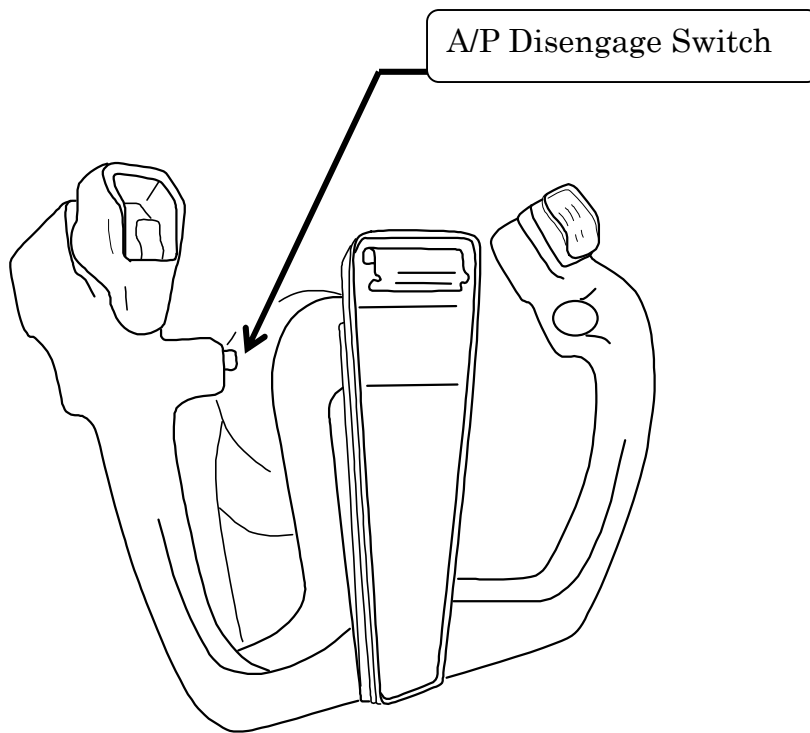
Figure 4 A / P Disengage Switch

The cause of A/P disengagement, therefore, could not be determined, although it is considered possible that a loss of valid signals or intermittent contact on switches or relays might have occurred as suggested in the response from the adviser of the United States of America, the State of Design and Manufacture of the Aircraft, as described in 2.10, or the Second PIC might have unconsciously pushed the A/P disengage switch on the control wheel.

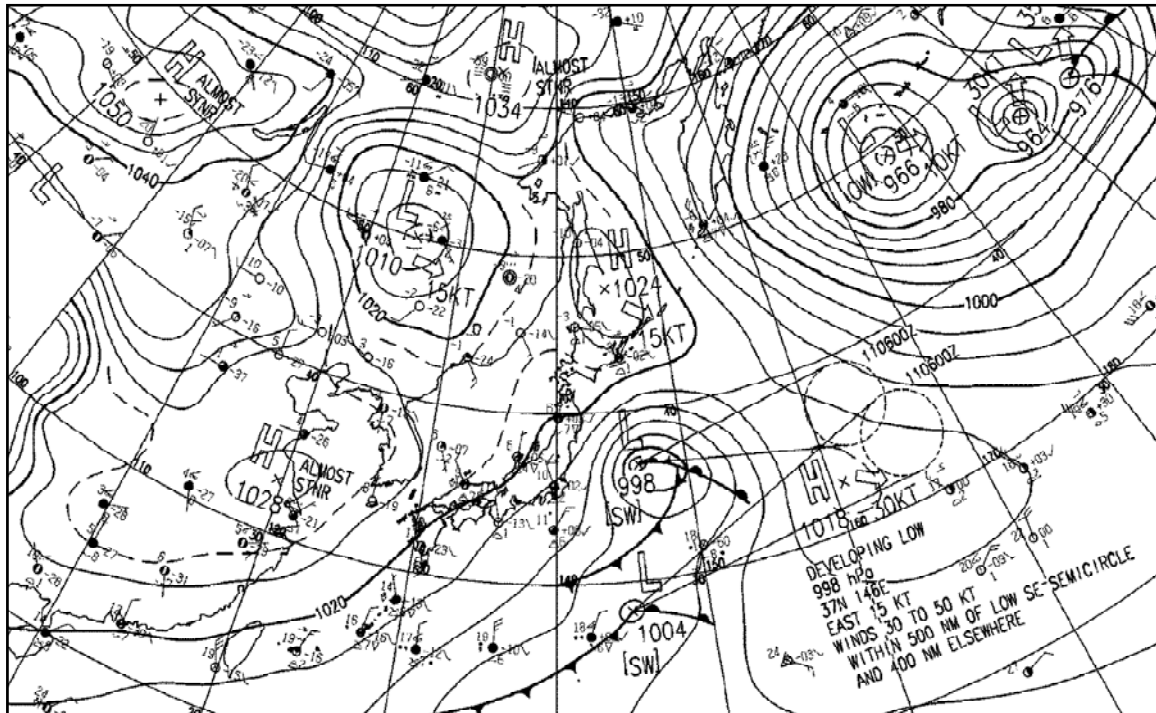
Figure 5 Asia Pacific Surface Analysis Chart  
at 15:00 on Feb. 10, 2008

According to the Asia Pacific Surface Analysis Chart at 15:00 on the day of the accident, the northern area of western Japan was covered by a high-pressure that had its center in the central region of China, while a low-pressure with fronts was extending over the sea east of the main island of Japan. The relevant Satellite Cloud Information Chart did not include any information suggesting the presence of clouds above 12,000 ft over the Sea of Japan, the Chugoku region or the Kansai region of Japan.

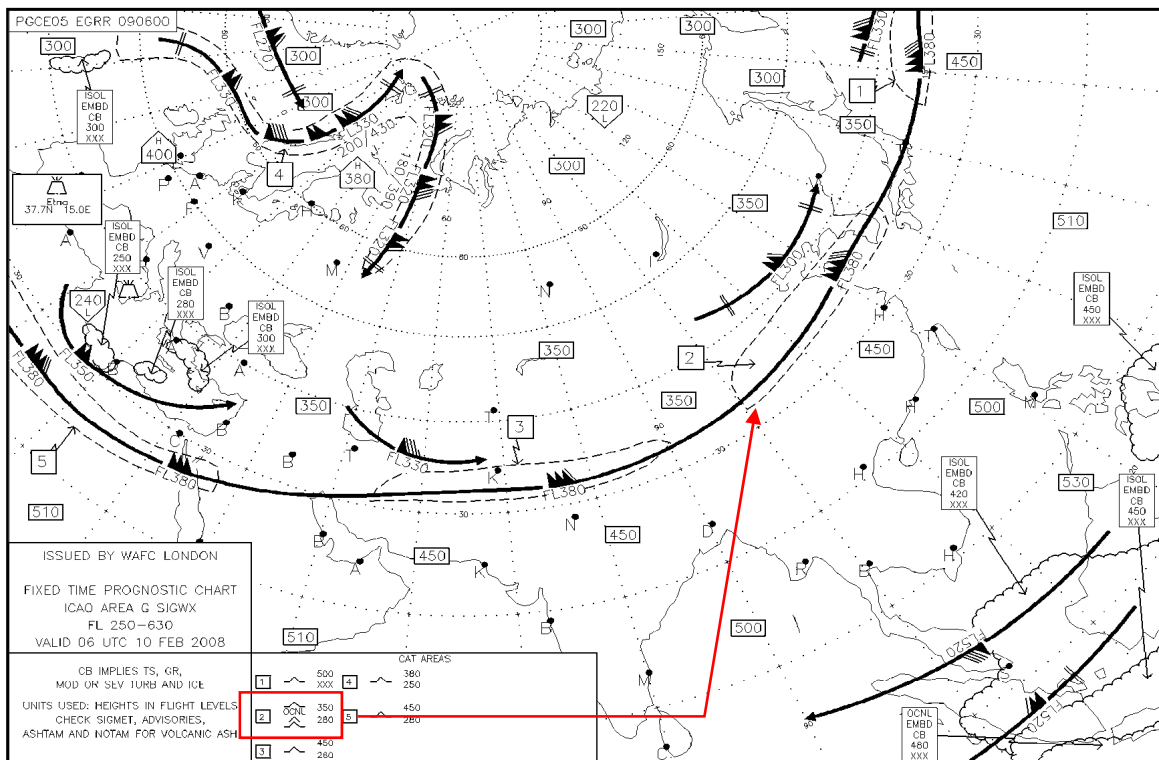
Figure 6 Significant Weather Prognostic Chart  
at 15:00 on Feb. 10, 2008

The Significant Weather Prognostic Chart valid at 15:00 on the day of the accident, which the PIC and other flight crewmembers received prior to the flight, showed a 180 knots jet stream zone at FL380, which stretched from China to Japan along the parallel of latitude that runs approximately 37 degrees north. It also showed a forecast zone of moderate or locally intensified CAT (Clear Air Turbulence) at FL280 – 350, which extended from 35 to 38 degrees north, a zone straddling the jet stream zone, and stretched from the 100 degrees east longitude line in China to South Korea including the Yellow Sea.

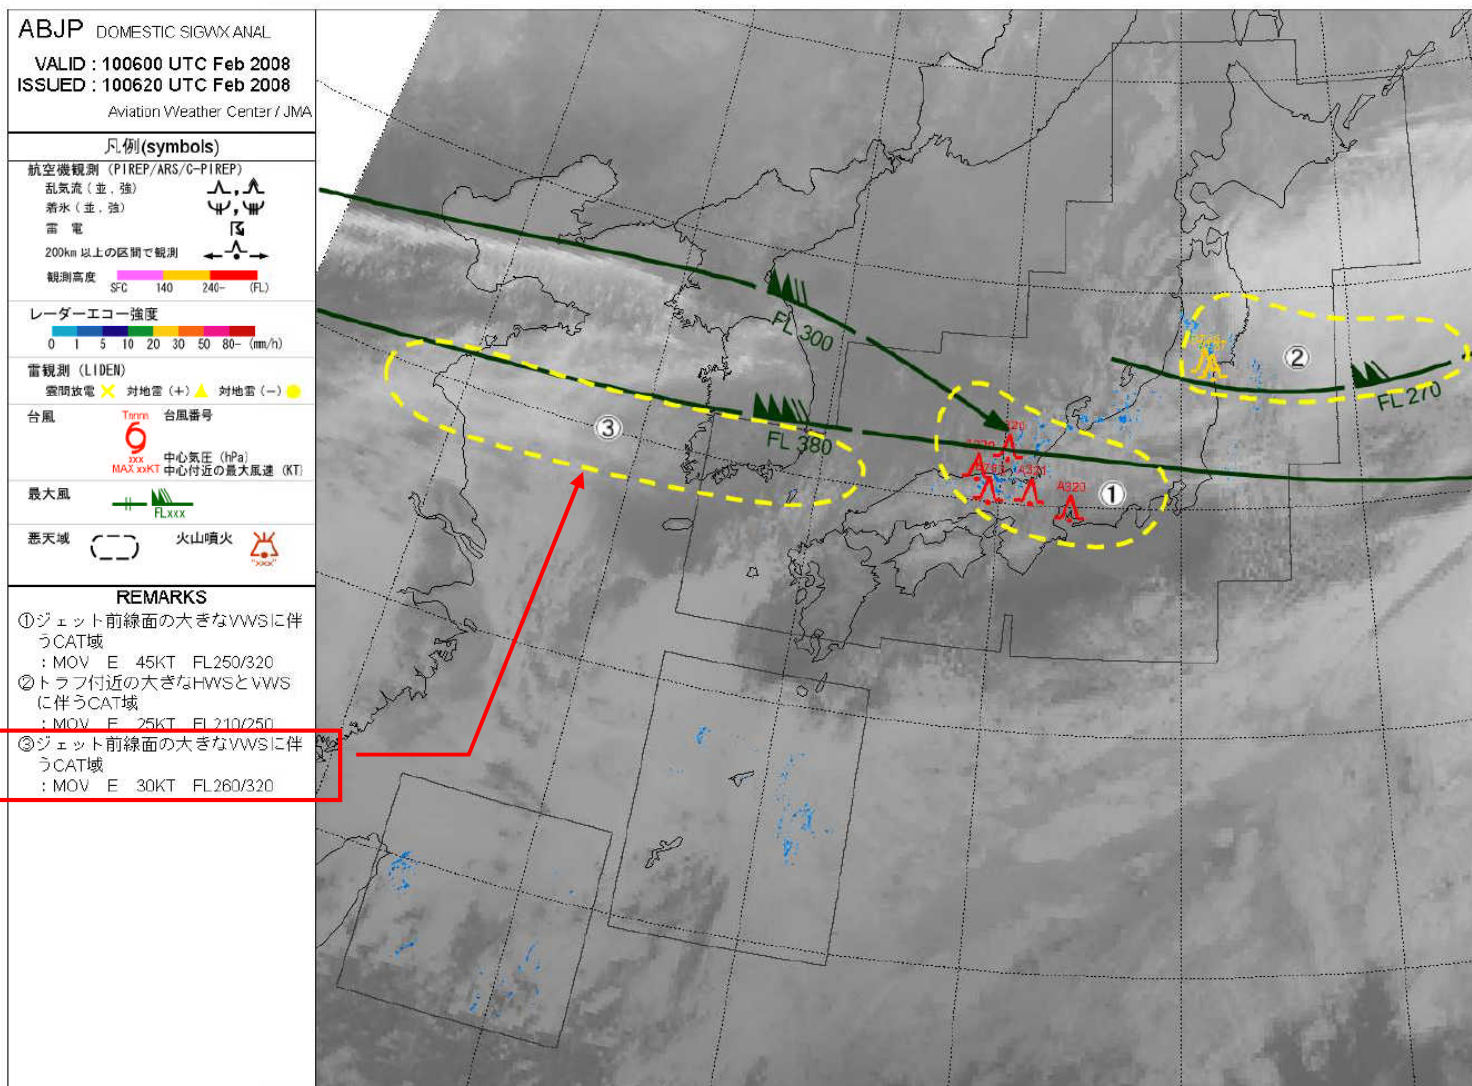
Figure 7-1 Significant Weather Analysis Chart at 15:00 on Feb.10, 2008

The Significant Weather Analysis Chart for users in Japan valid at 15:00 on the day of the accident showed a CAT zone at FL260 – 320 resulting from the great VWS (Vertical Wind Shear<sup>\*6</sup>) accompanied by a jet stream front, which extended widthwise from 34 to 36 degrees north and stretched from the Yellow Sea to the Sea of Japan off Yamaguchi Prefecture via the southern part of South Korea. The analysis thereof expected the CAT zone to move eastward at 30 kt.

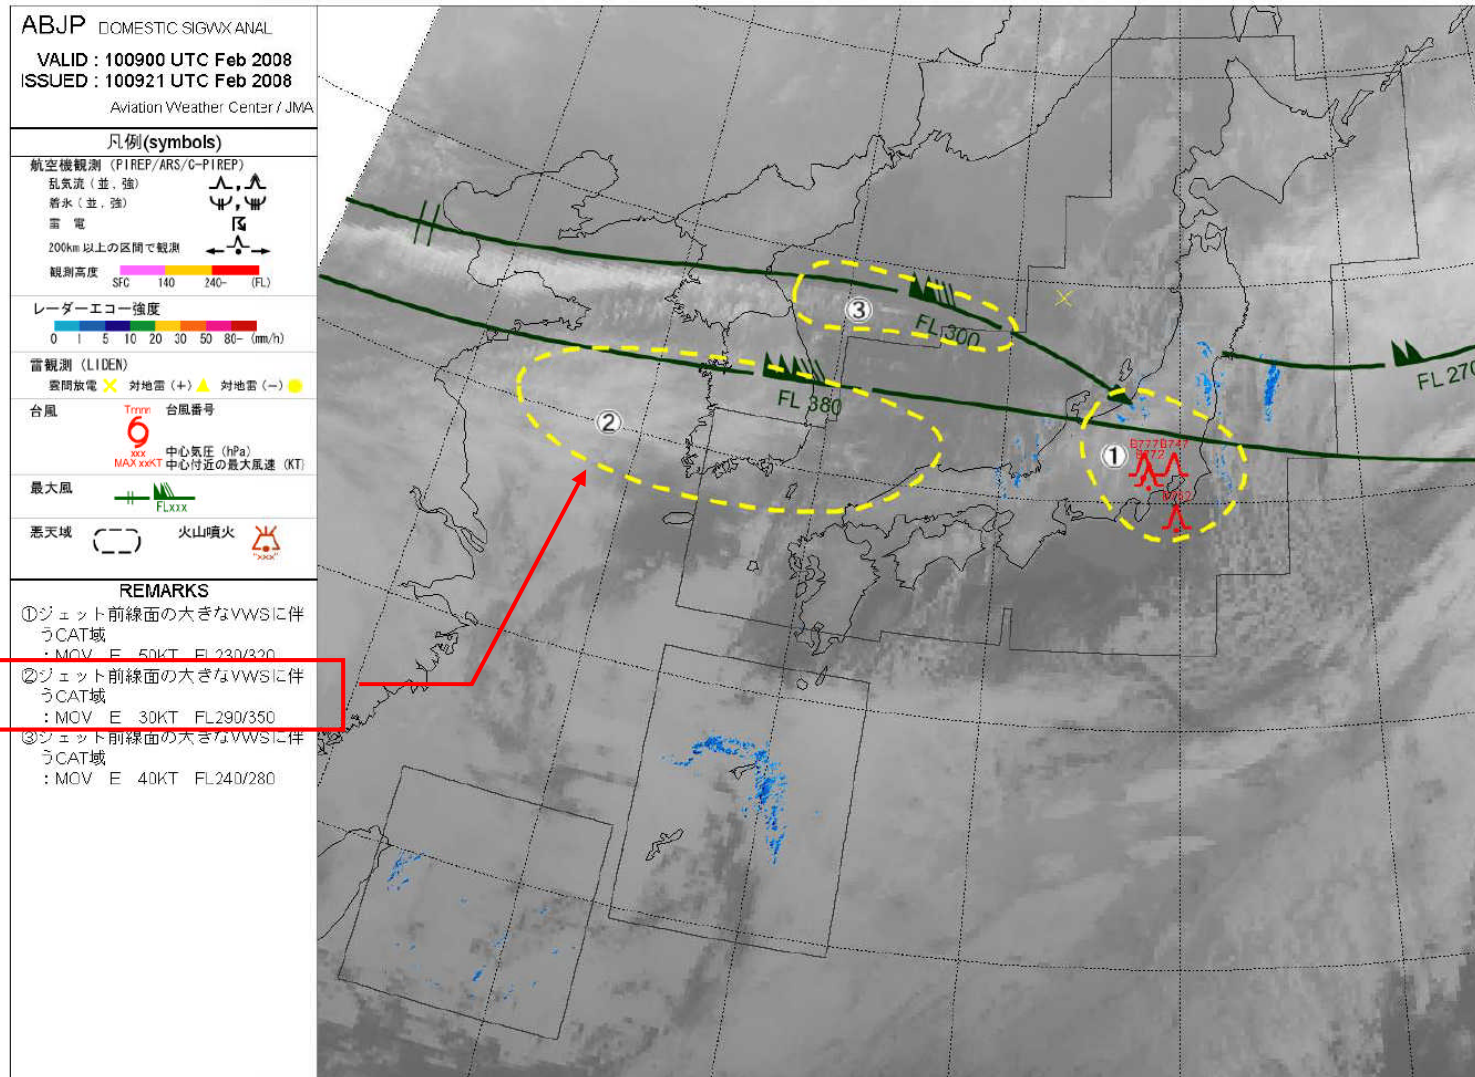
Figure 7-2 Significant Weather Analysis Chart at 18:00 on Feb.10, 2008

The Significant Weather Analysis Chart valid at 18:00 on the day of the accident showed a CAT zone at FL290 – 350 resulting from the great VWS accompanied by a jet stream front, which extended widthwise from 34 to 38 degrees parallel north and stretched from the Yellow Sea to the Sea of Japan off Shimane Prefecture via South Korea. The analysis thereof expected the CAT zone to

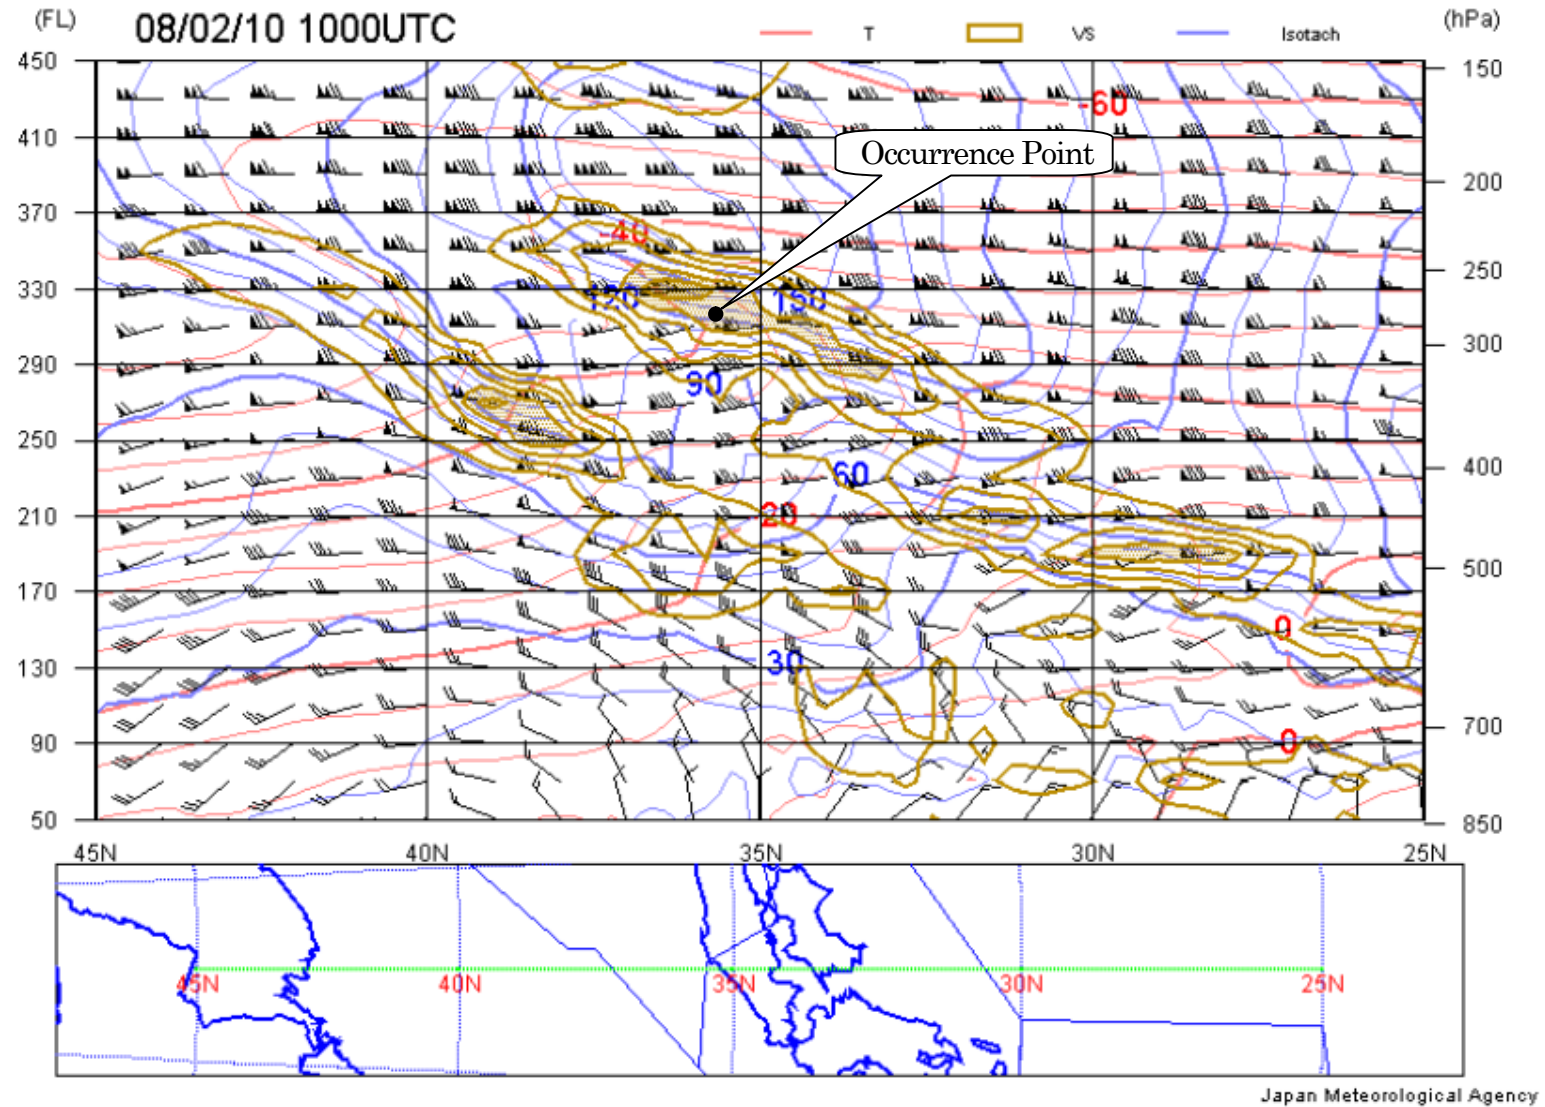
# Figure 8-1 Vertical Wind Shear Analysis Chart

The vertical wind shear analysis chart representing a vertical section along the 132.5 degrees east longitude line valid at 19:00 on the day of the accident, the vertical wind shear in the area where the accident occurred included a jet stream of 170 kt or faster in the air at FL380 – 350 and latitude near 35 degrees 30 minutes north, the point where the Aircraft encountered strong shaking, whereas the jet stream's velocity at FL310 was much lower, i.e., at 120 kt. That is, the vertical wind shear across FL330 – 310 was 12 – 15 kt/1,000 ft. The temperature at FL340 was about –35°C, whereas the isothermal curve for FL310 indicates a –40°C line extending from the north, showing that an inversion layer.

The vertical wind shear analysis charts described in 2.6.4 show a jet stream in the area above the point where the accident occurred; a strong wind of 180 kt was prevailing at FL380 and there was significant variation in wind velocity as represented by closely spaced isotachs in the area down to FL310, in addition to narrowly spaced isothermal lines extending along the strong wind line, which was bordered by a jet stream front extending from west to east. It is considered probable that vertical wind shear of 12 kt/1,000 ft or greater existed in the area of occurrence of the accident as well as an inversion layer as expected by the analytical data included in the charts.

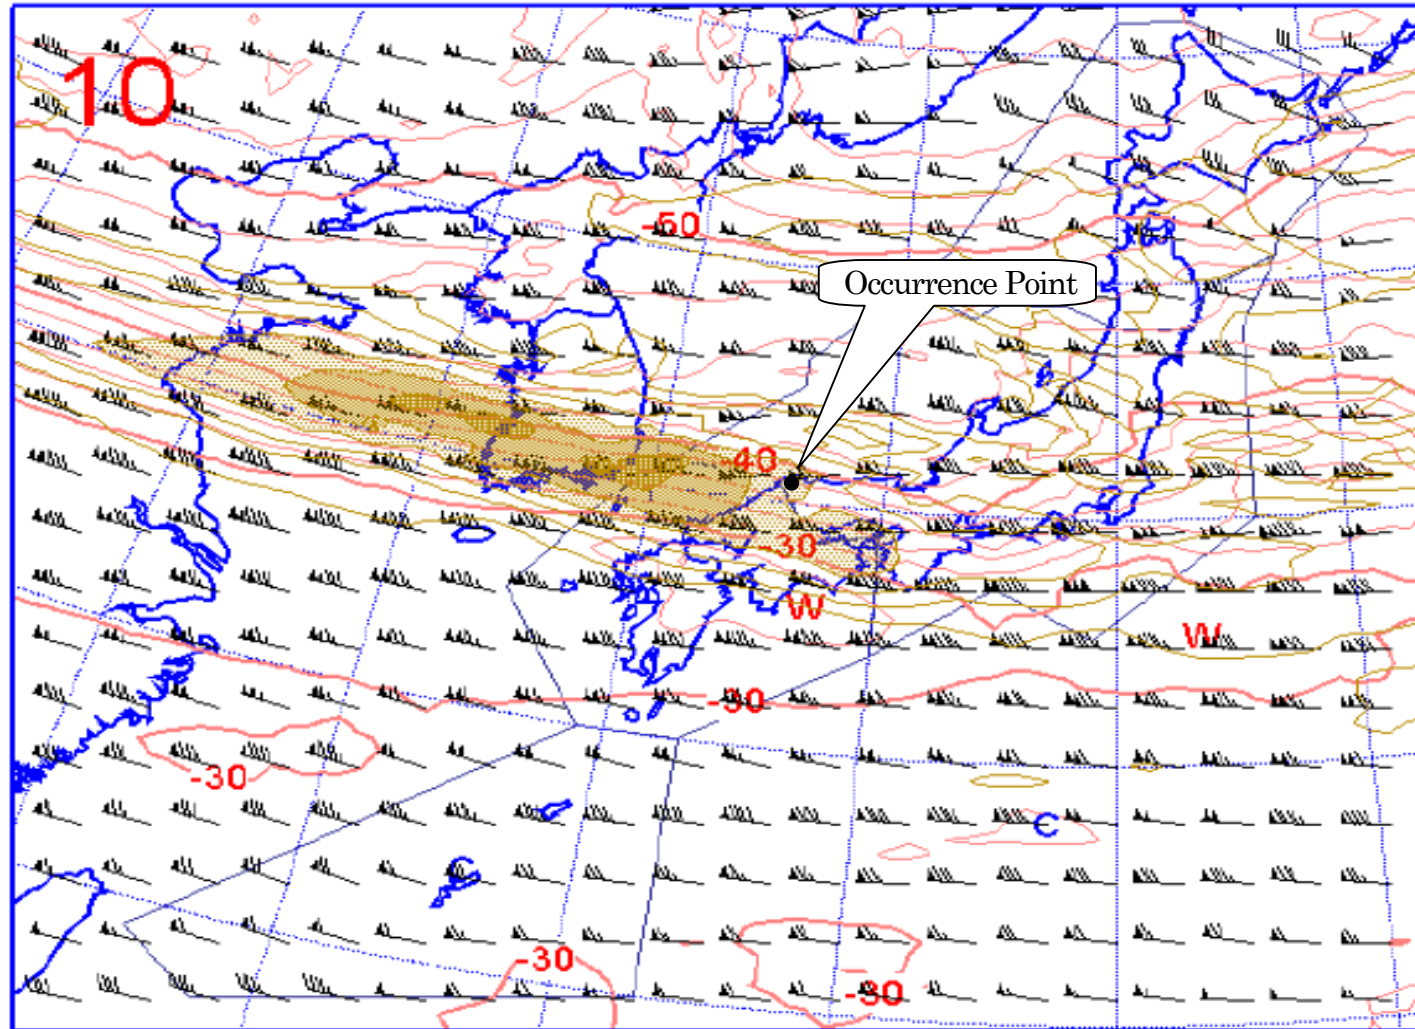
Figure 8-2 Vertical Wind Shear Analysis Chart

The vertical wind shear analysis chart representing a horizontal section at FL310 valid at 19:00 on the day of the accident shows isothermal lines extending at close intervals along the strong wind line, depicting the vertical wind shear was 12 kt/1,000 ft or greater extending eastward from the central part of China, covering the southern part of South Korea and reaching the Setouchi region of Japan.

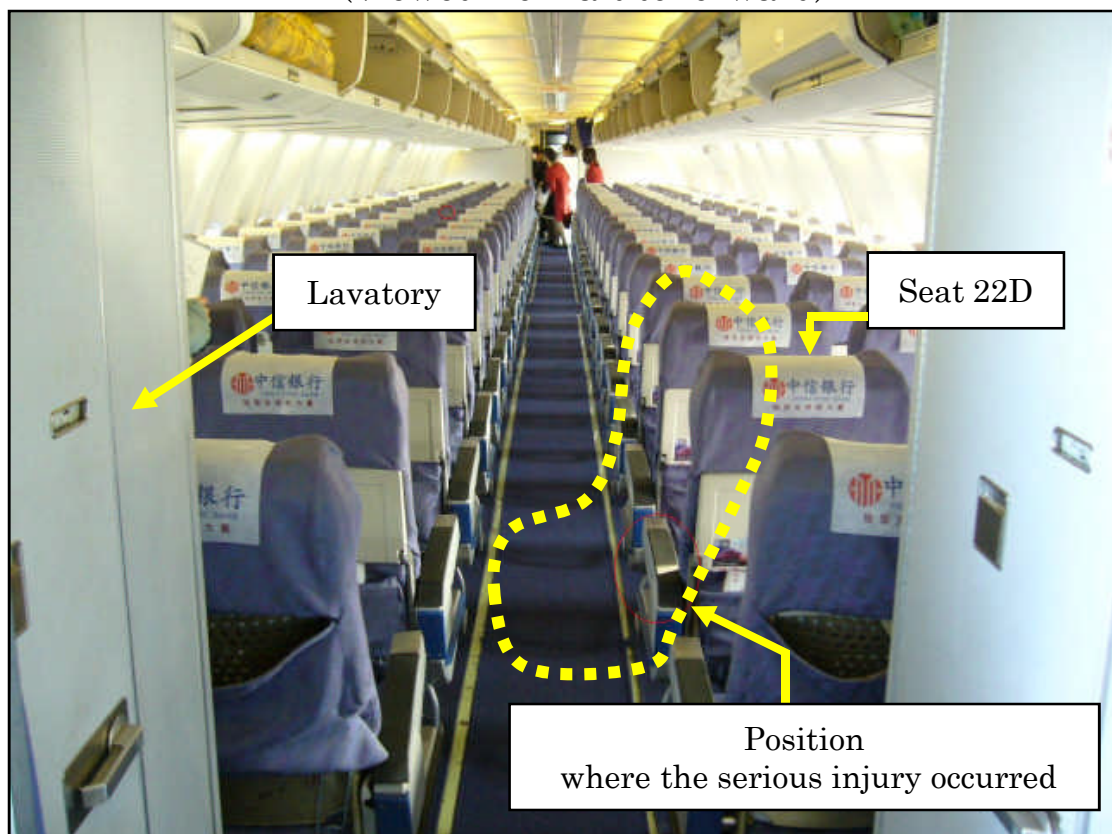
Photo 2 The Aisle of the Aircraft  
(Viewed from aft to forward)

It is considered highly probable that the latter passenger who was walking in the aisle from the lavatory back to her seat lost her balance due to the shaking, hitting her abdomen hard against a part of a nearby seat and thus sustaining serious injury.
