This document is based on the data collected on the circumstances of the accident, which then has been analysed for the investigation. The focus of the investigation of the tragic accident to GF-072 has been to establish what happened, to analyse how and why the occurrence took place, and from this analysis to determine what the occurrence reveals about the safety health of the aviation system. Such information is used to arrive at conclusions and make safety recommendations aimed at reducing or eliminating the probability of a repetition of the same type of occurrence, and where appropriate, to increase the overall safety of the aviation system.

## Executive Summary

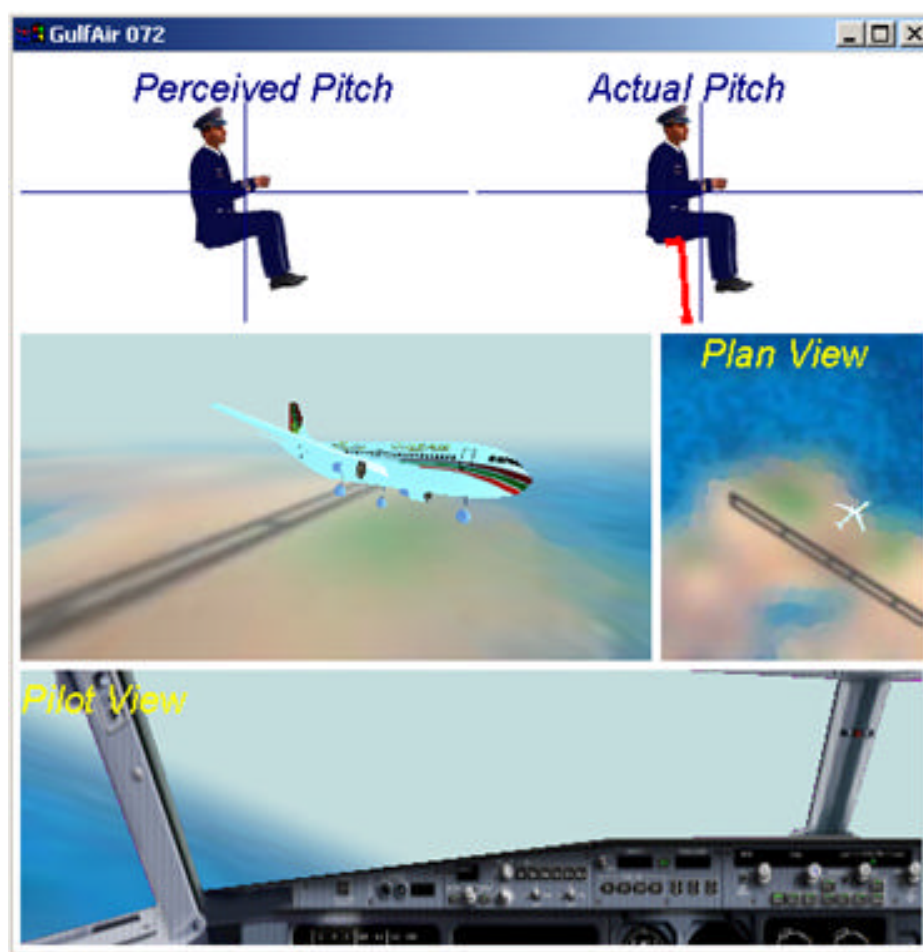
**Figure 1:** Perceived Pitch versus Actual Pitch just prior to stick forward (t=1929:43)  
(Red Arrows in Actual Pitch panel are the Gx and Gz acceleration vectors)

There are many in-flight forces that can produce a sensation of pitch up. It was an unfortunate condition of this flight that the pilots of Gulf Air 072 were exposed to several physical factors all acting in concert and some synergistically to produce a significant false pitch up sensation of approximately 12 degrees when in reality the aircraft was only pitched up 5 degrees (Figure 1, upper left, Perceived Pitch).

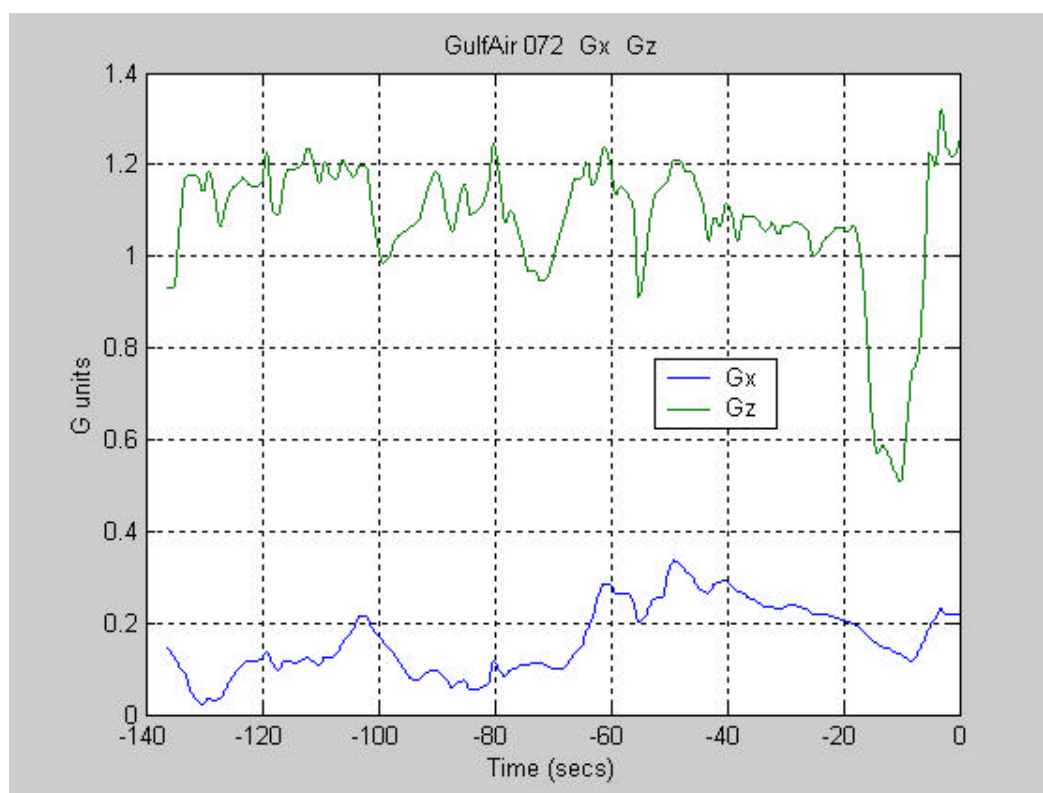
**Figure 2:**  $G_x$  and  $G_z$  Forces versus Time to impact

- 1) The aircraft was linearly accelerating from the beginning of the second go-around maneuver ( $t = 1929:07s$ ) until impact (Figure 2,  $G_x$ ). This contributed to changing the direction of the resultant force vector from directly in-line with the vertical torso of the pilot to a rearward direction (Figure 4, blue arrows). This force contributes to the somatogravic illusion, a misperception of attitude that results in frequent mishaps. There is a time lag associated with this perception and so the time of loss of visual orientation cues is important. A secondary effect of the maintained linear acceleration is to increase the magnitude of the overall resultant vector (gravito-inertial force (GIF)), which contributes to the G-excess effect.

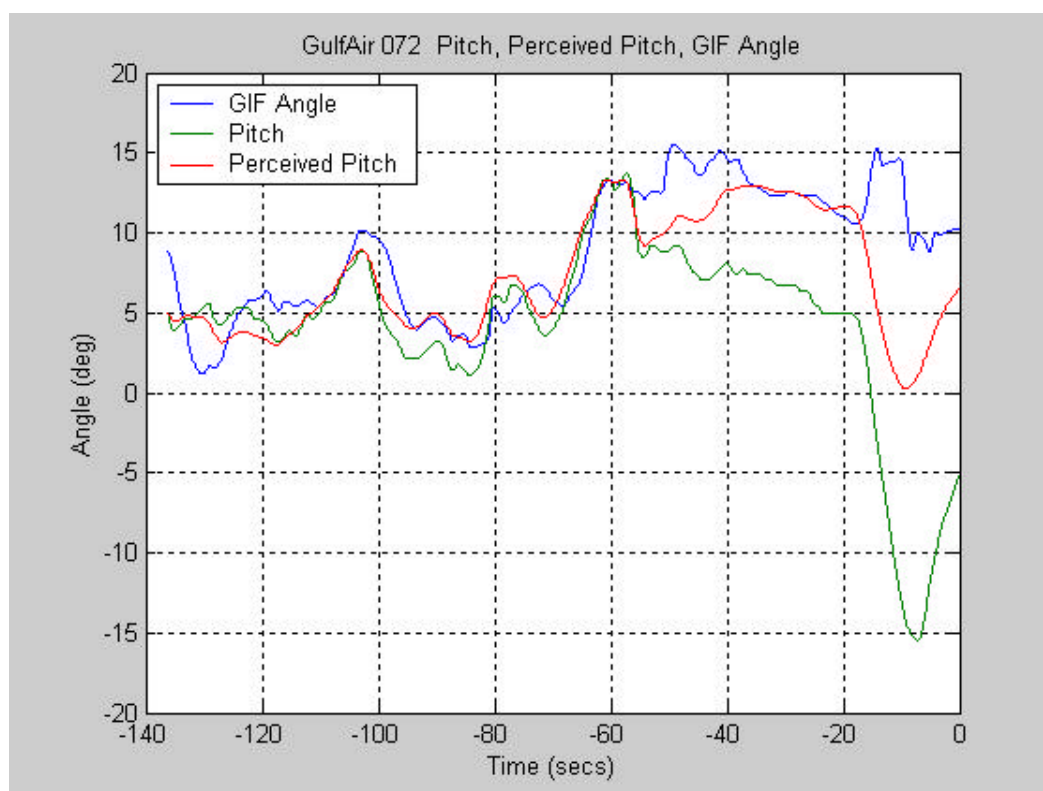
**Figure 3:** Pitch, Perceived Pitch, GIF Angle versus Time to Impact

- 4) Angular acceleration due to changes in aircraft pitch synergistically affects the somatogravic pitch illusion when the angular acceleration acts in the same direction as the somatogravic pitch illusion. On the other hand, strong linear acceleration can block the affects of the angular displacement (McGrath, 1990). In this mishap, the overall resultant force vector was rapidly decreasing in magnitude at the same time the aircraft pitched down resulting in a pitching forward perception (Figure 3). This explains why in Figure 3 the perceived pitch sensation does NOT follow the GIF angle. The preceding turn associated with the second go around contributes to this difference in two ways – first from the direct G excess pitch up and secondly by contributing to a larger change in the overall magnitude of the GIF.

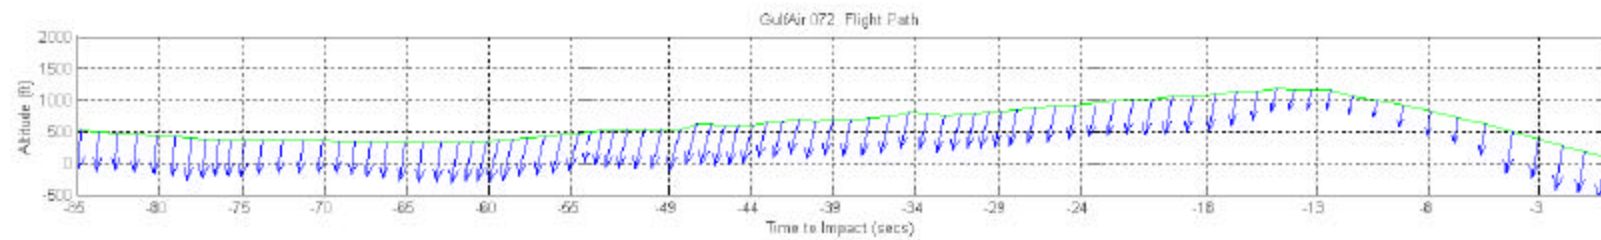
**Figure 4:** Flight Path of Gulf Air 072 versus Time to impact and Resultant Force Vector (GIF)

The dynamics of the first three physical forces mentioned above are summarized in the time course plot (Figure 4) showing the magnitude of the resultant force vector (GIF) and the angle this vector makes with respect to the upright (head-to-seat) axis of the seated pilot. The only factor missing is the pitch stimulus associated with angular acceleration about the pitch axis (# 4 physical force above).

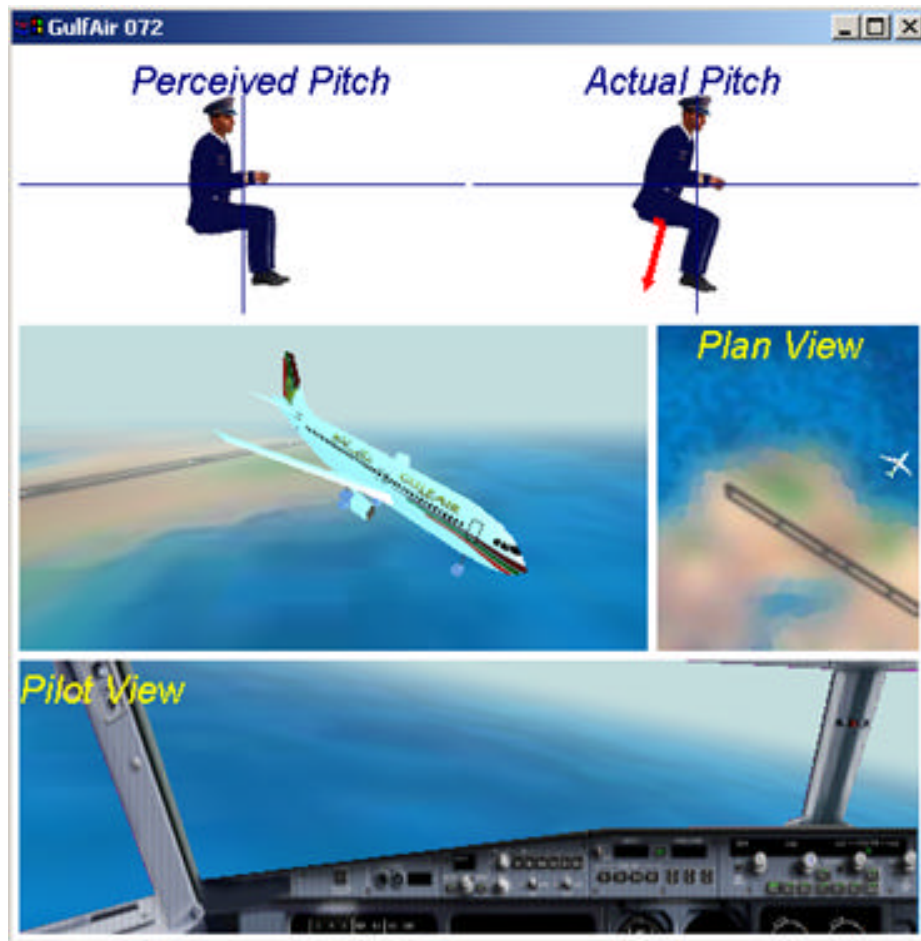
**Figure 5:** Perceived Pitch versus Actual Pitch just prior to stick back (t=1929:53)

The overwhelming nature of the pitch illusion is evidenced by the fact that the pilot in command did NOT follow the recommended GPWS procedure of “Pull up to full back stick and maintain”, since he believed he was approximately level and so only partially pulled the stick, (Figure 5; i.e. he pulled to approximately 11.7 degrees aft vice the maximum capability of 16 degrees aft, Figure 6)

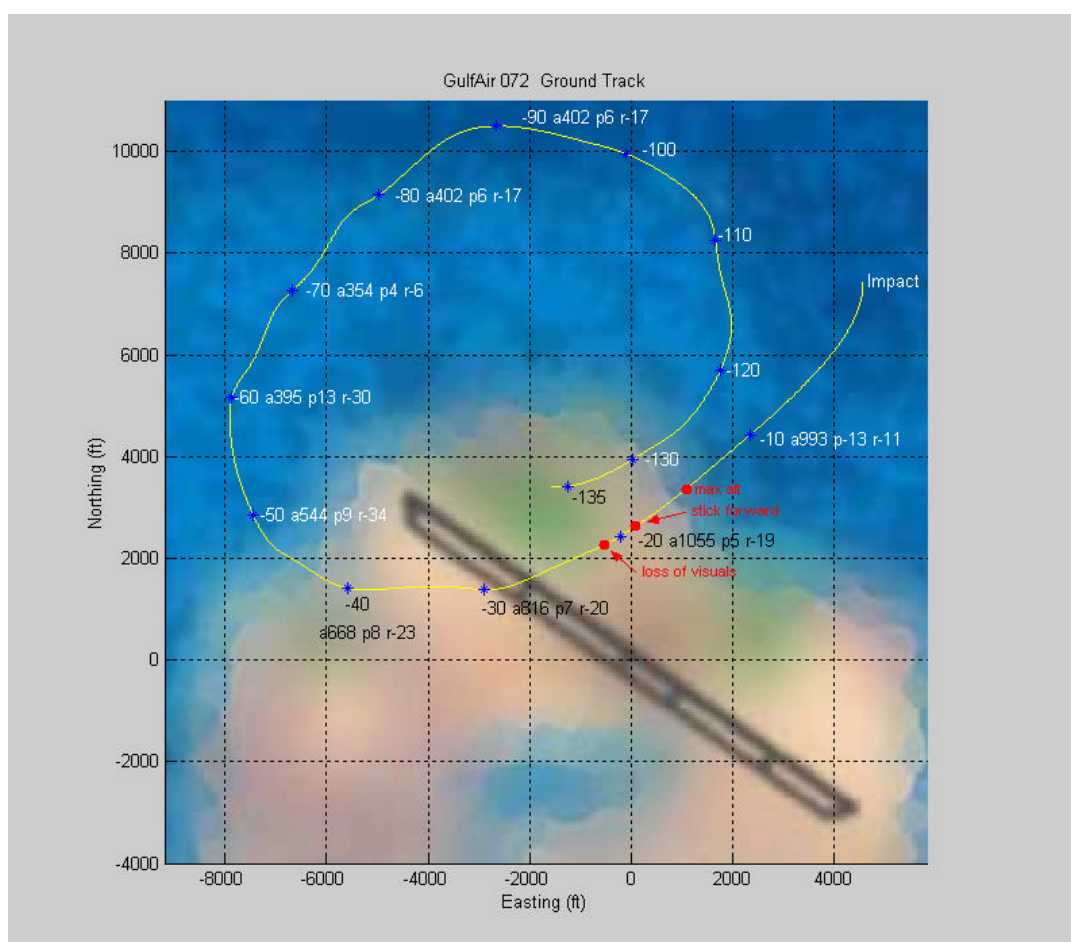
**Figure 7:** Flight Path (time to impact, altitude, pitch, roll)

reasons: – first the highest angle of bank occurs at this point and the G excess effect contributes to the early portion of the pitch up sensation, thereby “setting the stage” for the somatogravic illusion; secondly, the go around is associated with other physical forces mentioned in the above section. These forces have a synergistic influence on perceived pitch during the final 18 seconds when the GIF influence on the pitch sensation decreases as the canal input from the pitch forward comes into play.
