**AIRCRAFT ACCIDENT REPORT 4/90**

**Air Accidents Investigation Branch**

**Report on the accident to  
Boeing 737-400 G-OBME  
near Kegworth, Leicestershire  
on 8 January 1989**

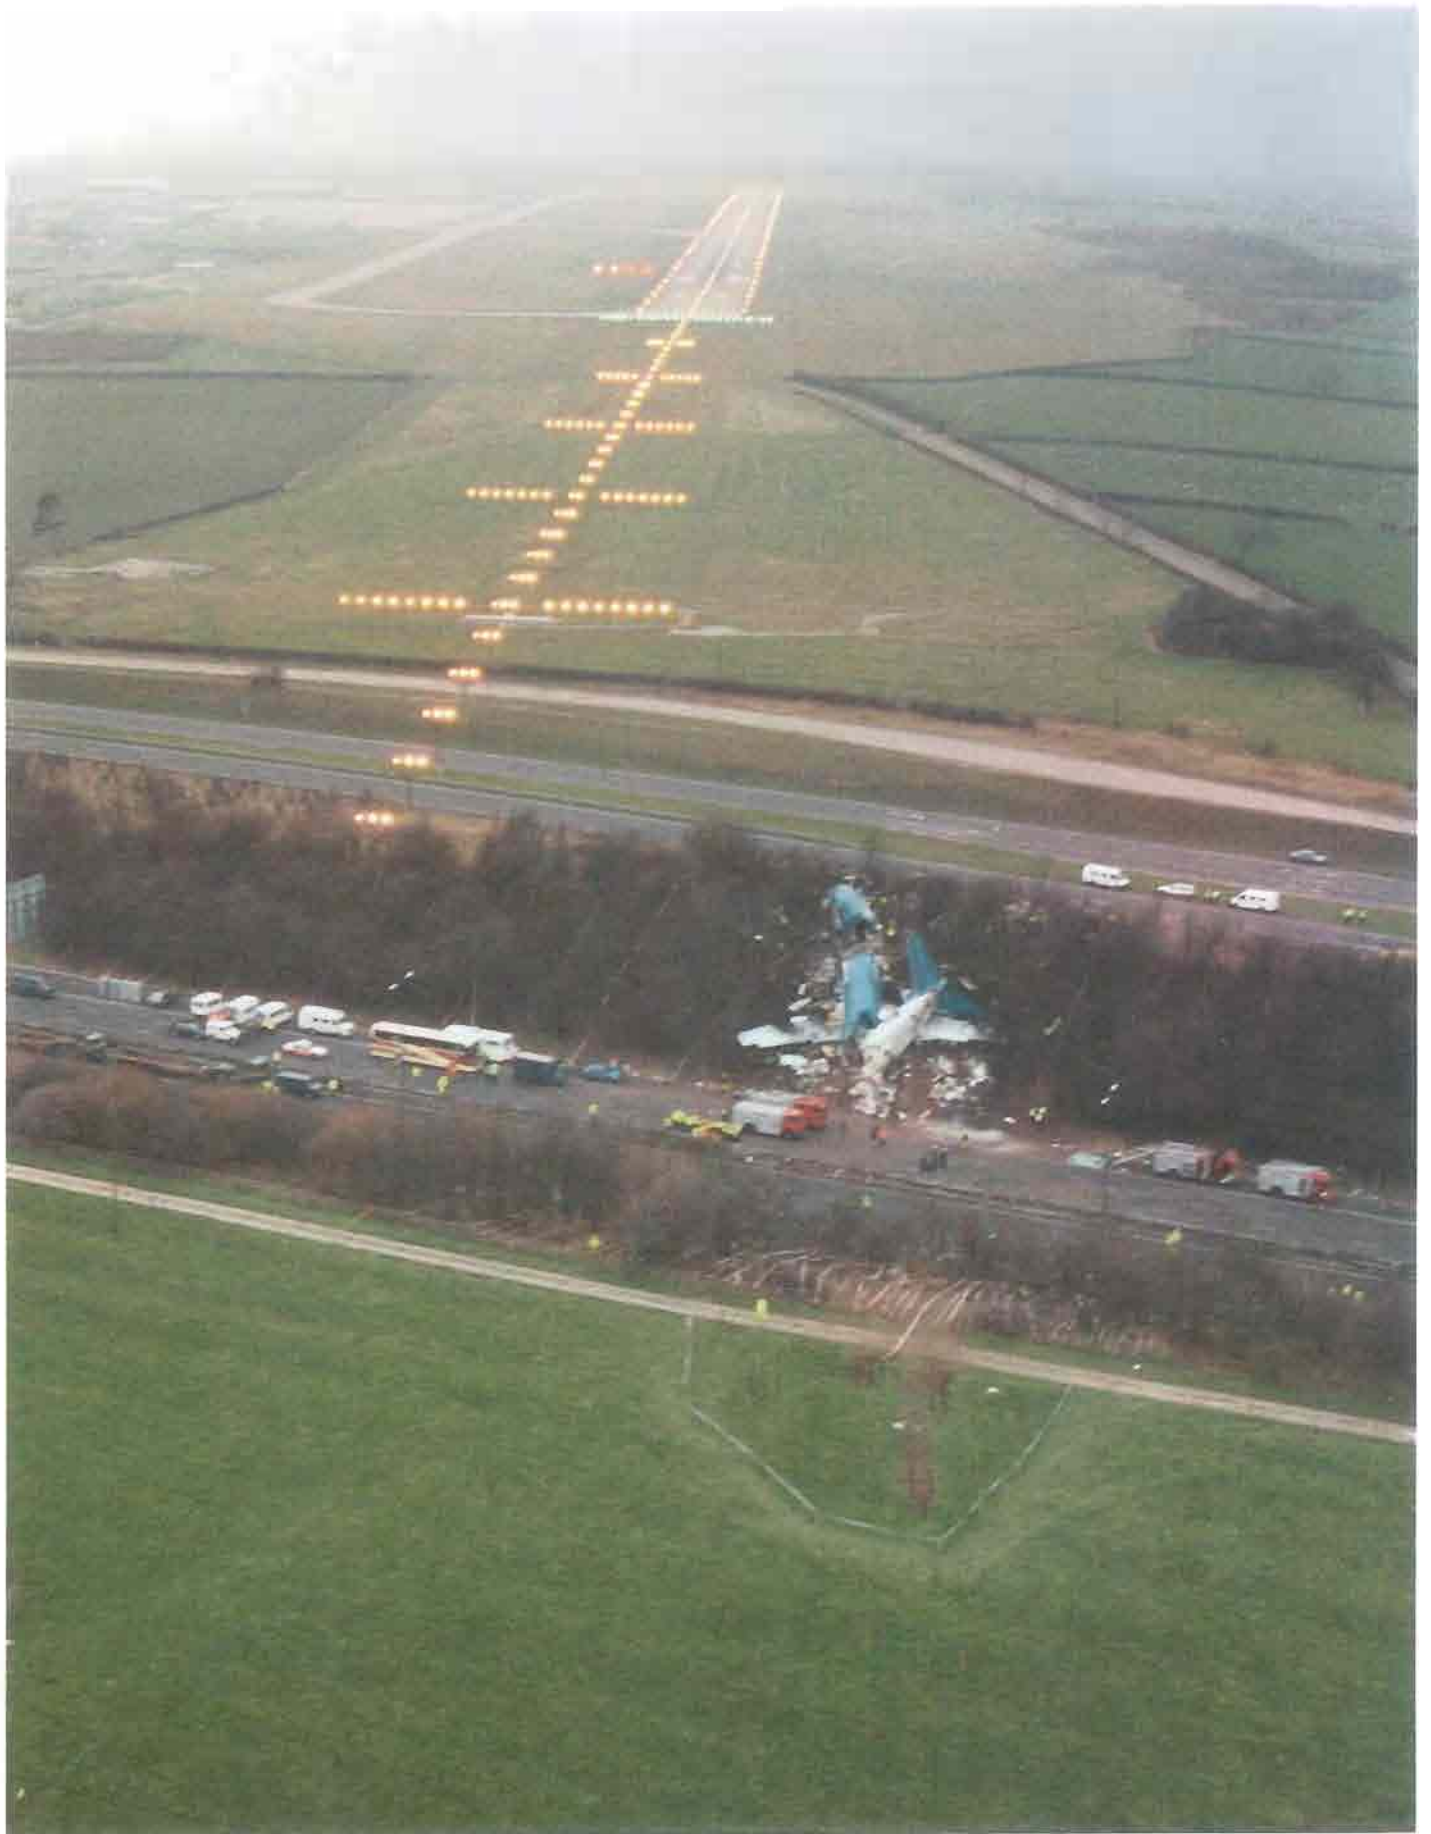
FIG 1: SHOWING CRASH-SITE OF G-OBME

G-OBME suffered severe impact damage and the fuselage broke into 3 main sections (Fig 1). The nose section travelled the greatest distance up the western embankment of the M1, the centre-section remained upright with the wings attached and the tail-section buckled over, and to the right of, that section of fuselage just aft of the wing.

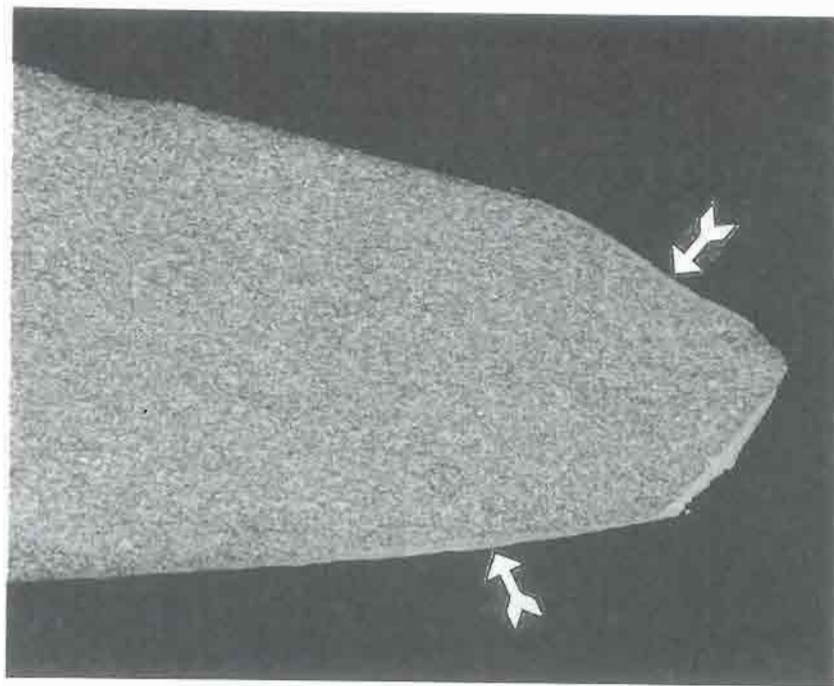
**Figure 3**

Microsection through the leading edge of blade 17 immediately below the plane of the fatigue crack.

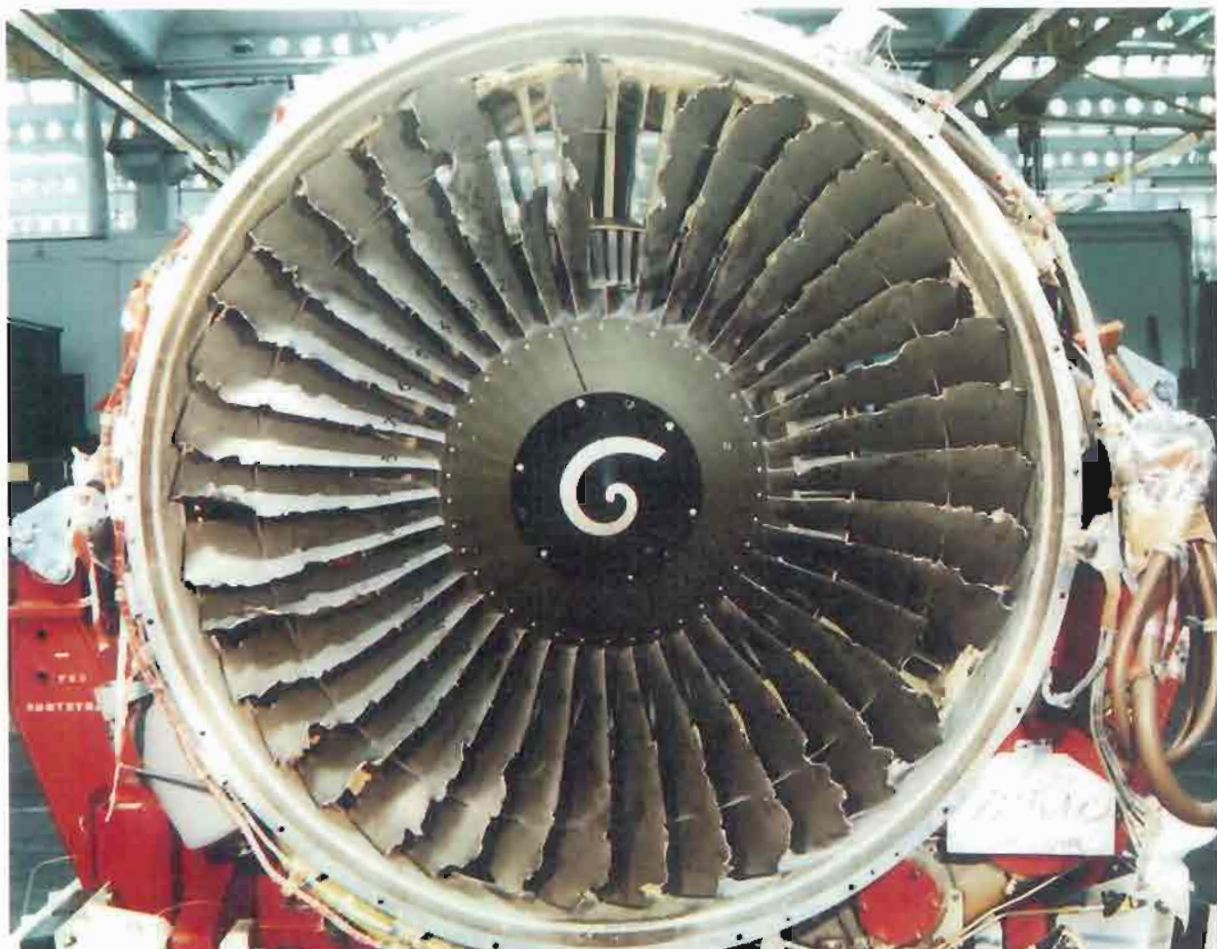
Figure 4(a)

View on front of fan of G-BNNL after in-flight fan blade outer panel separation showing the very severe leading edge damage to all the remaining blades.

The blade which suffered outer panel separation is at the 4 o'clock position.

Note also, at the 12 o'clock position where a full blade and a half blade have been broken away.

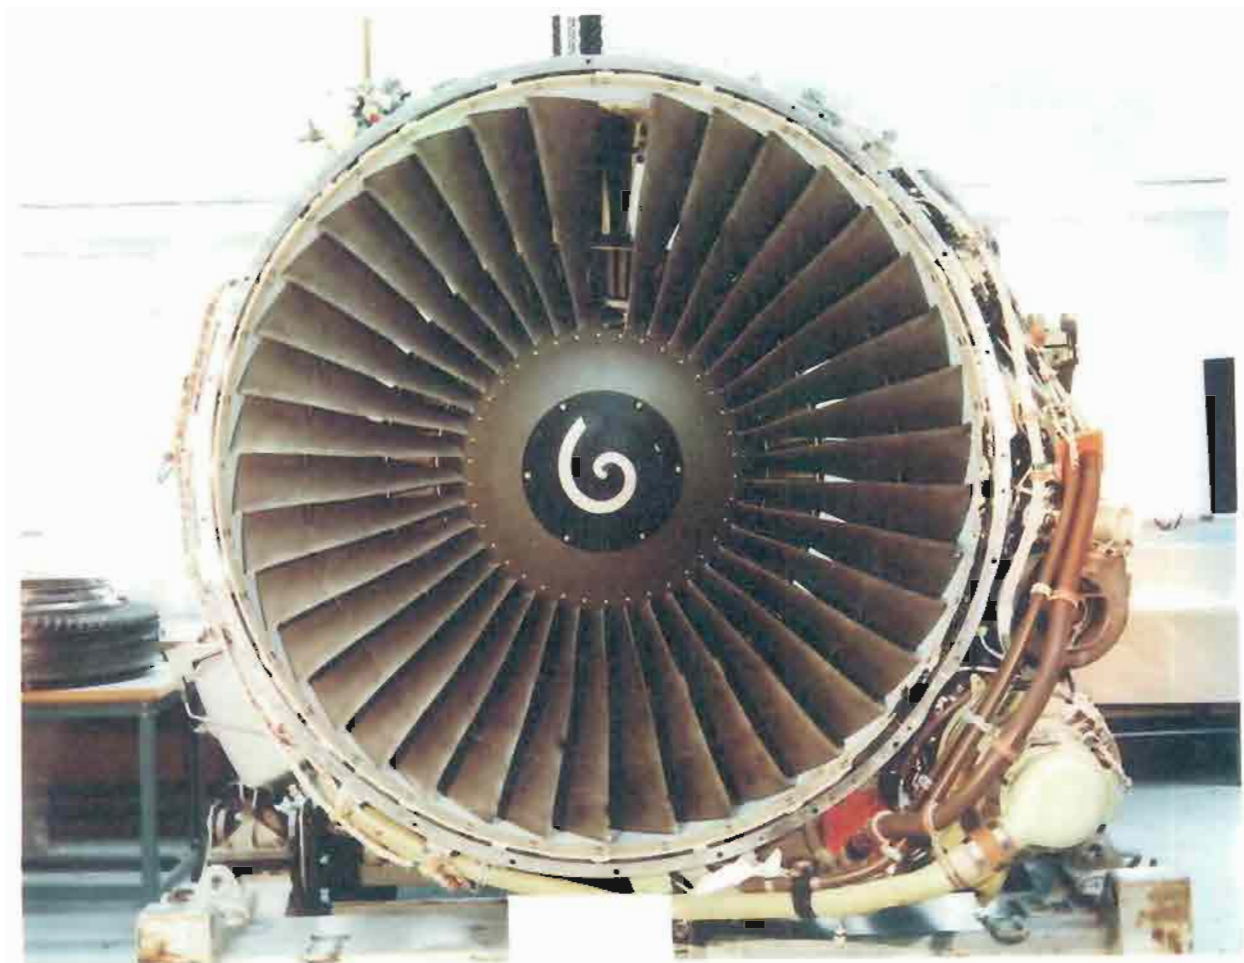
Figure 4(b)

View on front of fan of G-OBMG after in-flight fan blade outer panel separation showing the nearly total absence of leading edge damage on all the remaining blades.

The blade which suffered outer panel separation has been removed from the 12 o'clock position.

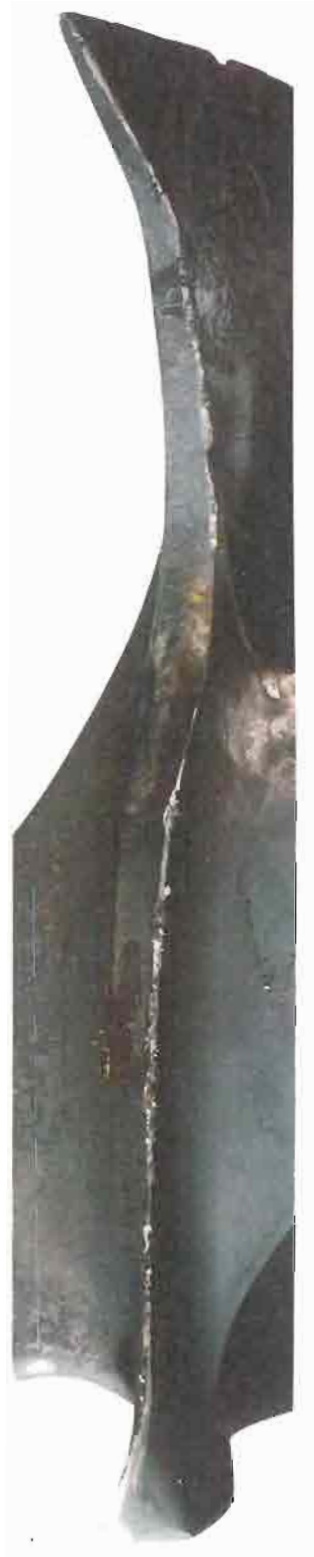
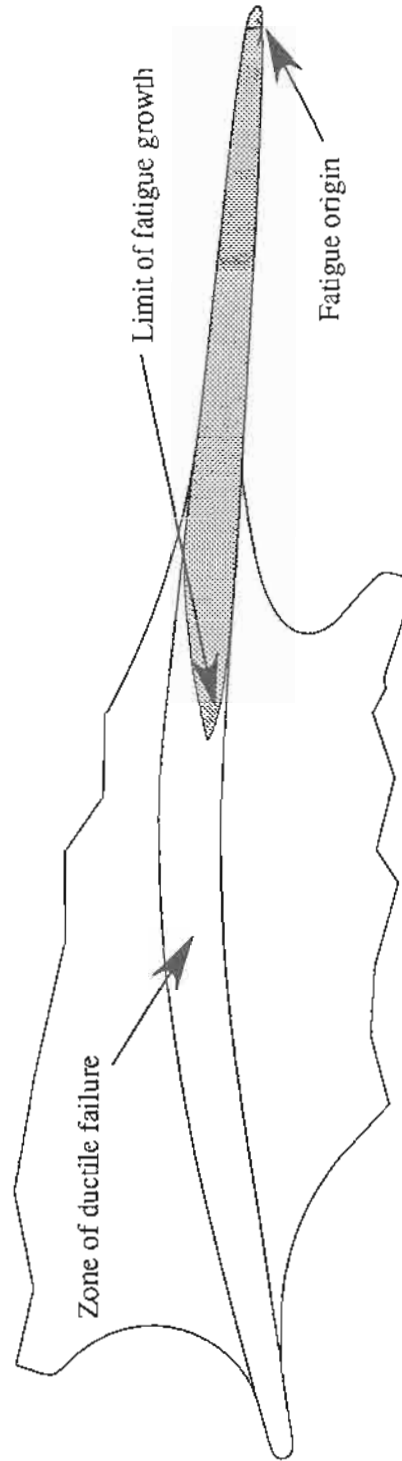
Appendix 1 Fig 5

Features of fan blade fracture from G-OBME

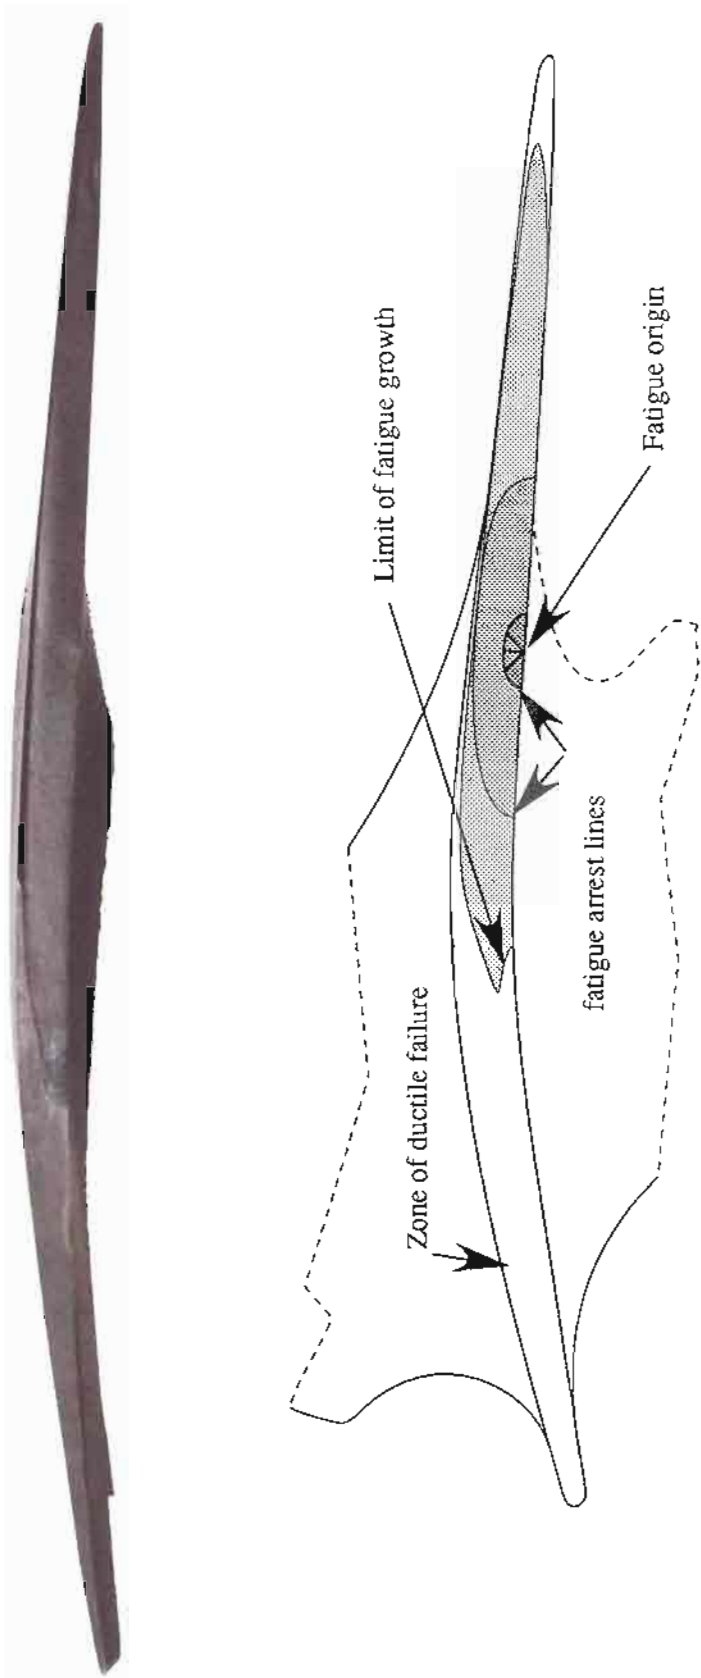
Features of fan blade fracture from G-BNNL

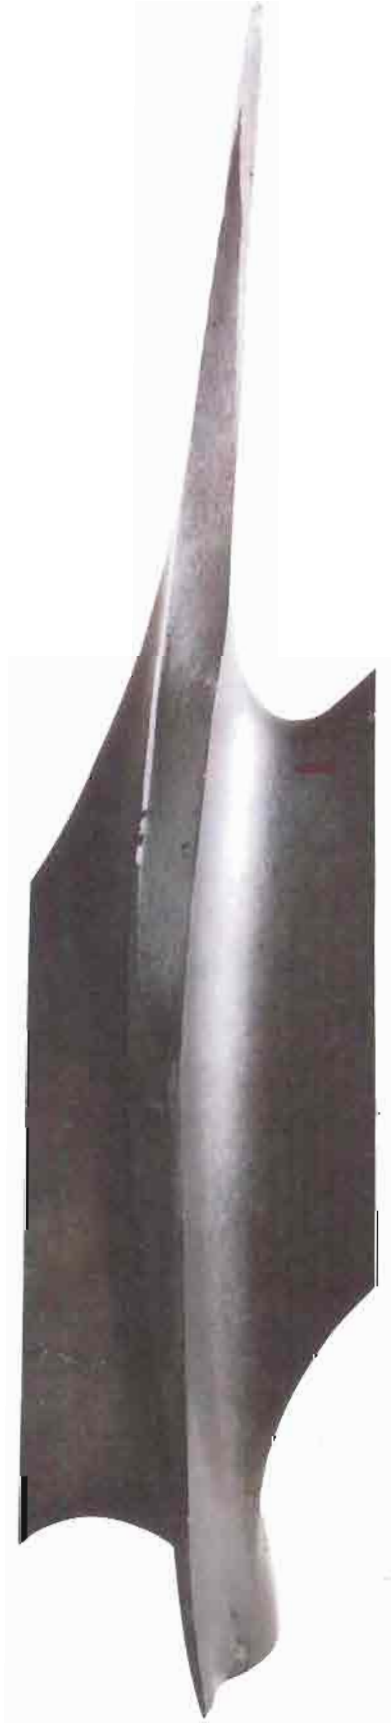
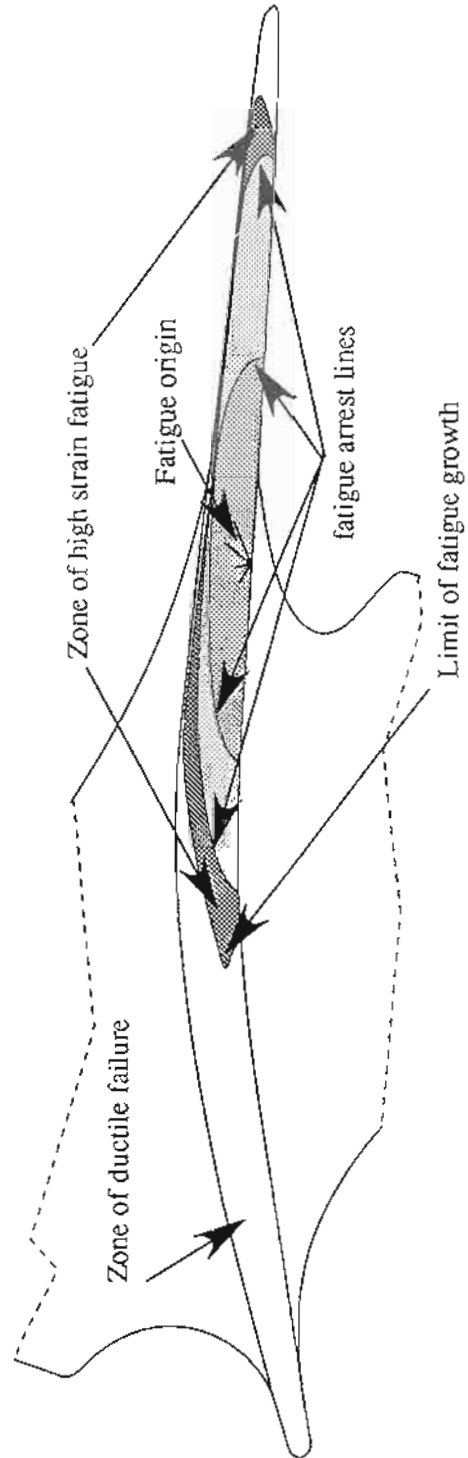
Appendix 1 Fig 7

Features of fan blade fracture from G-OBMG

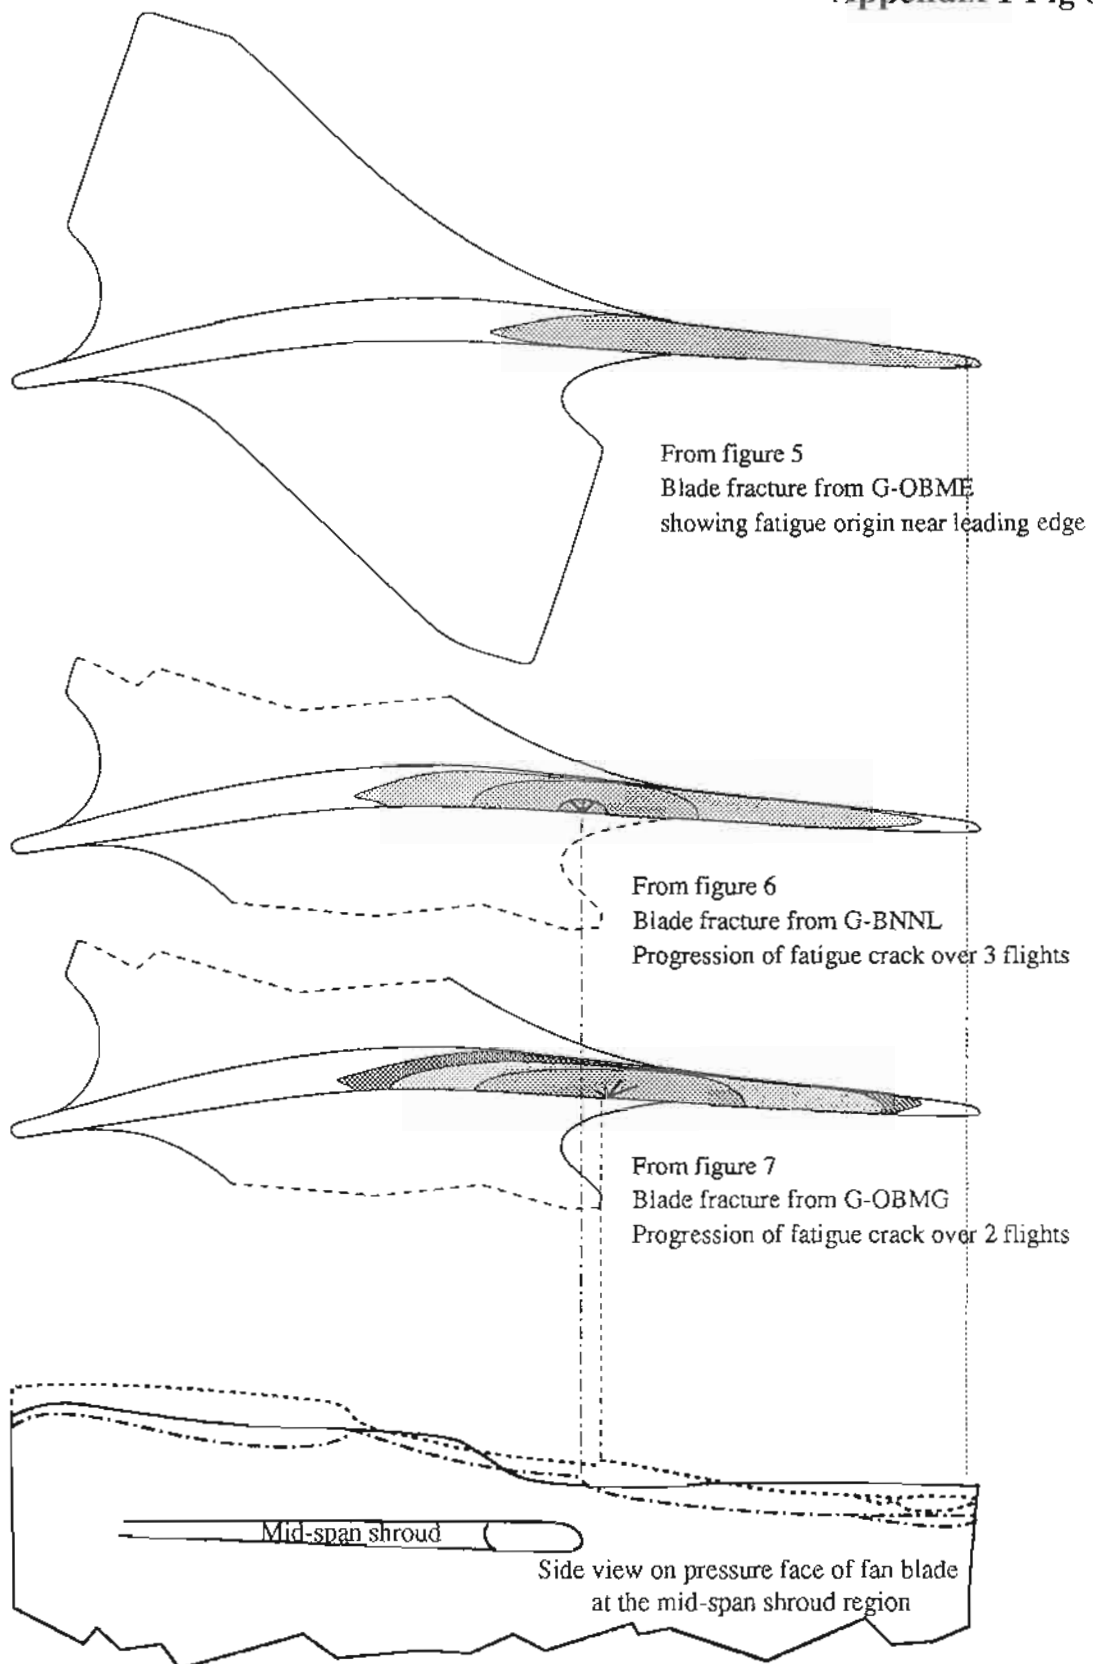
Appendix 1 Fig 8

Comparison of fracture lines on 3 fan blades
