ATSB TRANSPORT SAFETY REPORT
Aviation Occurrence Investigation AO-2008-053
Final

Oxygen cylinder failure and depressurisation
475 km north-west of Manila, Philippines
25 July 2008
Boeing Company 747-438, VH-OJK

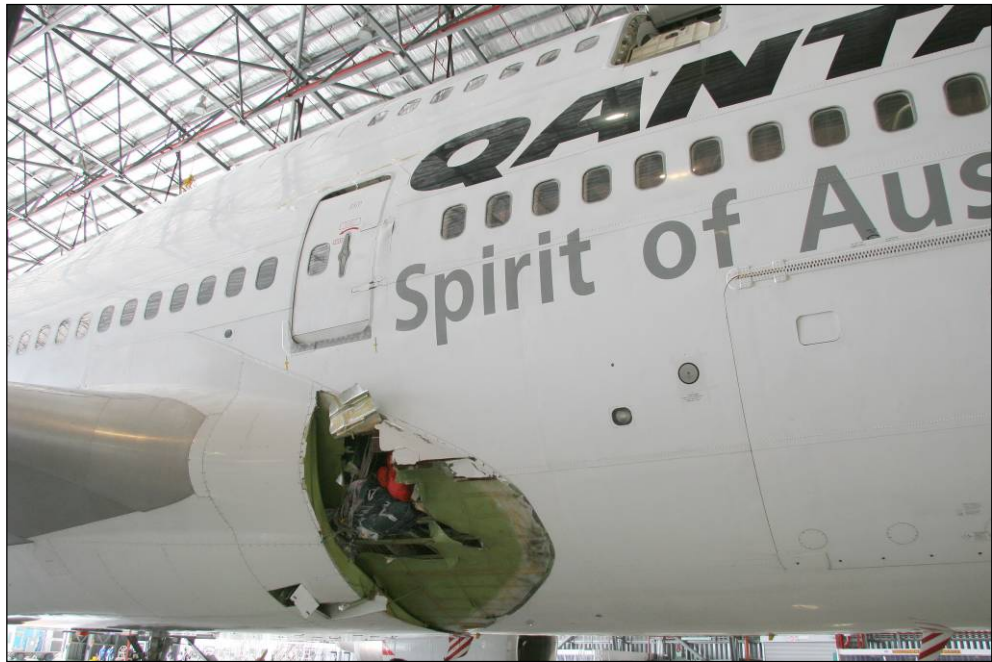
Figure 1: Fuselage rupture – external view

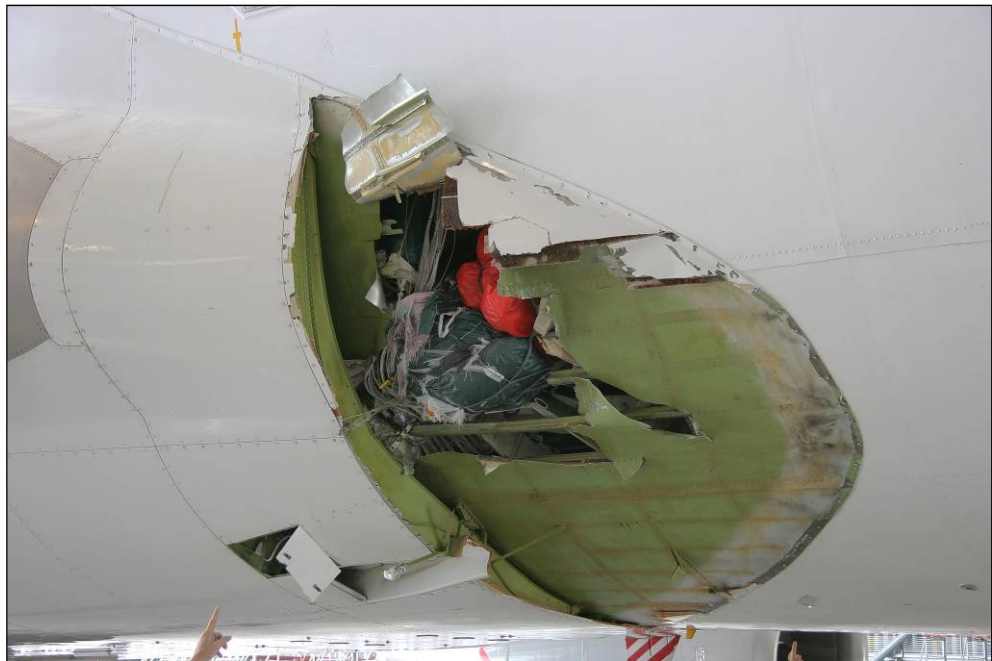
Figure 2: Fuselage rupture with protruding cargo

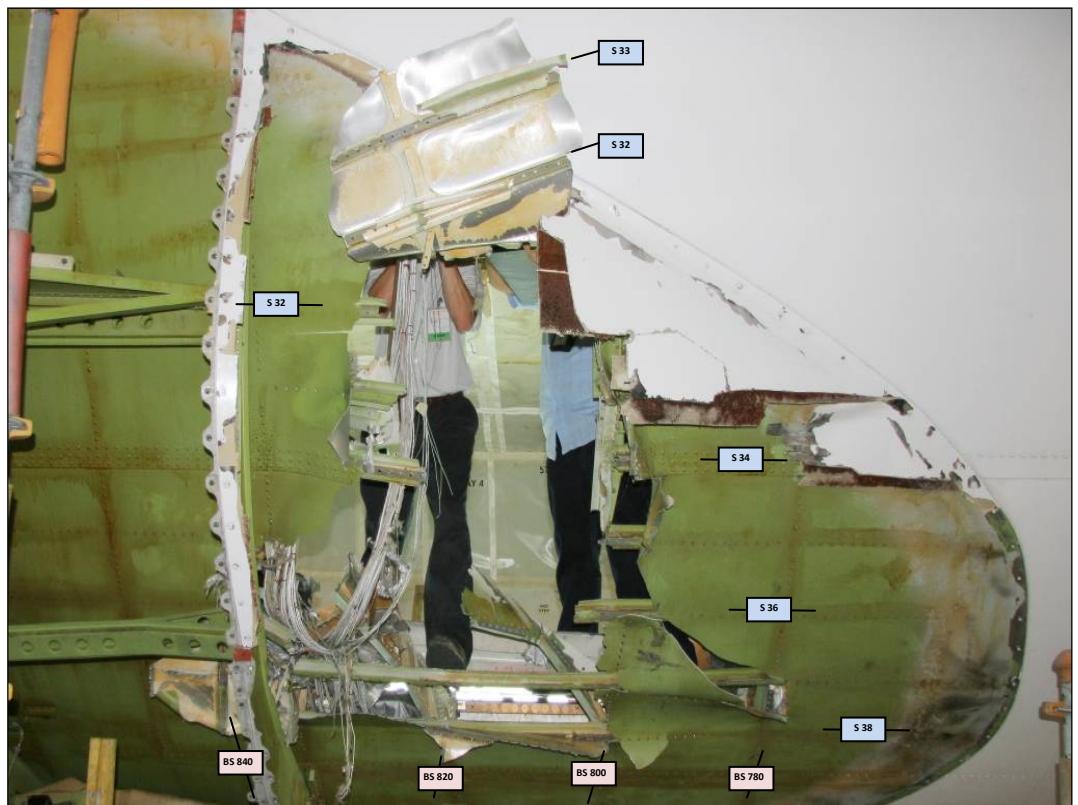
From an inspection of the aircraft by engineering staff and investigators from the Australian Transport Safety Bureau (ATSB), it was evident that the aircraft’s fuselage ruptured over an area measuring approximately 2 x 1.5 m (6.6 x 4.9 ft) and located immediately forward of the right wing leading edge transition. Fuselage materials, wiring and cargo from the aircraft’s forward hold were protruding from the rupture. Further investigation determined that the fuselage rupture had, in itself, been induced by the forceful bursting of one of a bank of seven oxygen cylinders located along the right side of the cargo hold. Those cylinders (with an additional six located above the hold) provided the passengers’ emergency supplementary oxygen supply. An analysis of the damage produced by the ruptured cylinder showed that the force of the failure had projected the cylinder vertically upward into the aircraft’s cabin, where it had impacted the R2 door frame, handle and the overhead panelling and structure, before presumably falling to the cabin floor and being swept out of the aircraft during the depressurisation. No part of the cylinder body was located within the aircraft, despite a thorough search.

Figure 3: Extent of the fuselage rupture, after removal of further transition fairings. Stringers [S] and Body Stations [BS] are denoted

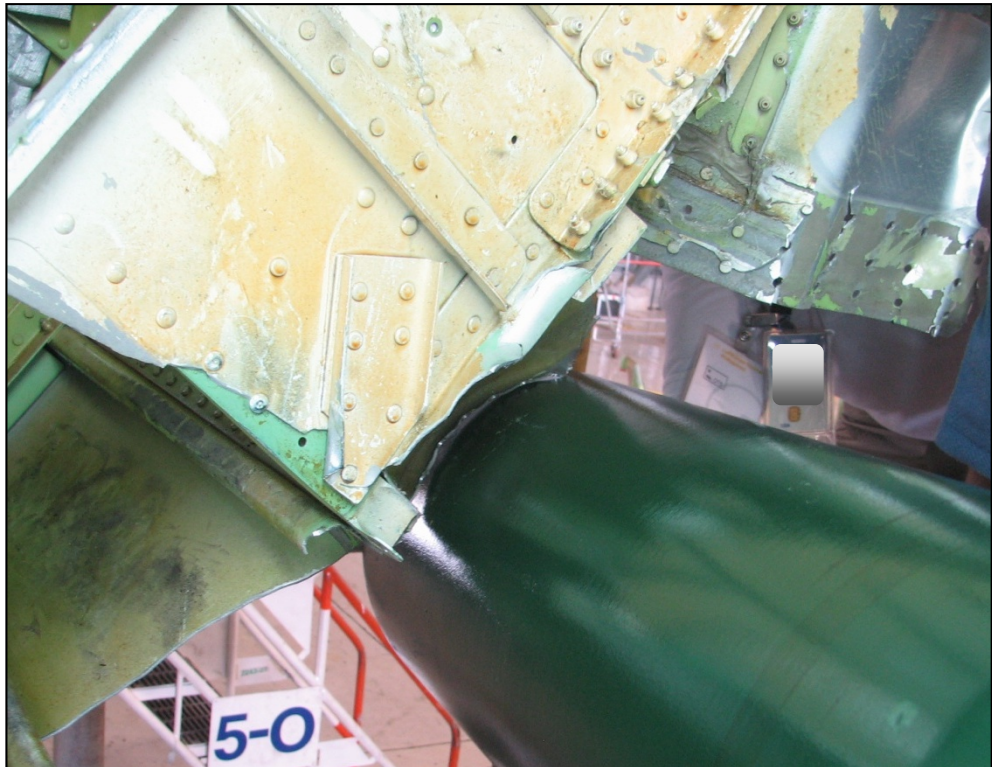
Figure 6: Oxygen cylinder held against skin fold to illustrate conformance

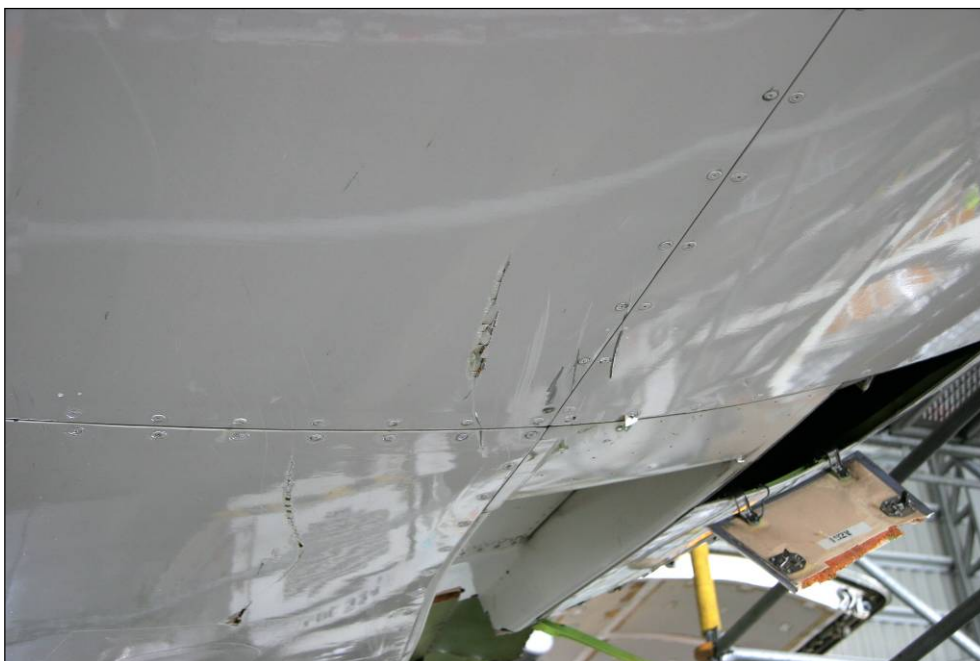
Figure 7: Panel damage to the rear of the rupture site

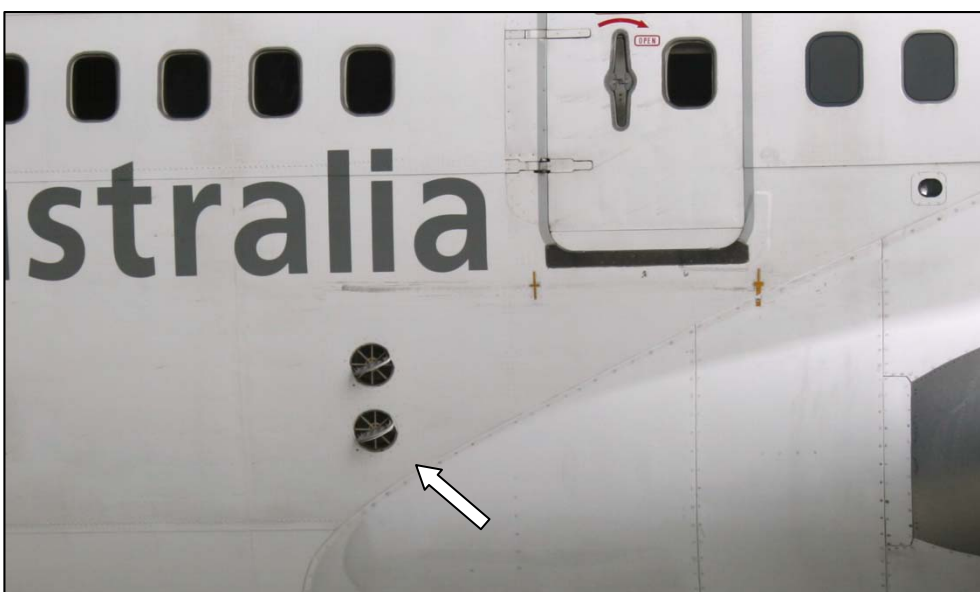
Figure 8: Pressure relief valve blowout doors open (arrowed)

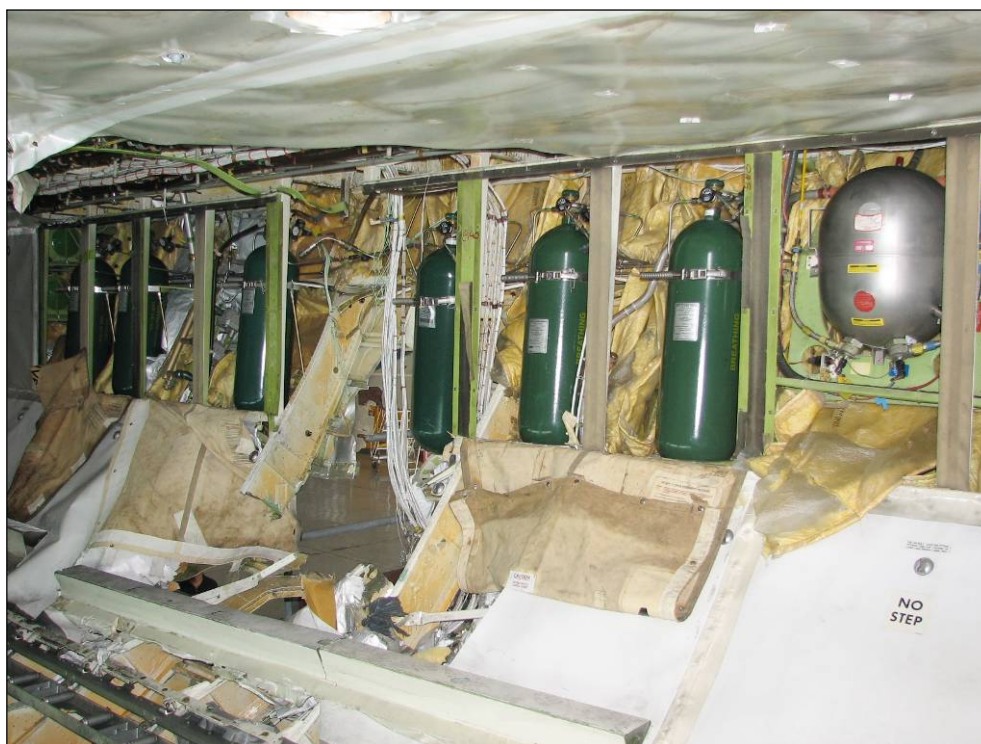
Following removal of all cargo materials and lowering of the hold right-side curtain panels, it was found that the fuselage rupture was aligned with the nominal position of the number-4¹¹ passenger emergency oxygen cylinder; one of seven such cylinders in a bank along the right side of the hold (Figure 9). A further six cylinders were located in a central location within the ceiling of the cargo hold. The number-4 cylinder was missing from the bank, with the upper support bracket bent

Figure 9: Forward cargo hold wall with remaining six oxygen cylinders

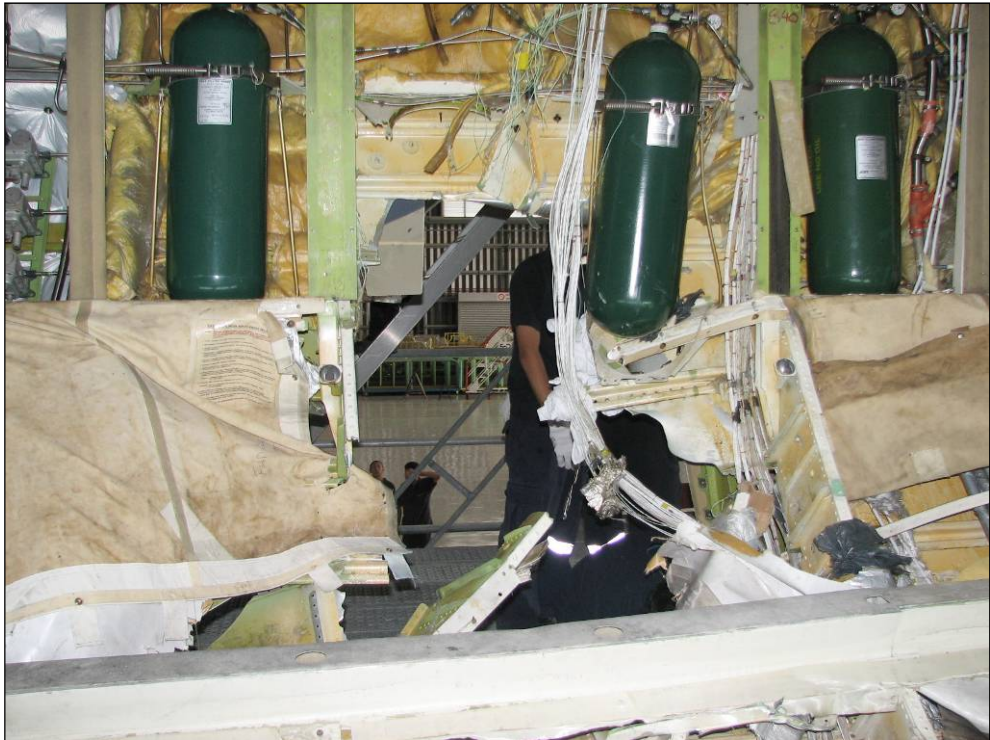
Figure 10: Fuselage rupture coincident with mounting position of the number-4 oxygen cylinder

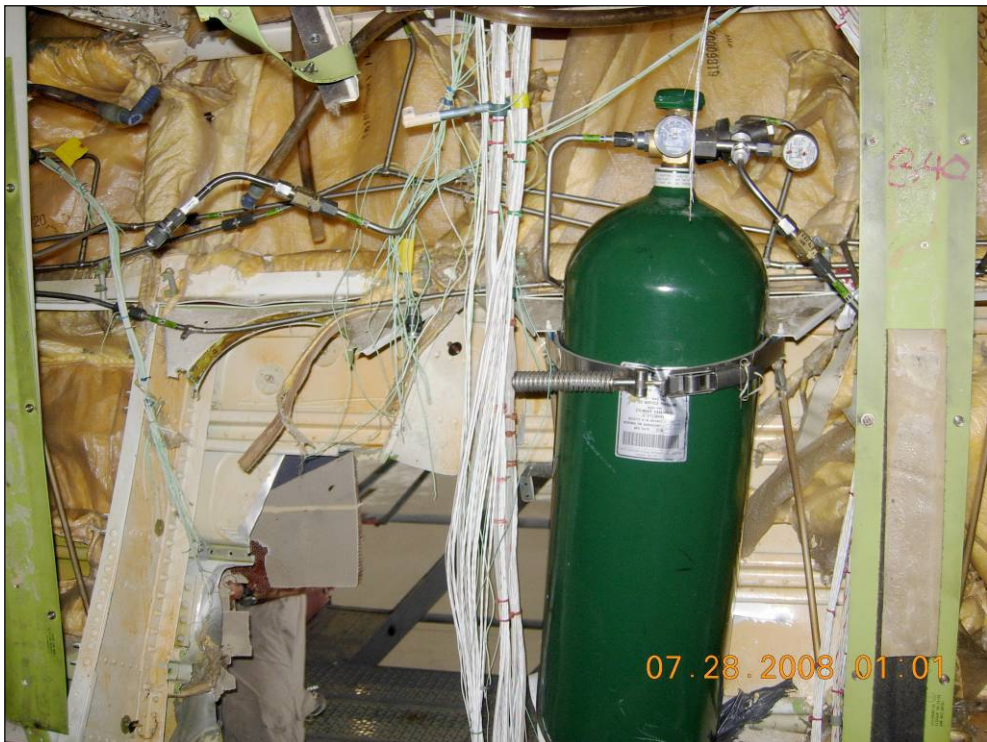
Figure 11: Number-5 oxygen cylinder adjacent to fractured fittings and lines from the number-4 cylinder

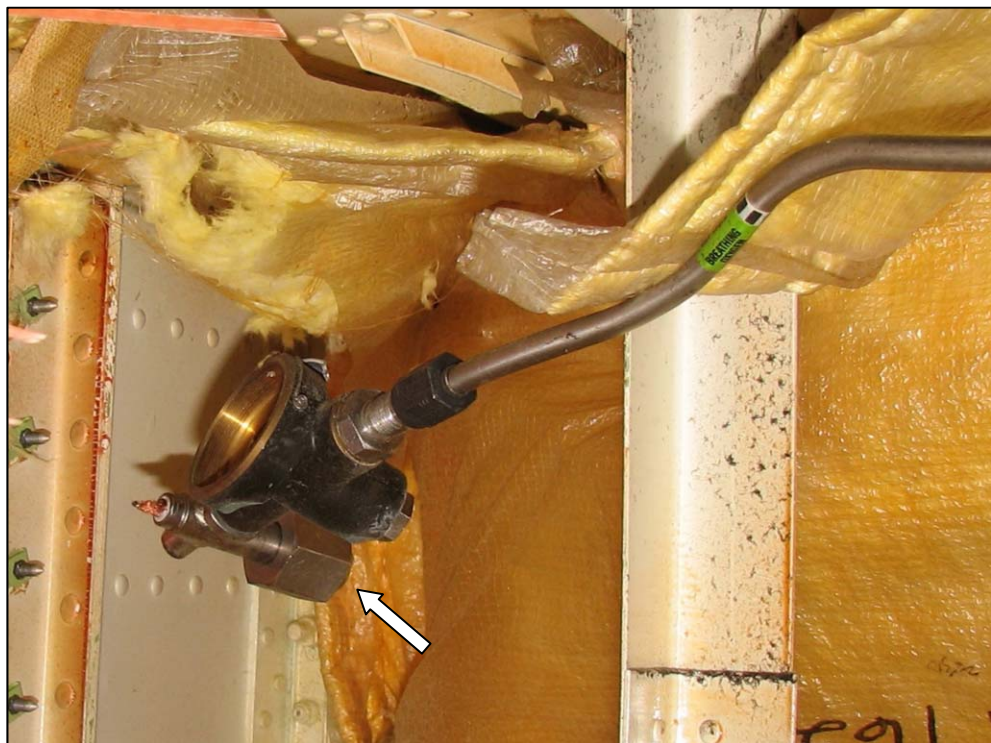
Figure 13: Number-4 cylinder pressure reducer and tee-piece - fractured away from cylinder valve at arrowed connection

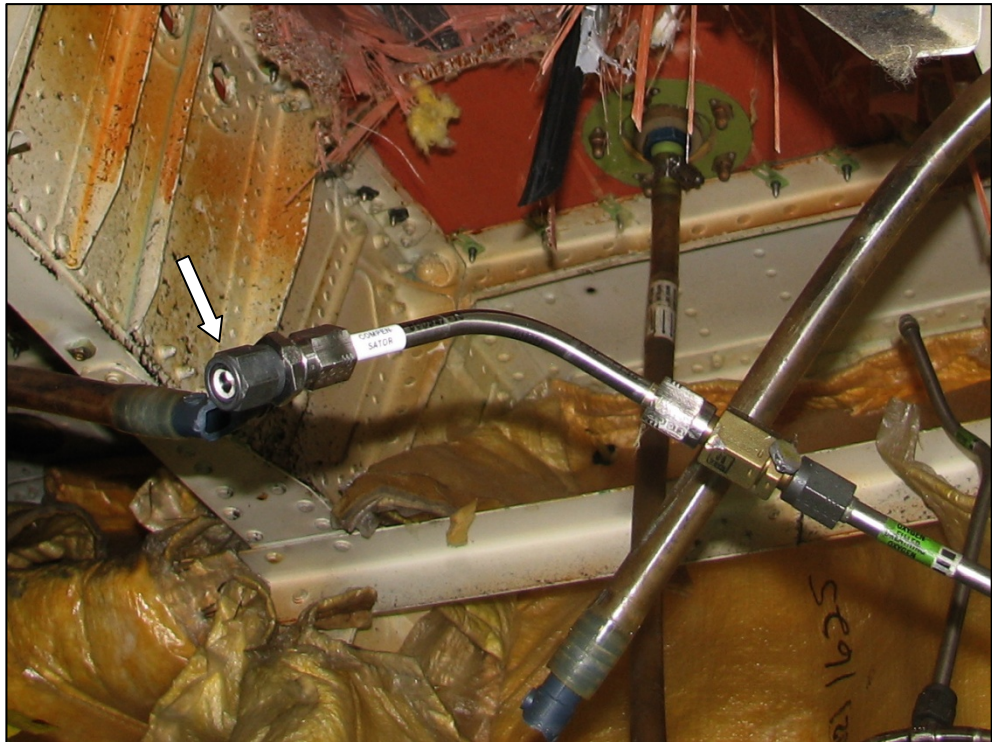
Figure 14: Number-4 cylinder service line fracture (arrowed)

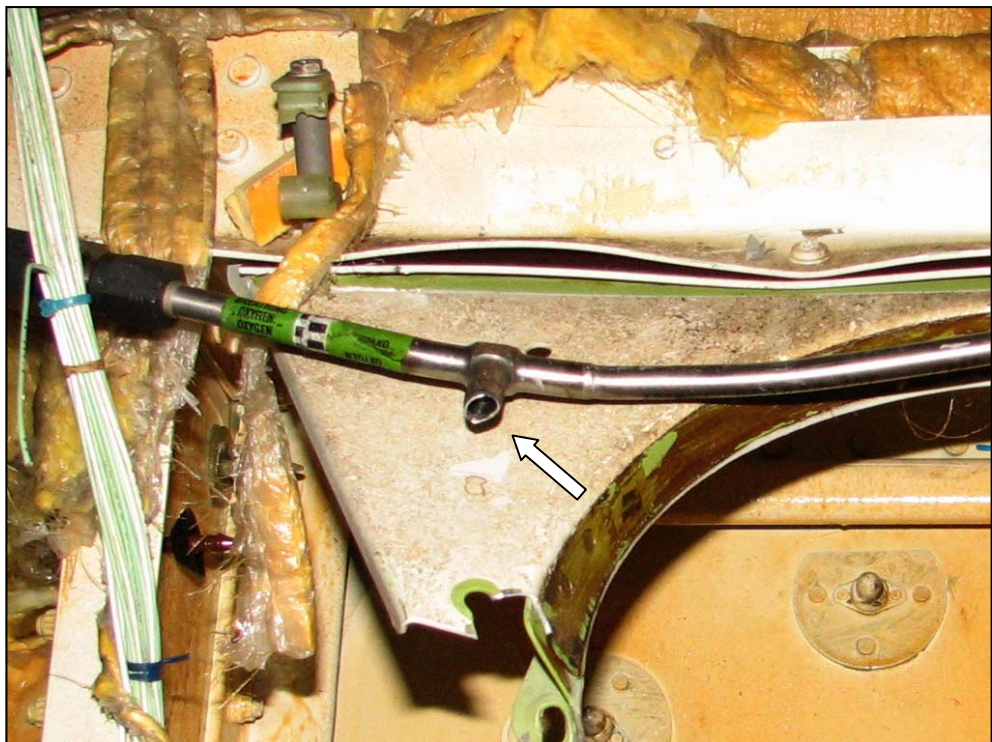
Figure 15: Number-4 cylinder overpressure discharge line fracture (arrowed)

Close examination of all exposed connections, fittings and lines showed no evidence of heating, sooting or discolouration that might have suggested localised combustion had occurred within or in proximity to the cylinder and its connections.

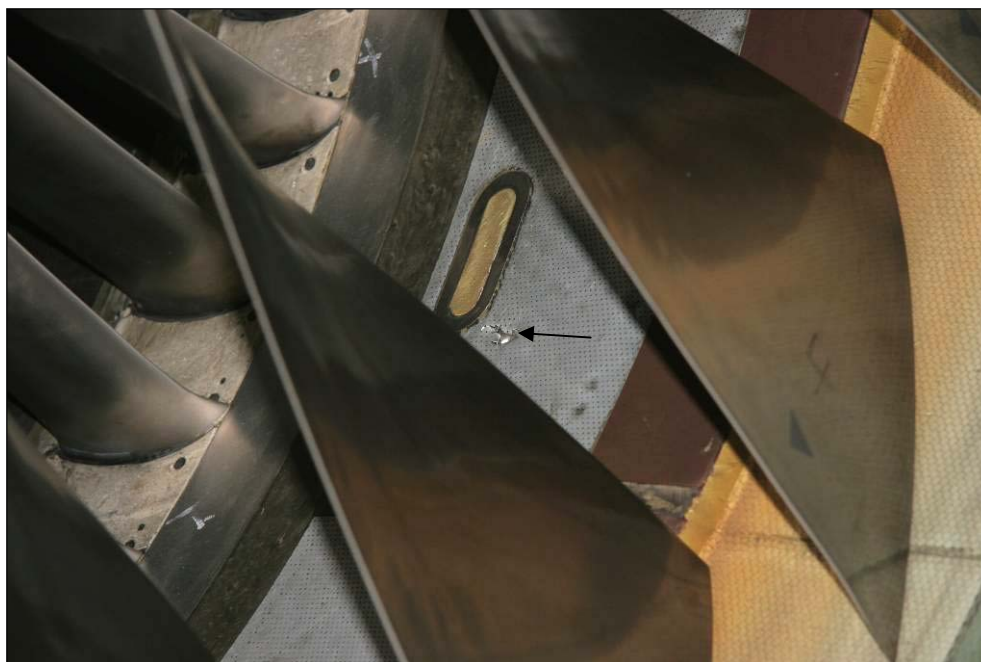
Figure 16: Damage to acoustic lining (arrowed) behind the number-3 engine fan

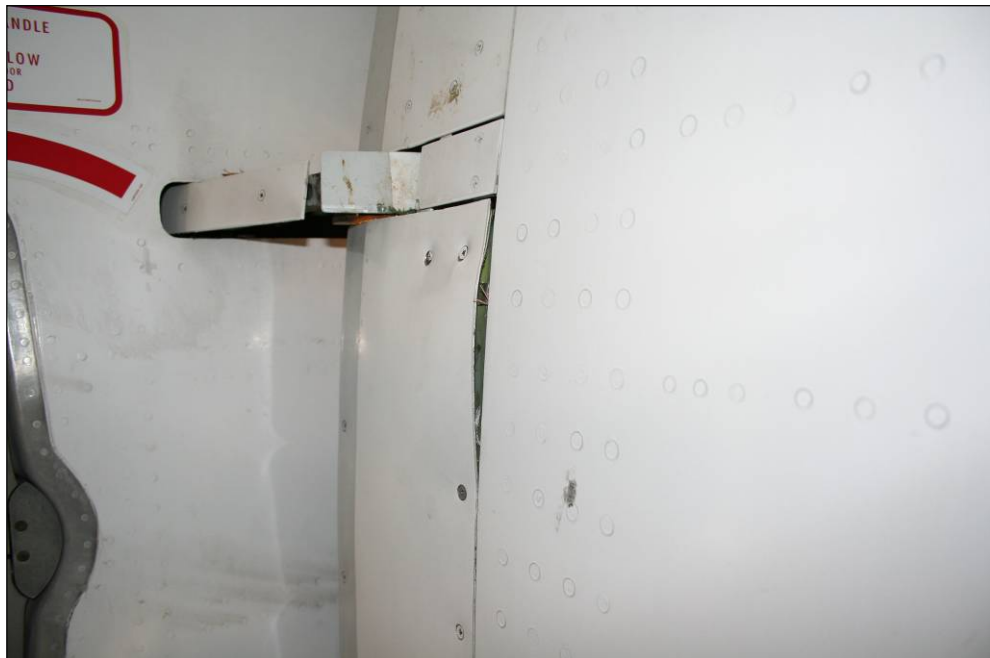
The R2 door into the aircraft's main cabin was located directly above the fuselage rupture (at STA 830). An external panel located between the two door hinges showed localised outward bulging from a point immediately below the upper hinge, with the forward edge of the panel raised above the surrounding fuselage skin

Figure 17: Cabin R2 door – damage to external panelling

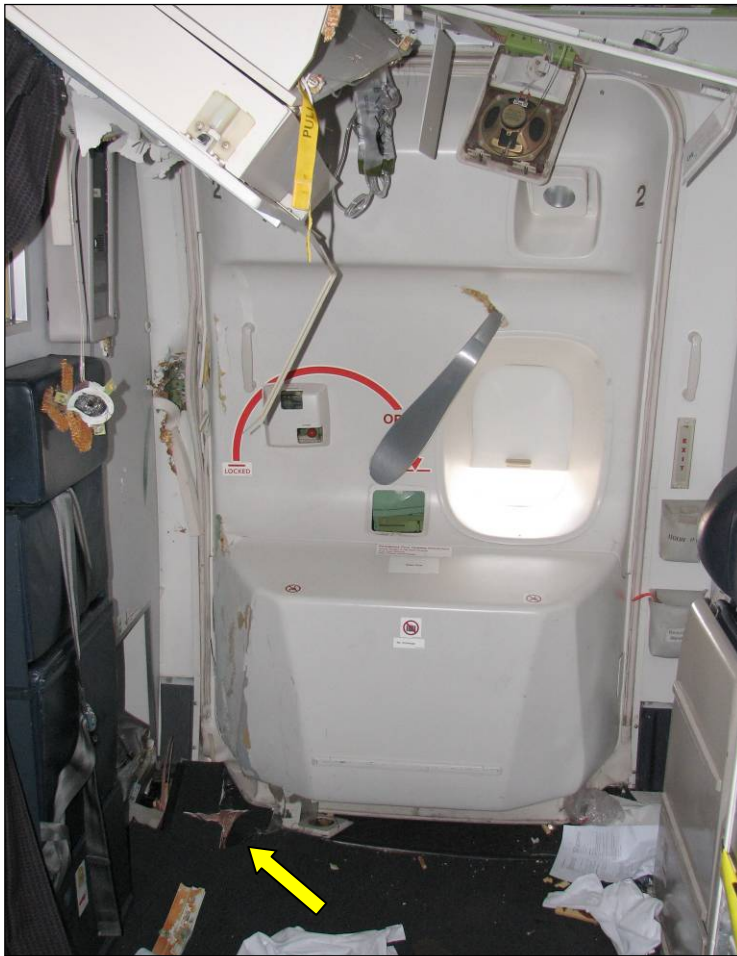
Figure 18: Interior of R2 door and cabin – location of floor hole arrowed

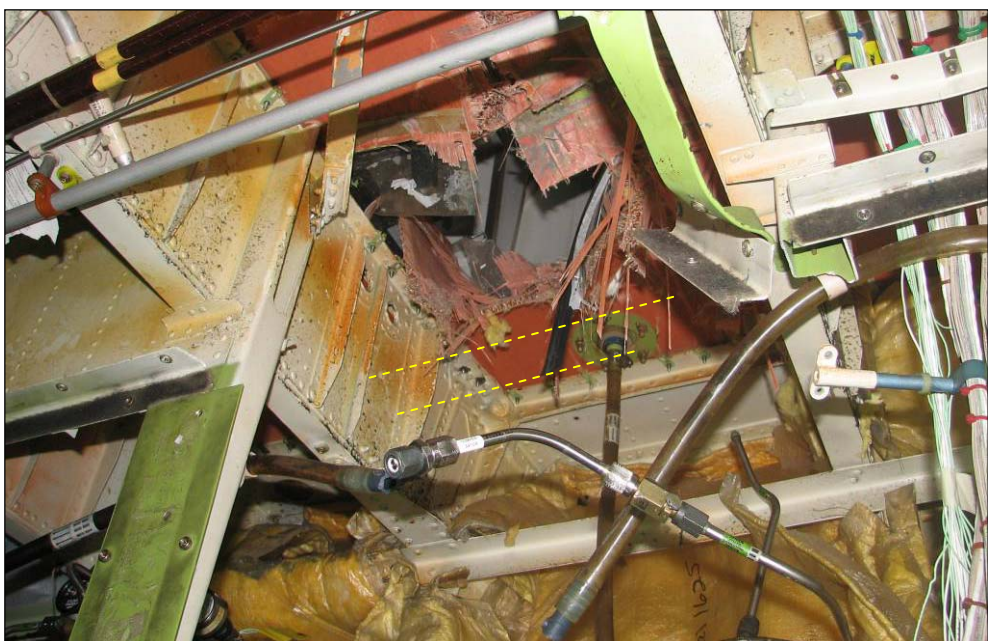
Figure 19: Hole in cabin floor – viewed from position of number-4 oxygen cylinder. Broken yellow lines mark the normal route of the first officer's aileron control cables

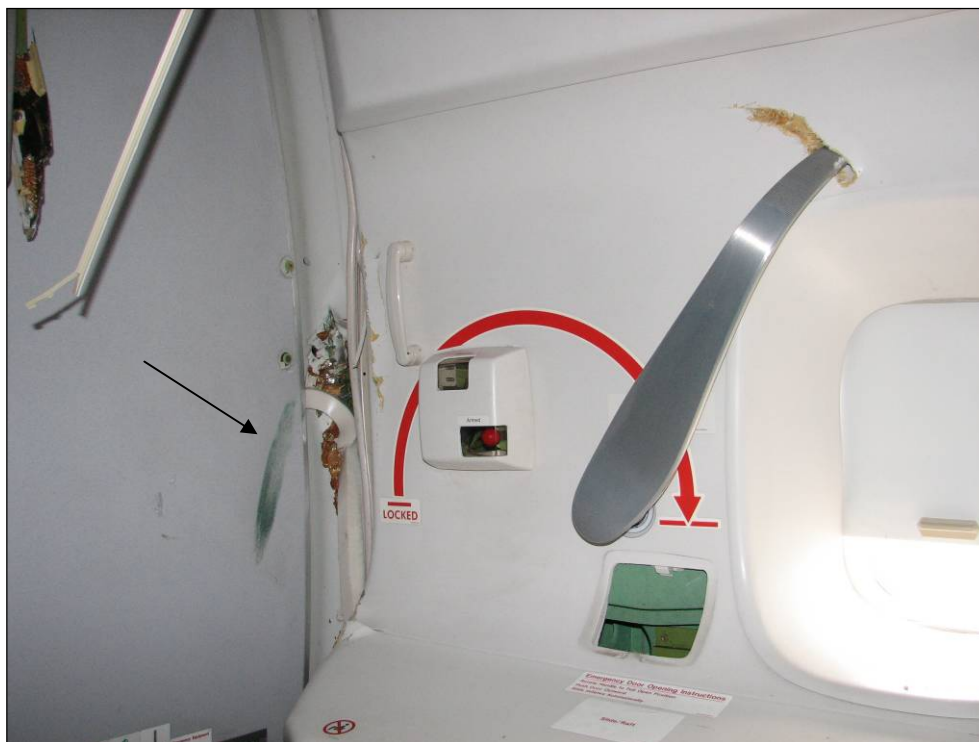
Figure 20: Door frame damage, green paint smear and rotated R2 door handle

The internal door handle was found in approximately the one-o'clock position (looking from inside), with the turned-in handle end embedded into the door lining material. That position was consistent with a movement through approximately 120 degrees from the fully-closed (locked) position. A 180 degree handle movement represented the fully open position. The downward facing surfaces of the handle end (when the door is in the locked position) showed damage and abrasion consistent with impact against another object. Inspection of the internal door systems showed the handle shaft had fractured and the actuating cam plate and retainer had pulled away from its associated mechanism (Figure 21), allowing the handle to rotate freely. As such, the handle position as observed inside the cabin was not indicative of the actual door security.

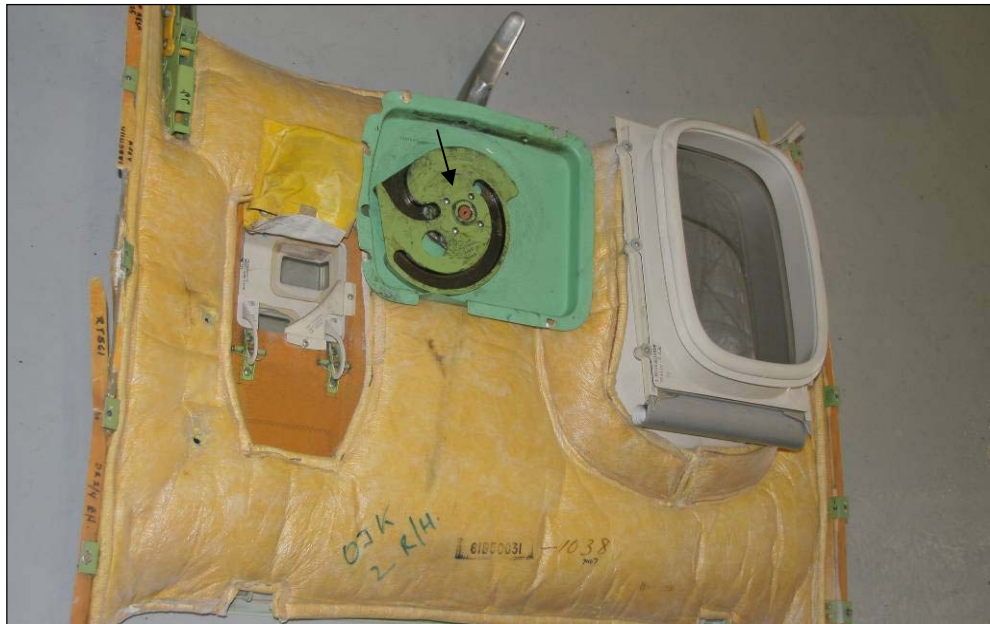
Figure 21: R2 door panel underside – fractured shaft and separated plate

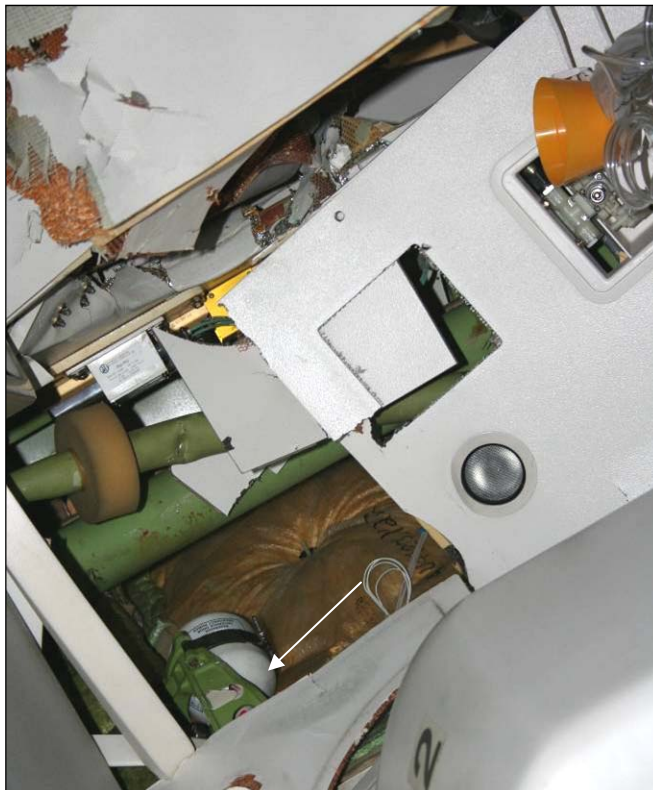
Figure 22: Damage above R2 door, exposing the EPAS cylinder (arrowed)

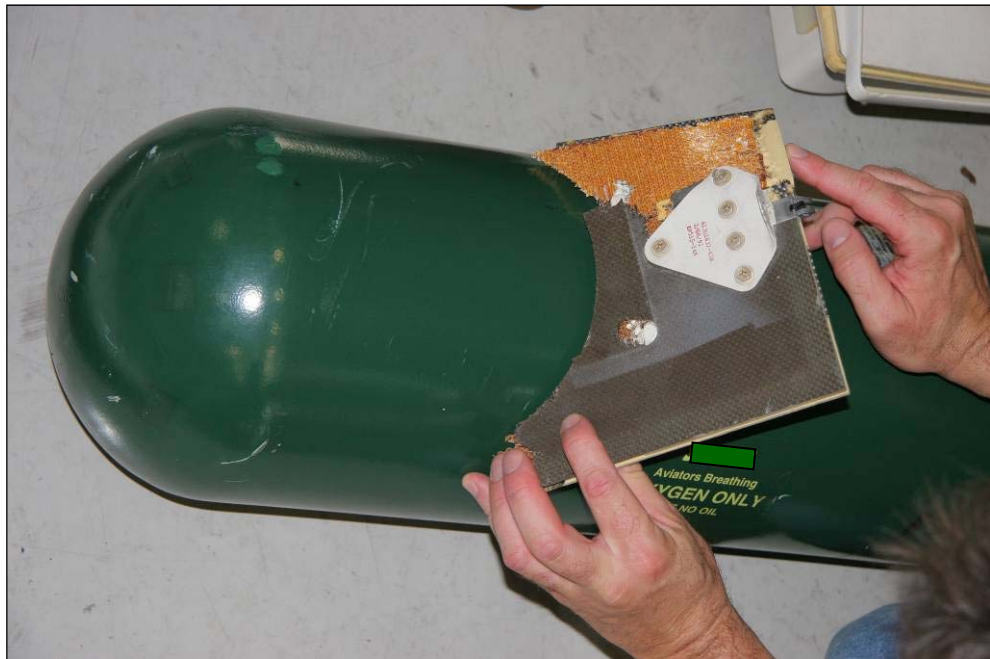
Figure 25: Panel with cut-out placed against another oxygen cylinder to illustrate the conformance in diameter

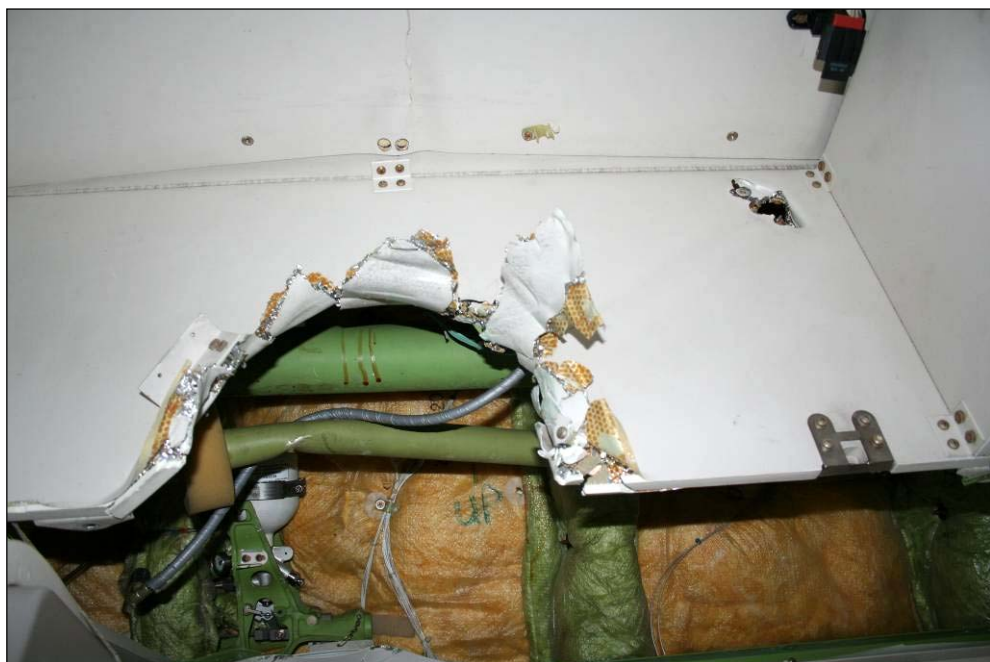
Figure 26: Semi-circular damage in partition of compartment above R2 door

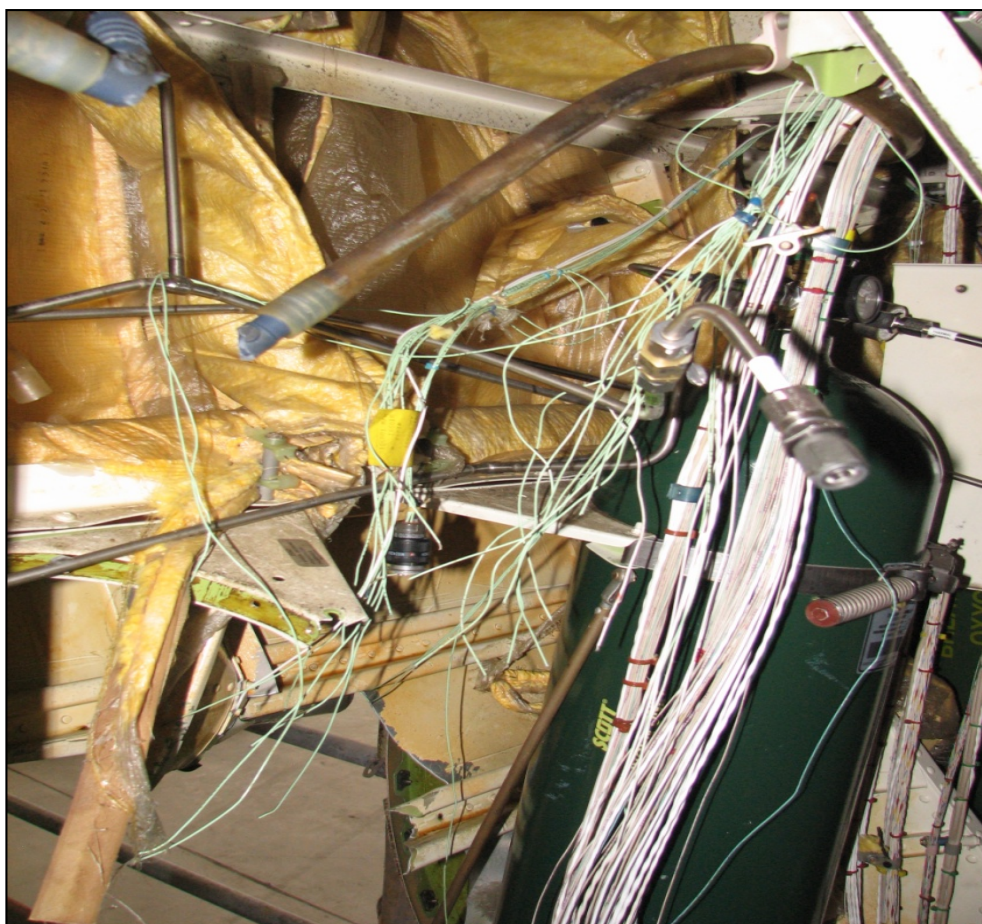
Figure 27: Damaged wiring adjacent to the number-4 cylinder location

Several fractured wires would have affected the functionality of the oxygen system flow control units (FCU) and the system reset solenoid. According to the manufacturer's analysis, the fractured wires would have impaired the flight crew's ability to:

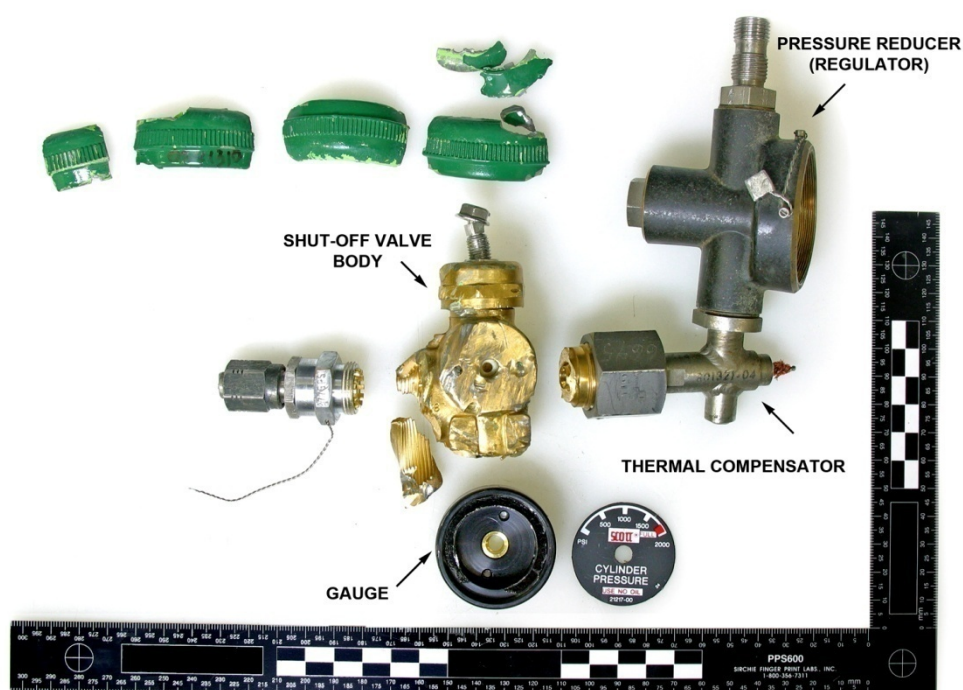
Figure 40: Cylinder number-4 valve components and fragments recovered

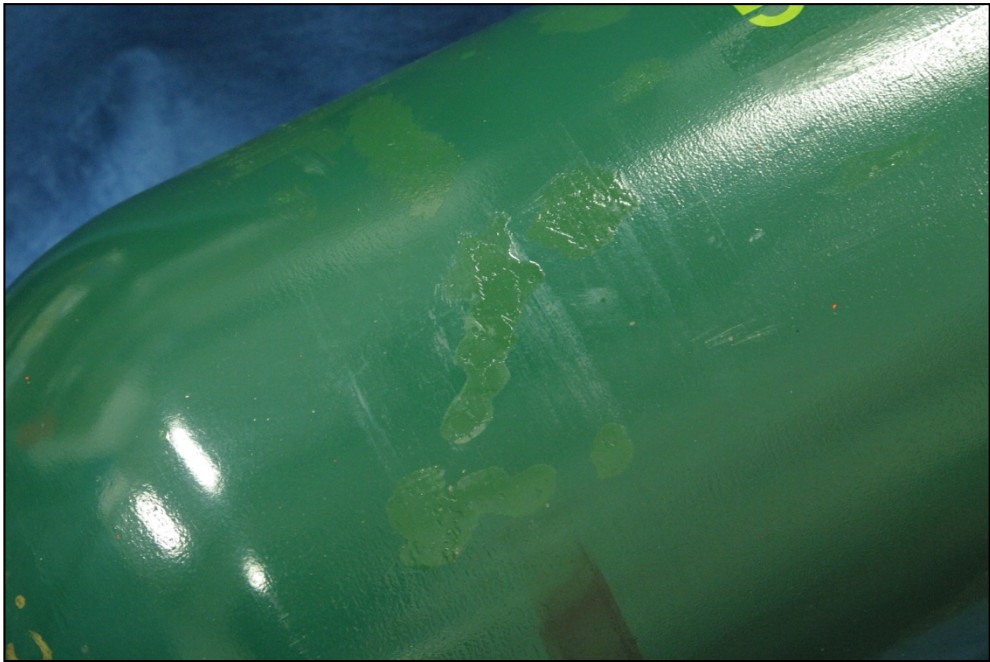
Figure 43: Surface paint repair on cylinder S/N 883198

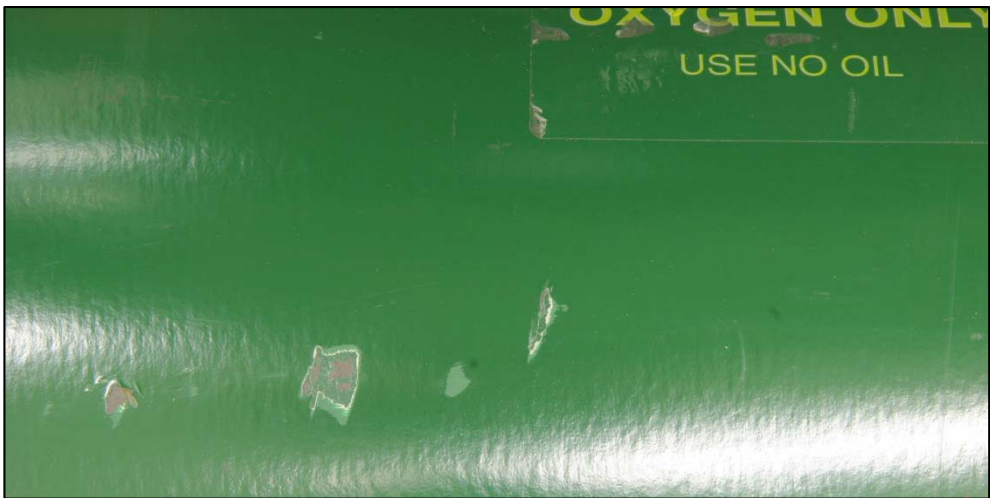
Figure 44: External surface marks on exemplar cylinder S/N 535598

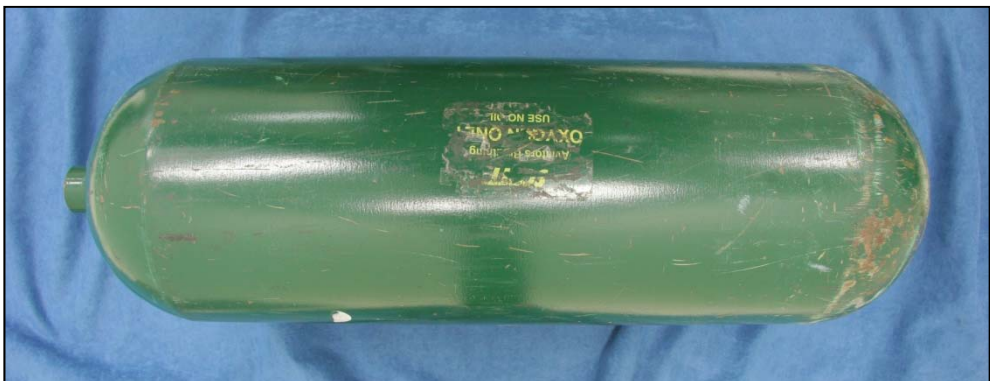
Figure 45: Cylinder S/N 535691 – relatively poor external surface condition

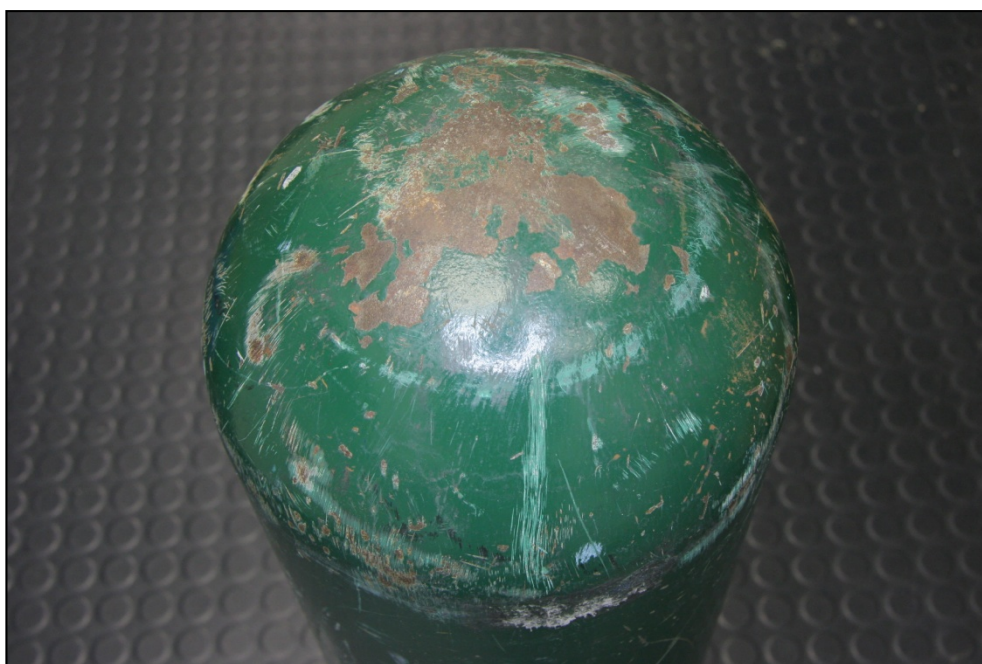
Figure 46: Paint loss and abrasion on lower dome of cylinder S/N 535691

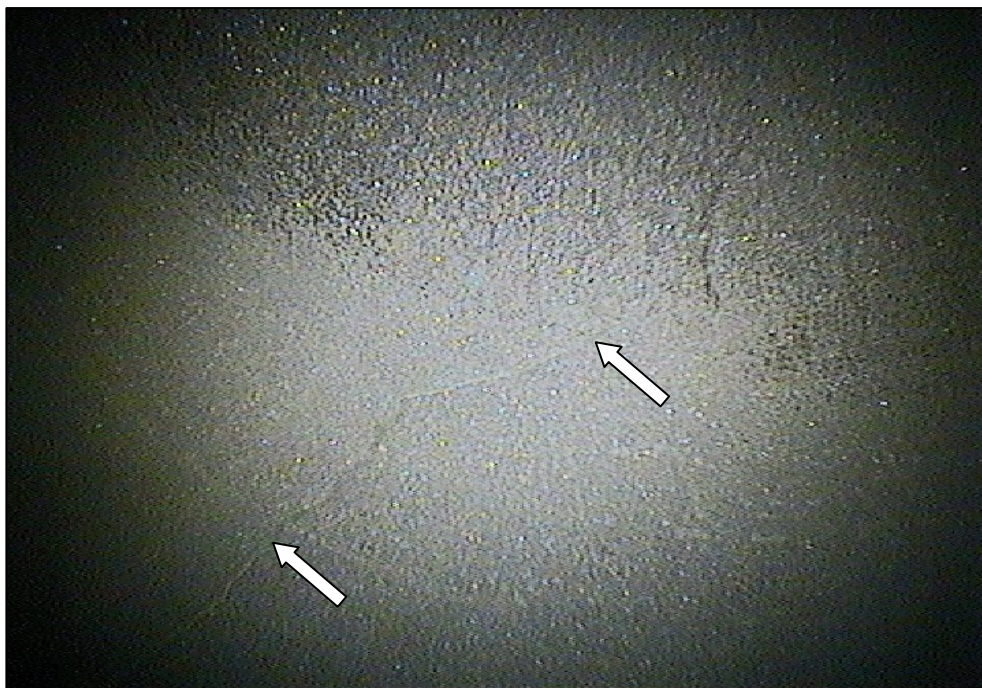
Figure 48: Linear feature observed inside cylinder S/N 535626 (arrowed)

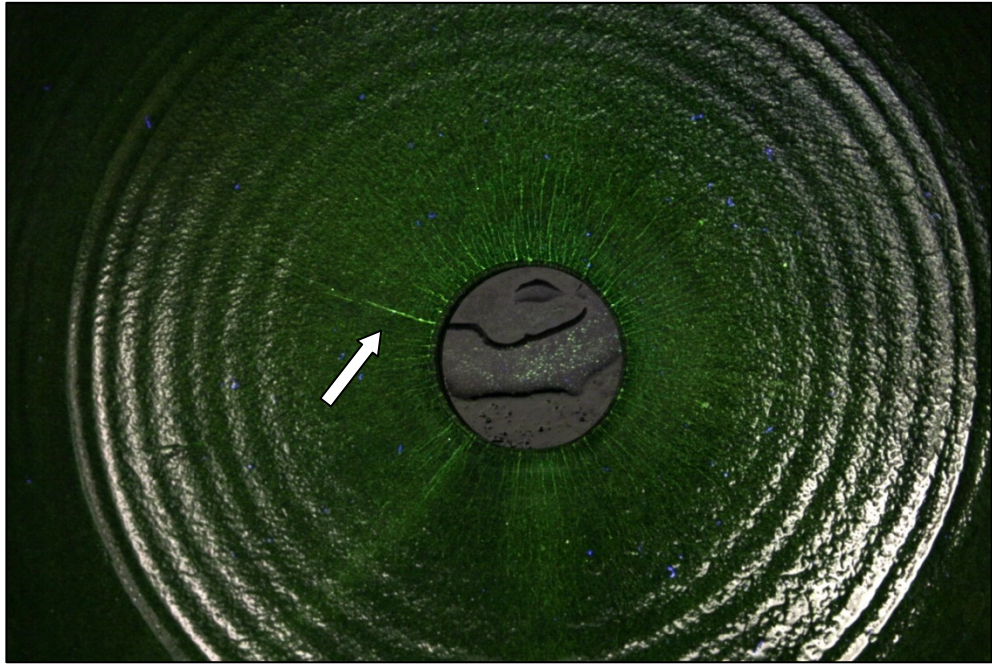
Figure 53: Linear indications extending from the internal neck bore of cylinder S/N 535626 (largest arrowed)

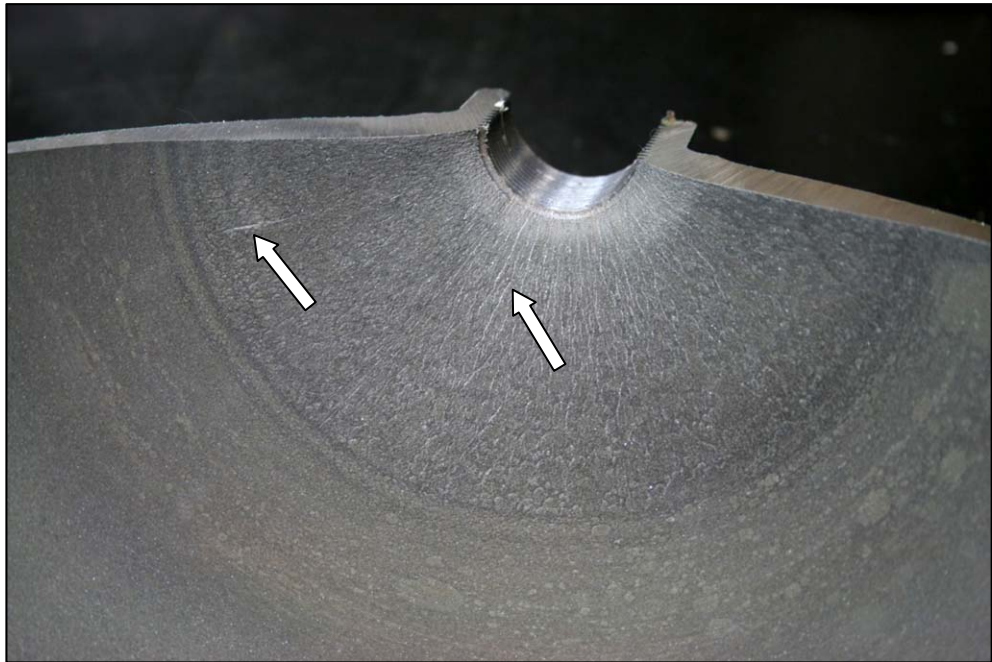
Figure 54: Linear features on the internal surfaces around the cylinder neck

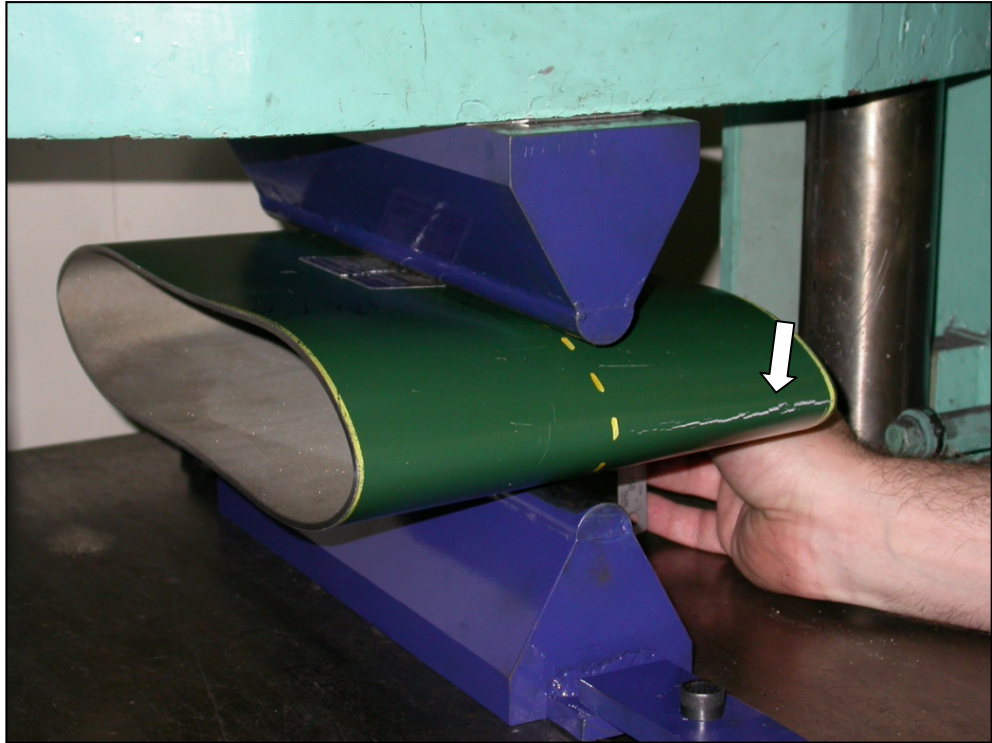
Figure 61: Completed flattening test, with area of cracking arrowed

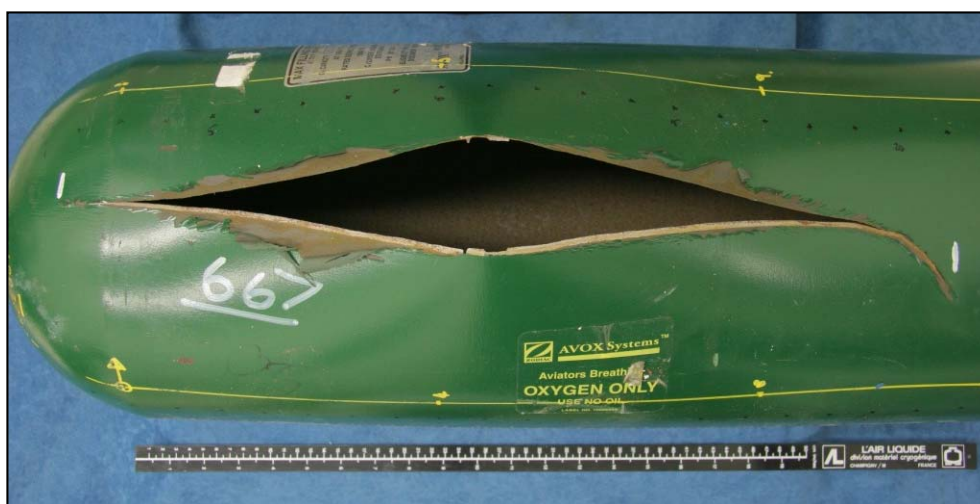
Figure 62: Rupture of cylinder S/N 535667
