ATSB TRANSPORT SAFETY REPORT
Aviation Occurrence Investigation AO-2008-053
Final

Oxygen cylinder failure and depressurisation
475 km north-west of Manila, Philippines
25 July 2008
Boeing Company 747-438, VH-OJK

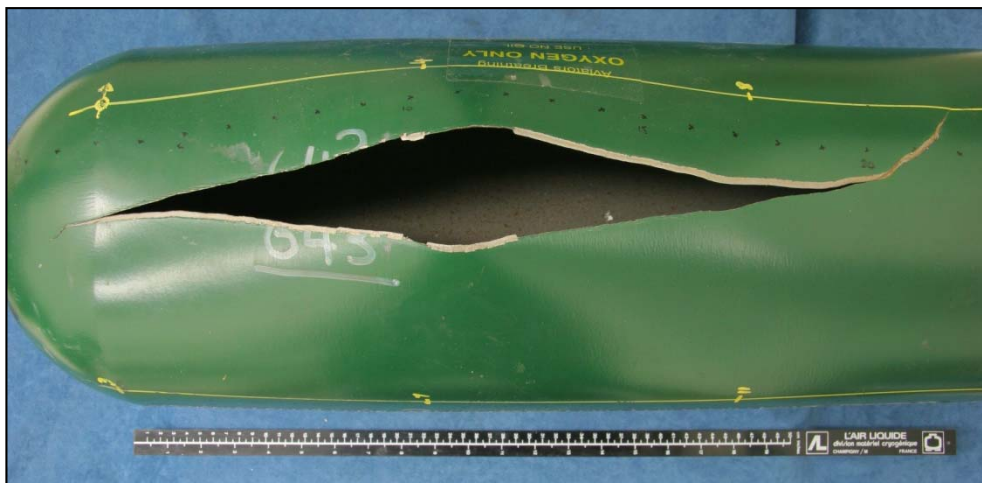
Figure 63: Rupture of cylinder S/N 535643

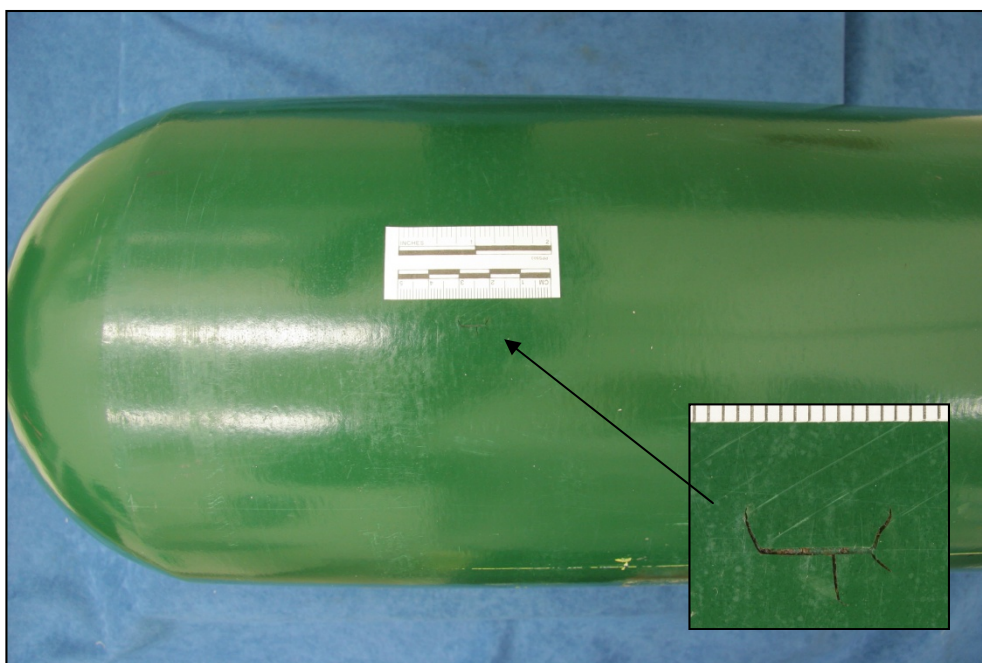
Figure 64: Leak of cylinder S/N 535598

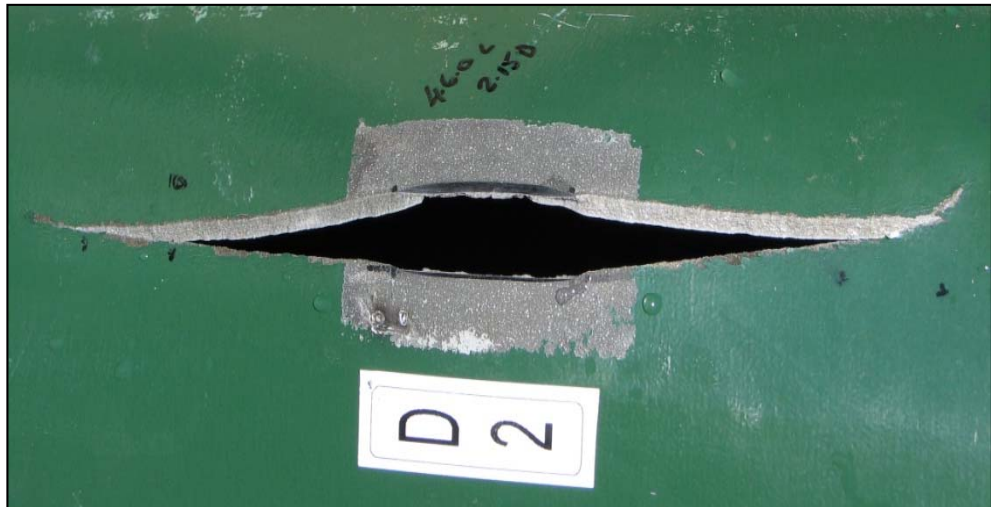
Figure 70: Cylinder 240341 ruptured at a 46.5 mm L x 2.15 mm D artificial flaw (Test No. 7)

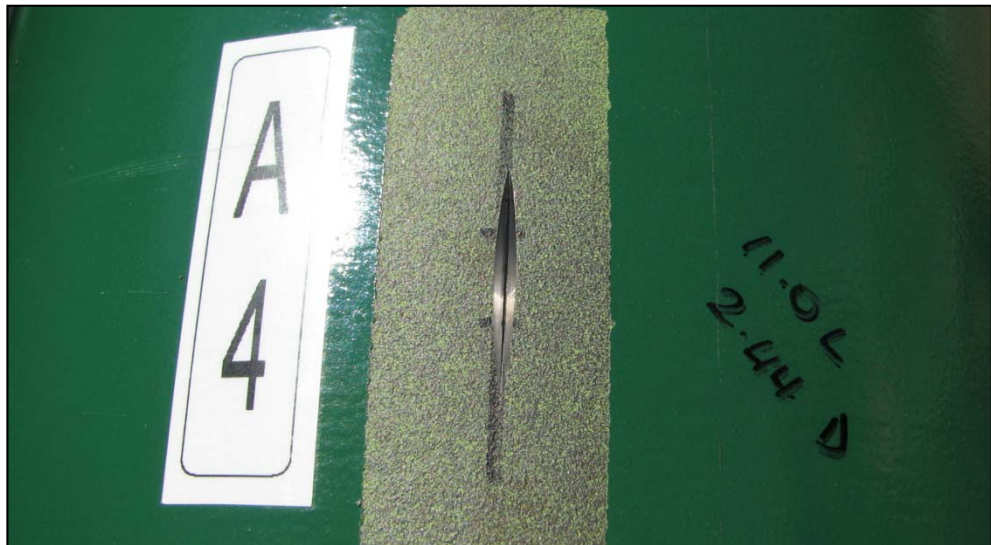
Figure A5: Flaw A4, after testing – failure by leaking

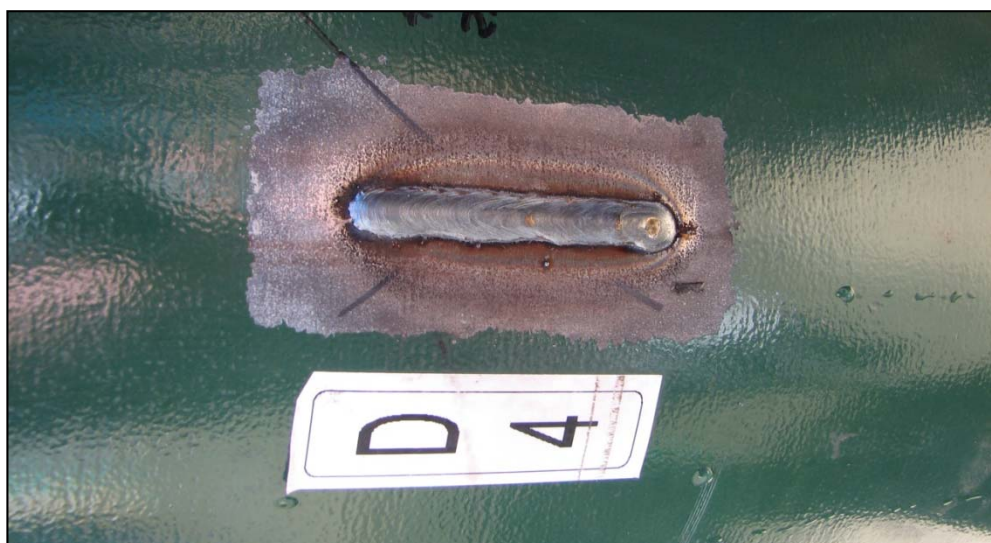
Figure A6: Flaw D4, after failure by leaking and over-welding in preparation for subsequent tests

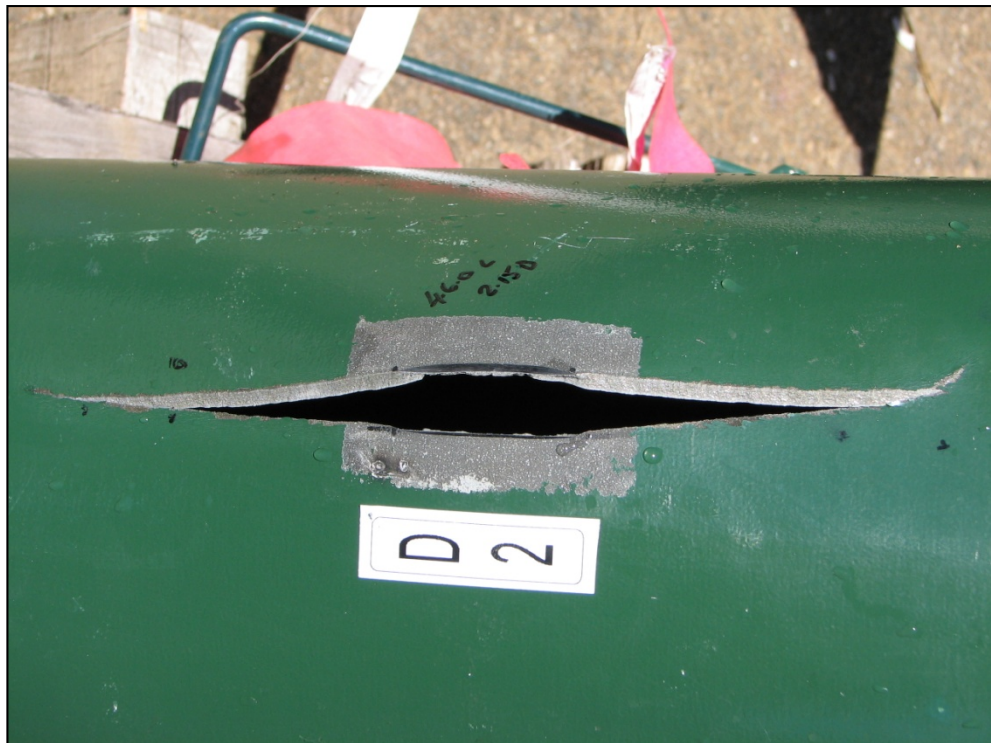
Figure A7: Flaw D2, after testing – failure by bursting (rupture)

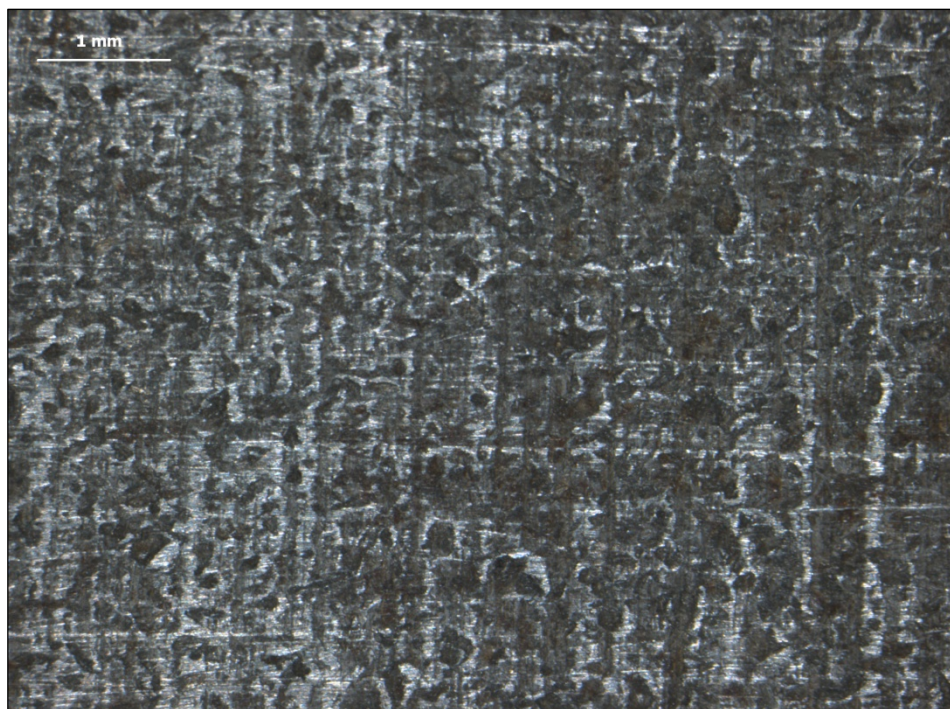
Figure B6: Magnified view of A-Gasol[®] sample shown in Figure B5, showing very minor general corrosion and discolouration

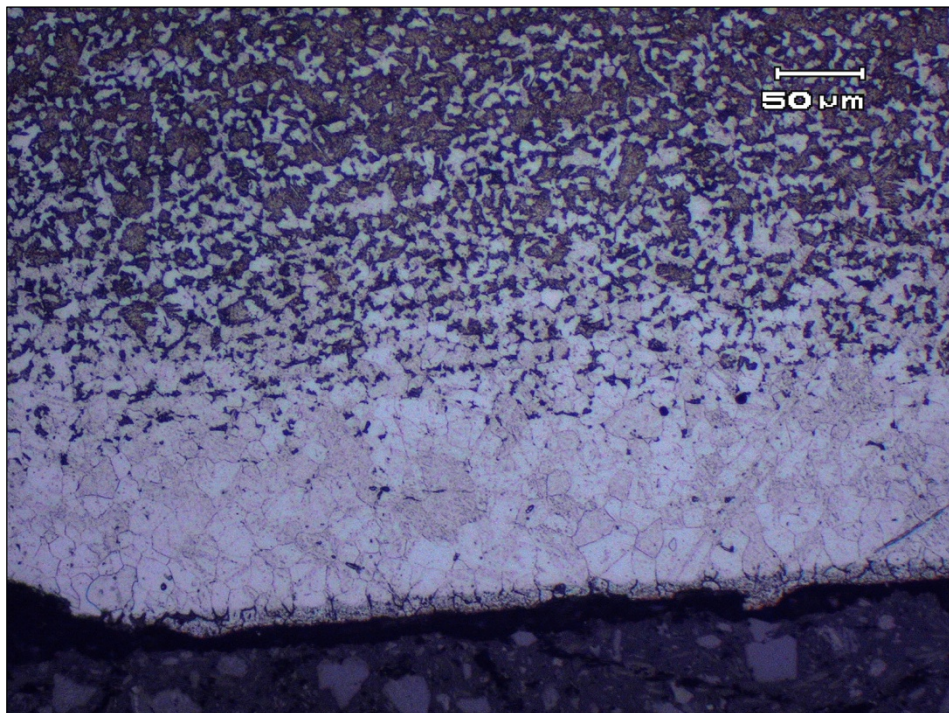
Figure B8: Micrograph of a sample removed from A-Gasol solution. Note the grain boundary penetrations (consistent across all samples). The sample was etched in 2% Nital

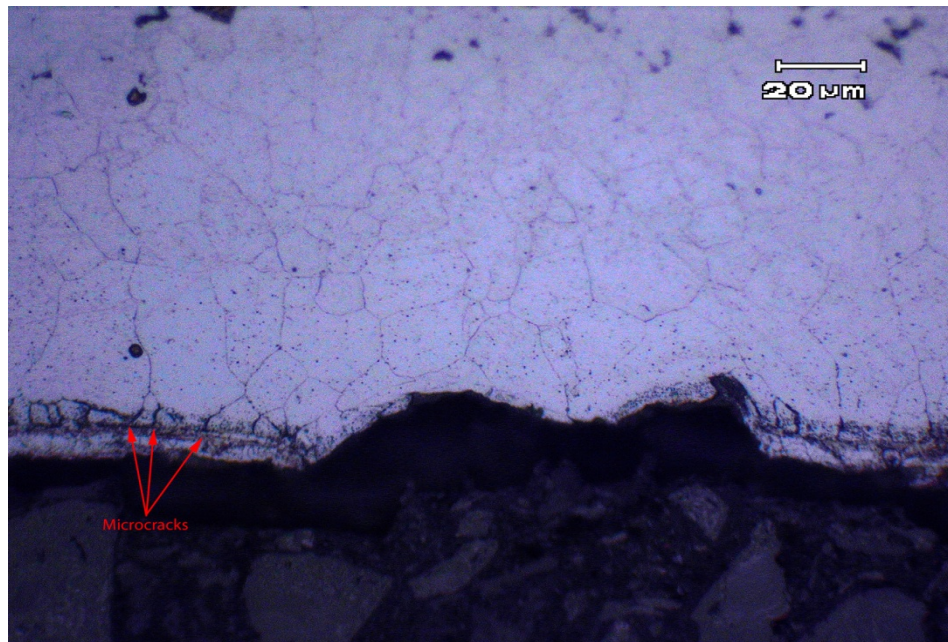
Figure B9: Magnified view of image in Figure B8, showing general corrosion and shallow grain-boundary penetrations
