SERIOUS INCIDENT

Aircraft Type and Registration:	Boeing 777-236, G-YMMP	
No & Type of Engines:	2 Rolls-Royce RB211 Trent 895-17 turbofan engines	
Year of Manufacture:	2001	
Date & Time (UTC):	14 June 2010 at 1617 hrs	
Location:	Singapore International Airport	
Type of Flight:	Commercial Air Transport (Passenger)	
Persons on Board:	Crew - 12	Passengers - 202
Injuries:	Crew - None	Passengers - None
Nature of Damage:	Extensive damage at rear of right engine nacelle and further airframe damage	
Commander's Licence:	Airline Transport Pilot's Licence	
Commander's Age:	44 years	
Commander's Flying Experience:	14,770 hours (of which 4,934 were on type) Last 90 days - 192 hours Last 28 days - 79 hours	
Information Source:	AAIB Field Investigation

Synopsis

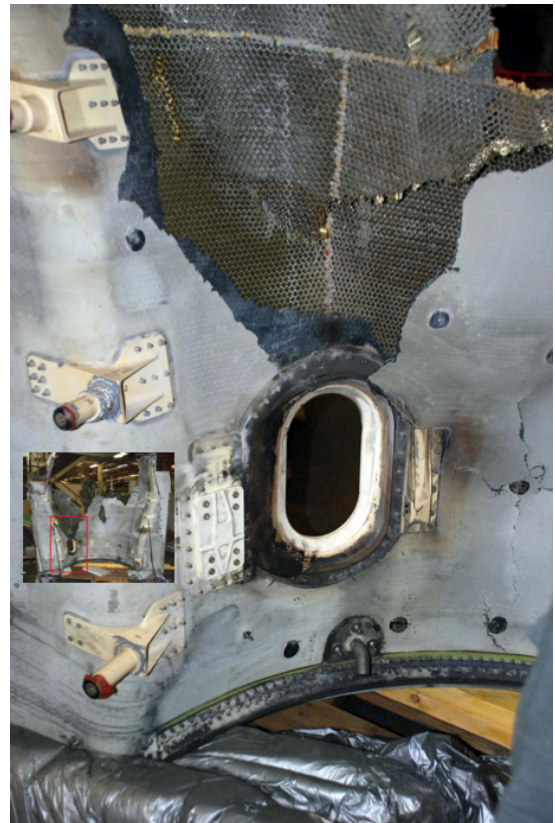
Figure 6

During this examination the manufacturer identified several locations with clear indications of thermal exposure and disbond. Of those, the location of greatest interest was around the drag link fitting, immediately above the HP3 cutout (Figure 6). This was among the more discoloured areas, and it was clearly included in the disbonded region of the panel. The discolouration of

other areas of the inner wall was evidence of overheating at those locations, but the manufacturer reported that discolourations outside the disbond region associated with the panel collapse were ‘*unlikely to be implicated in the failure*’ of the panel. This was consistent with the manufacturer’s initial assessment at Amsterdam.

The manufacturer further noted significant characteristics of the disbonded surface. These included areas with low bond strength, as evidenced by small fillet scars and/or adhesive failure between the honeycomb core and the facesheet, and a region of significantly overheated adhesive between the drag links next to the HP3 cutout.

HP3 duct disbond location
