Accident  
Investigation Board  
Norway

SL 2009/12

**REPORT ON AIRCRAFT ACCIDENT AT ØSTRE  
ÆRA, HEDMARK, NORWAY ON 16. JULY 2004  
INVOLVING ANTONOV AN-28 YL-KAB, OPERATED  
BY A/C RIGAS AEROKLUBS**

Date: 18.06.2009  
SL Report: 2009/12

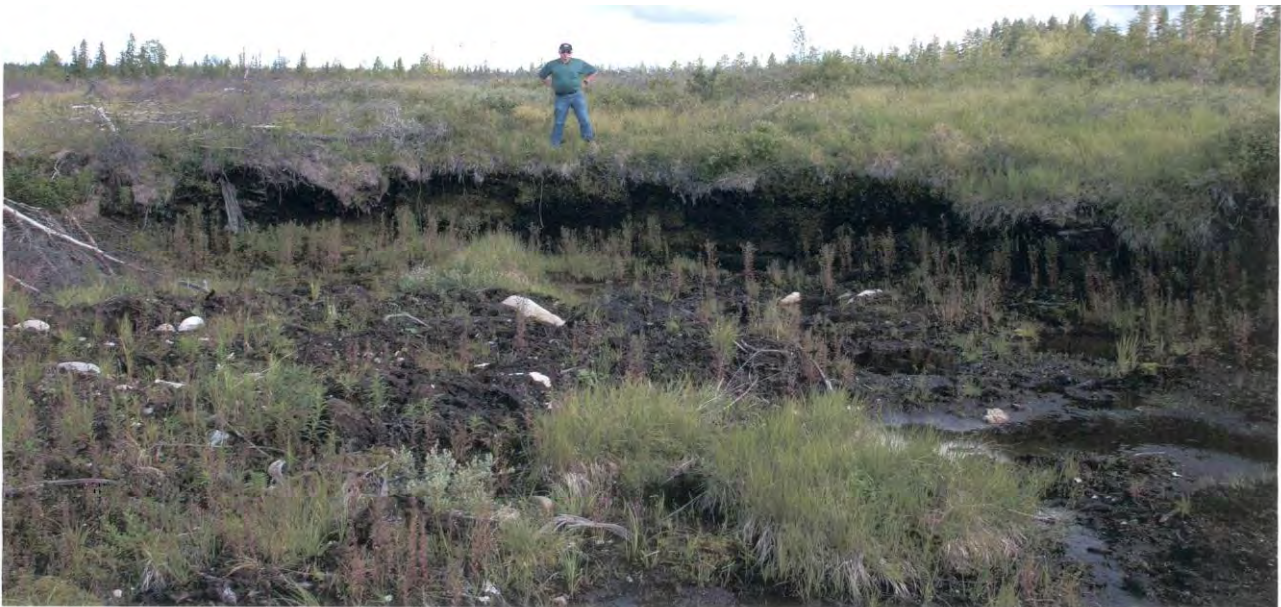
The PF first positioned the aircraft on downwind on a southerly course west of the airfield, in order then to make a left turn to final on runway 01. The landing took place around halfway down the runway, at a faster speed than normal - according to the Commander's explanation approximately 160-170 km/h. The PF braked using the wheel brakes, but when he realized that he would not be able to stop on the length of runway remaining, he ceased braking. He knew that the terrain directly on the extension to the runway was rough, and chose to use the aircraft's remaining speed to lift it off the ground and to alter course a little to the right. The aircraft passed over the approx. 2.5 m high embankment in the transition between the runway level and the higher marshy plateau surrounding the northern runway area, see Figure 1.

*Figure 1: Embankment approx. 60 m beyond the end of the track in the extension of runway 01. The picture has been taken in the direction of travel.*

The AIBN believes that the crew, after having entered this difficult situation, carried out a satisfactory emergency landing under very demanding conditions. The fact of the parachutists being within the approach sector made the scenario more complex, and a landing ahead of the threshold had to be avoided. With the flaps non-functional, it is understandable that the speed was high and the touchdown point not optimal. The fact that the Commander got the aircraft into the air again and landed on the higher marshy plateau, was probably crucial to the outcome. Continued braking would have resulted in the aircraft running into the earth embankment at relatively high residual

The terrain in the extension to runway 01 at Østre Åra, with an approx. 2.5 m high earth embankment around 60 m from the threshold, could inflict severe damage to aircraft and injury to onboard personnel in the event of a potential high-speed overrun. The AIBN recommends that the CAA-N should assess whether it needs to order the owner of Østre Åra airstrip to smooth out the terrain in the extension to runway 01.

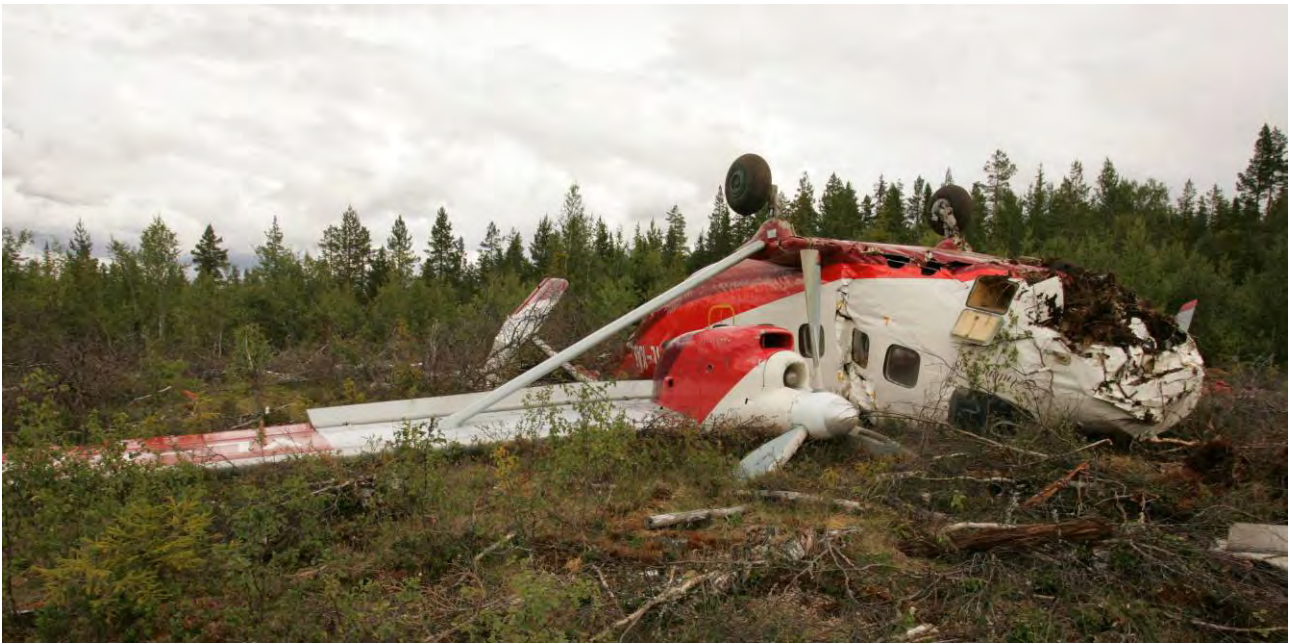
The aircraft ran approx. 230 m in ground effect before landing on its wheels in the flat marshy area north of the airfield. After around 60 m of roll-out, the nose wheel and the aircraft's nose struck a ditch and the aircraft turned over lengthways. It came to rest upside down with its nose section pointing towards the landing strip, see Figure 2. The floor of the cockpit was pushed up so that the nose wheel came through the floor and partially into the cockpit (Figure 3).

*Figure 2: Aircraft wreckage after the accident.*

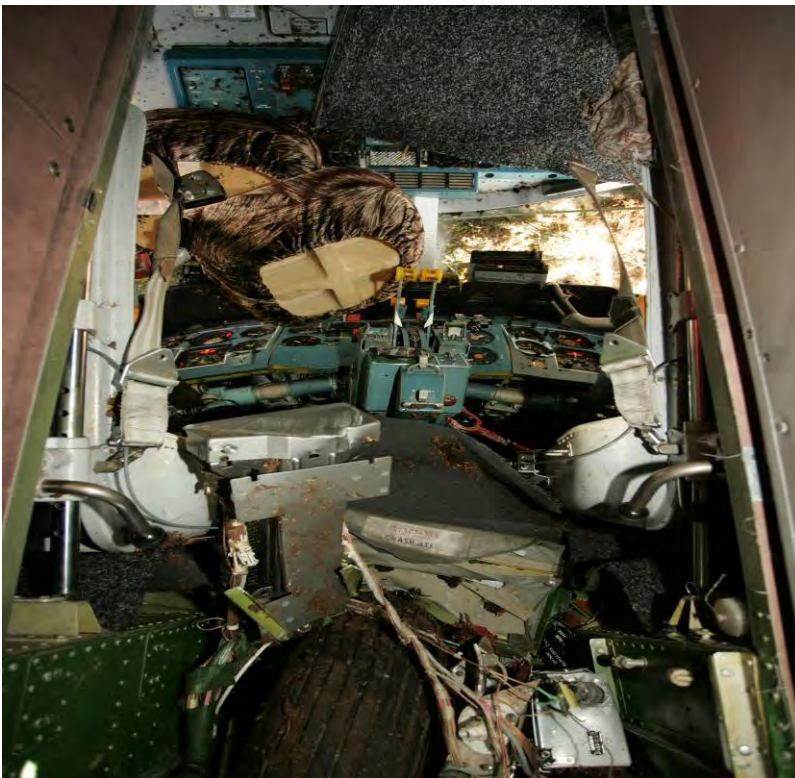
*Figure 3: Cockpit with floor pushed up and the nose wheel penetrating through the floor.*

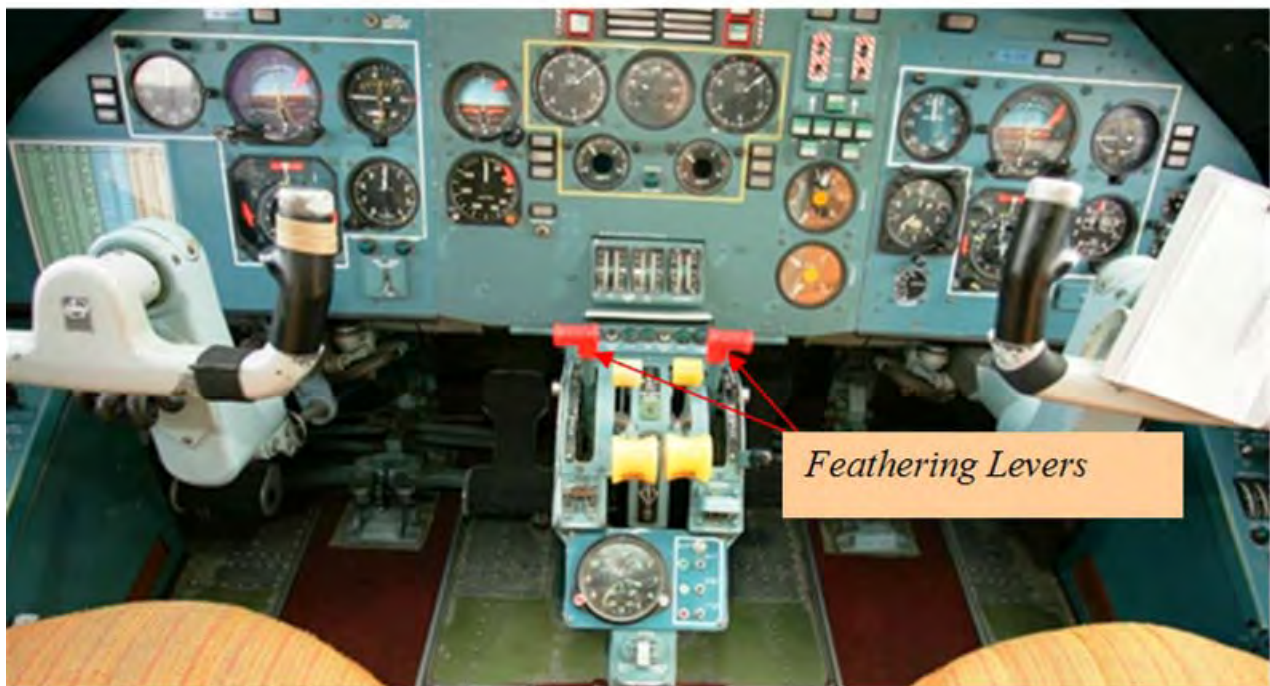
Two red-painted handles (Feathering Levers), one for each engine, are located on either side of the pedestal, between the pilots (see Figure 4). With the handles in the forward position, the automatic feathering system is armed for both engines. According to the aircraft manual, automatic feathering and shutdown of the engine's fuel supply will occur if the combination of compressor rpm and pressure gradient are lower than the set values, 56 % and 2.6 respectively. To avoid this, during a descent no air should be tapped from the engines to the anti-icing system if the compressor rpm is reduced below 72 %.

Figure 4: AN-28 Flight Deck with instrument panel, central console and red Feathering Levers.

In the folder in the cockpit there was a procedure for starting engines in the air. The procedure contained an item about verifying that the Feathering Lever is in the forward position, but did not mention that, after automatic feathering of the propeller, it is first necessary to re-arm the system. According to the explanation given by the crew of YL-KAB, both Feathering Levers were in the

The experienced Commander assessed the distance to the cumulonimbus cloud as sufficient to allow the drop to be carried out, and expected that they would then rapidly make their way out of the exposed area. It appeared, however, that problems arose when the aircraft was exposed to turbulence and icing from the cloud. The AIBN believes the limits of the engines' operational range were exceeded since the anti-icing system was switched on while the power output from the engines was low, in combination with low airspeed, turbulence and sudden manoeuvring. At that, both engines stopped, and the propellers were automatically feathered. The AIBN believes the engines would not restart because the Feathering Levers were not moved from the forward to the rear position and forward again, as is required after automatic feathering.
